Welcome to Wheaton Revitalization News!

Look Ahead - Week of November 26 to December 2

Installation of Tie-Back Anchors & Support of Excavation System (SOE)

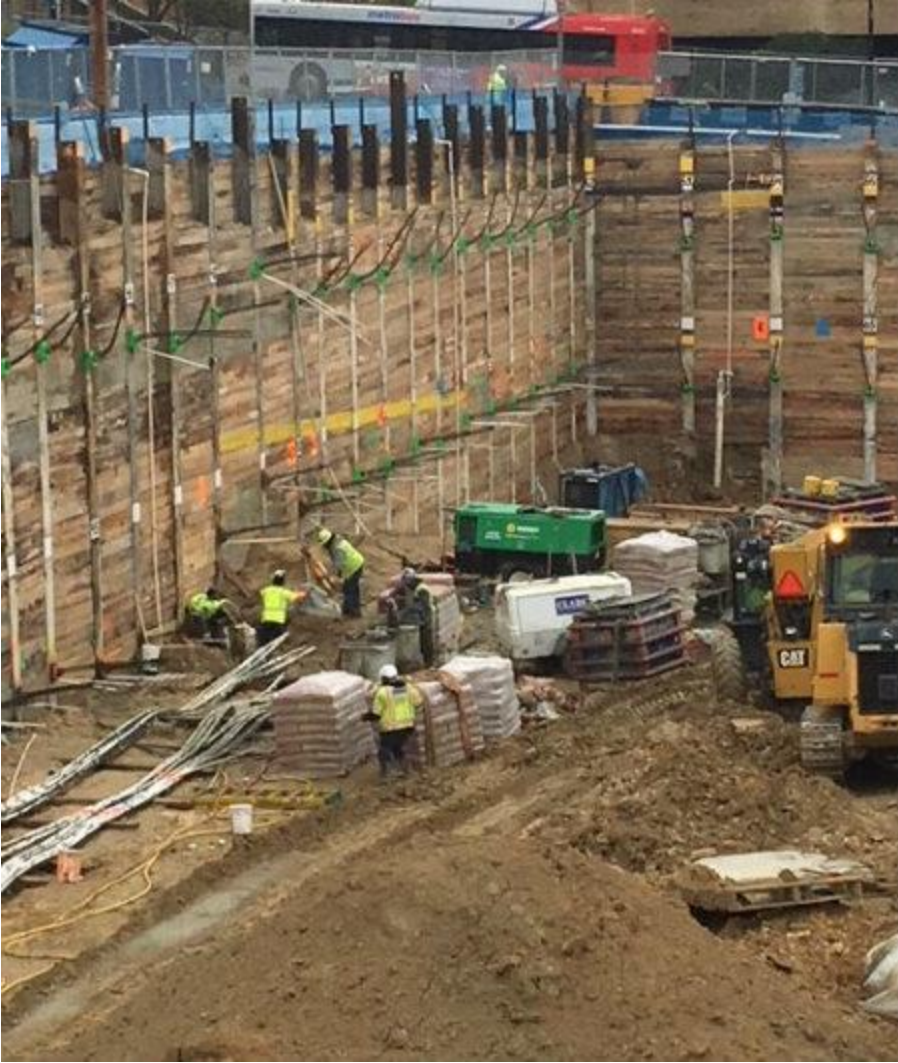
The Hole Deepens at the South End near Reddie Drive

The Support of Excavation (SOE) system continues to advance as the ongoing excavation deepens the hole. Currently, the depth of the excavation has exceeded 40 feet in places - advancing towards 55 feet which is the bottom of the hole. (See photos)

Mass excavation for the building’s foundation continues. Currently, the contractor has excavated upwards of 40 feet deep in places (see photo), and continues excavating daily. The bottom of the hole is expected to be reached in early-January 2018, weather permitting.

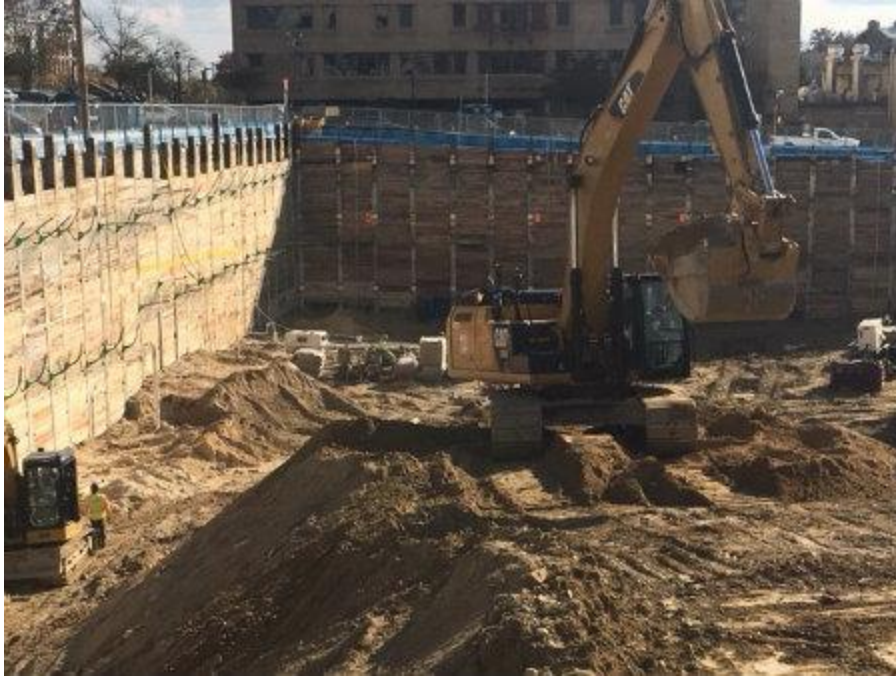
Excavator Removing an Earthen Ramp

To excavate the entire hole, the contractor must continually “move the access ramp around” to complete the excavation in rectangular fashion. At some point, the ramp itself must be excavated. Interestingly, at the end of the process, the excavation equipment must be air-lifted from the bottom of the hole with the use of a crane since the last order of business is to excavate the access ramp from top-to-bottom.
