Welcome to Wheaton Revitalization News!

Look Ahead - Week of October 29 to November 4

Installation of Tie-Back Anchors & Support of Excavation System (SOE)

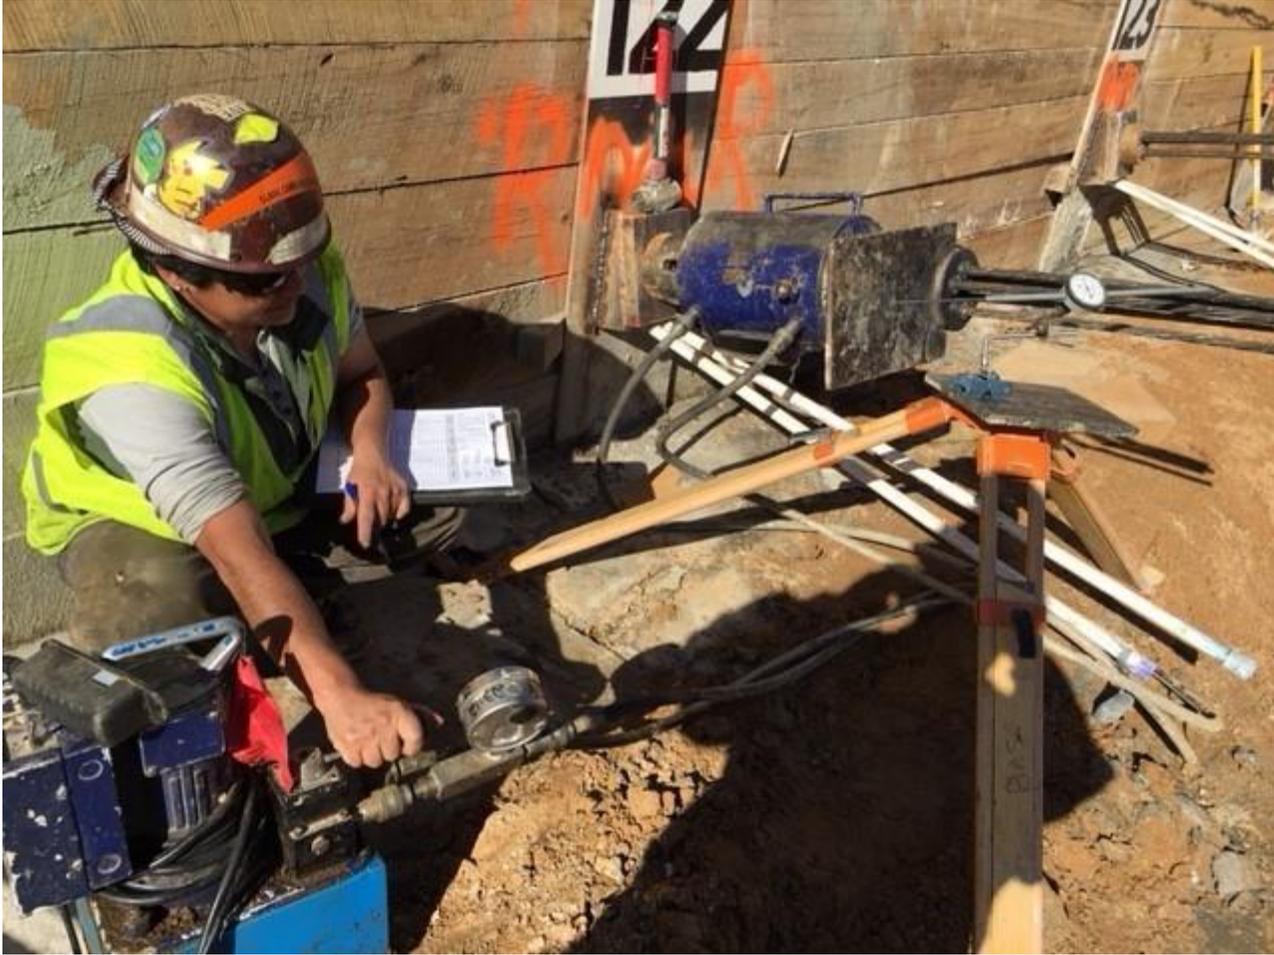
Hydraulic Jack-out Testing of Embedded Tie Back Anchor

The Support of Excavation continues to advance with the depth of excavation. Installation of tie-back anchors (see photo) continue as the excavation deepens. Likewise, hydraulic “pull-out” testing of tie back anchors is in progress (see photo). A hydraulic jack is calibrated to exert a specified “pull-force” on the grouted tie back anchor. Elongation of the anchor is measured and recorded and compared to “allowable and expected elongation”. The extent of elongation under the specific imposed hydraulic load determines whether the anchor is fully engaged (set) or must be replaced. This test ensures embeddedness and the subsequent integrity of the anchor.

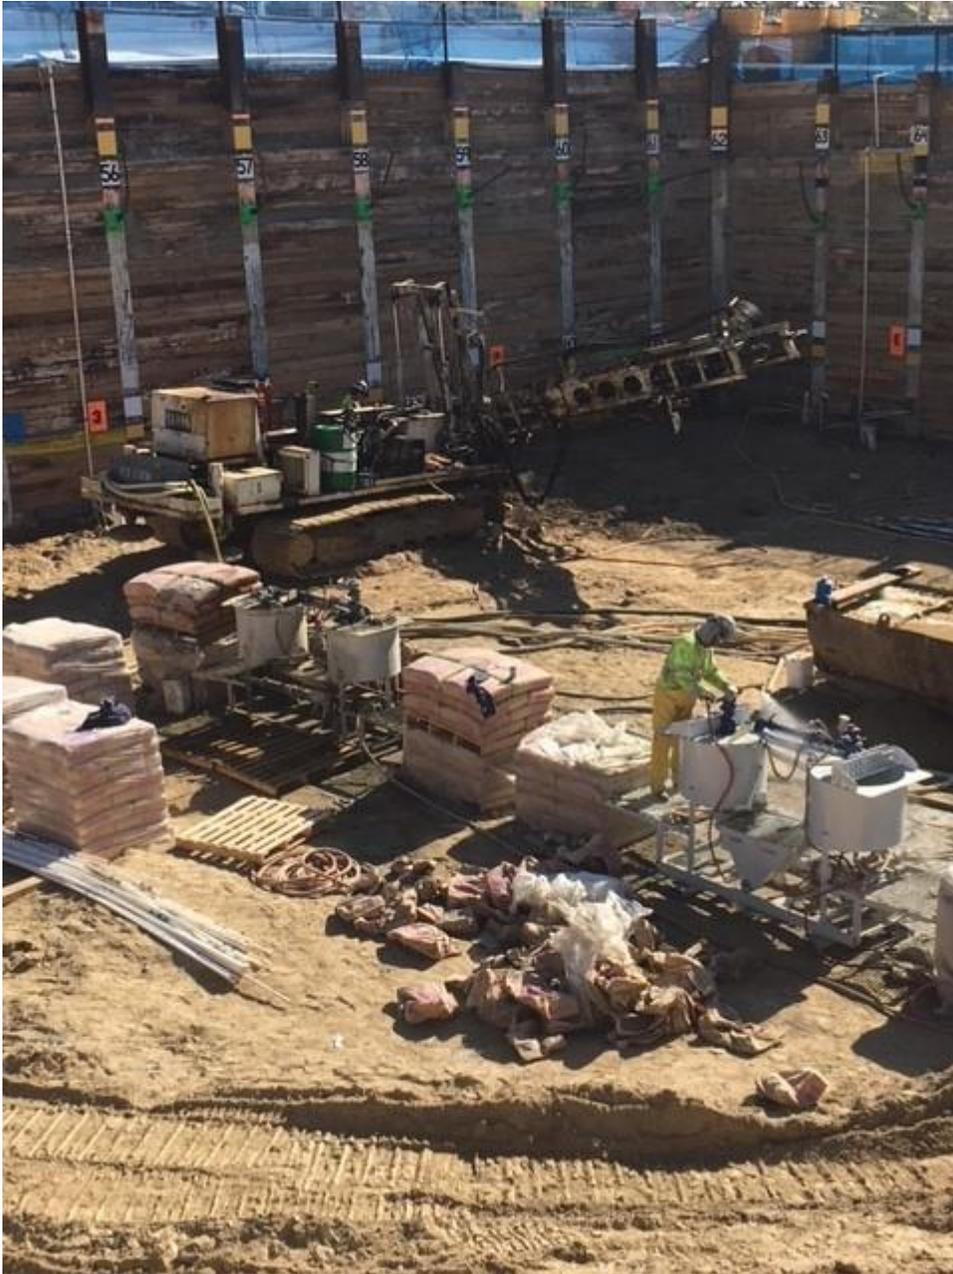
Tie Back Drill Rig (background)

Grout Operation (foreground)

In all, three (3) tiers of tie-back anchors will be installed as excavation advances to the bottom of the hole. Installation of the second tier of tie back anchors has commenced. As noted in previous reports, tie-back anchors are an integral part of the Support of Excavation system. The Support of Excavation system will advance to the bottom of the hole along with excavation to allow for construction of the building’s foundation.
