WETLAND INVESTIGATION REPORT

FOR ACTIVITIES TO IMPLEMENT 2005 BASE REALIGNMENT AND
CLOSURE ACTIONS

NATIONAL NAVAL MEDICAL CENTER
BETHESDA, MARYLAND

March 2008

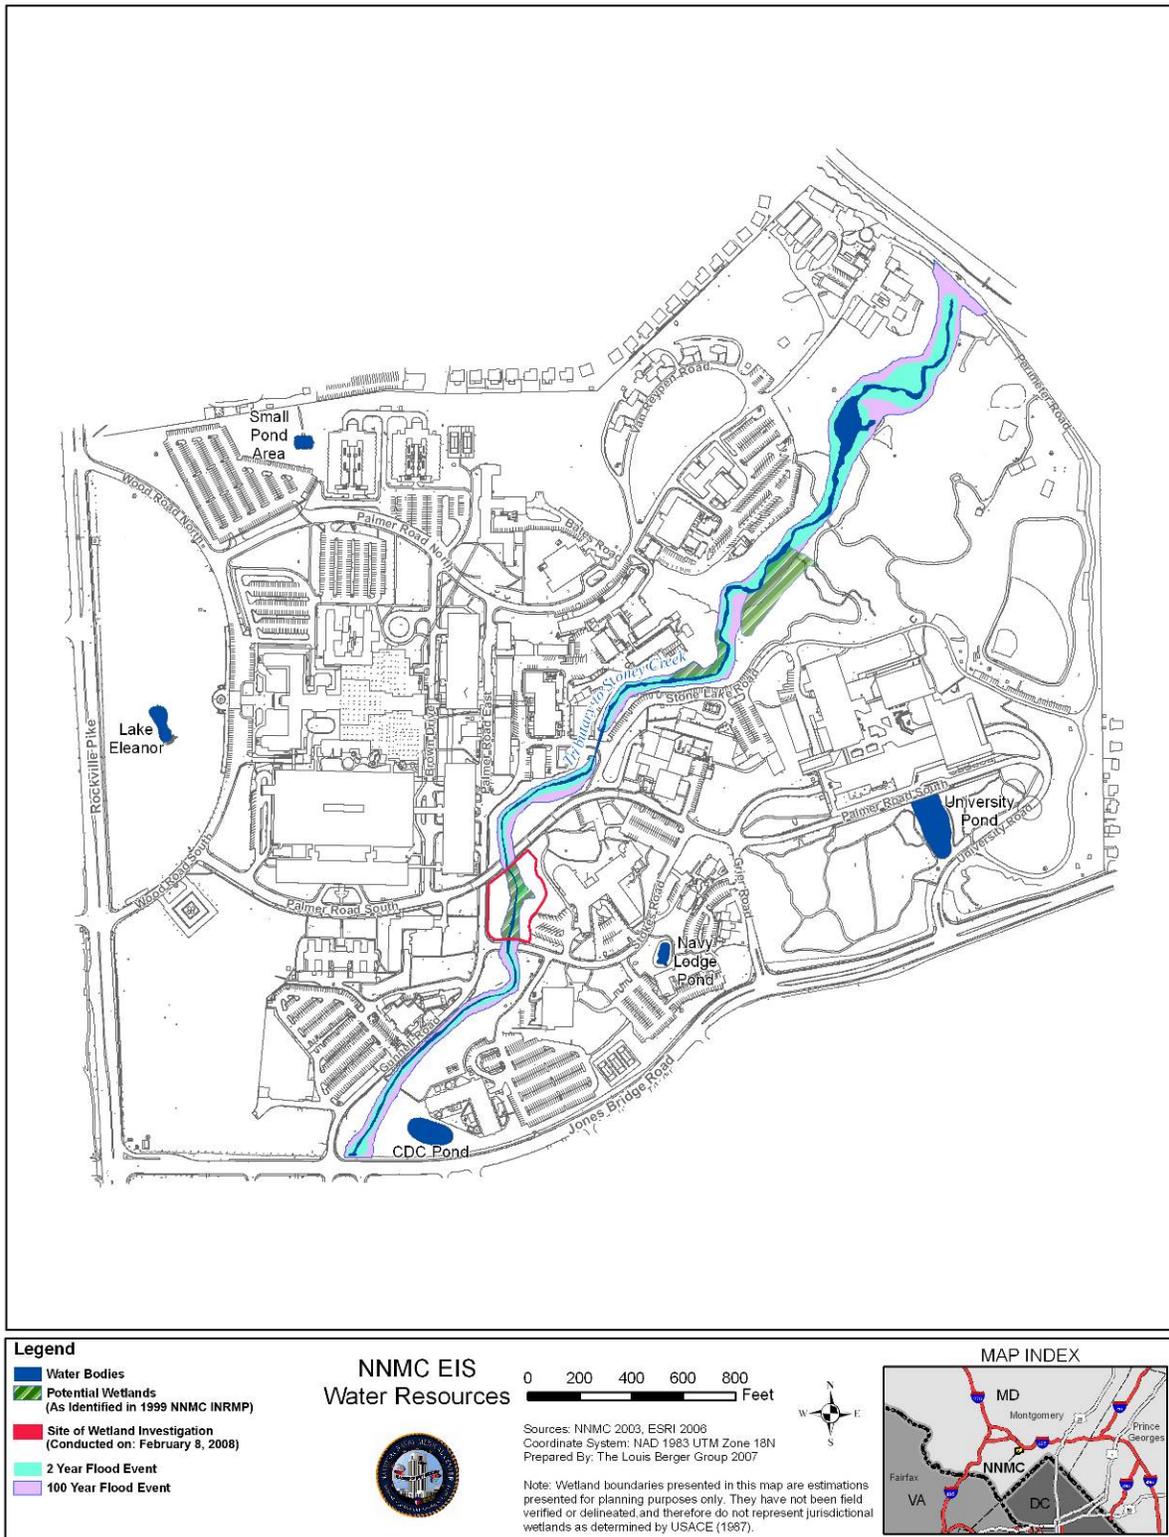
Figure 1-1: NNMC Investigation Site

To determine the presence or absence of wetlands, an on-site investigation was conducted to identify any wetlands and other waters of the United States that may be affected by this proposed action. This wetland investigation report supports the EIS, for the Navy's Proposed Action of providing the necessary facilities to implement BRAC 2005 actions at NNMC. The area investigated (herein referred to as the study area) is less than 1.0 acre, and is located along both sides the unnamed tributary to Stoney Creek bounded by Gunnel Road to the west, Palmer Road South to the north, Building 23 to the East, and Stokes Road to the south. This area is located directly west of the proposed South Parking Facility (Figure 1-1).

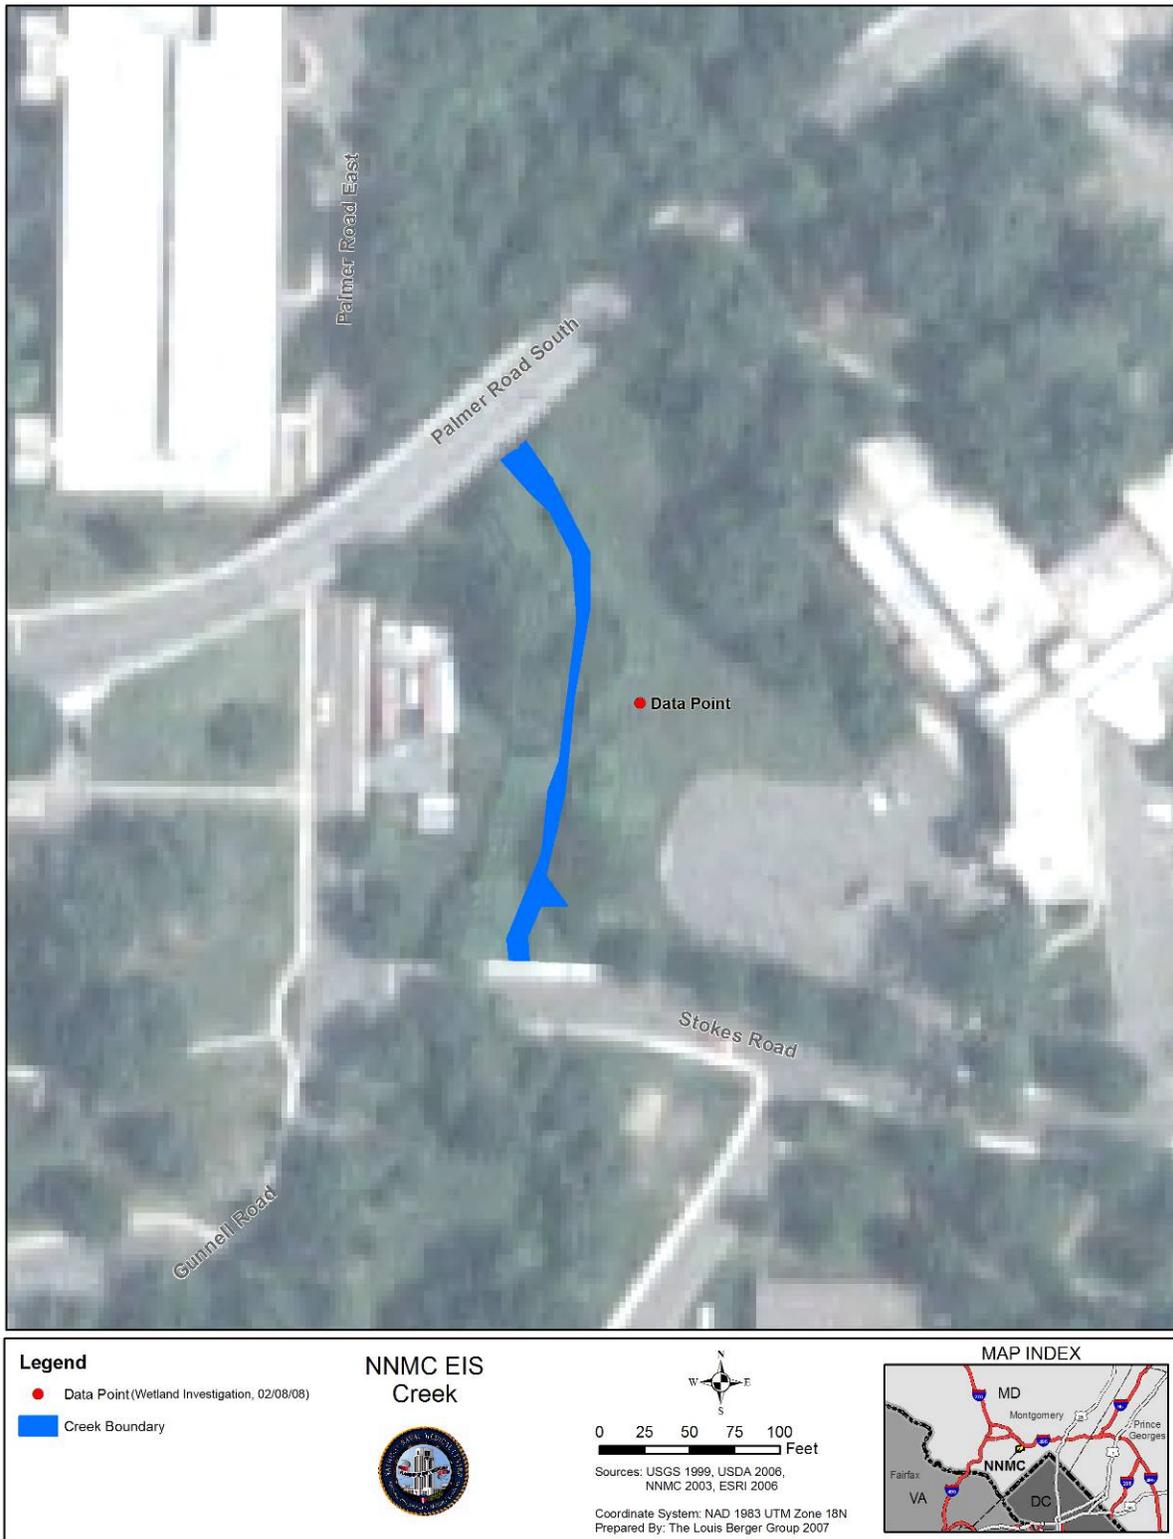
Figure A-1: Map of Study Area

Results of the wetland investigation show one watercourse (the unnamed tributary to Stoney Creek) and no wetlands occur within the study area. The watercourse accounted for a total of .058 acres (.0235 ha) of the study area. This watercourse is characterized as a riverine lower perennial creek with an unconsolidated bottom made up of gravel and cobble. It runs the entire length of the study area, entering the study area from underneath the bridge on Stokes Road and exiting beneath the Palmer Road Bridge. The banks of this watercourse are typically 3 to 6 feet apart and 0.5 to 2 feet high, with several stormwater outfalls draining into this stretch. Much of the banks along this stretch have been armored with boulders. This stream has perennial system characteristics such as evidence of bed and bank, gravel bars and sediment sorting. There was also some meandering in the stream and some small riffles and pools.

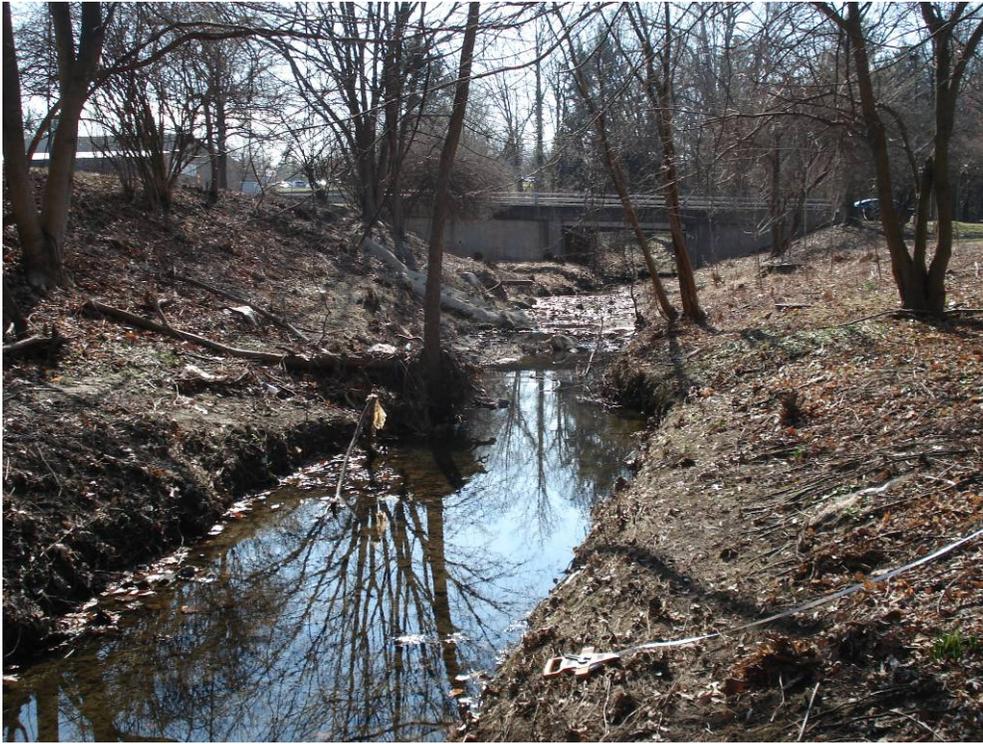
Figure C-1 Watercourse A (Southern View/Upstream)

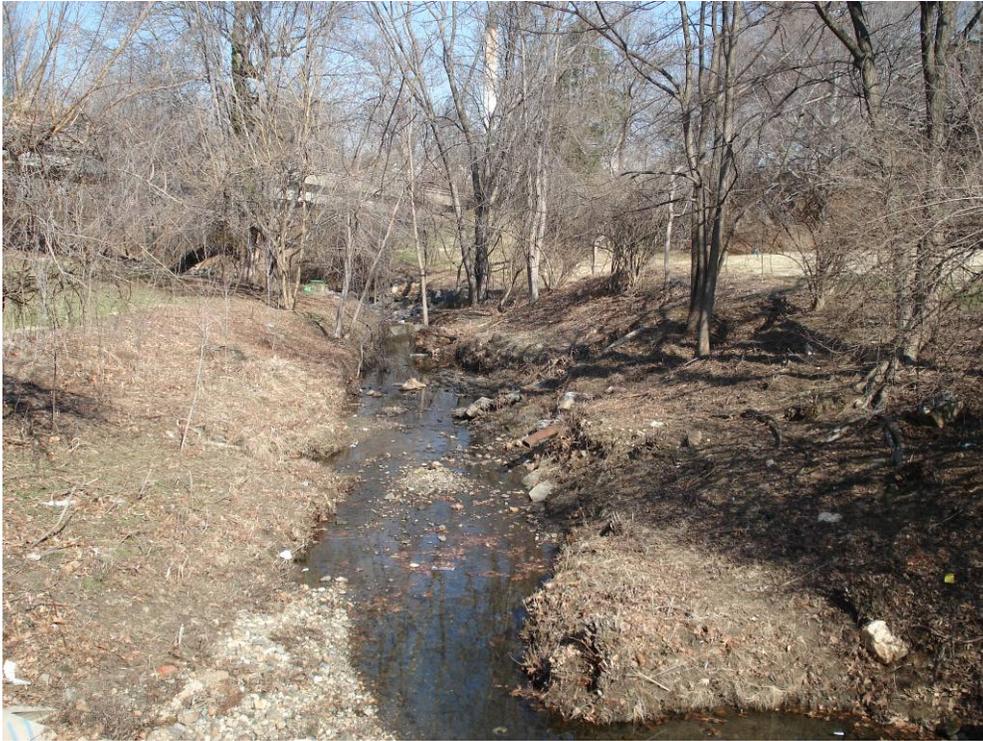
Figure C-2: Watercourse A (Northern View/Downstream)

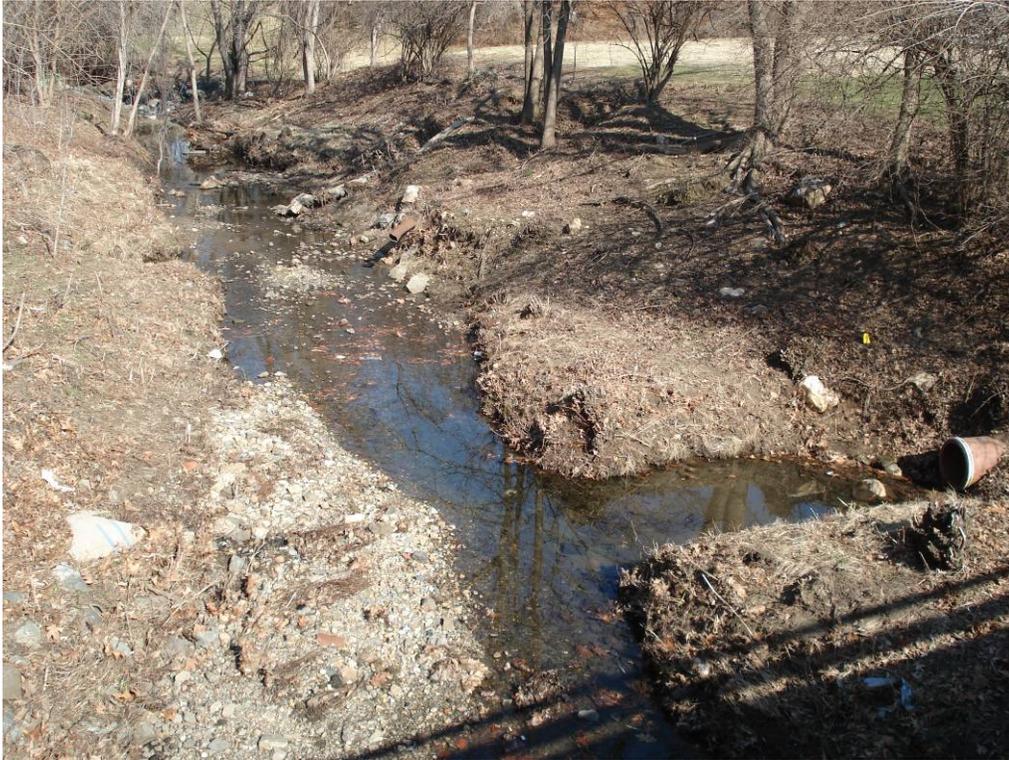
Figure C-3: Watercourse A (Northern View/Downstream) First Stormwater Outfall Downstream from Stokes Road Bridge

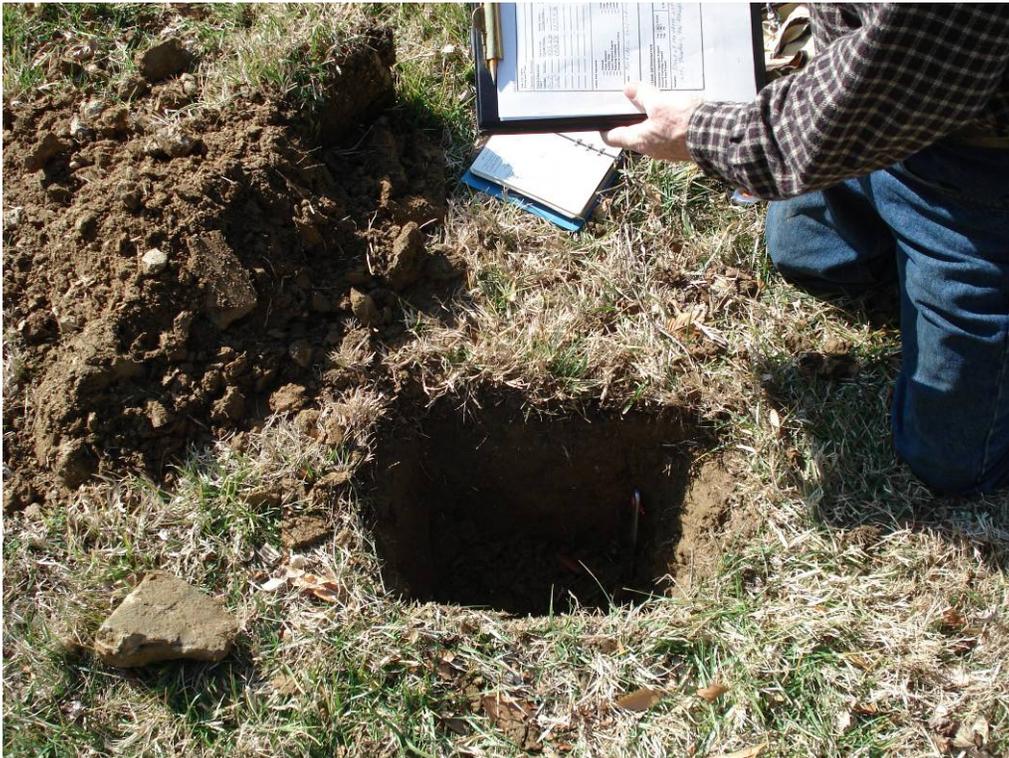
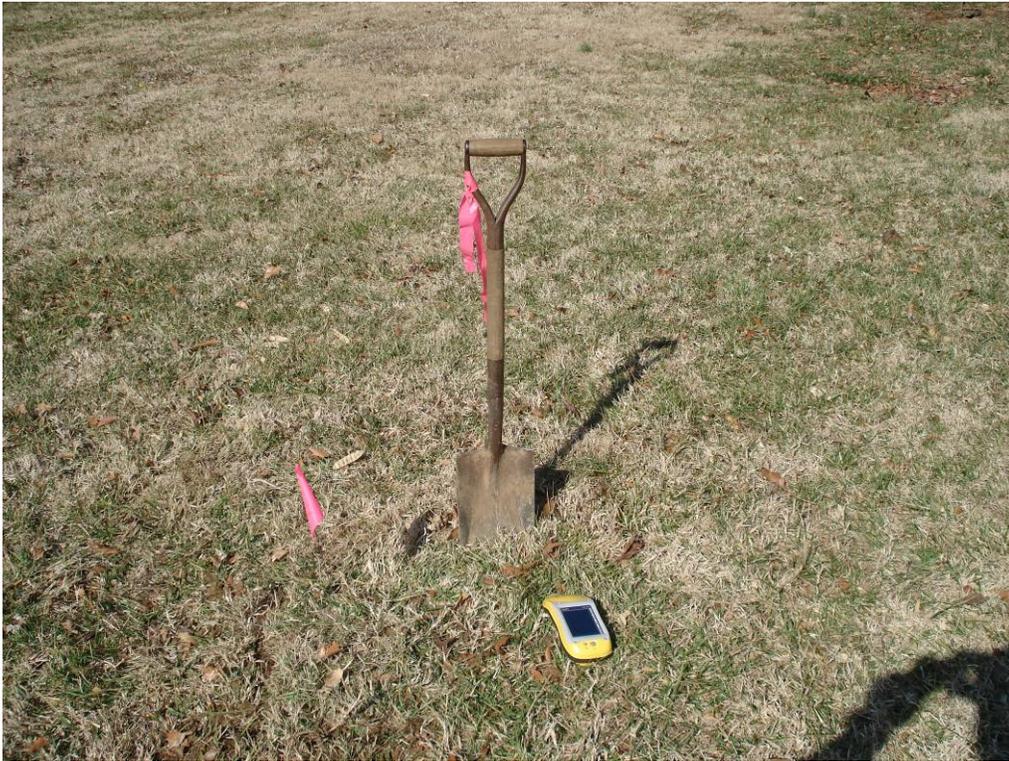
Figure C-4: Data Point Test Pit

probe. This general reconnaissance of the site revealed no obvious indications of wetlands on the site (i.e., no hydrophytic vegetation, no signs of hydrology, and no hydric soils). To confirm these findings, a data point was then taken at the point of lowest elevation in the study area. A soil test pit was excavated to look for the presence of hydric soils. No hydric soil indicators were found within the soil test pit. There was no hydrophytic vegetation, and no signs of wetland hydrology. See Appendix B for complete data sheet.

On-site field investigations, however, revealed that the soils present differed slightly from the documented NRCS mapping unit. The general texture of the soil observed at the soil test pit was loamy with gravel and mica present and mottles were present below 7-inches. The soil color was 10YR 3/4 to 7-inches and 10YR 4/4 below 7-inches. The color of the mottles was 7.5YR 4/6. There also appears that some of the soils within the study area have been modified with fill material.

Depth (inches)	Horizon	Matrix Color (Munsell Moist)	Mottle Colors (Munsell Moist)	Mottle Abundance/ Size/Contrast	Texture, Concretions, Structure, etc.
0-7"		10YR 3/4	n/a	n/a	loam; gravel; and mica present
7-15"		10YR4/4	7.5 YR 4/6	few, medium, prominent	loam; gravel; and mica present
