## PARKS/FIDS/FOREST MITIGATION

## **NATURAL RESOURCE INVENTORY BETHEL CHURCH PROPERTY**

RK&K conducted a Natural Resource Inventory on the Bethel Church property in Germantown, Maryland, during April through June 2013. The Bethel Church property is a 119.4-acre site bounded on the north by Wilson Farm and residents of 22001 and 22005 Wildcat Road; on the south by Brink Road; on the east by residences on Davis Mill Road; and on the west by residences on Treva Court (see NRI Plan in **Appendix D**).

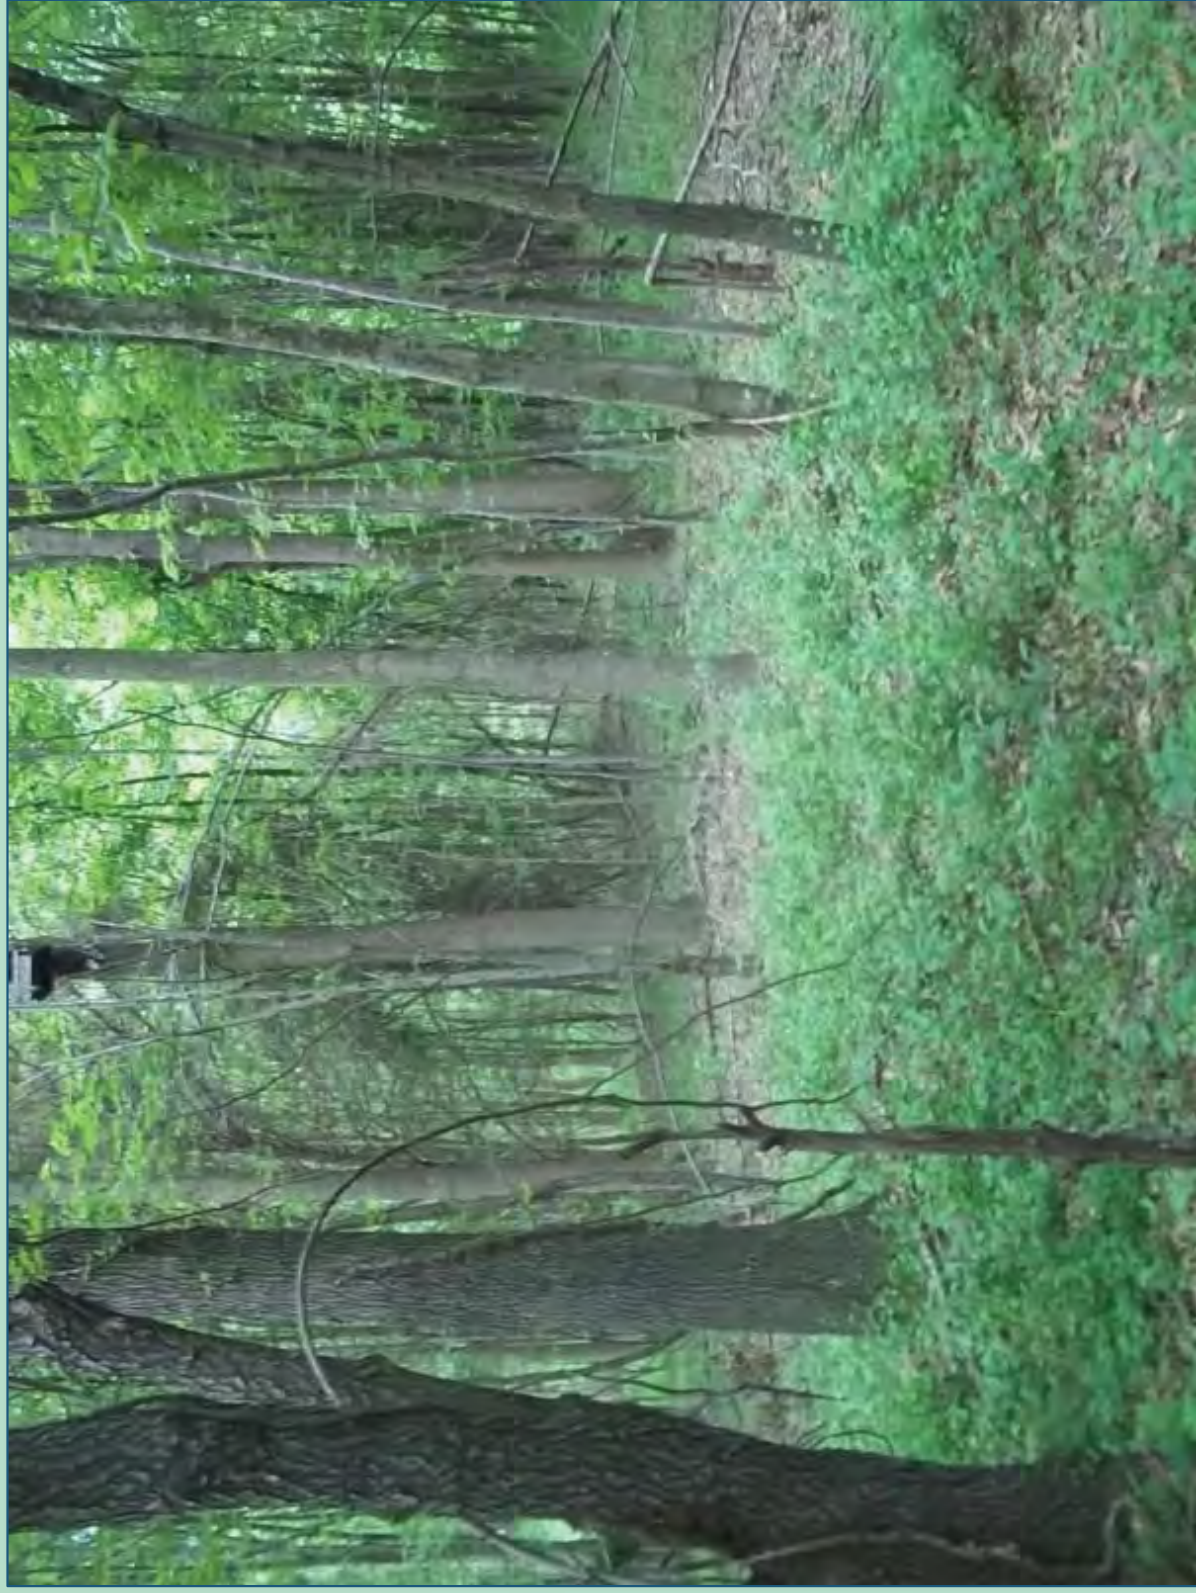
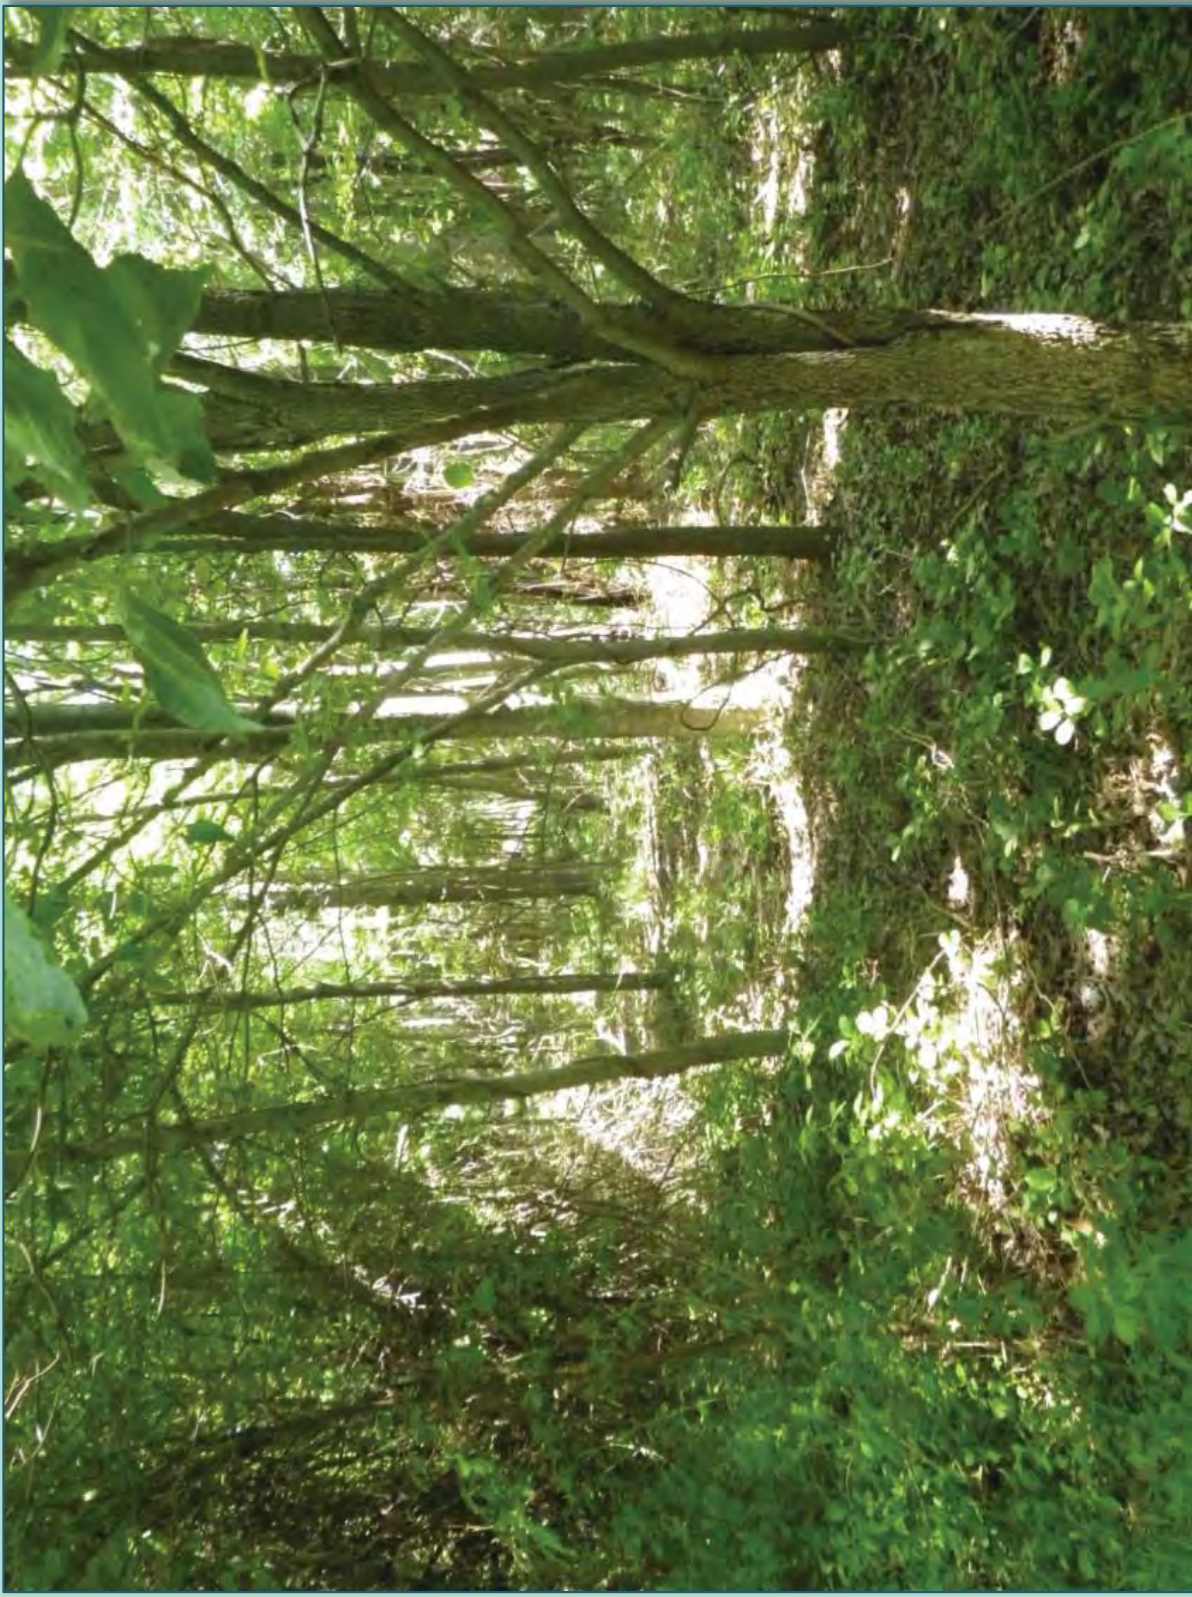
## Bethel Church – Forest Stand 1

Canopy closure is estimated at 70-80% and downed woody debris was moderate. FS1 has a fair forest condition rating and a low Forest Retention Value since it contains only one specimen tree and is used as a wildlife corridor with moderate wildlife habitat value, and contains moderate invasive plant cover.

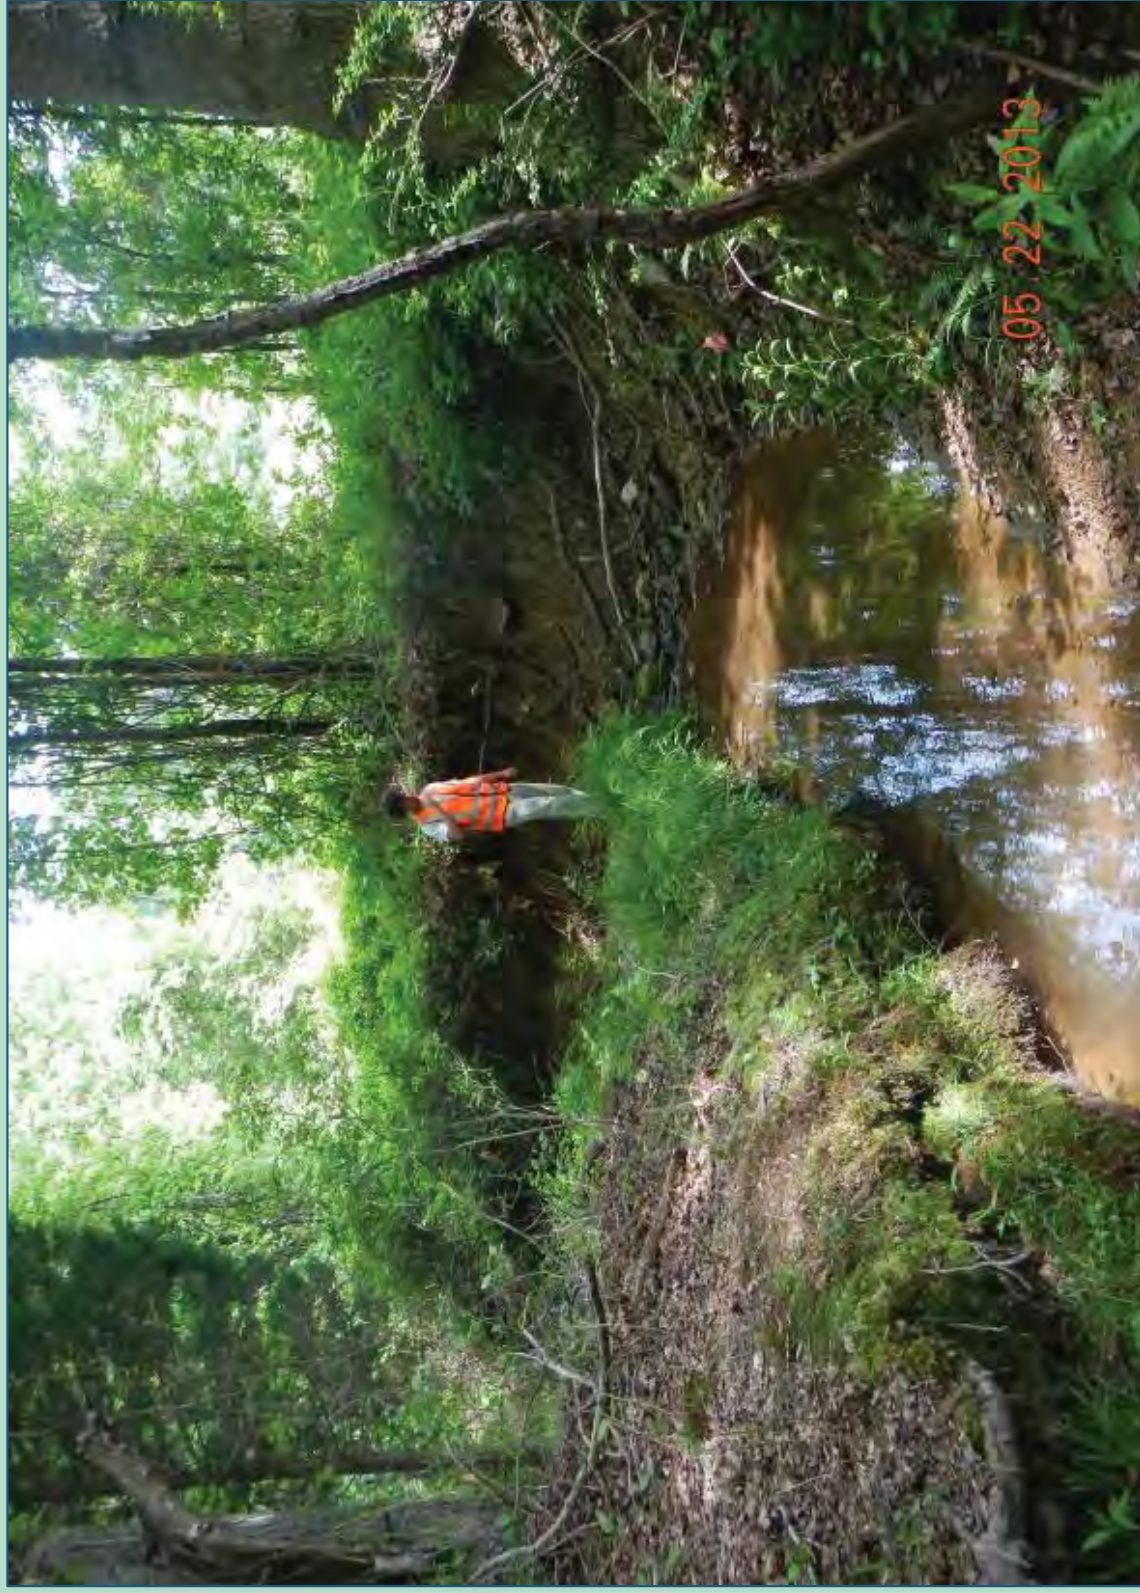
# Bethel Church – W1: Tributary to Great Seneca Creek

W1 is a perennial, unnamed tributary to Great Seneca Creek that originates on the Bethel Church property from wetland seeps associated with wetlands W9, W10, and W11; and flows to the east until it joins W2. W1 is a relatively permanent water (RPW) with a natural channel shape, width of 2 to 5 feet, bank depth of 2 to 4 feet, water depth of 2-8", and banks with slopes varying from 1:1 to 3:1. Channel substrate consists of silts, cobbles, sands, and gravel. The feature has well defined bed and banks and observed indicators of the ordinary high water mark include sediment deposition, presence of litter and debris, and sediment sorting. The forest surrounding W1 is dominated by red maple, black cherry, red cedar, greenbrier, jewelweed, *Polystichum acrostichoides* (Christmas fern), *Vitis riparia* (grape vine), and *Sphagnum* spp. (sphagnum moss). Maryland DNR's Stream Waders collected benthic macro-invertebrate samples at a site (860-3-2001) downstream of

Feature W1 in 2001. The site had a total of 14 macroinvertebrate families, with 10 EPT taxa and 3 Dipterans, resulting in a “Fair” IBI score of 3.00. Ephemeropterans made up 43% of the macroinvertebrates in the sample, indicating healthy stream conditions. The feature provides adequate habitat for fish and benthic macroinvertebrates due to its stable conditions, variety of substrates, and presence of riffle-pool sequences. Feature W1 was flowing during the April 2011 and May and June 2013 field reviews, and is jurisdictional under Rapanos guidance.

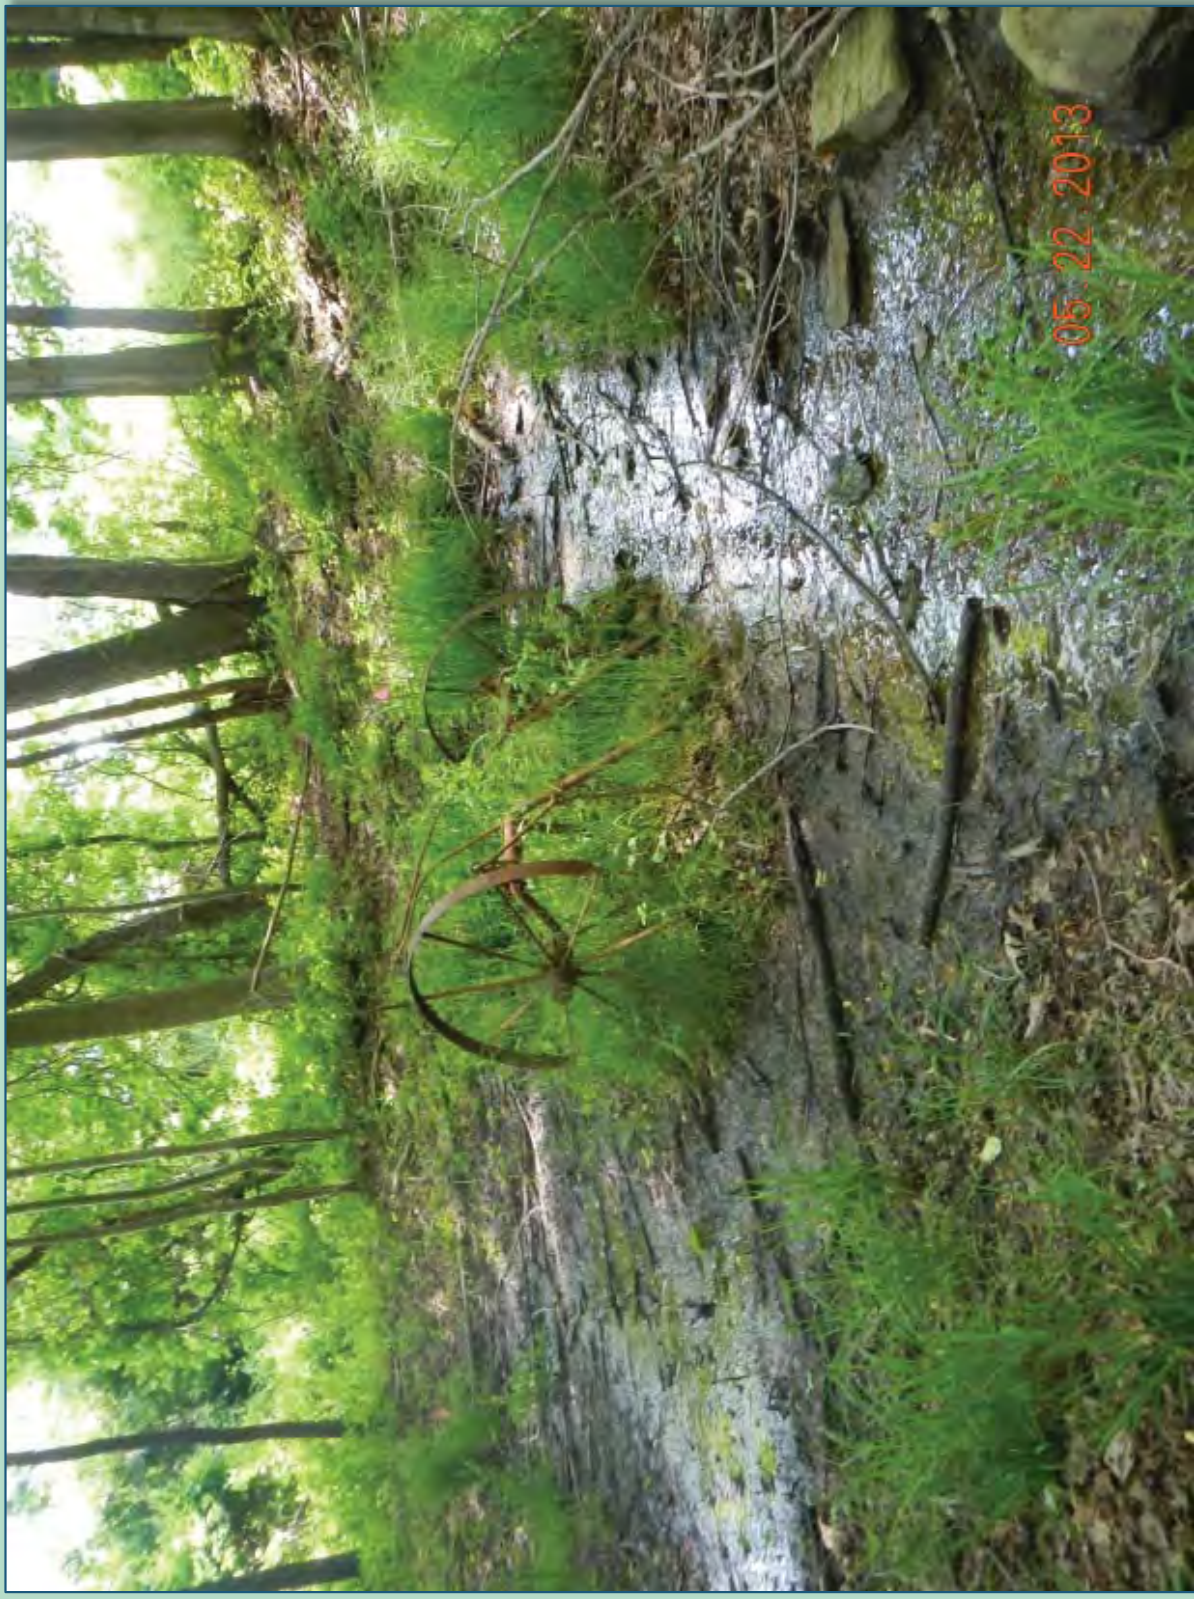
## Bethel Church – W11

W11 is a small forested wetland abutting W1. Dominant vegetation includes red maple, *Berberis thunbergii* (Japanese barberry), jewelweed, redbud, and Oriental Bittersweet. Primary indicators of hydrology include A1: Surface water and B9: Water-stained leaves. Seeps from the slopes in the northwestern portion of W11 supply hydrology to this wetland. The soils in W11 meet the requirements of Hydric Soil Indicator F3: Depleted Matrix. Feature W11 is a USACE jurisdictional wetland since it meets the three-parameter definition of a wetland and is adjacent to Features W1, an RPW flowing year round. W11 resource quality is good based on the undisturbed condition of the resource and lack of invasive species.

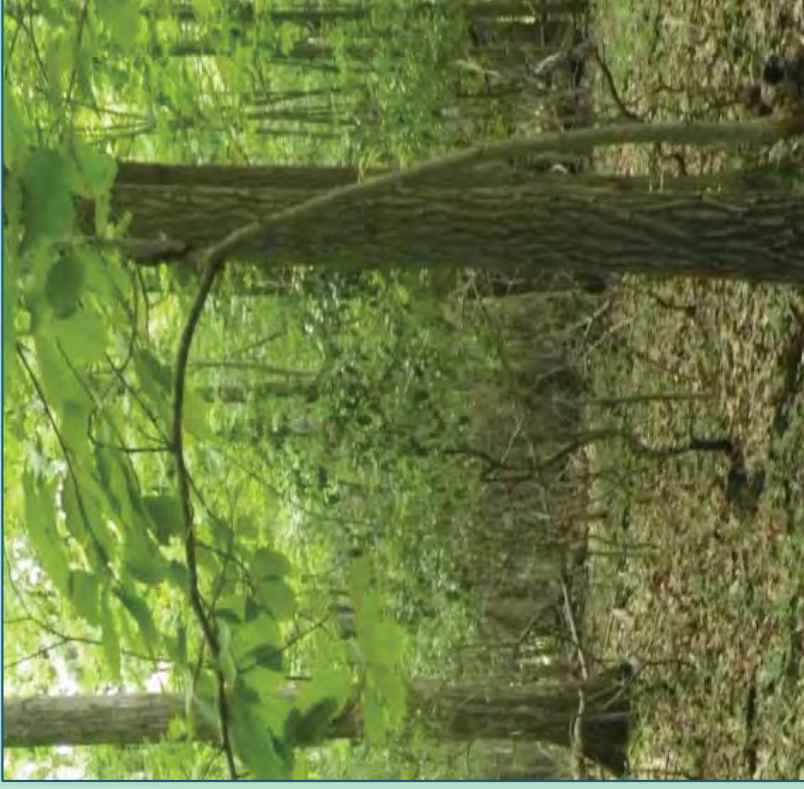
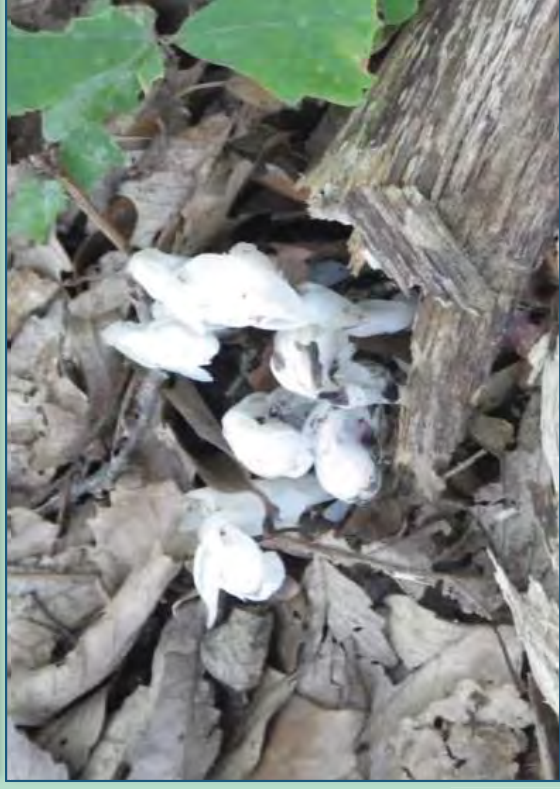
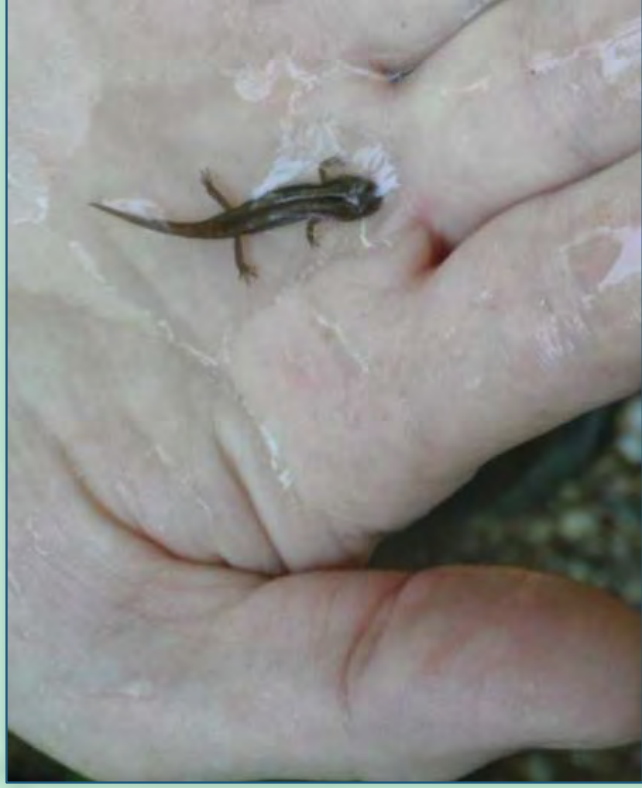
## Bethel Church - Unique Features

- Located near the North Germantown Greenway
- Unique Plants
- Good wildlife habitat

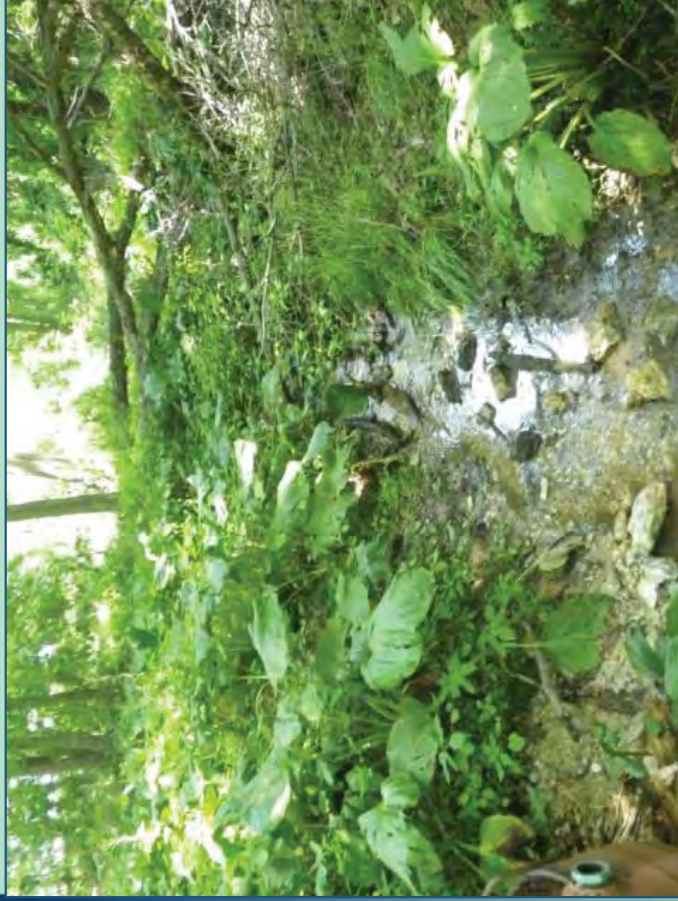
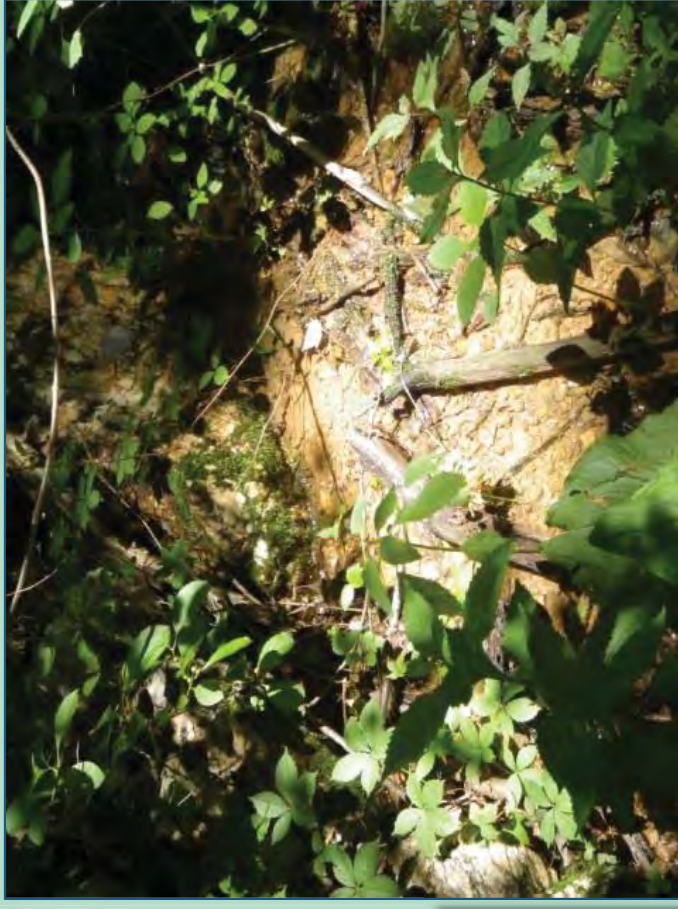
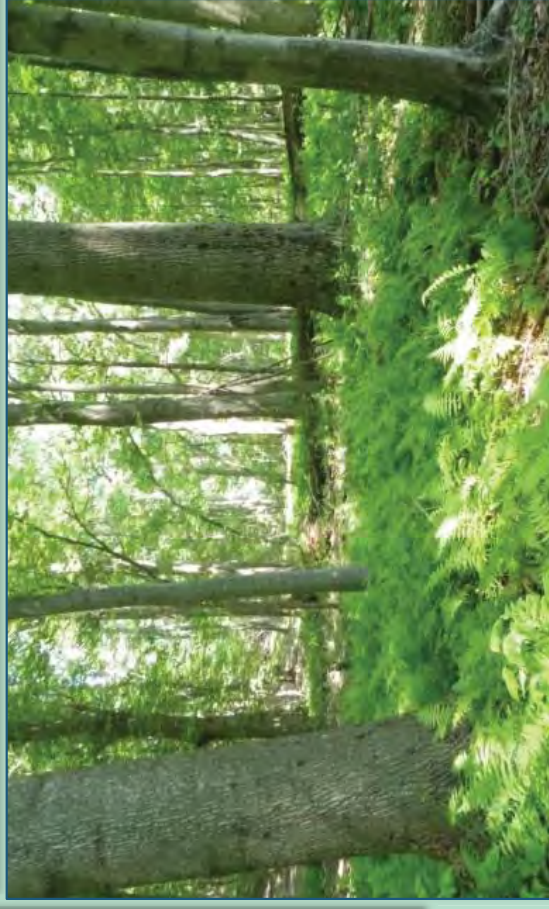
## Bethel Church - Unique Features

- Seep fed wetlands
- 397 Specimen Trees

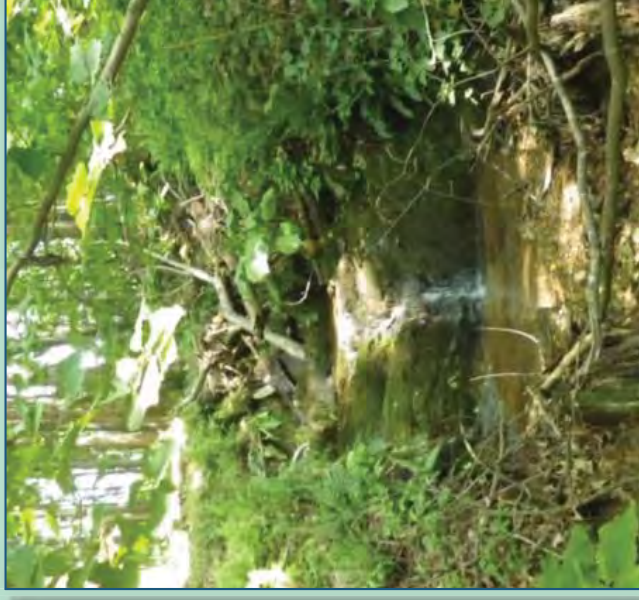
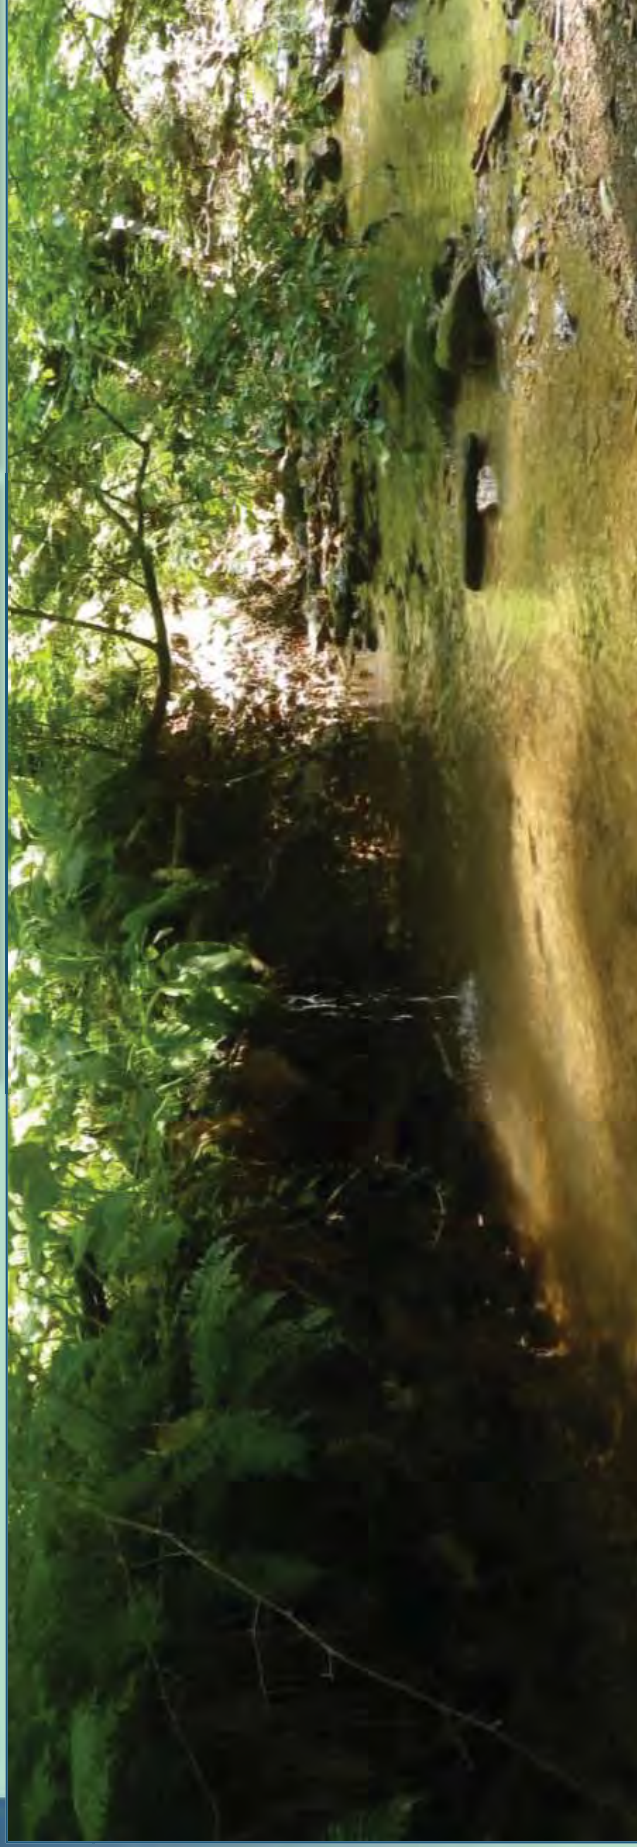
# Wilson Property Unique Features

- Proximity to North Germantown Greenway & Goshen Recreation Park
- Wetland Seeps & Unique Stream Features
- Use III-P tributaries to Wildcat Branch

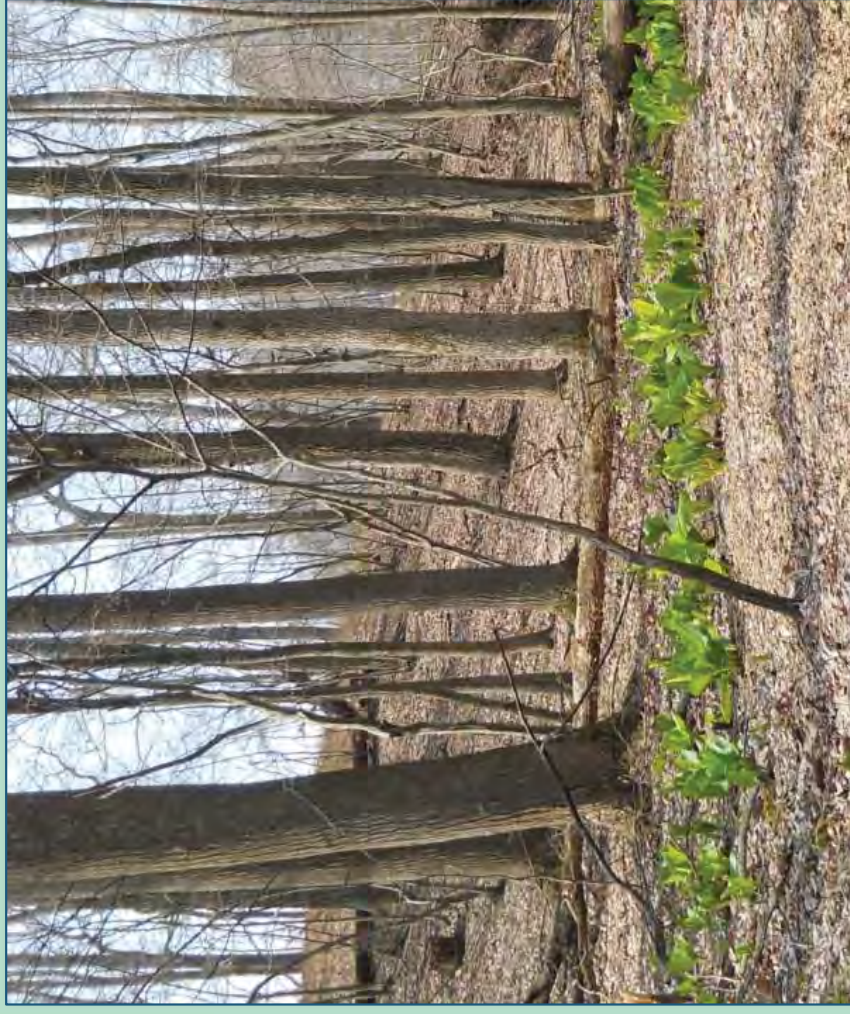
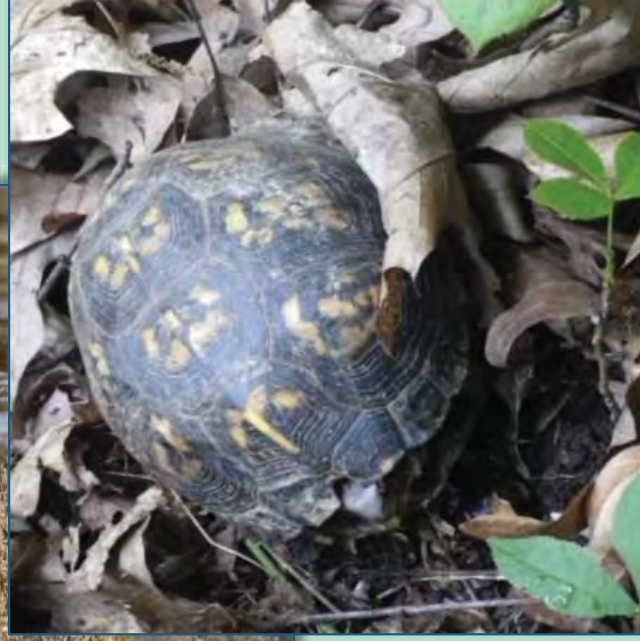
# Wilson Property Unique Features

- 298 Specimen Trees
- Good wildlife habitat

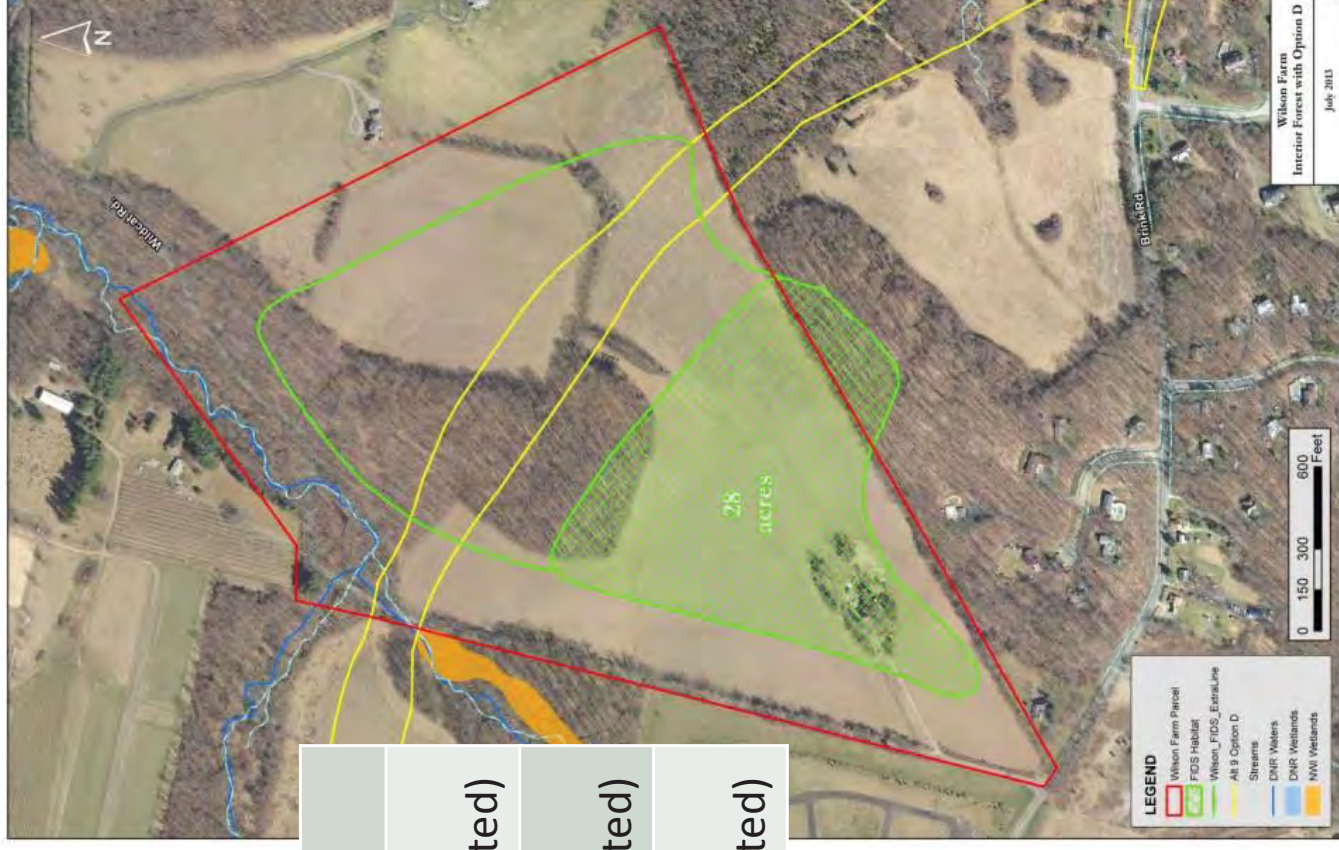
# Wilson Property – Forest Mitigation Potential

Parcel Area	105 acres
Reforestation Potential	71 acres (64 acres if Option D were selected)
Forest Preservation	34 acres mid-succession (29 acres if Option D were selected)
Potential FIDS Habitat	60 acres (28 acres if Option D were selected)

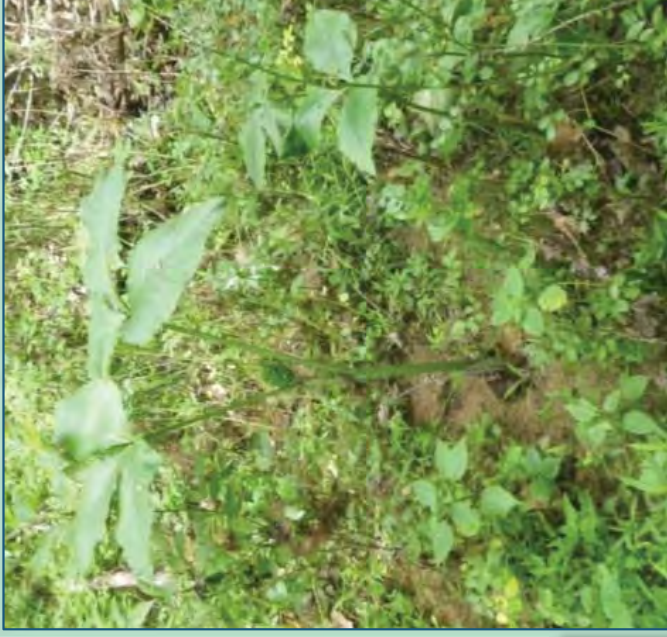
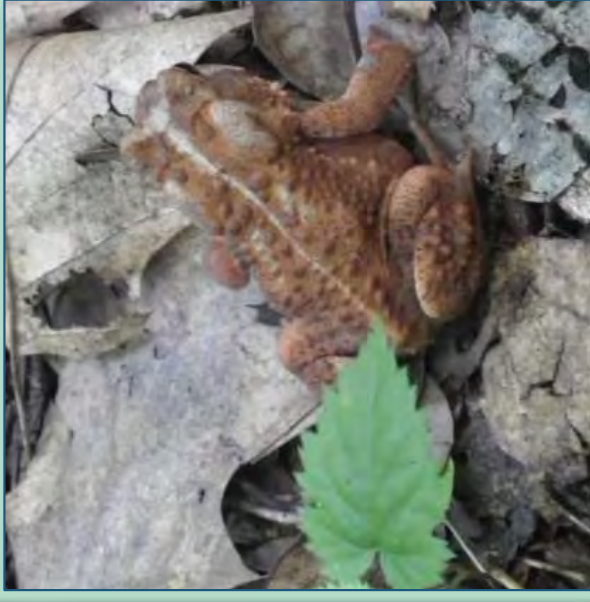
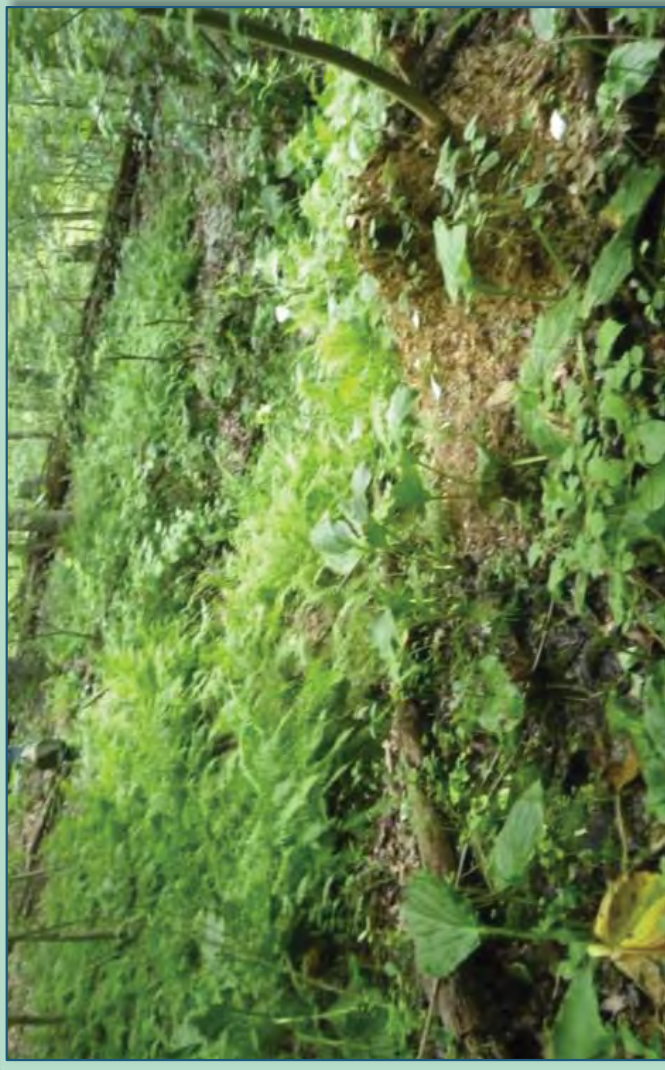
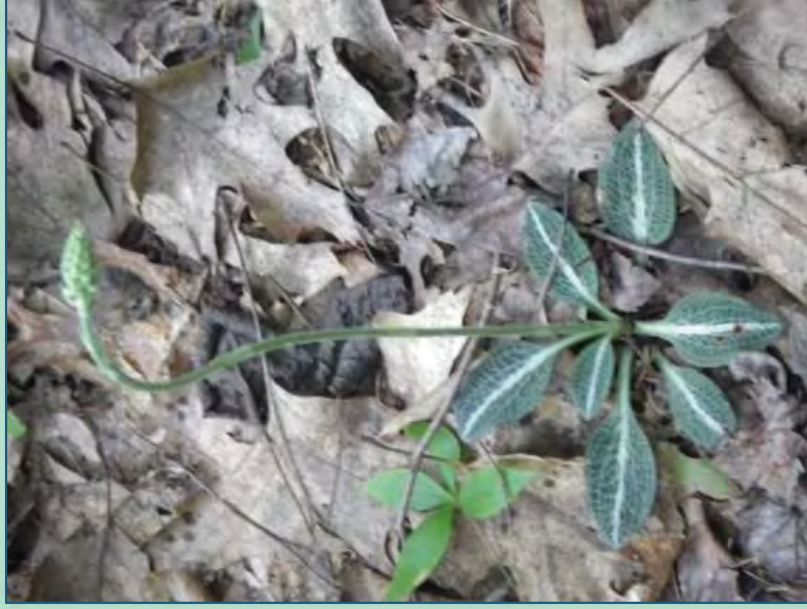
# Snow Property Unique Features

- Wetlands originating from slope seeps
- Unusual Plants
- Good wildlife habitat
