Facility Planning Study - Phase I

Goldsboro Road

Environmental Site Assessment

Montgomery County Department of
Transportation

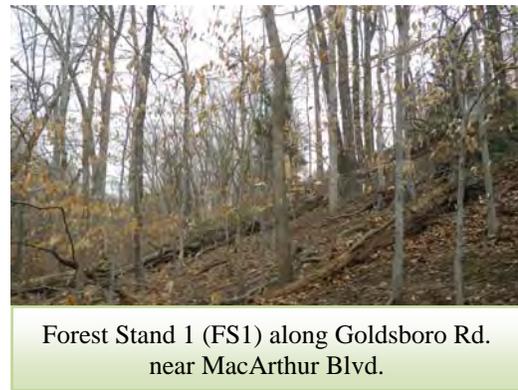
FS1 is an early to mid-successional Tulip Poplar Association forest that surrounds Goldsboro Road throughout the entire study area. This urban forested community is dominated by 12-20-inch DBH tulip poplar (*Liriodendron tulipifera*), American sycamore (*Platanus occidentalis*), American beech (*Fagus grandifolia*), northern red oak (*Quercus rubra*), and white oak (*Quercus alba*) in the tree canopy. Dominant understory species include black gum (*Nyssa sylvatica*), red maple (*Acer rubrum*), American beech (*Fagus grandifolia*), box elder (*Acer negundo*), black locust (*Robinia pseudoacacia*), spicebush (*Lindera benzoin*), and white mulberry (*Morus rubra*). Common herbaceous species include common greenbrier (*Smilax rotundifolia*), Japanese honeysuckle (*Lonicera japonica*),

Forest Stand 1 (FS1) along Goldsboro Rd. near MacArthur Blvd.

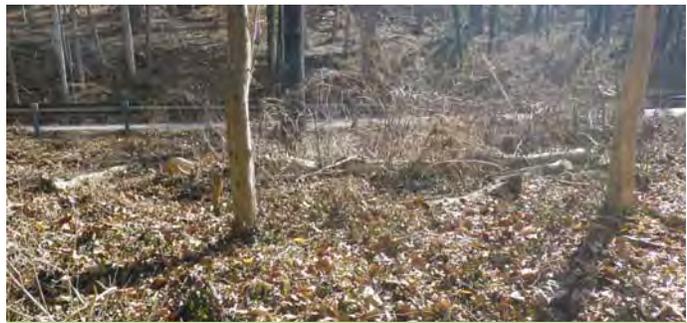
Wetland W1 is a palustrine emergent/palustrine forested (PEM/PFO) wetland located along the westbound side of Goldsboro Road within the western limits of the project study area. Dominant vegetation includes box elder, multiflora rose, and purple-leaf wintercreeper. The soils in this area met the hydric soil indicator F3: Depleted Matrix. Hydrologic indicators include

Wetland W1 along Goldsboro Rd. near MacArthur Blvd.

sediment deposits, water-stained leaves, and geomorphic position. This wetland receives hydrology from an intermittent stream that flows through the center of the wetland. This small stream becomes less defined as it passes through the study area into wetland W1. Three 18-inch pipes, mostly blocked with leaf litter and debris, convey hydrology from W1 and the stream across Goldsboro Road. These pipes drain into the main stem of the Minnehaha Branch on the eastbound side of Goldsboro Road. This wetland feature is not shown on NWI or MD DNR GIS mapping, however this area is considered jurisdictional, since all three wetland parameters were met during field investigations.

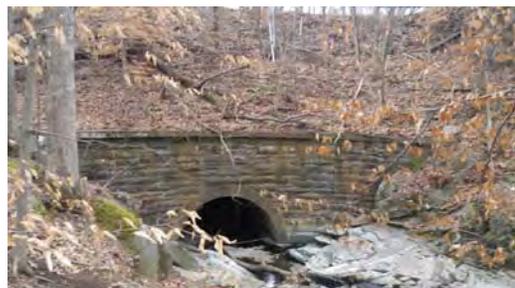
The Minnehaha Branch was identified as Waters of the U.S. W2. This perennial, relatively permanent waters (RPW) flows alongside Goldsboro Road throughout the entire study area and crosses under the roadway at two locations (Tulip Hill Terrace and Goldleaf Drive). The western portion of the stream within the study area (closer to MacArthur Blvd.) has a more natural channel shape and includes bedrock and cobble as

Waters of the U.S. W2 – Minnehaha Branch at MacArthur Blvd.

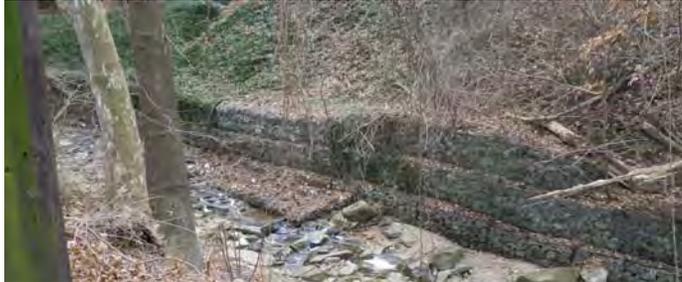
substrate, while the eastern portion becomes increasingly channelized and includes sections with gabion baskets. The substrate in the eastern portion includes more silt, sand, and gravel and the side slopes exhibit more significant erosion. Overall, stream width averages 10-15 feet and water depth averages 12-18 inches. Sediment deposition, water stained leaves, litter and debris, scour, and flow were observed during the investigation. Vegetation along the banks consists primarily of American sycamore, tulip poplar, beech, and spicebush, with a higher incidence of black locust, greenbrier, English ivy, and bamboo in the more disturbed areas. This feature is identified on MD DNR GIS mapping and is considered jurisdictional under Rapanos guidance.

Waters of the U.S. W2 – Minnehaha Branch near Massachusetts Ave.

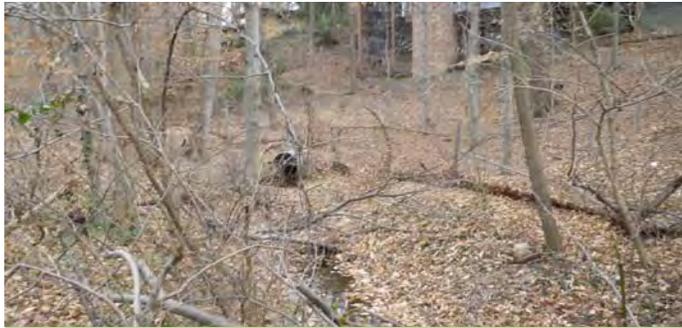
Waters of the U.S. W3 is an intermittent RPW located along eastbound Goldsboro Road, just east of Tulip Hill Terrace. This feature originates at a 36-inch pipe and flows approximately 100 feet downstream into another 36-inch pipe, where it crosses under Goldsboro Road and connects to Minnehaha Branch (Waters of the U.S. W2). W3 has stable banks with an average width of

Waters of the U.S. W3 – East of Tulip Hill Terrace

2-5 feet and water depth of 6-10 inches. Substrate includes silt and sand and adjacent vegetation consists of box elder, beech, red maple, tulip poplar, and English ivy. Disturbed leaf litter, water staining, litter and debris, and flow were observed during the investigation. W3 is not shown on MD DNR GIS mapping but is considered jurisdictional under Rapanos guidance.

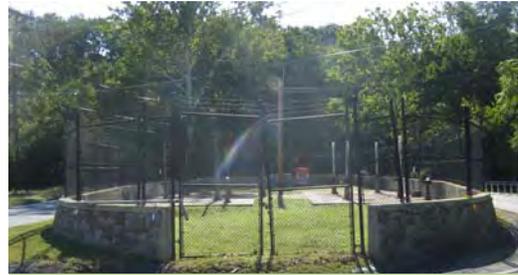
Washington Aqueduct Valve Station at the Goldsboro Rd. / MacArthur Blvd. Traffic Circle

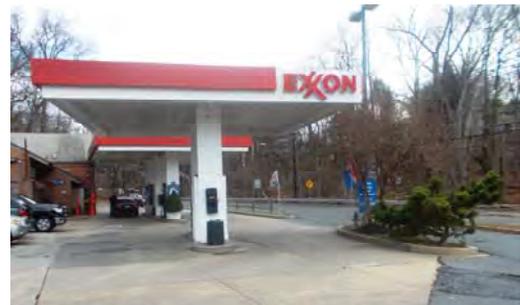
An inspection of the Exxon gas station identified four gasoline underground storage tanks (USTs), adjacent to the filling station island, approximately 15 to 20 feet from the project site. Adjacent to the Exxon repair shop was an exterior chemical storage area, partially protected by steel/concrete posts. This area contained: one 275-gallon aboveground heating oil tank; a double-walled waste oil container; several plastic 55-gallon drums of used antifreeze; and two steel 55-gallon drums labeled for storage of waste oil and water. The heating oil tank was in good condition and had no signs of visible staining underneath. The waste oil tank appeared to be significantly rusted but otherwise in good condition with no signs of visible staining. The 55-gallon drums were in good condition and labeled for disposal.

Exxon Gas Station at Goldsboro Rd. /
MacArthur Blvd.

Site A, Exxon Gas Station: Owned by Southside Oil, LLC, this facility has had four gasoline fiberglass-reinforced plastic USTs since their installation in May 1979 (three 6000-gallon, one 8000-gallon). Two additional USTs, a 1000-gallon tank for used oil and a 1000-gallon tank for heating oil, were removed from the Exxon site in March 1997. High concentrations of petroleum contamination in soil and groundwater were found in the area near the current USTs, and three monitoring wells were installed in July 1997. Quarterly sampling of these wells found high levels of MTBE and BTEX in groundwater that flowed southward toward the Goldsboro Road/MacArthur Boulevard intersection. Sampling continued until the wells were abandoned in August 1998.

Based on the available information, there is a risk that the proposed project could encounter cost impacts due to subsurface hazardous material contamination emanating from the Exxon gas station at 6729 Goldsboro Road. Due to the potential environmental hazards within and near the subject area the project team recommends that, as design progresses, an assessment of the affected project area near the gas station be conducted, including the collection of soil and groundwater samples for the characterization of the nature and extent of potential contamination within the planned or presumed construction area. The primary contaminants of concern should include common petroleum constituents (such as diesel-range organics and gasoline-range organics), BTEX, MTBE, and hazardous metals. Pending the results of the additional assessment, special soil and groundwater-handling specifications may be required during excavation, for site worker health and safety exposure concerns and environmental protection requirements.

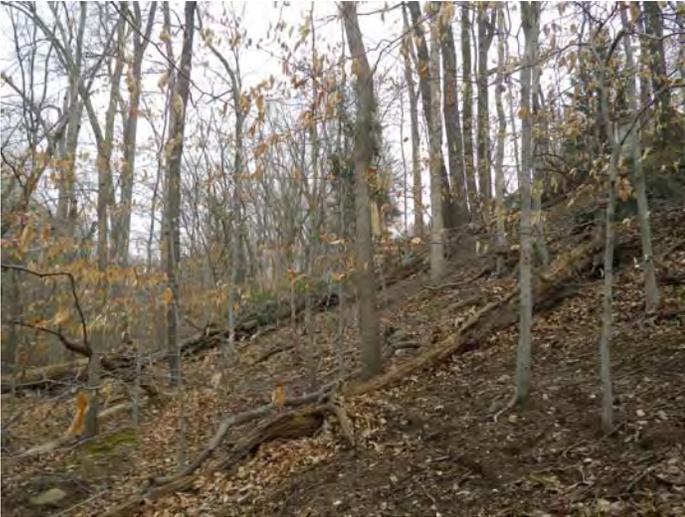
FS 1 (western end)

General Stand Conditions: Urban forest surrounding Goldsboro Road. Overall forest in fair condition. Areas of disturbance along road edges includes smaller trees (6-12"), that are often invasive species.
