Heat damage

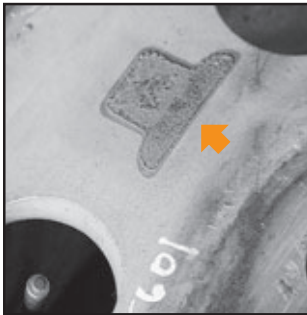
Charred Sticker (prior to 2009)

After January 2009 the new Alcoa Logo may not show heat damage.

A blistered, charred, blackened or cracked-looking logo decal on an Alcoa wheel may indicate that the wheel has been exposed to excessive heat as shown in picture to the left, or discoloration as shown in picture to the right

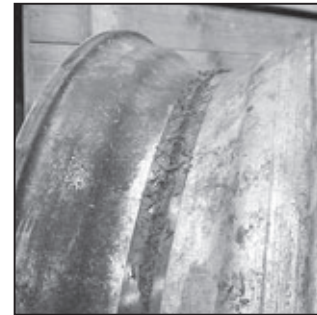
A wheel may discolor from excessive heat. It can appear a dull grayish color and will not polish to a bright finish as a typical wheel would.

Discoloration of Wheel

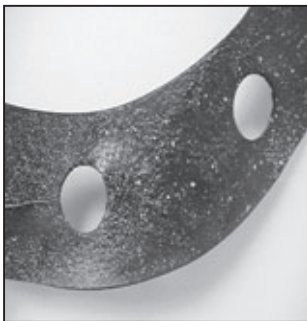
Charred High Temperature Nylon Spacer

Inspect all axle end components for signs of exposure to excessive heat. Pay particular attention to brake drums (or discs), high temperature nylon spacer wheel liners and tire beads. If these components show signs of overheating, the entire assembly, including the wheel, should be replaced.

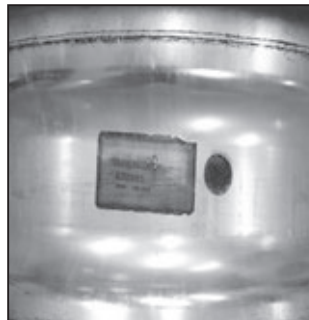
Charred Heat Indicator Drop Center (2009 and after)

Wheels manufactured starting in January 2009 will have a 1 inch clear round heat indicator located next to the roll stamp on the inside shown on the left and right, along with the same 1 inch clear round heat indicator located on the tire side drop well as shown in the photo above.

If either of these round labels show signs of blistering, or have a charred, blackened, or cracked look, this may indicate that wheel has been exposed to excessive heat.

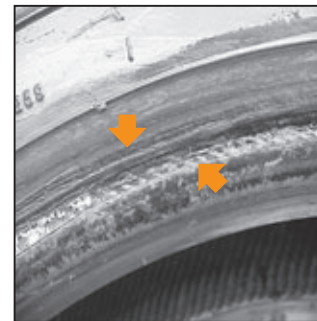
Charred Rubber

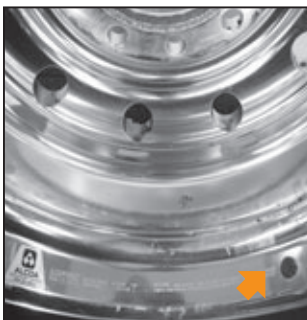
Charred Heat Indicator (2009 and after)

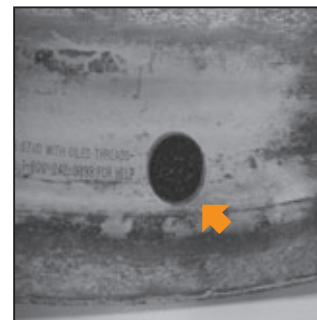
Charred Heat Indicator (2009 and after)
