CONDITION SURVEY
of
MONTGOMERY COUNTY GARAGE 47/47A
at
7401 WAVERLY STREET, BETHESDA, MARYLAND

DECEMBER 17, 2015

HAA Project No. 15-198

HOLBERT APPLE ASSOCIATES, INC. ♦ STRUCTURAL ENGINEERS

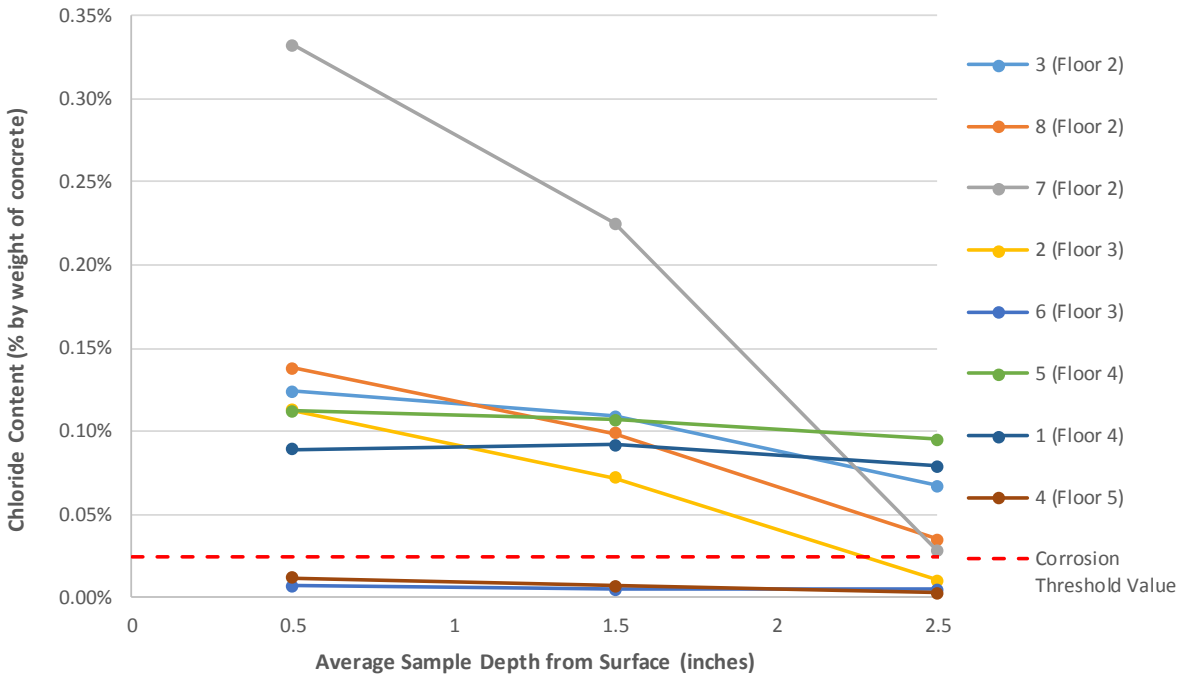
In order to better evaluate these results, the graph below showing chloride content vs depth was developed. An average depth was used for each depth increment (e.g., average of 0.5 inches shown for 0 to 1 inch sample). Also the legend is sorted by elevation that the sample was taken (i.e., sample 3 was taken at highest elevation and sample 4 at lowest elevation).

Based on the graph above, a variation in the amount of chloride-ion contamination can be observed throughout the collected samples. This variation can be attributed to any one of the following: varying

- **Contamination Above Threshold Limit for Most Samples:** Generally, a chloride-ion content of around 0.025% of concrete weight is considered to be the threshold value above which corrosion of steel in the concrete will begin. This threshold is highlighted in the figure above with a dashed red line. Most of the samples had chloride-ion levels well above this threshold for the 1st and 2nd inch of depth and most were above the threshold even for the 3rd inch of depth down. Considering the code requirements at the year of construction and the estimated thickness of the slab (approximately 4" to 5"), the top rebar level is probably located somewhere within the top 2 inches, on average. Based on these results, the potential for corrosion initiation, as well as ongoing corrosion, for the reinforcement in these areas of the garage slabs are high.

- **Decrease in Chloride Contamination with Depth**: Typically, chloride-ion contents found in garage slabs decreases with the increase in depth from the surface. This reflects the condition where the chlorides contained in de-icing salts (brought into the garage by vehicles) are deposited on the surfaces of the slabs as melted water which soaks into the concrete. Thus, the chloride-contamination is higher near the surface where the salt is deposited by the water, working its way down into the slab. This process is confirmed by these test results which show a drop in chloride-ion content from the 1st inch to the 3rd inch. Interestingly, some samples (5 and 1) have slightly lower chloride-ion content in the 2nd inch compared to the 1st inch. This is likely due to the effect of chloride-ions being washed away from the surface of the concrete (due to rain water as well as possible power washing over time). Large amounts of cracking as well as porous concrete near the surface of the slab, can also possibly lead to deeper penetration of moisture and chloride-ions. Considering the total thickness of the slab (approximately 4"-5"), almost the full-depth of the slabs at these locations can be assumed to be contaminated above the corrosion threshold value; which means that there is a high potential for corrosion for both the top and bottom reinforcement.

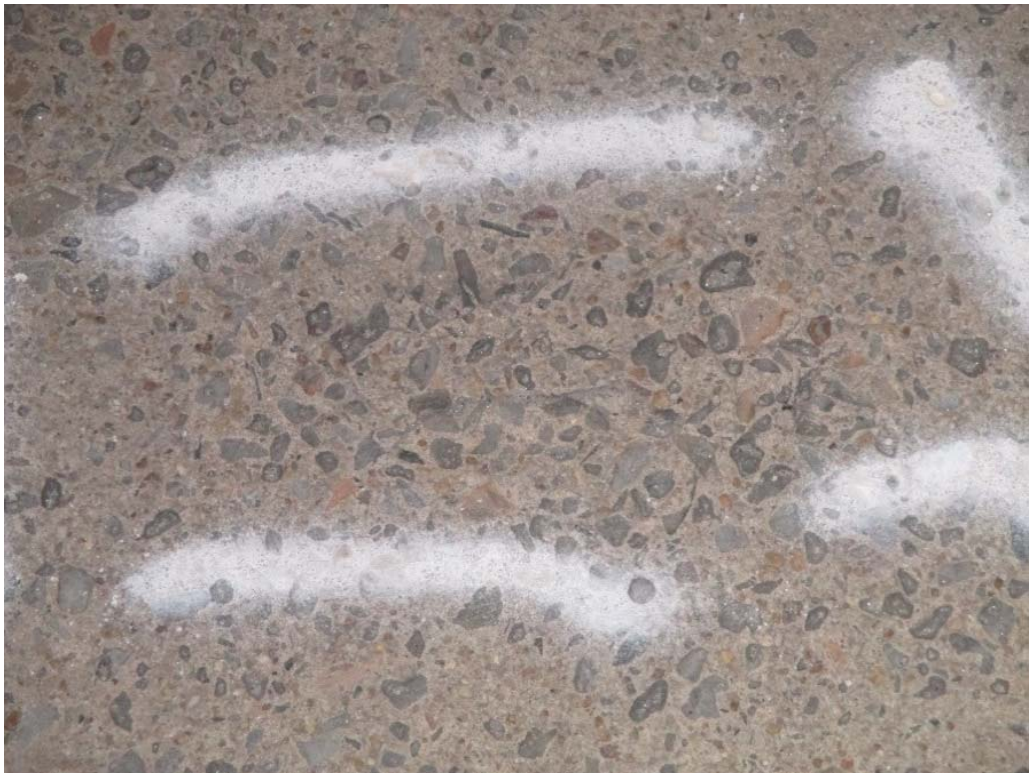
- **Slab Surface Damage:** Besides the failure of previous patches and the halo effect damage, many new delaminated or spalled surface areas were found throughout all levels of this phase of the garage (Photo No. 1). Moderate to severe scaling (i.e., loss of surface mortar and clearly exposed aggregates) were also observed, mainly at the top exposed floor (Photo No. 2). This scaling damage is usually caused by freezing and thawing effects and/or other construction related issues such as over-finishing or finishing while bleed water is on the surface. It is also worth noting that a membrane coating existed over some of the slab surfaces at some levels and, as a result, it is not possible to say for sure whether all of the areas of possible delaminated concrete detected using chain-drag and hammer sounding were actually concrete delaminations or only debonded areas of coating. The only effective way to tell for certain would be to completely remove the coating in suspect areas to evaluate the concrete underneath.

Typical Garage 47 Slab Damage

Area within white painted lines is delaminated concrete. Note the rectangular areas of different colors indicating previous slab repairs made at different times, most of which are now delaminated.

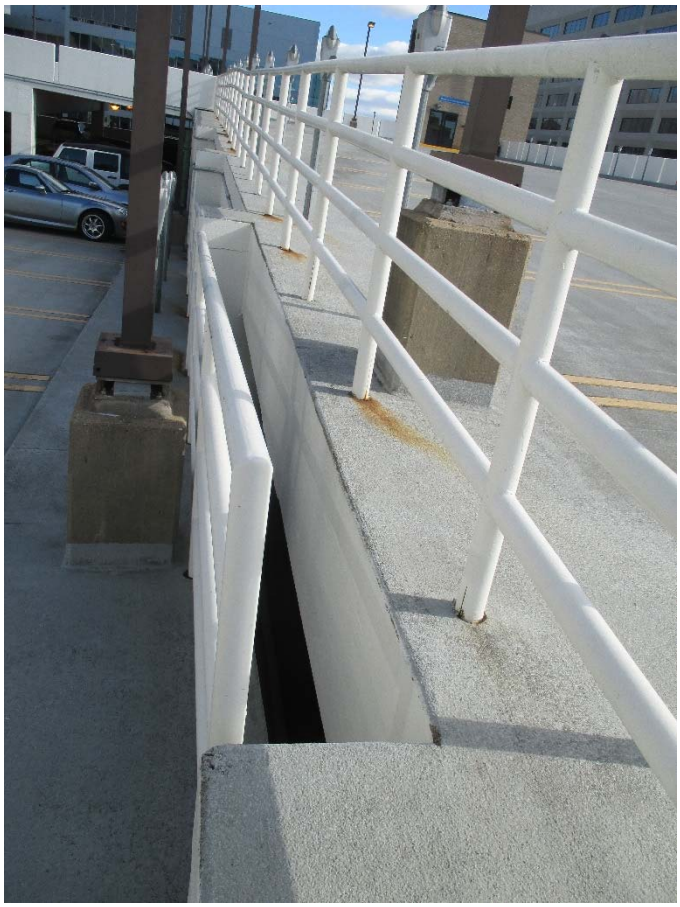
Photo No. 7
Typical Guardrail Damage – Garage 47
The bases of many guardrail posts are corroding and some corrosion is also occurring at the upper portions of the guardrails.

- **Guardrail Damage:** The base of some of the guardrails was heavily corroded and the posts and railings were also corroding at a few locations (Photo No. 7).

- **Guardrails:** Corrosion of the guardrails could cause the guardrails to fail and allow a person to fall of an elevated deck. All of the corroded guardrail elements should therefore be repaired, replaced and/or cleaned and painted to insure the structural integrity of the rail system. Sealant should be placed around the bottoms of all posts to try to deter future corrosion.
