# Cabin John Creek Watershed

## 3.16 Lower Booze Creek Stream Restoration

### 3.16.1 Introduction

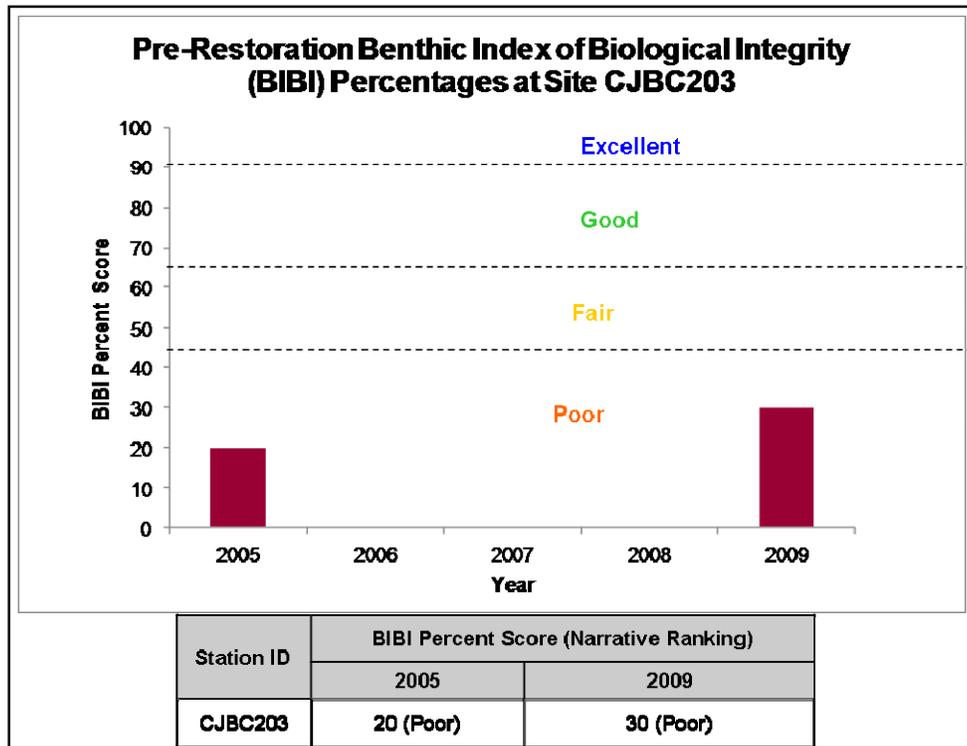
The benthic macroinvertebrate community at CJBC203, as assessed using the MCDEP Benthic Index of Biological Integrity (BIBI), was Poor in both years in the pre-restoration period (**Figure 3.16.8**). The BIBI percentage in 2005 was 20, the lowest possible percentage. In 2005, only seven individuals were collected. In order to calculate an accurate BIBI score there must be at least 60 individuals collected per sample. If there are fewer than 60 individuals, the BIBI is automatically given the lowest possible percent score of 20. Therefore, the 2005 BIBI percent score was given a 20. In 2009, greater than 60 individuals were collected and the BIBI percentage increased to 30. The community in 2009 had a high proportion of shredders with this individual metric scoring in the highest range. Field data sheets from the 2009 benthic macroinvertebrate monitoring task are included in *Appendix D*.

**Figure 3.16.8 – Pre-Restoration Benthic Index of Biological Integrity (BIBI) Percentages at CJBC203**

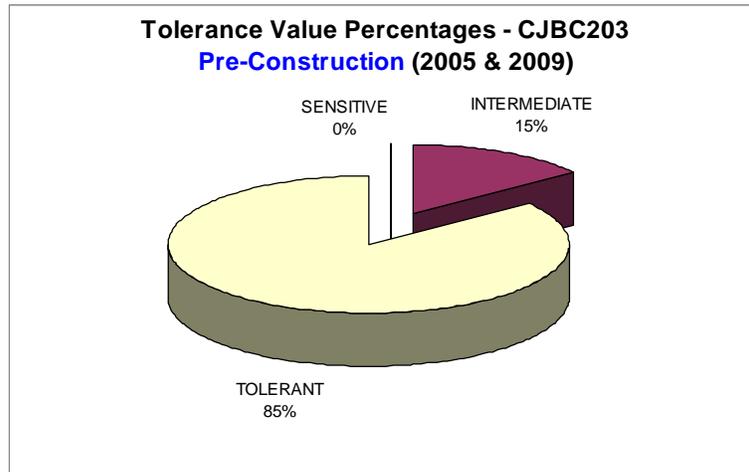
The pre-restoration community of benthic macroinvertebrates at CJBC203 was dominated by Chironomidae (non-biting midges), which comprised 80 percent of the community. Midges are considered tolerant taxa. *Tipula* sp. (crane fly) was the second most dominant taxon prior to restoration, representing 8 percent of individuals collected. Crane flies are considered intermediate in sensitivity. Overall, this site was dominated by tolerant taxa (85 percent) prior to

restoration, with the remaining 15 percent represented by taxa intermediate in sensitivity (*Figures 3.16.9*). Taxa sensitive to pollution were absent during the pre-restoration period.

**Figure 3.16.9– Benthic Macroinvertebrate Tolerance Composition at CJBC203 Prior to Restoration**

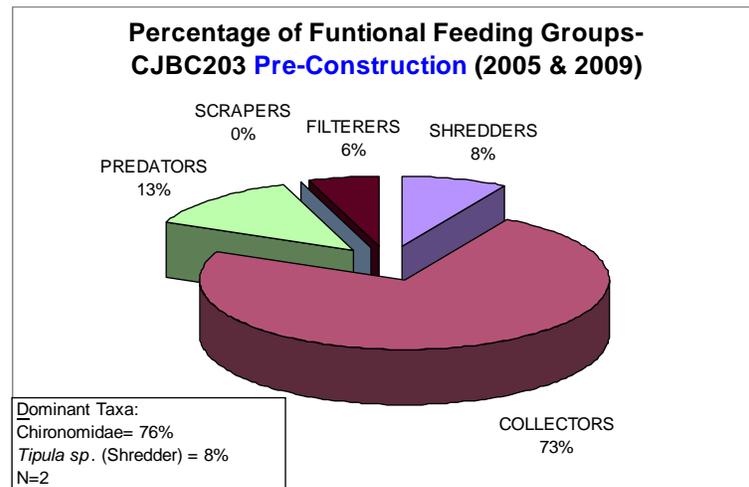
Collectors were the most dominant functional feeding group at CJBC203 prior to restoration. Collectors do not require specific stream conditions and are not considered a specialized feeding group. Scrapers and shredders are considered more specialized feeders that require less degraded stream conditions or specific habitat features. Scrapers were not collected at this site and shredders comprised eight percent of the community (*Figure 3.16.10*).

**Figure 3.16.10 – Benthic Macroinvertebrate Functional Feeding Group Composition and Dominant Species at CJBC203 Prior to Restoration**

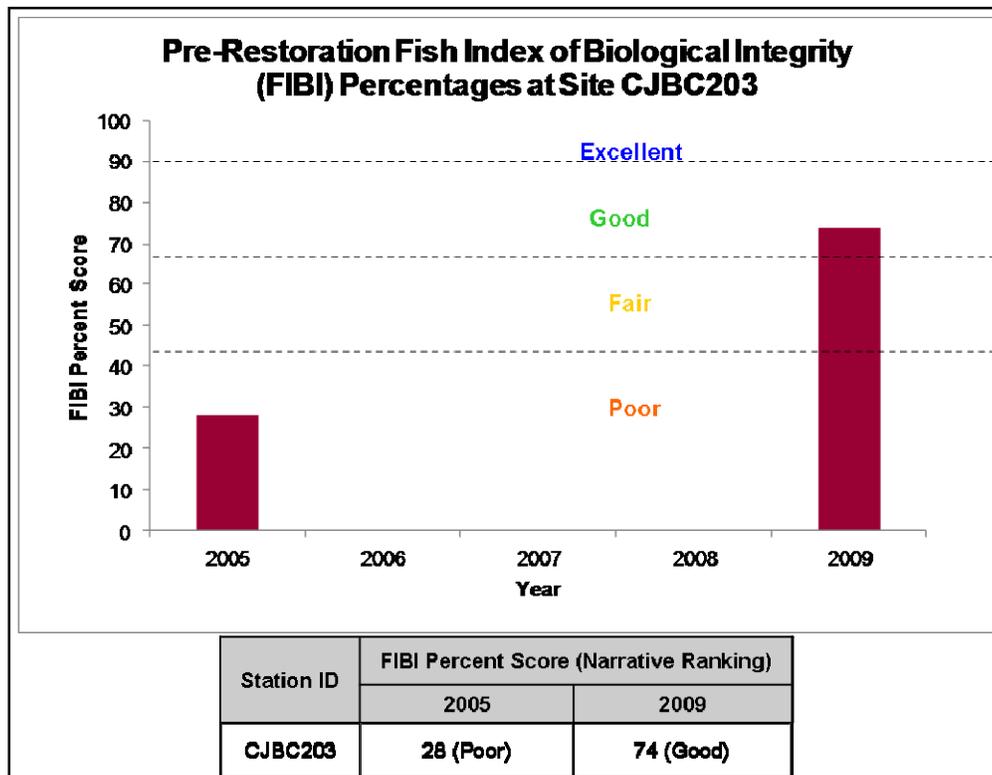
The pre-restoration fish community, as assessed using the MCDEP Fish Index of Biological Integrity (FIBI), was Poor (28 percent) in 2005 and Good (74 percent) in 2009 (**Figure 3.16.11**). Fish abundance was very low in 2005; only three individuals were collected. Similarly, the abundance of benthic macroinvertebrates in the 2005 community was also very low. In 2009, 935 individuals were collected at this site, a substantial increase from 2005. The increase in FIBI percentages between 2005 and 2009 was likely due to the considerable increase in fish abundance. Seven out of nine individual metrics increased between 2005 and 2009, including the total number of fish species, number of riffle benthic insectivorous individuals, number of minnow species, proportion of tolerant individuals, proportion of pioneering species, and total number of individuals. Field data sheets from the 2009 fish monitoring task are included in *Appendix D*.

**Figure 3.16.11 – Pre-Restoration Fish Index of Biological Integrity (FIBI) Percentages at CJBC203**

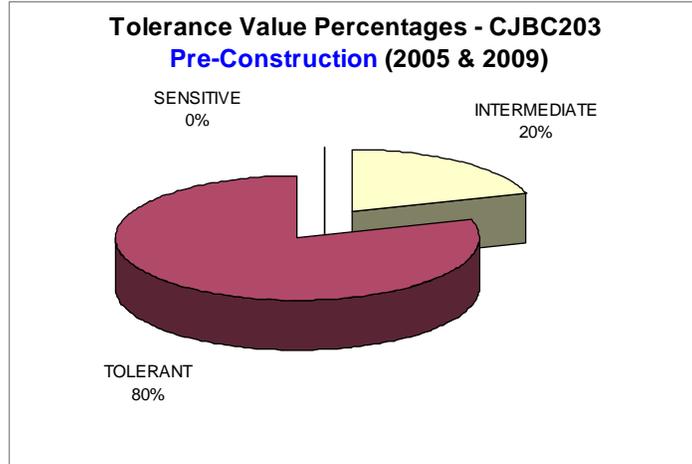
Tolerant fish species heavily dominated CJBC203 prior to restoration (80 percent) (*Figure 3.16.12*). Tolerant species collected at this site included blacknose dace, bluegill, bluntnose minnow, creek chub, green sunfish, swallowtail shiner, and white sucker. The remainder of individuals collected are considered intermediate in sensitivity, and include central stoneroller, longnose dace, and silverjaw minnow.

**Figure 3.16.12 – Fish Tolerance Composition at CJBC203 Prior to Restoration**

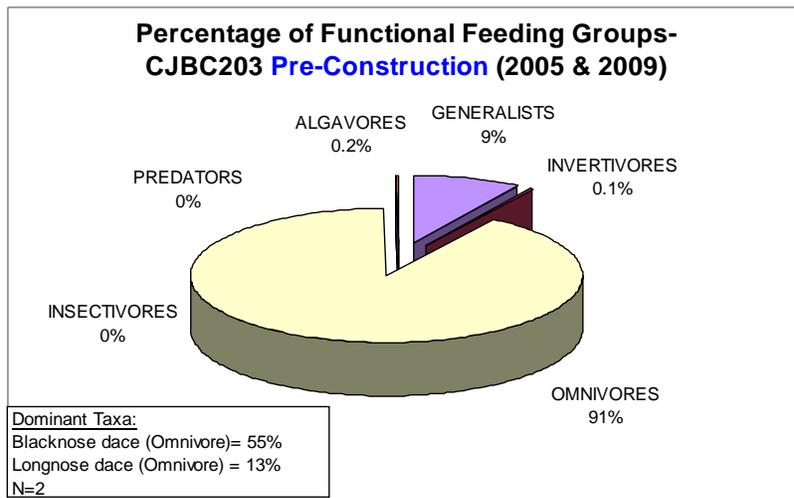
During the pre-restoration period, site CJBC203 was heavily dominated by omnivorous fish species, which comprised 91 percent of the fish community (*Figure 3.16.13*). Omnivorous fish species collected at this site included blacknose dace, bluntnose minnow, longnose dace, silverjaw minnow, swallowtail shiner, and white sucker. Generalists made up most of the rest of the community (nine percent), with more specialized feeding groups including invertivores (bluegill) comprising only 0.1 percent of the community.

**Figure 3.16.13 – Fish Functional Feeding Group Composition and Dominant Species at CJBC203 Prior to Restoration**

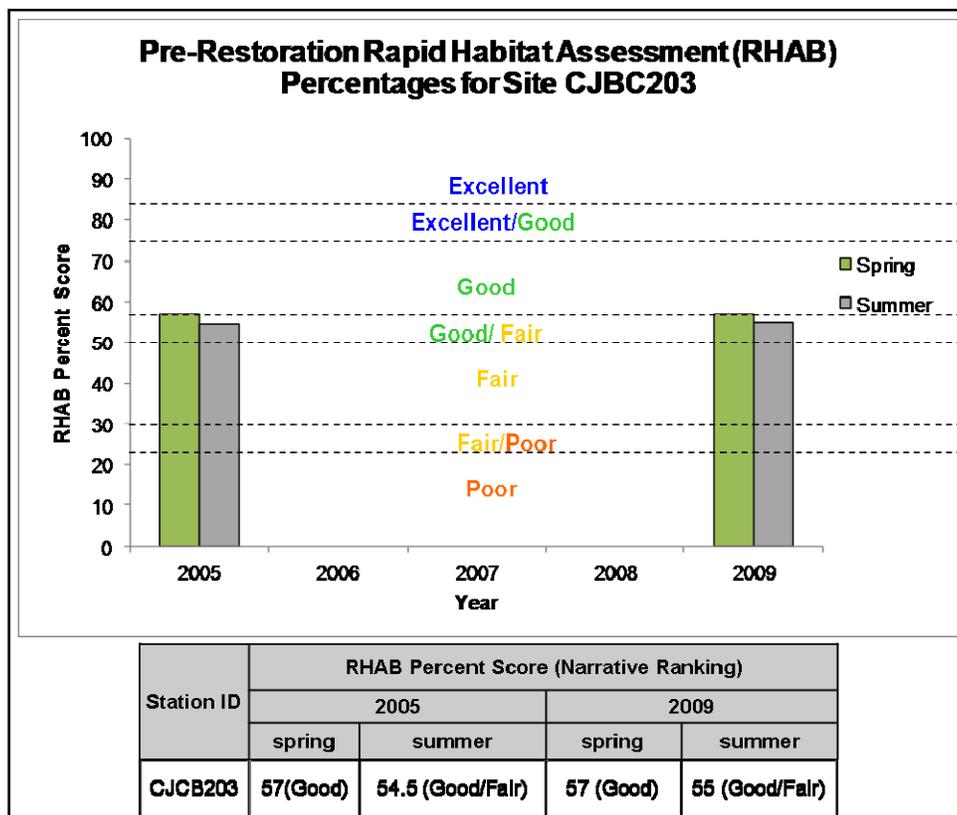
Pre-restoration aquatic habitat was evaluated at CJBC203 in the spring and summer of 2005 and 2009. During this time, aquatic habitat percentages were similar, with scores in the Good range in the spring and in the Good/Fair range in the summer of each monitoring year. Epifaunal substrates for benthic macroinvertebrates were generally suboptimal, fish habitats ranged from marginal to suboptimal, and streambanks were moderately stable. **Figure 3.16.14** shows aquatic habitat scores before restoration at CJBC203.

**Figure 3.16.14 – Pre-Restoration Rapid Habitat Assessment (RHAB) Percentages at CJBC203**
