3.18 Little Falls III Mall Tributary Stream Restoration

3.18.1 Introduction

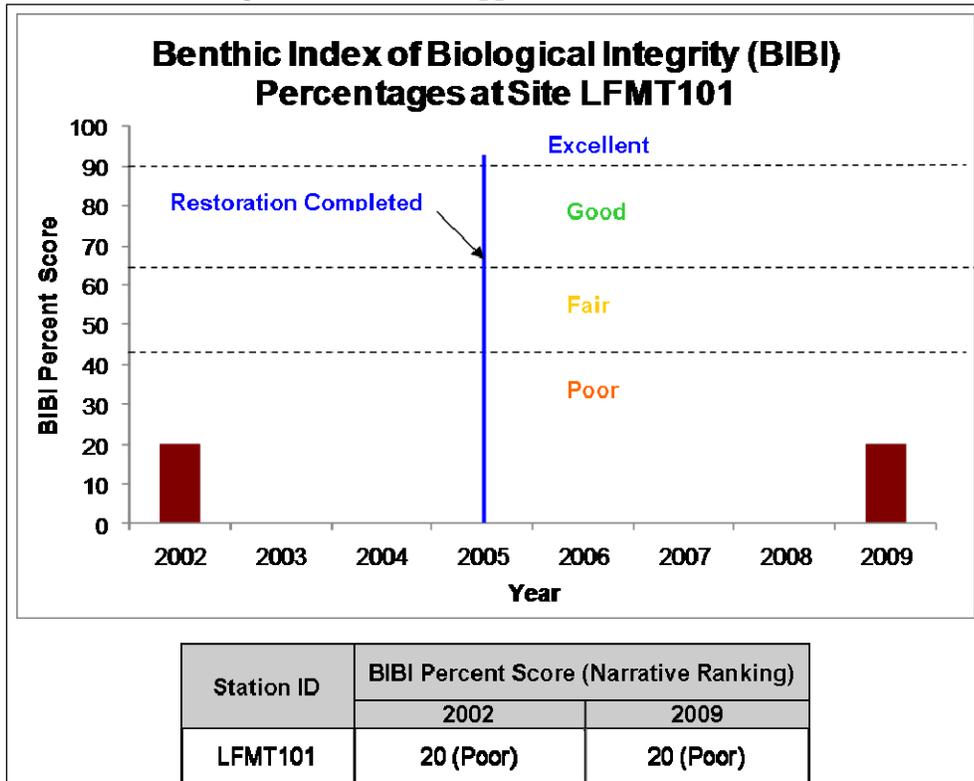
Figure 3.18.6 – Pre- and Post-Restoration Benthic Index of Biological Integrity (BIBI) Percentages at LFMT101

The benthic macroinvertebrate community at LFMT101, as assessed using the MCDEP Benthic Index of Biological Integrity (BIBI), was Poor in both the pre- and post-restoration periods (*Figure 3.18.6*). The baseline BIBI percentage prior to restoration was 20, which is the lowest possible BIBI percentage. Note that prior to restoration, the number of individuals collected was 29, which is below the threshold for calculating the BIBI, thus the lowest possible BIBI score was assigned at this site in 2002. Following restoration, the number of individuals increased to 127, but the BIBI percentage remained at 20. Field data sheets from 2009 benthic macroinvertebrate monitoring are included in *Appendix D*.

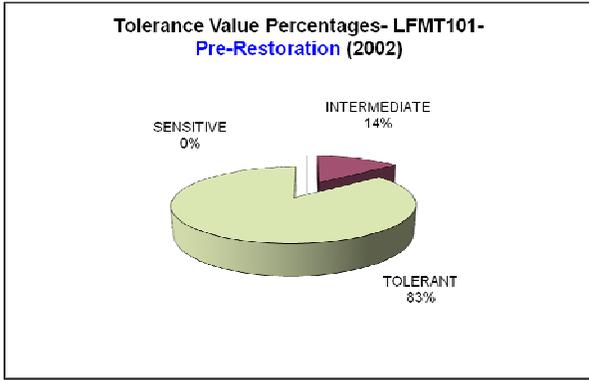
Figure 3.18.7 – Benthic Macroinvertebrate Tolerance Composition at LFMT101 Prior to Restoration

Site LFMT101 was dominated by tolerant taxa (83 percent) prior to restoration, with the remaining 14 percent represented by taxa intermediate in sensitivity (*Figures 3.18.7 and 3.18.8*). Following restoration, the site experienced an increase in the proportion of tolerant benthic macroinvertebrate taxa to 98 percent, and a decrease in the proportion of taxa intermediate in sensitivity to two percent.

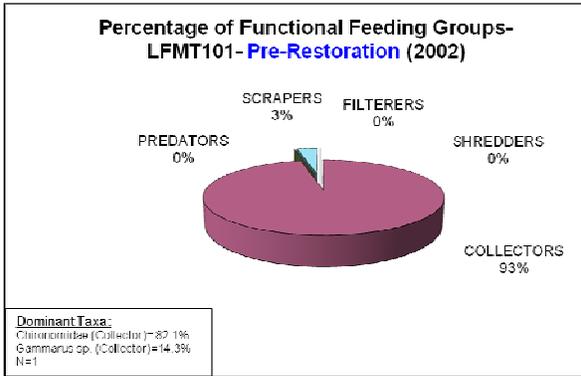
Figure 3.18.9 – Benthic Macroinvertebrate Functional Feeding Group Composition and Dominant Species at LFMT101 Prior to Restoration

Collectors were the most dominant functional feeding group at LFMT101 both before and after restoration. Prior to restoration, the community was comprised of 93 percent collectors and three percent scrapers (*Figures 3.18.9 and 3.18.10*). After restoration the percentage of collectors decreased from 93 percent to 84 percent. The remainder of the community was represented by predators (16 percent) and filterers (0.8 percent). More specialized feeders such as scrapers and shredders that require less degraded stream conditions or specific habitat features were absent from the benthic macroinvertebrate community following restoration.

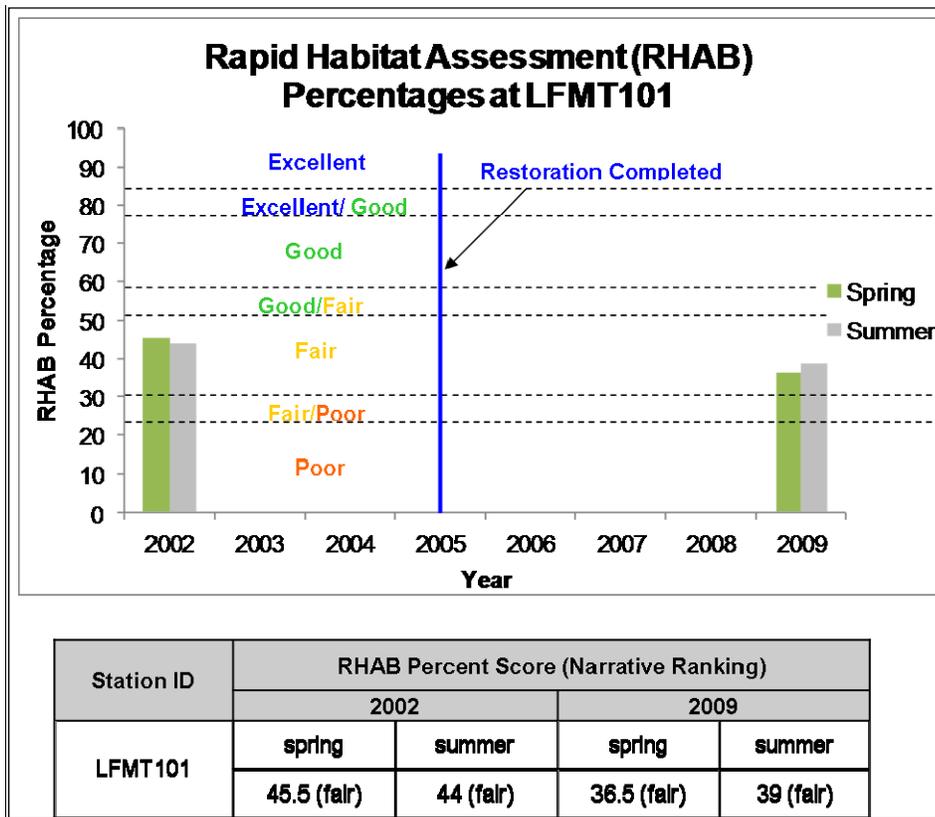
Figure 3.18.11 – Pre- and Post-Restoration Rapid Habitat Assessment (RHAB) Percentages at LFMT101

Pre-restoration aquatic habitat was evaluated at LFMT101 in the spring and summer in 2002. During this period, percentages were in the Fair range with scores of 45.5 and 44.0, respectively (*Figure 3.18.11*). Following restoration, aquatic habitat was evaluated in the spring and summer of 2009. During 2009, aquatic habitat percentages were lower than they were in the pre-restoration period but still within the Fair range, with scores of 36.5 and 39.0, respectively. The lower aquatic habitat percentages observed following restoration were due to a decrease in instream cover for fish, higher embeddedness, and an increase in sediment deposition. Field data sheets for this task are located in *Appendix D*.
