3.6 Lockridge Drive Stream Restoration

3.6.1 Introduction

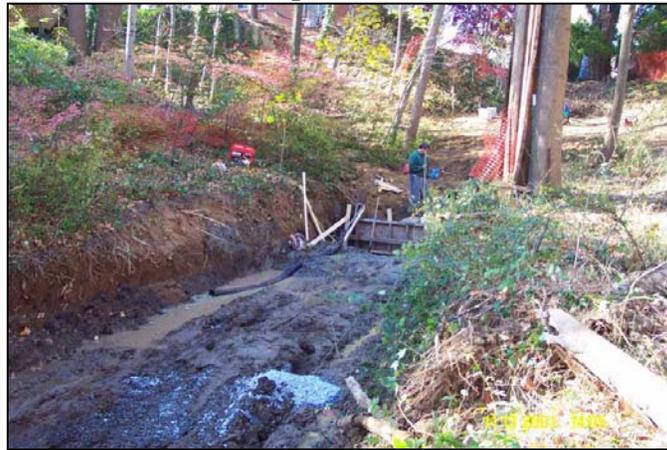
Figure 3.6.4 – Lockridge Drive Check Dam Construction at Outfall Channel – During Construction (2001)

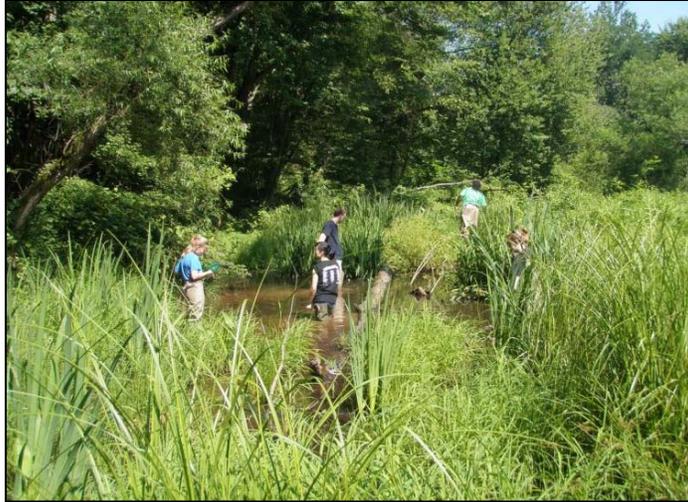
Figure 3.6.6 – Lockridge Drive Constructed Wetland (2009)

A high percentage of impervious surfaces and a lack of stormwater management in the drainage area had degraded stream conditions in the Lockridge Tributary. The stream had become eroded and entrenched, with unstable storm drain outfalls and poor aquatic habitat. The project was initially designed as a stormwater pond opportunity, but due to community concerns and potential tree loss, the project evolved into a stream restoration, storm drain outfall stabilization (*Figure 3.6.3*), and wetland/vernal pool creation project. Stream restoration was limited to the stream channel and consisted of check dams (*Figure 3.6.4*) and rip rap bank stabilization (*Figure 3.6.5*) designed to avoid disturbance of the riparian trees. A wetland/vernal pool with wetland vegetation was created nearby for amphibians (*Figure 3.6.6*).

A new wetland was constructed where the Lockridge tributary enters the mainstem of the Northwest Branch (**Figure 3.6.7**). This wetland is also considered a vernal pool since it is isolated from the stream, lacks fish, and dries up at least occasionally. Herpetofauna (amphibian and reptile) monitoring was performed post-restoration within the wetland in 2005, 2007, and 2009. In addition, wetland characteristics, plants, and invertebrates were also noted.

In October 2009, the wetland area had approximately 35 percent open water, and 65 percent Palustrine Emergent Wetland (PEM). The dominant emergent species found were *Scirpus cyperinus* (woolgrass), *Leersia oryzoides* (rice cutgrass), and *Iris versicolor* (harlequin blueflag). The site received an overall MDE wetland score of 94 out of 100, or a grade of “A” (**Table 3.6.4**).

The created wetland was well-established and colonized by many wetland species. Amphibian habitat could be improved if shade trees were planted adjacent to the pool to cool wetland water temperatures. However, the created wetland had evidence of deer browse and invasive plants in 2009. Treatment of the floodplain for invasives is recommended.

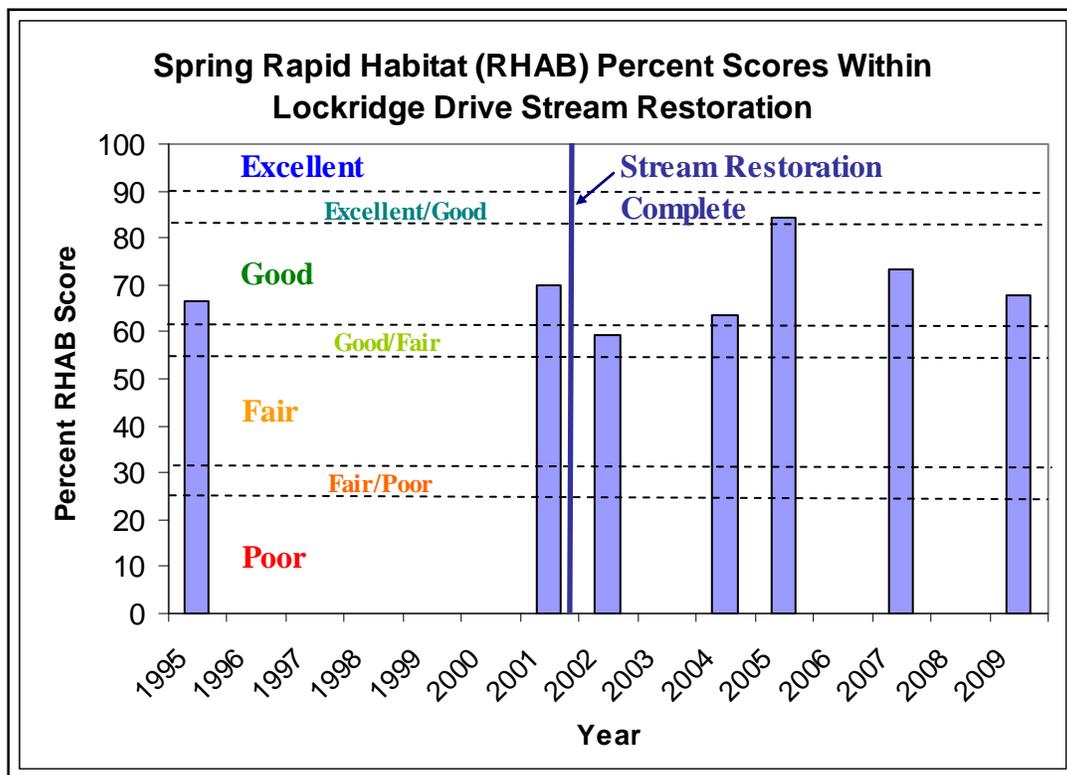
Spring rapid habitat (RHAB) scores for the Lockridge Drive site (NWLR102) were rated as Good prior to restoration (1995 and 2001), Good/Fair for the first year post-restoration (2002), Good in 2004, Excellent/Good in 2005, and Good for 2007 and 2009 (*Figure 3.6.13*). Most

aquatic habitat parameters were similar pre- and post-restoration although a few parameters improved and some declined. In-stream habitat, sediment deposition, and channel flow status parameters improved after restoration. Bank vegetative protection and riparian buffer width generally declined after restoration.

Figure 3.6.13 – Pre- and Post-restoration Spring Rapid Habitat (RHAB) Percent Scores at Site NWLR102

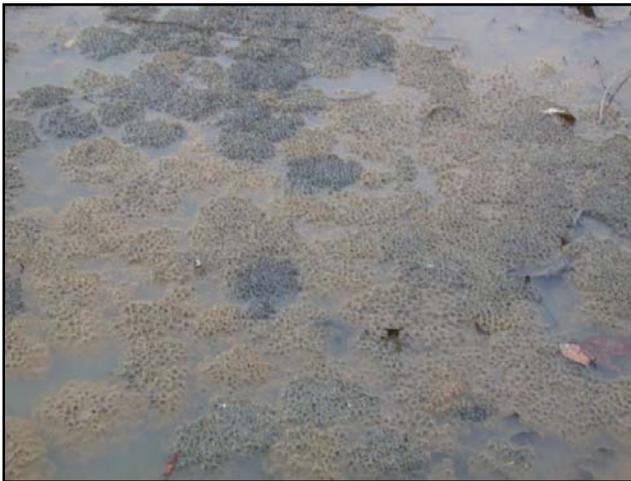
In the spring of 2005, the created vernal pool was measured to be 82 feet long, 26 feet wide, and two feet deep. Air temperature was 83°F and water temperature was 61°F. Emergent vegetation and *Typha latifolia* (broadleaf cattail) were present. Obligate wetland species *Lithobates sylvaticusi* (wood frog) egg masses and tadpoles were observed in mass quantities (**Figure 3.6.14**). In addition, four adult *Lithobates palustris* (pickerel frog), a facultative vernal pool species, were found in the pool in 2005. A *Dryocopus pileatus* (pileated woodpecker) was also observed around the pool (**Figure 3.6.15**). In the spring of 2007, the vernal pool measured 98 feet long, 30 feet wide, and two feet deep, with emergent vegetation and cattails present. More than 500 *Lithobates sylvaticusi* (wood frog) tadpoles and approximately 100 *Lithobates catesbiana* (American bullfrog) tadpoles were found.

Figure 3.6.14 – *Lithobates sylvaticusi* (wood frog) egg masses in Lockridge Created Vernal Pool in 2005
