## 3.15 Piping Rock Drive Stormwater Pond

### 3.15.1 Introduction

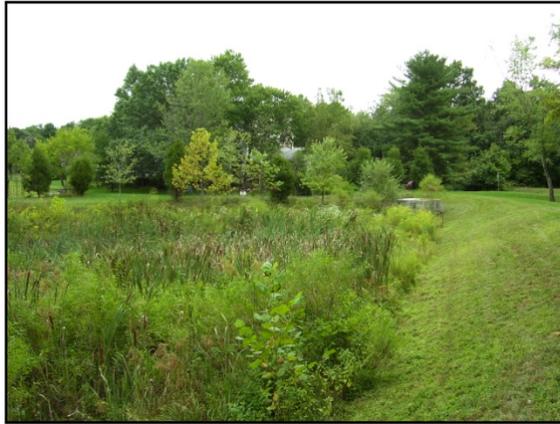
*Figure 3.15.1 – Piping Rock Drive Stormwater Pond in 2009*

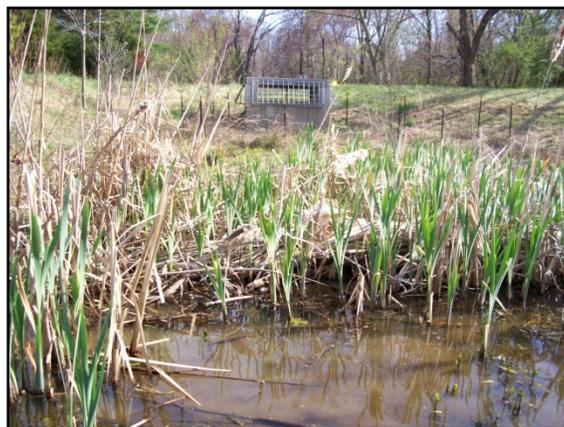
*Figure 3.15.2 – Piping Rock Drive Stormwater Pond in 2009*

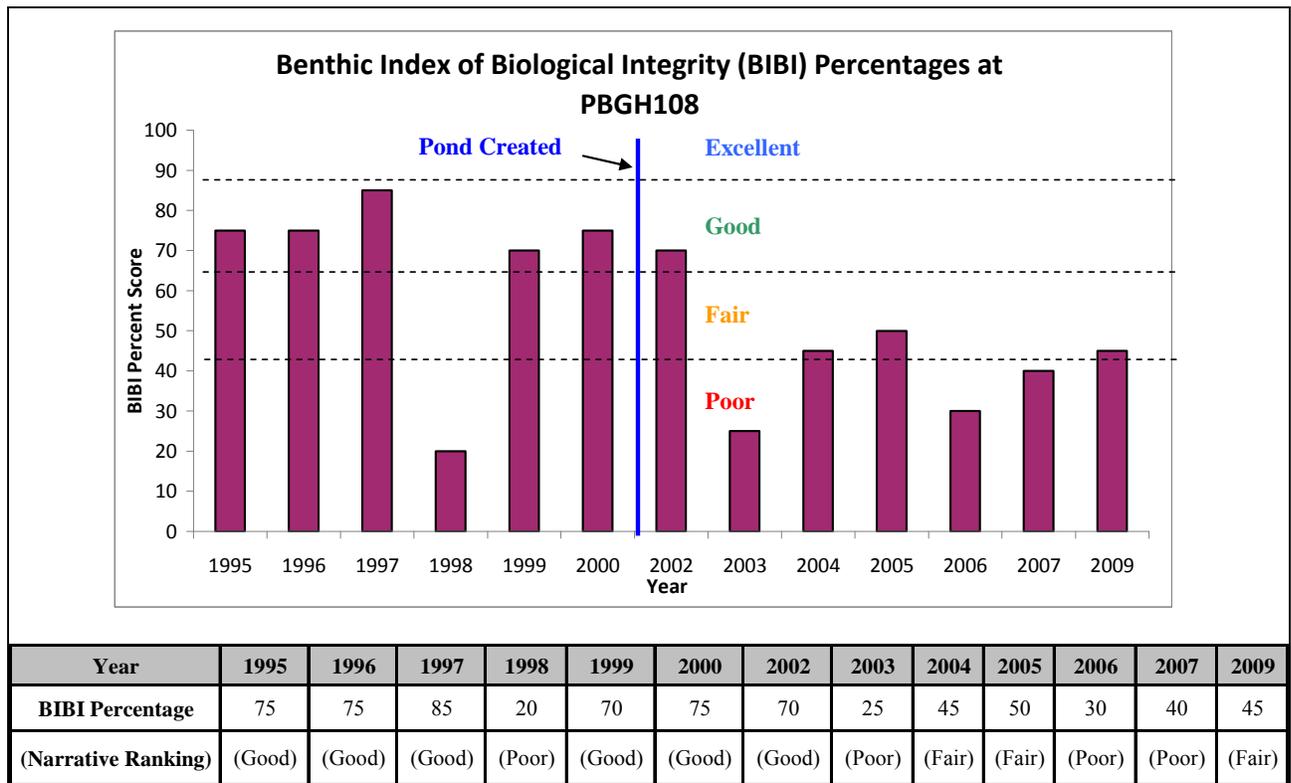
**Figure 3.15.5 – Pre- and Post-Restoration Benthic Index of Biological Integrity (BIBI) Percentages at PBGH108**

The BIBI percentages were generally lower during the post-restoration period when compared to the pre-restoration data (*Figure 3.15.5*). The community was dominated by several sensitive Ephemeroptera, Plecoptera, and Trichoptera (EPT) taxa during the pre-restoration monitoring period. These taxa were either completely absent or present in reduced numbers during the post-restoration period. One of the most consistent declines in the benthic community was the increase in biotic index among years. The biotic index is a weighted measure of the tolerance values of the community. The lower the tolerance value, the less tolerant (more sensitive) a taxon is to degraded conditions, with zero being the least tolerant to degradation and nine being the most tolerant to degradation. The biotic index ranged from 2.3 to 7.1 prior to pond

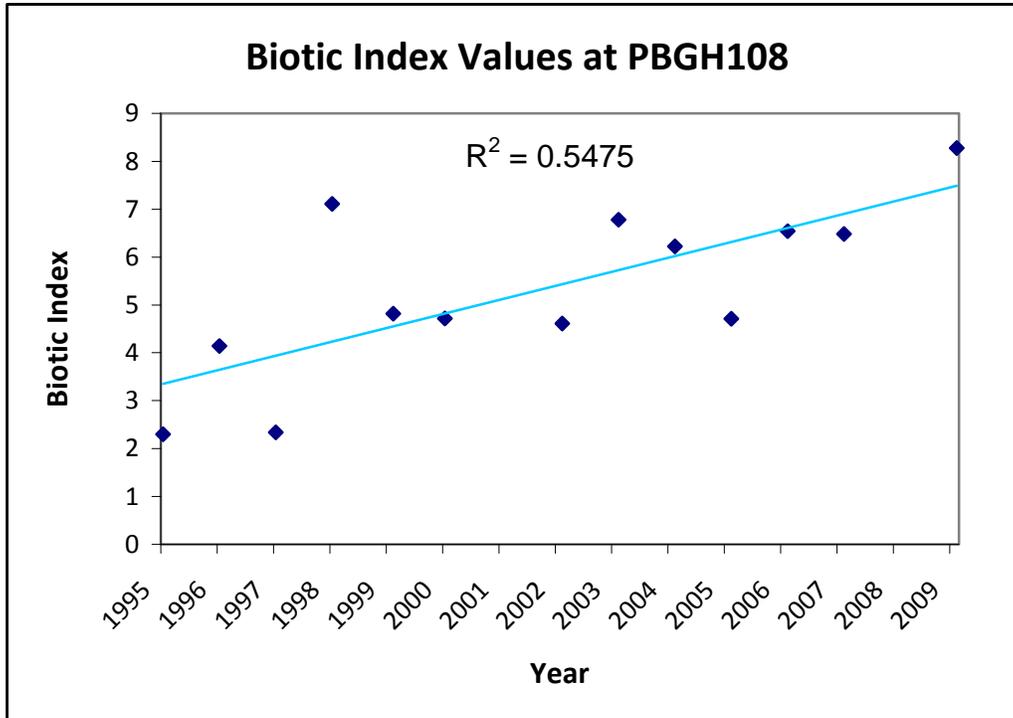
construction with most years having values near or below four. Post-restoration, the biotic index ranged from 4.6 to 8.3 with most years having values above six (**Figure 3.15.10**). Other patterns of individual benthic macroinvertebrate metrics were not constant over time. 2009 field data sheets for this task are included in **Appendix D**.

**Figure 3.15.10 – Biotic Index values at PBGH108. Biotic Index = (number of individuals per taxa × Tolerance values for all taxa and total) / total number of organisms.**

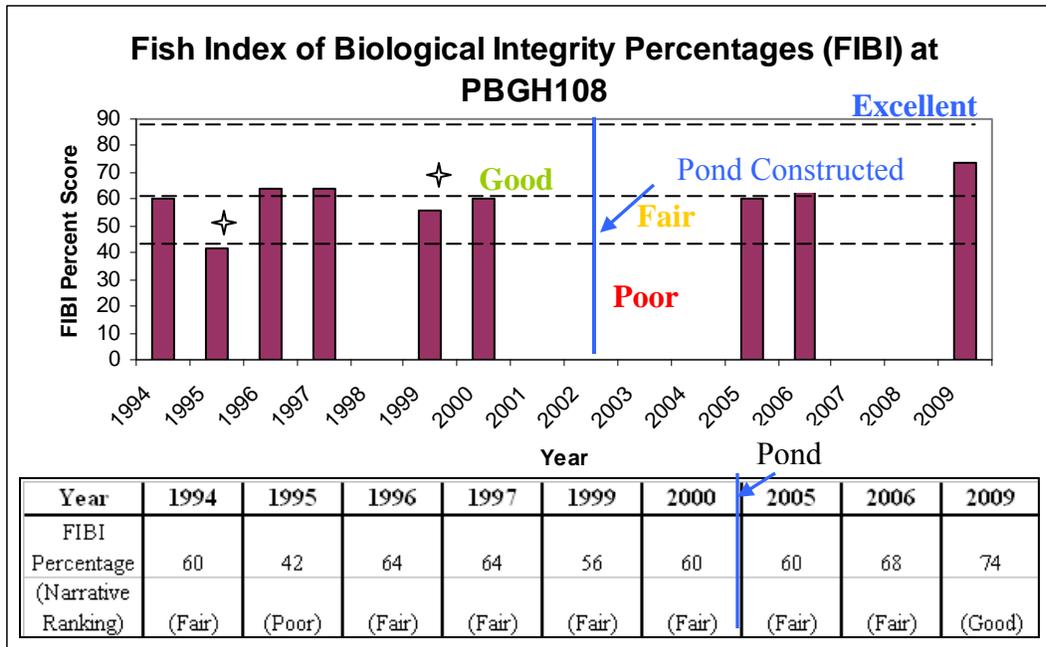
The pre-restoration fish community, as assessed by the MCDEP Fish Index of Biological Integrity (FIBI), generally remained Fair from 1994 to 2000, with one intervening year (1995) scoring in the Poor range (**Figure 3.15.11**). Based on the Palmer Hydrological Drought Index (PHDI) data from the National Oceanic and Atmospheric Administration (NOAA), moderate to severe drought conditions existed in the area in March and April prior to the collection of fish in July, 1995 (NOAA 2009). *Salmo trutter* (brown trout) were only collected from 1994 through 1996. Historically, the Good Hope tributary of the Paint Branch has been the primary spawning ground for the naturally reproducing brown trout population. However, the brown trout fishery has experienced significant declines in the last few decades, especially within the upper portions of the Good Hope subwatershed.

The fish community assessments conducted during the post-restoration period showed a steady increase in the FIBI score, from Fair to Good. In 2009, *Cottas caeruleomentum* (Blue Ridge sculpin) were collected for the first time at this site. Blue Ridge sculpin are considered an intolerant (pollution-sensitive) fish species and were the cause of the FIBI score increase in 2009. This was also the first time since 1996 that any intolerant species was found at PBGH108. Field data sheets from 2009 fish monitoring are included in **Appendix D**.

**Figure 3.15.11 – Pre- and Post-Restoration Fish Index of Biological Integrity (FIBI) Percentages at PBGH108**

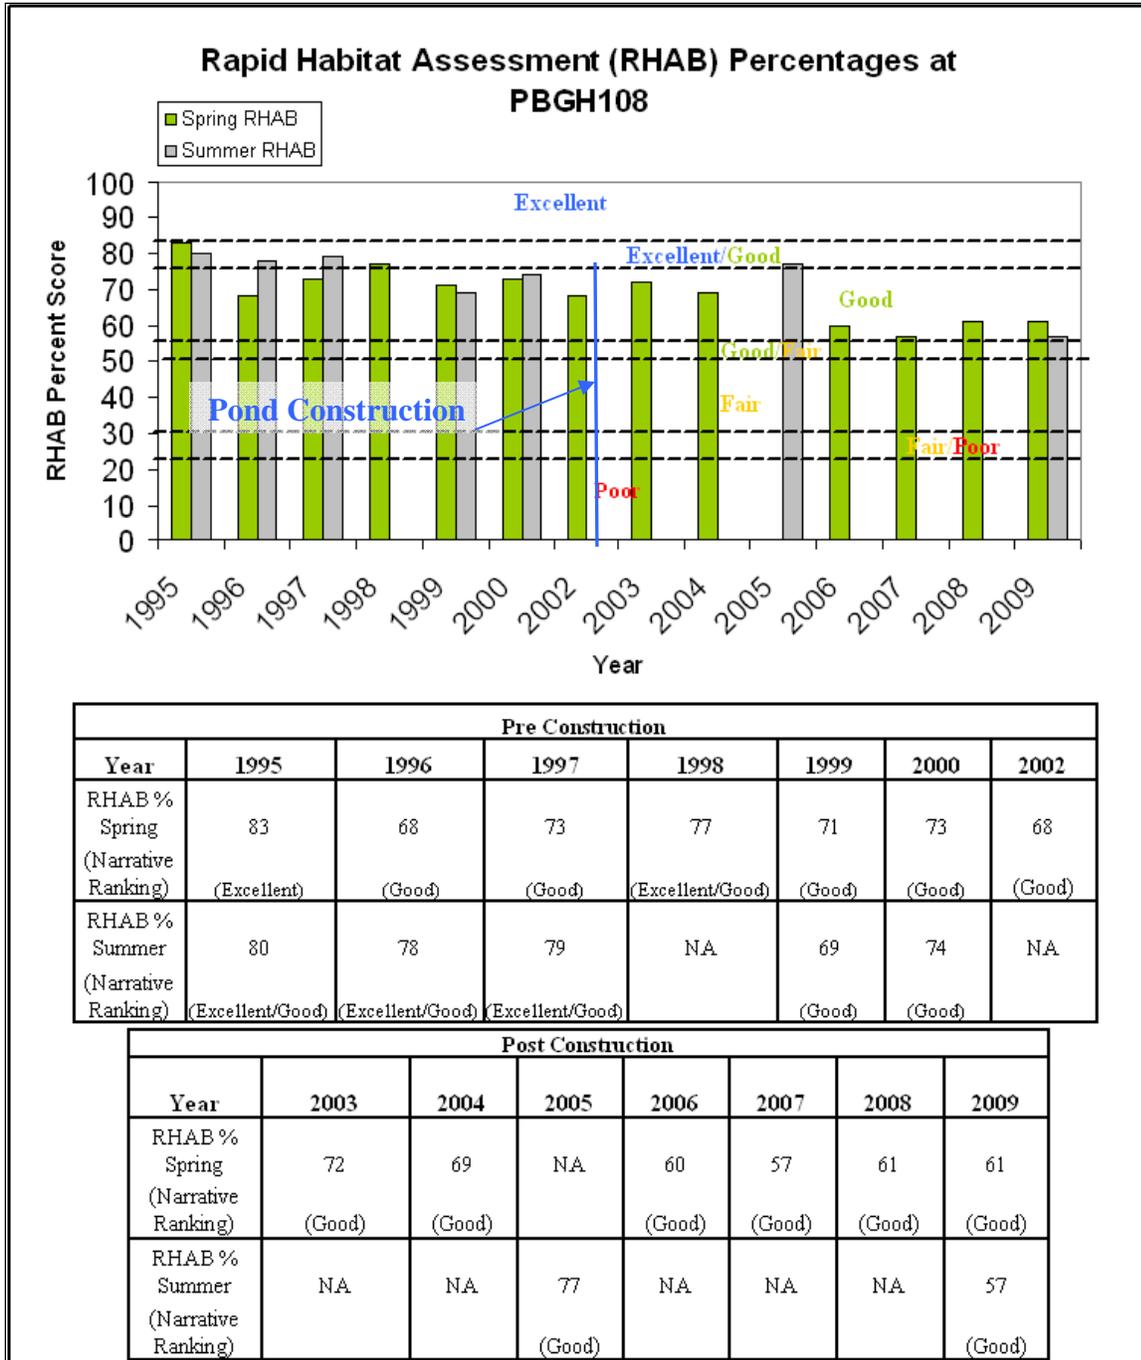
Aquatic habitat was evaluated at PBGH108 from 1995 to 2009, with the exception of 2001. Habitat quality showed gradual declines during the pre-restoration period (**Figure 3.15.16**). Epifaunal substrate and the frequency of riffles metrics experienced the clearest declines during the pre-restoration period. Sediment deposition and bank stability were generally rated lower than other individual habitat parameters throughout the pre-restoration period. Despite declines in individual habitat metrics, the overall aquatic conditions remained in the Good range.

Aquatic habitat during the post-restoration monitoring period continued along a similar downward trajectory observed during the pre-restoration period. While several assessments rated the aquatic habitat similarly to the pre-restoration scores (i.e., spring of 2003 and summer of 2005), the majority of the post-restoration scores were below what was observed during the pre-restoration period (**Figure 3.15.16**). Generally, epifaunal substrate, riffle/run frequency, and bank stability scores continued to be rated lower than other individual habitat metrics and continued to decline during the post-restoration monitoring period. Aquatic habitat scores showed substantial declines after 2005.

**Figure 3.15.16 – Pre- and Post-Restoration Rapid Habitat Assessment (RHAB) Percentages at PBGH108**

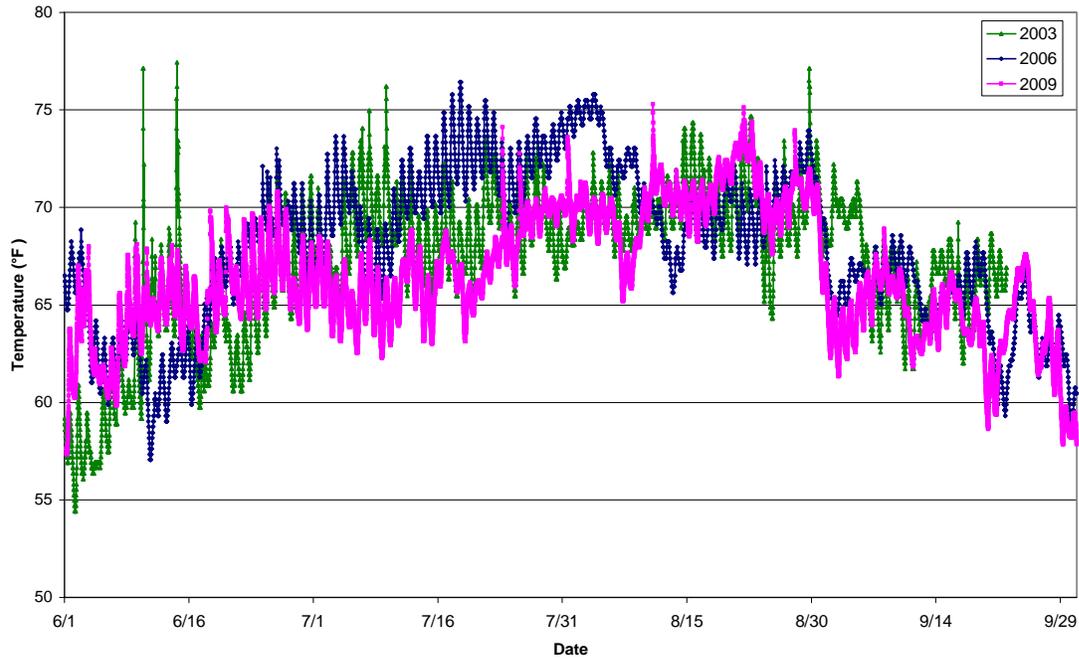
Although average temperatures between the upstream and downstream sites only differed by a little more than one degree, the percentage of readings above 68°F was higher at the site downstream of the pond. In addition, a paired t-test performed on the 2009 data, comparing means between the upstream and downstream site, yielded a highly significant difference (p value <0.0001) between temperatures upstream and downstream of the pond. On average, downstream temperatures were 1.04 degrees warmer than upstream temperatures. Post-restoration temperature profiles from all years are plotted for each site and presented below (*Figures 3.15.20* and *3.15.21*).

Figure 3.15.20 – Stream Temperature Upstream of the Piping Rock Drive Stormwater Pond in 2003, 2006, and 2009

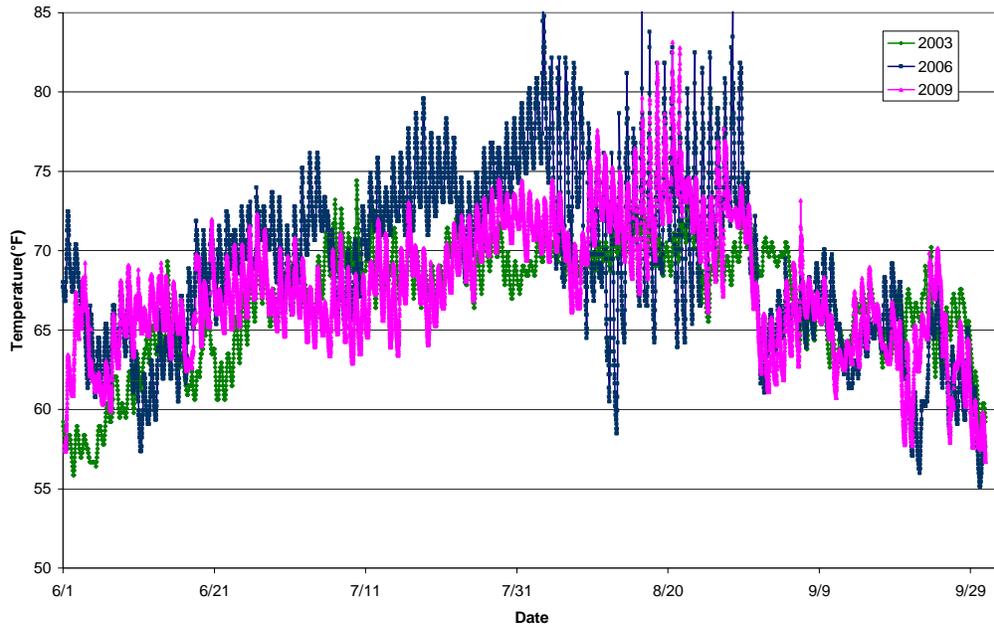
Figure 3.15.21 – Stream Temperature Downstream of the Piping Rock Drive Stormwater Pond in 2003, 2006, and 2009

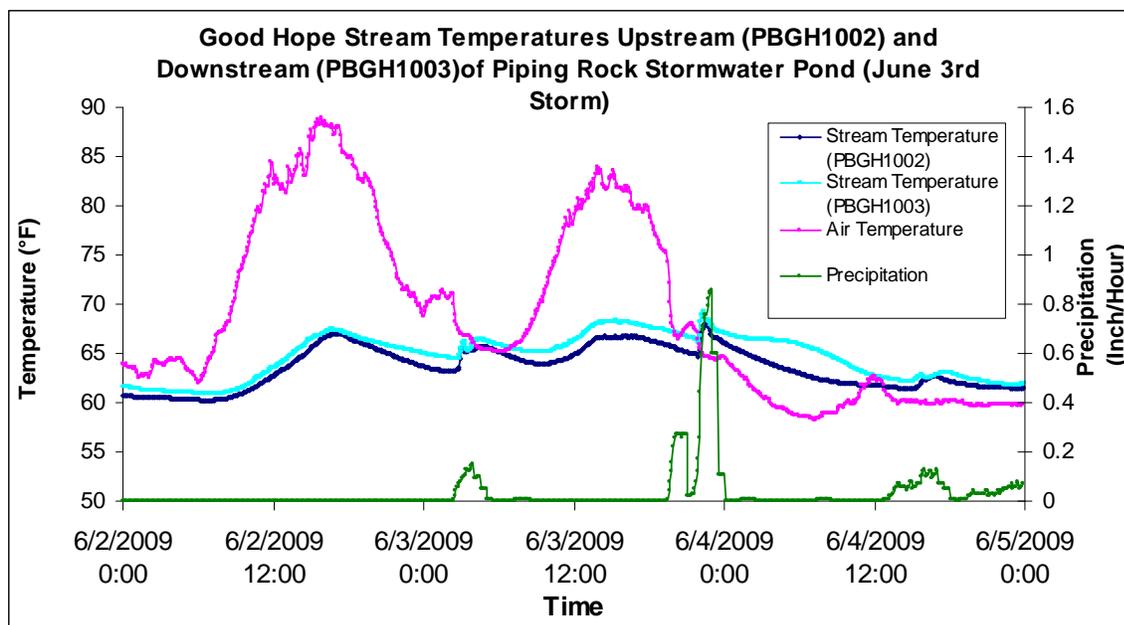
**Figure 3.15.22 – Precipitation, Air, and Stream Temperatures, Upstream (PBGH1002) and Downstream (PBGH1003) of the Piping Rock Drive Stormwater Pond during the June 3rd Storm**

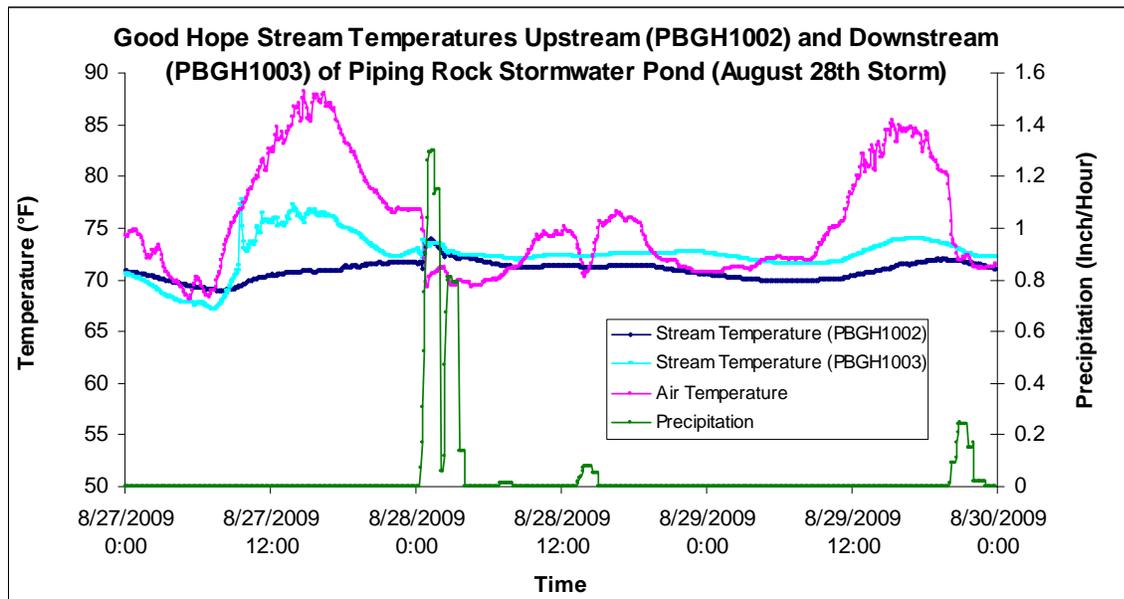
As shown in **Table 3.15.8** below, average, minimum, and maximum stream temperatures above and below the pond for the August 28, 2009 event, were much higher than those observed during the June 3, 2009 storm event (**Figure 3.15.23**). The general temperature increase from June to August is typical as stream temperature trends typically reflect summer air temperature trends. This general trend in climbing temperatures can be seen in Figures 13.4.15 and 13.4.16.

**Figure 3.15.23 – Precipitation, Air, and Stream Temperatures Upstream (PBGH1002) and Downstream (PBGH1003) of the Piping Rock Drive Stormwater Pond during the August 28<sup>th</sup> Storm**
