Upper Rock Creek

3.22 Stream Valley Drive Stream Restoration

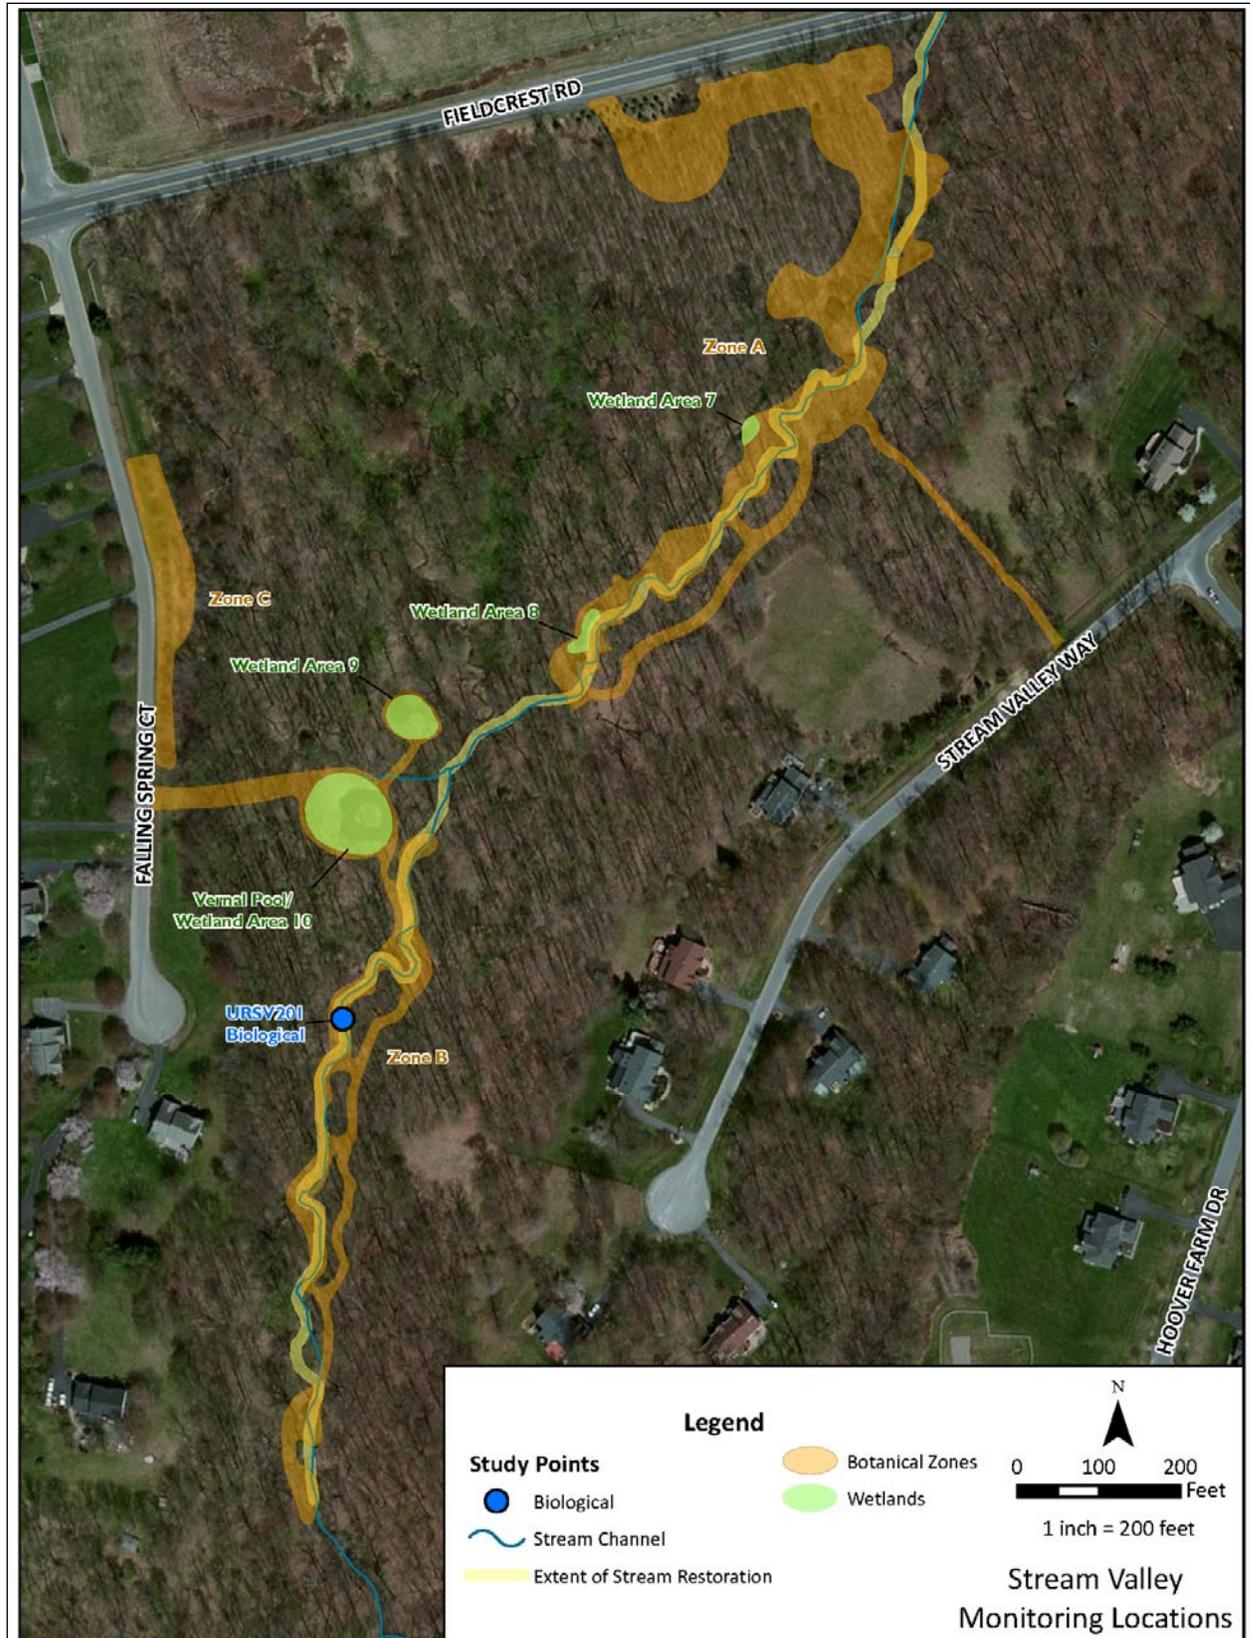
Figure 3.22.4 – Map of 2009 Monitoring Locations at the Stream Valley Restoration Site

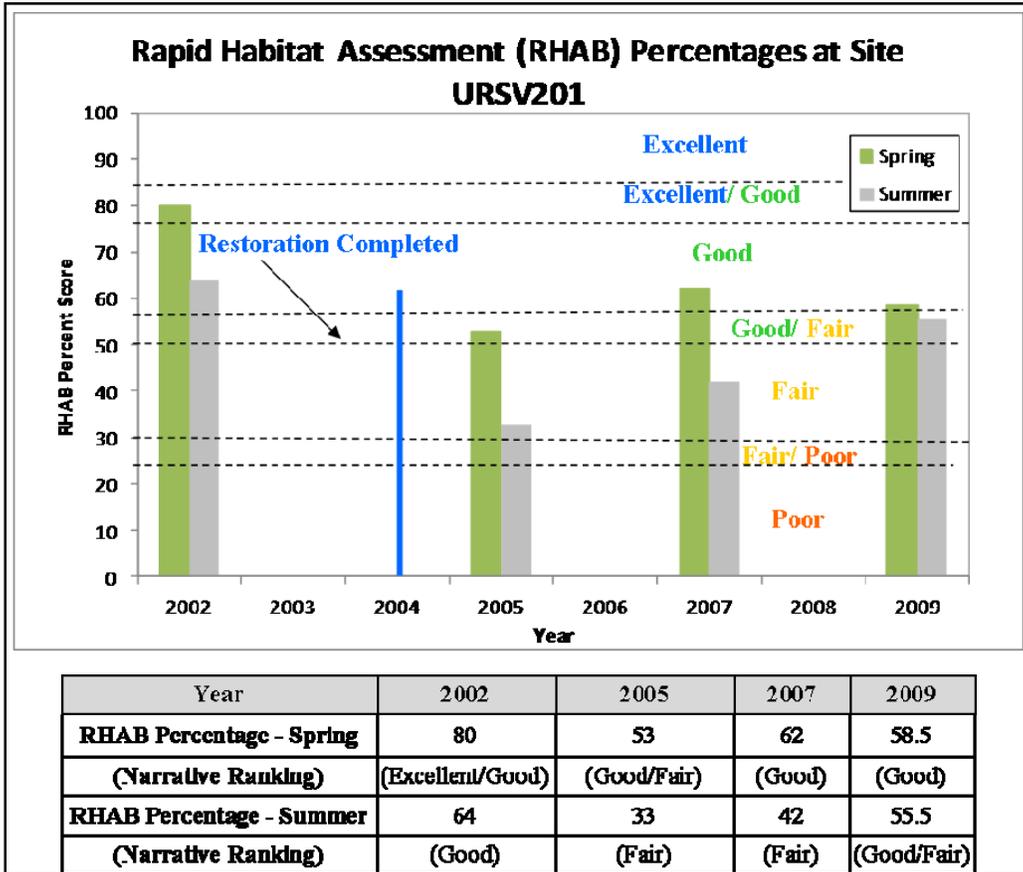
Aquatic habitat assessed by the EPA Rapid Bioassessment Protocol (RHAB) scored in the Excellent/Good and Good ranges in the spring and summer of 2002, respectively (*Figure 3.22.17*). Habitat percentages were generally in the suboptimal and optimal ranges with sediment deposition and embeddedness values consistently scoring lowest of all assessed parameters during this time and epifaunal substrate values and channel alteration consistently scoring the highest.

Figure 3.22.17 - Pre- and Post-Restoration Rapid Habitat Assessment (RHAB) Percentages at URSV201

Overall, post-restoration aquatic habitat percentages declined from the pre-restoration period but were variable over time, with several of the individual habitat scores ranging from poor to suboptimal. Spring aquatic habitat percentages were consistently rated higher than summer percentages, scoring in the Good and Good/Fair ranges. Summer aquatic habitat percentages scored in the Fair and Good/Fair ranges. The lowest habitat percentages were noted in 2005, a very dry year, when the stream was dry, with the exception of pools that were filled with water. After 2005, aquatic habitat scores improved, but were still below pre-restoration ranges.

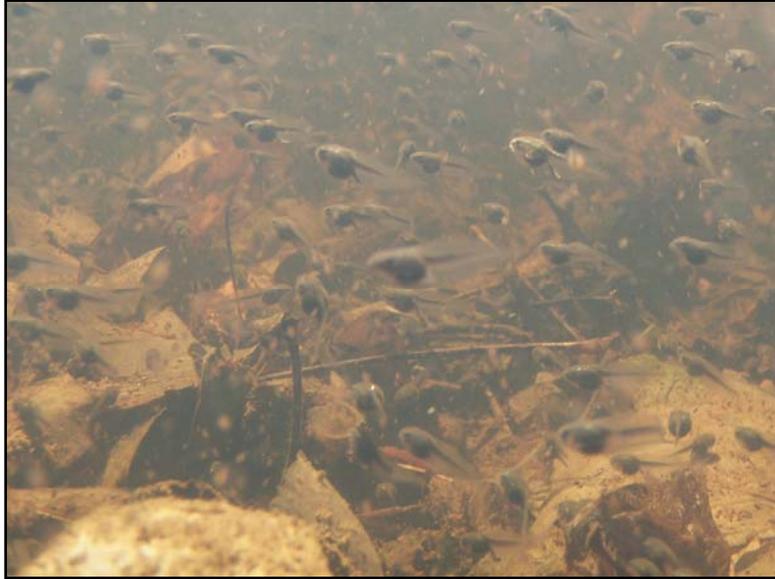
In 2009, the vernal pool dimensions were the same as they were in previous years. During the 2009 site visit, the vernal pool appeared to be full when monitored, the depth of the water in the pool was approximately 1 foot, and the temperature within the vernal pool was 45°F. Emergent and submerged herbaceous vegetation was found growing in the vernal pool. Additionally, a large fallen tree branch and many smaller pieces of downed woody debris were observed in the pool creating a natural vernal pool condition (**Figure 3.22.20**). Spring peepers were heard calling from the pool, more than 1,000 *Bufo* sp. (toad) tadpoles were seen swimming in the pool, and four spotted salamander egg masses were observed (**Figure 2.22.21**). The egg masses were submerged and attached to the woody debris. Several invertebrate taxa were also observed including: Culicidae (mosquito larvae), Dytiscidae (diving beetles), copepods, and Gerridae (water striders). No crayfish burrows or fish were seen in or around the pool. Field data sheets for the 2009 vernal pool monitoring task are included in **Appendix D**.

Figure 3.22.21 – Created Vernal Pool at Site URSV201 in 2009, Picturing *Anaxyrus* sp. (unknown toad) tadpoles
