Turkey Branch Subwatershed

3.23 Turkey Branch Stream Restoration and Stormwater Ponds

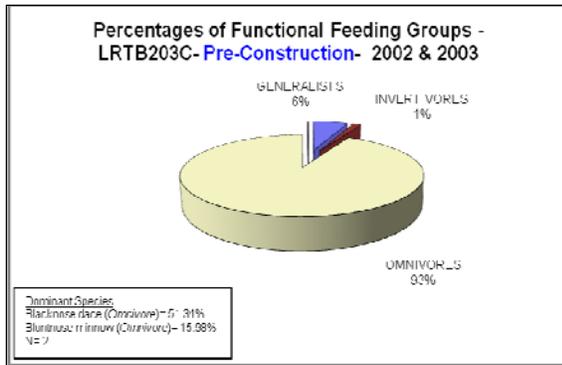
Figure 3.23.44 – Fish Functional Feeding Group Composition and Dominant Species at LRTB203C Prior to Restoration

At site LRTB203C, the percentage of invertivores increased from the pre- to post-restoration monitoring period and the percentage of omnivores decreased from 93 to 87 percent. The increase in invertivore percentage was due to an increase in two species of sunfish, bluegill (*Lepomis macrochirus*) and pumpkinseed (*Lepomis gibbosus*), an increase in percentages of tessellated darter (*Etheostoma olmstedi*) and spotfin shiner (*Cyprinella spiloptera*), and the presence of both roseyside dace (*Clinostomus funduloides*) and eastern mosquitofish (*Gambusia holbrooki*) in the post-restoration period that were absent prior to restoration. **Figures 3.23.44** and **3.23.45** show the percentages of each functional feeding group at LRTB203C for the pre- and post-restoration monitoring periods, respectively.

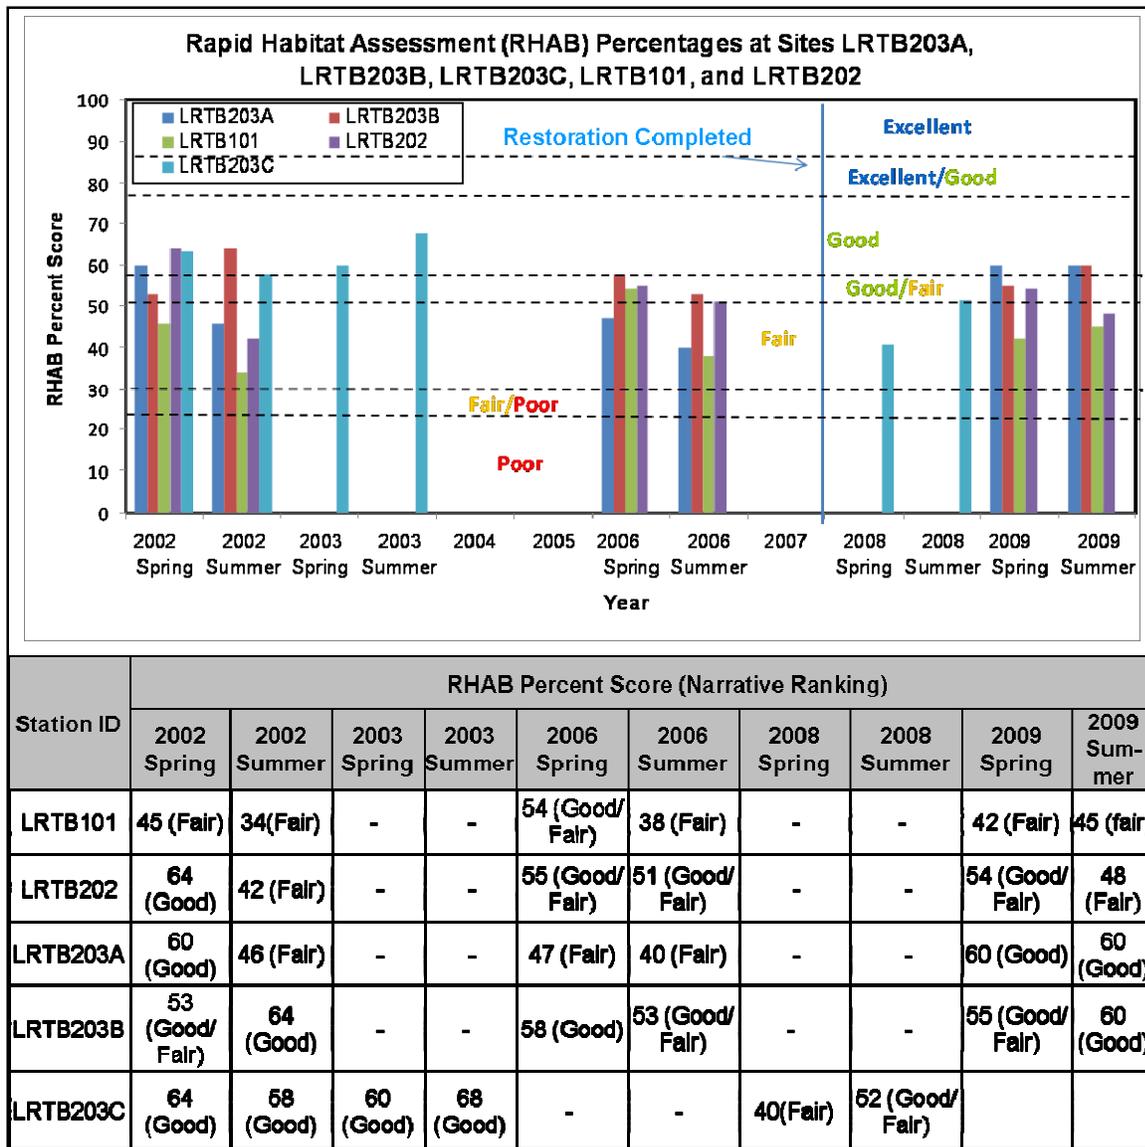
Figure 3.23.46 – Pre- and Post-Restoration Rapid Habitat Assessment (RHAB) Percentages at LRTB203A, LRTB203B, LRTB203C, LRTB101, and LRTB202

Pre-restoration aquatic habitat was evaluated at LRTB101, LRTB202, LTRB203A, and LRTB203B in the spring and summer in 2002 and 2006. Pre-restoration aquatic habitat was assessed at LRTB203C in 2002 and 2003. Scores were in the Fair, Fair/Good, and Good ranges in the pre-restoration periods, with 40 percent of the sites scoring in the Good range, 25 percent of the sites scoring in the Fair/Good ranges, and 35 percent of the sites scoring in the Fair range. Prior to restoration, Turkey Branch sites generally had suboptimal in-stream cover for fish, marginal epifaunal substrate for benthic macroinvertebrates, and moderate sediment deposition. Bank stability was variable among sites, but most sites had moderately unstable to unstable banks and marginal streambank vegetative protection. Embeddedness was also variable, but most sites were estimated to have between 50 and 75 percent embeddedness. Sites LRTB202, LRTB203B, and LRTB203C generally had higher scores for in-stream cover and LRTB203B and LRTB203C had higher epifaunal substrate scores. **Figure 3.23.46** shows aquatic habitat scores prior to and after restoration at all Turkey Branch sites.

Aquatic habitat percentages were similar at all Turkey Branch sites after restoration but showed a declining trend; 30 percent of the sites scored in the Good range, 20 percent scored in the Good/Fair range, and 40 percent scored in the Fair range. Sites LRTB101 and LRTB203C were rated slightly lower after restoration due to lower in-stream cover and epifaunal substrate scores. Site LRTB203A was rated slightly higher due to higher in-stream cover and epifaunal substrate scores, and LRTB202 and LRTB203B were rated similarly before and after restoration. At most sites, riffle frequency and bank stability improved after restoration.

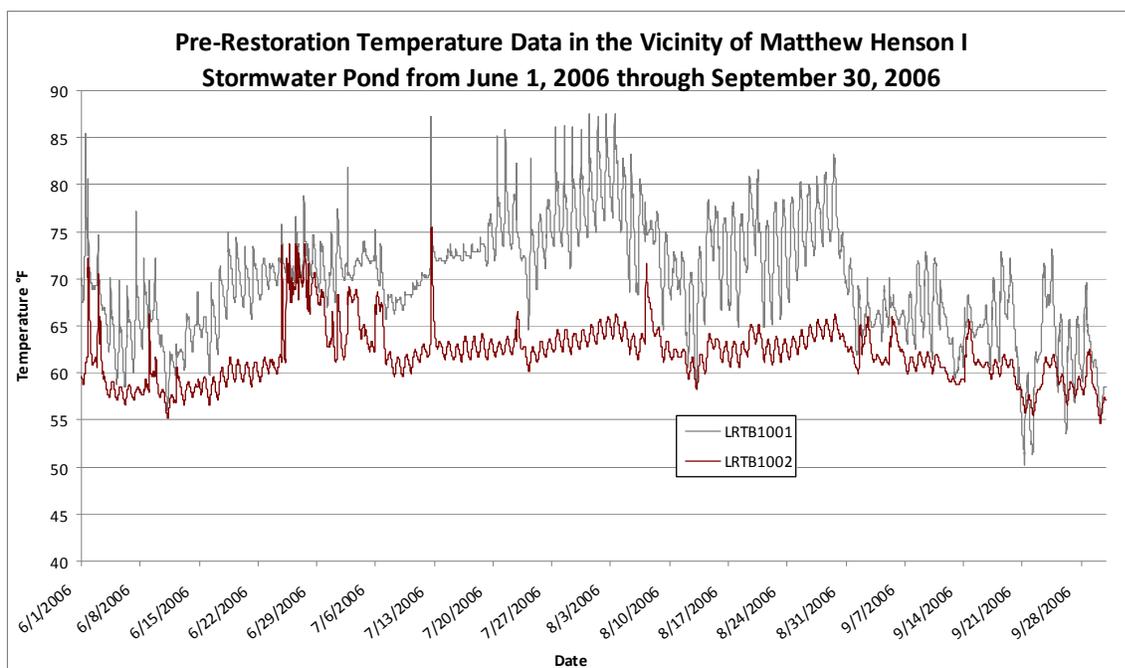
Figure 3.23.60 – Pre-restoration Stream Temperature Data from Matthew Henson I Stormwater Pond (Sites LRTB1001 and LRTB1002) from June 1 to September 30, 2006

In 2006, pre-restoration temperature data were collected in the project area from sites LRTB1001 and LRTB1002. These two sites are located on a tributary to Turkey Branch, southwest of Georgia Avenue (MD 97). The logger at LRTB1001 was deployed upstream of the future site of Matthew Henson I stormwater pond and the logger at LRTB1002 was deployed downstream (**Figure 3.23.6**). The average temperatures were 69.8 °F and 62.0 °F at sites LRTB1001 and LRTB1002, respectively. No readings at either site exceeded the Use I COMAR temperature standard of 90 °F. The maximum temperature at LRTB1001 (87.5°F) was higher than the maximum temperature at LRTB1002 (75.6°F). Temperature profiles from 2006 are plotted in **Figure 3.23.60**.

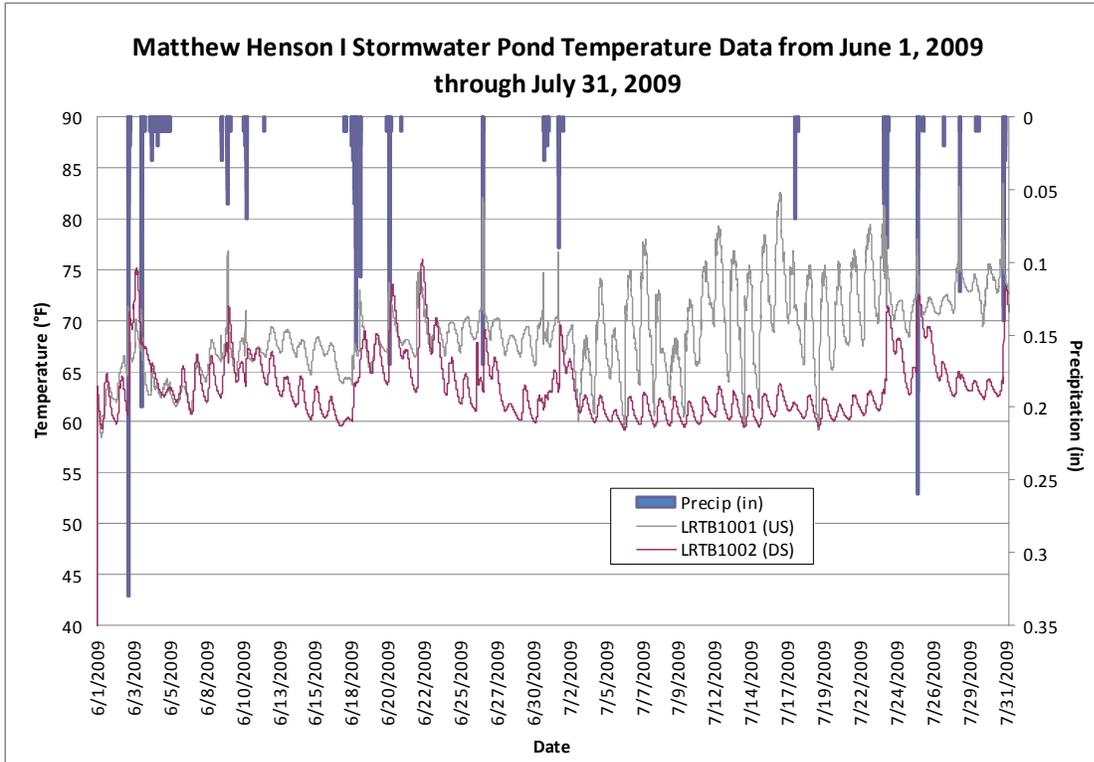
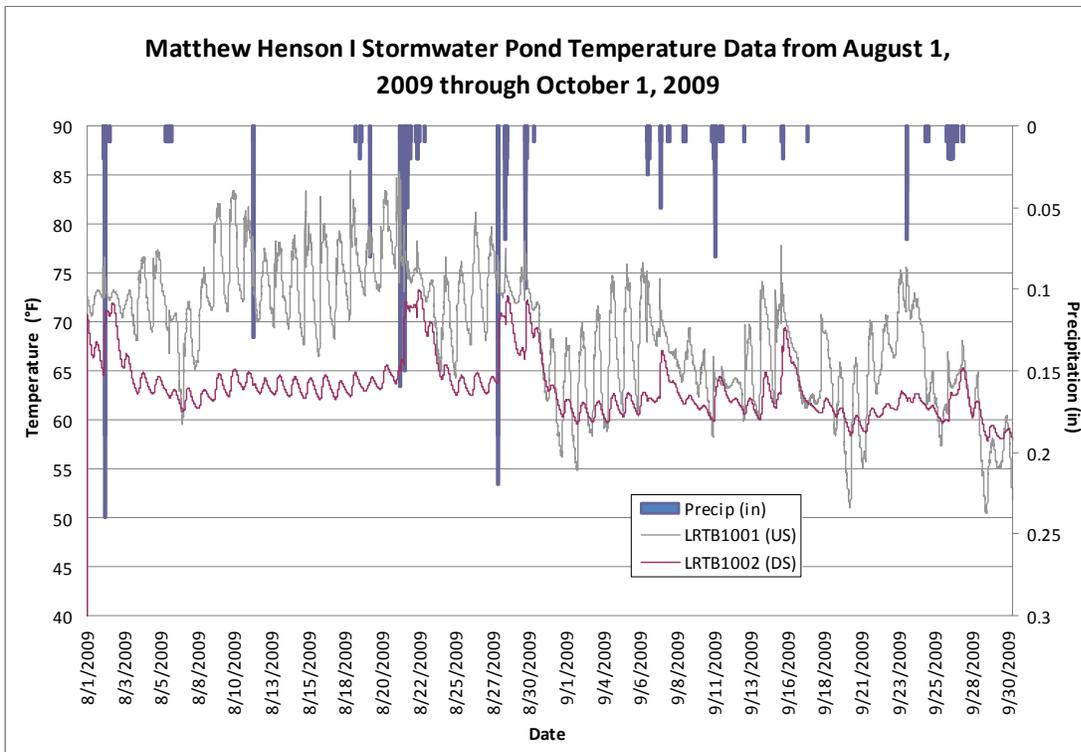
Post-restoration temperature data were collected in 2009 at Matthew Henson I sites LRTB1001 (upstream) and LRTB1002 (downstream). Temperatures did not exceed the Use I temperature threshold at either of these sites. The average temperature upstream of the Matthew Henson I stormwater pond was 68.9°F. The average temperature downstream of the pond was 63.4°F, 5.5°F lower than the upstream site. **Table 3.23.15** shows the minimum, maximum, and average temperature at both Matthew Henson I sites, and the differences between these values. The maximum temperature in 2009 was also higher upstream (85.4°F) of the pond than downstream (75.9°F). In addition, a paired t-test performed on the 2009 data, comparing means between the upstream and downstream site, yielded a highly significant difference (p value <0.0001) between temperatures upstream and downstream of the pond. In this case, temperatures were significantly higher upstream of the pond than below. Post-restoration temperature profiles from all sites are plotted and presented below (**Figures 3.23.61** and **3.23.62**).

Figure 3.23.61 – Stream Temperature in the Vicinity of the Matthew Henson I Stormwater Pond at Sites LRTB1001 (US) and LRTB1002 (DS), from June 1 to July 31, 2009

Figure 3.23.62 – Stream Temperature in the Vicinity of the Matthew Henson I Stormwater Pond at Sites LRTB1001 (US) and LRTB1002 (DS), from August 1 to September 30, 2009

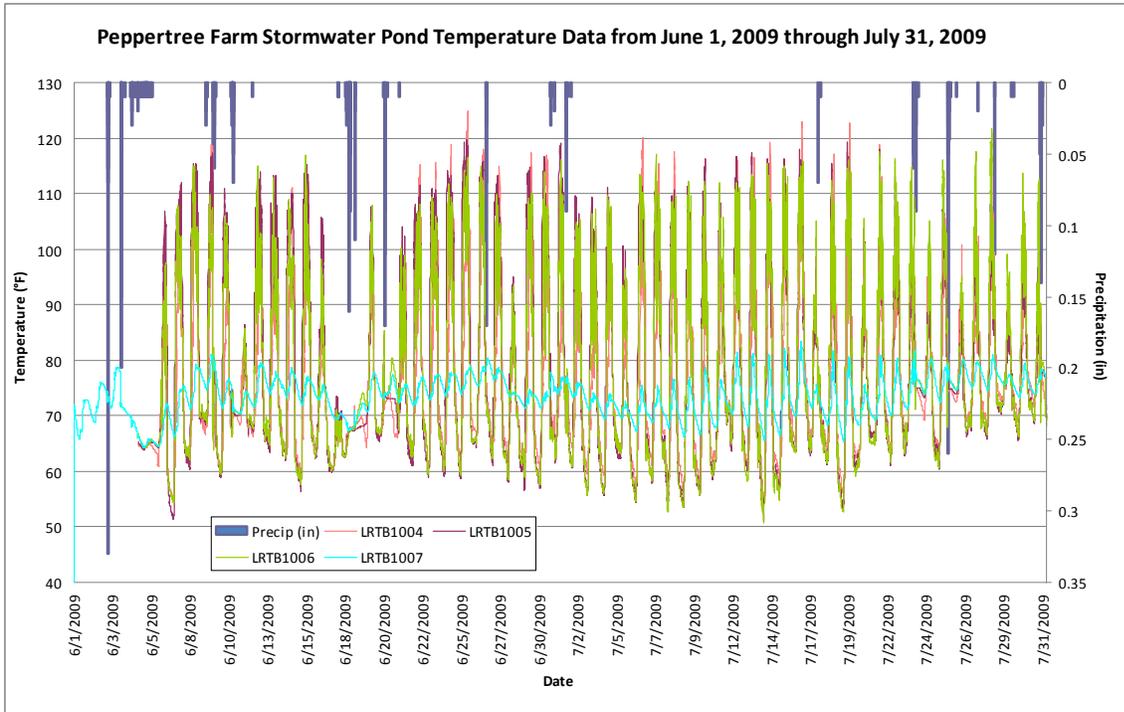
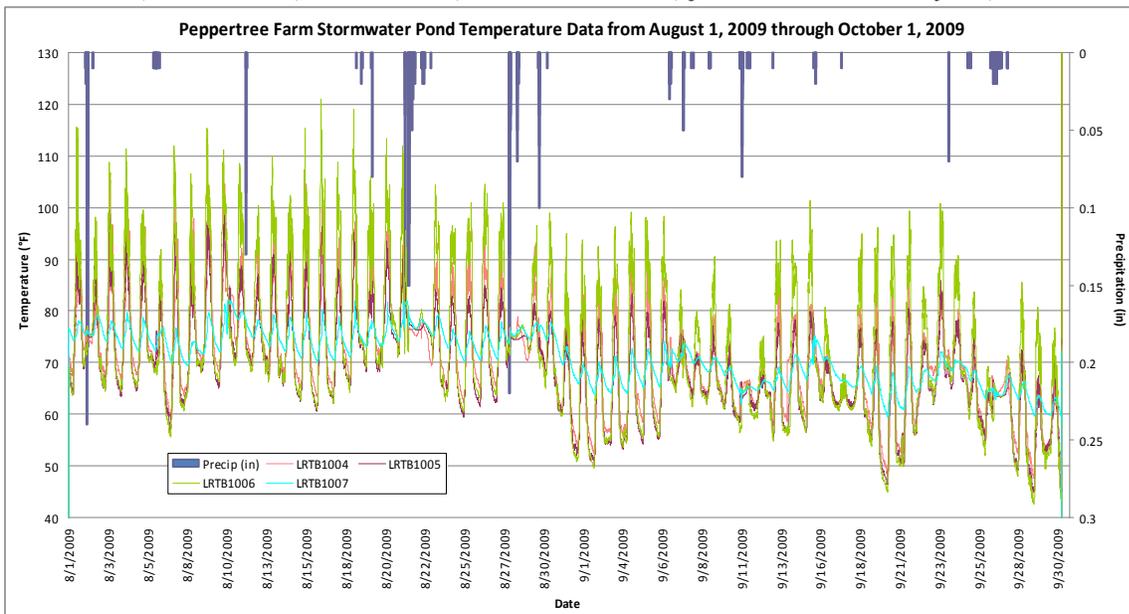
None of the temperature values downstream of the ponds exceeded the Use I threshold of 90°F. The minimum temperatures from within the ponds were much lower than measured in the stream below the ponds, ranging from 11.4 to 16.5°F lower, and the maximum temperatures within the ponds were much higher than measure in the stream, ranging from 36.1 to 41.1 degree higher. Maximum summer temperatures within the pond were extremely high, ranging from 120 to 125°F, nearly 35°F above the Use I temperature standard. Between 8.6 and 17.9 percent of the readings taken from within the ponds exceeded the Use I temperature standard of 90°F. Yet, it is clear that the loggers were often dewatered, recording air temperatures; these data should not be used to document thermal impacts from the ponds. Therefore, paired t-tests comparing mean temperatures between each of the ponds and the stream temperature downstream were not possible. At the time of installation, the loggers were deployed as deep as possible; however, when they were retrieved, all three pond loggers were dewatered. An improved methodology has been developed to prevent this from happening in the future.

Figure 3.23.65 – Stream Temperature in the Vicinity of the Peppertree Stormwater Pond at Sites LRTB1004, LRTB1005, LRTB1006, and LRTB1007, from June 1 to July 31, 2009

Figure 3.23.66 – Stream Temperature in the Vicinity of the Peppertree Stormwater Pond at Sites LRTB1004, LRTB1005, LRTB1006, and LRTB1007, from August 1 to September 30, 2009

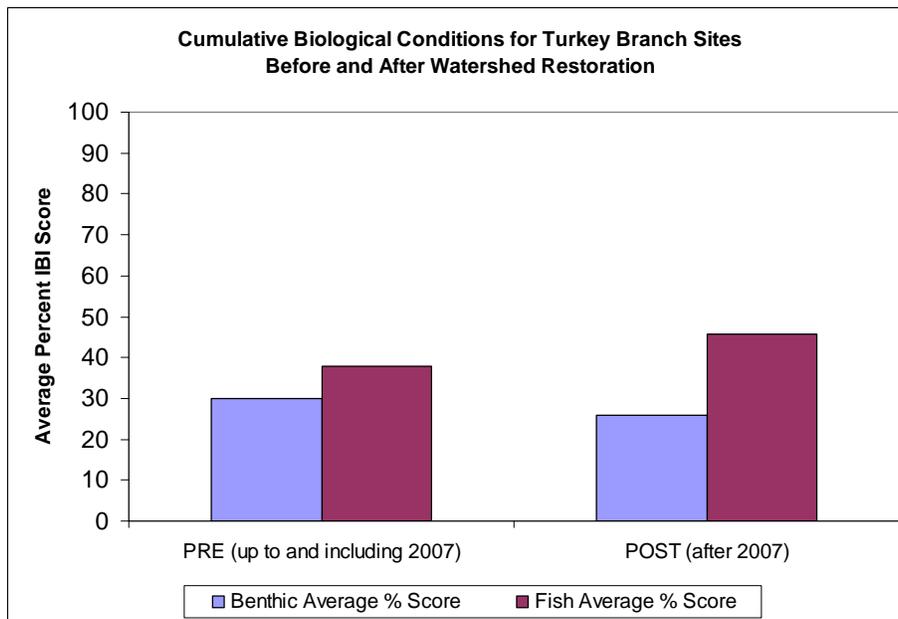
Figure 3.23.67 – Cumulative Biological Conditions for Turkey Branch Sites Prior to and After Restoration

So far, cumulative watershed effects have been mixed. Fish communities have shown a slight improvement and benthic macroinvertebrate communities have shown a decline (*Figure 3.23.67*).

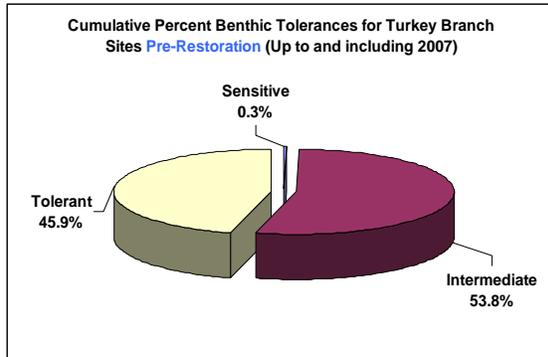
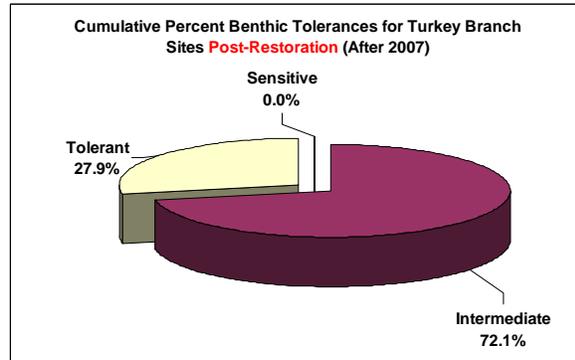
Other measures of benthic macroinvertebrate community composition have shown mixed results, with most indices pointing to community decline. Sensitive taxa, although not abundant prior to restoration, were present, but were completely absent from the community after restoration (*Figures 3.23.68 and 3.23.69*). Tolerant taxa declined after restoration and intermediate taxa increased suggesting an improvement in the community; however, changes in laboratory

Figure 3.23.68 – Cumulative Benthic Macroinvertebrate Tolerance Composition for Turkey Branch Sites Prior to Restoration

Figure 3.23.69 – Cumulative Benthic Macroinvertebrate Tolerance Composition for Turkey Branch Sites After Restoration

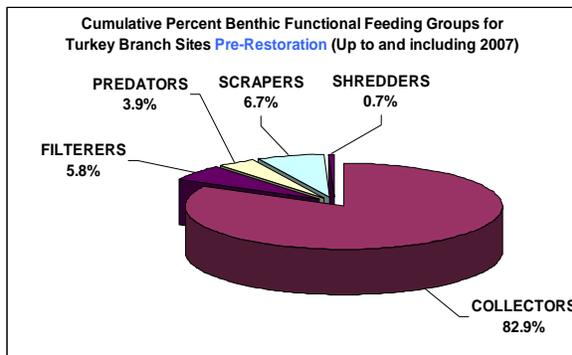
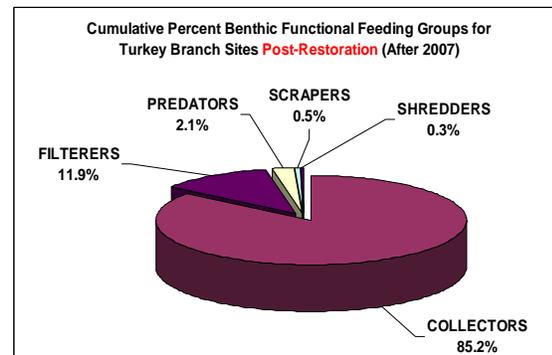
protocol are most likely the reason for the perceived shifts in tolerance. Additionally, declines in specialized benthic macroinvertebrate feeders such as scrapers and shredders occurred after restoration, while generalist feeders such as filterers and collectors increased, also suggesting declines in benthic macroinvertebrate community quality (*Figures 3.23.70 and 3.23.71*).

Figure 3.23.70 – Cumulative Benthic Macroinvertebrate Feeding Group Composition for Turkey Branch Sites Prior to Restoration

Figure 3.23.71 – Cumulative Benthic Macroinvertebrate Feeding Group Composition for Turkey Branch Sites After Restoration
