SUBJECT: **Piney Branch Elementary School Pool**

Future Options Preliminary Report
PINEY BRANCH E.S. INDOOR POOL
7510 Maple Ave. Takoma Park, MD 20912

APRIL 28, 2015

Piney Branch Elementary School Indoor Pool Future Options Preliminary Report

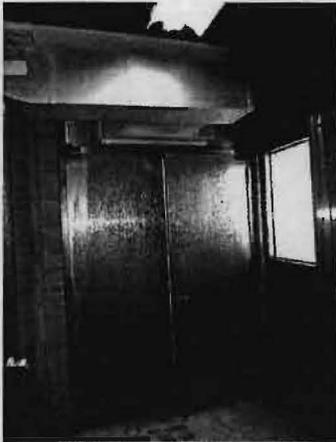
Signs of wear and tear and general ageing can be seen throughout. But no extreme deterioration was readily observable with the exception of moisture issues, corroding and spalling concrete around the pool equipment room, and significant corrosion on the stainless steel doors and frames around the pool caused by the humid and chloramine laden atmosphere in this area.

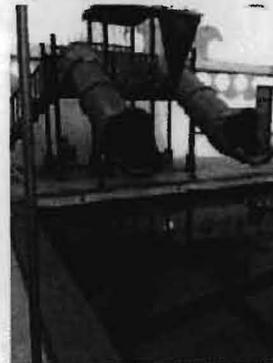
The 42' x 75' six lane swimming pool structure is in excellent condition for the age of the facility. The pool tank is watertight and appears to be free of any structural deficiencies. The ceramic tile pool finish should be re-grouted.

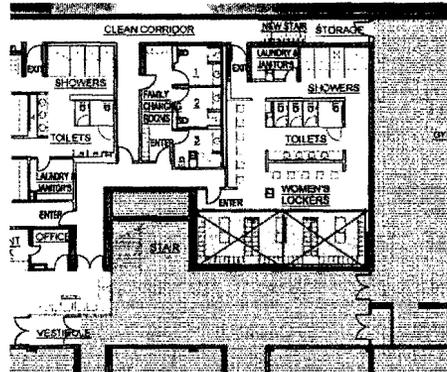
3. MCPS staff indicate that if the locker area with the bathrooms is separated from the school, the part of the school in that vicinity would be left without adequate bathroom facilities. Therefore they do not accept losing access to the pool bathrooms from the school side.

It may be possible to overcome this problem by providing the school with additional bathrooms that are accessible only from the school side, which can be achieved by reducing the area of the lockers and the number of family changing rooms. This would result in additional costs and require a revised design as well as MCPS's agreement to accept fewer but new toilets & lavatories.

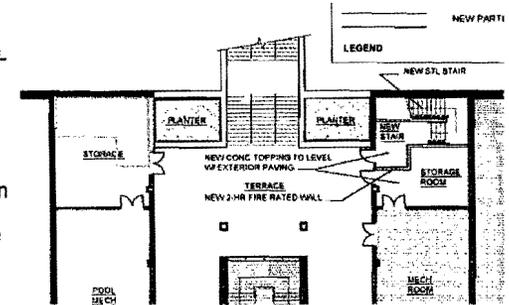
4. It is likely that the school will not agree to give up the storage that is needed to build the new stair to provide a second means of egress from the Lockers area below. An alternative solution that is acceptable to the school will need to be worked out.

One option may be to build an enclosed space where the current planter is next to the storage area in question. Another could be to offer comparable storage elsewhere in the pool side, such as the area next to the pool mechanical room on the upper level. A third option can be locating the stair in the existing planter area, but that location will likely result in wasted space in the lockers areas below due to the circulation that would be needed around the stair. Further study is needed in consultation with the MCPS.
