SIGNIFICANT INJURY INVESTIGATION REPORT

**219 Frederick Avenue
October 2, 2008**

April 2009

Frederick Avenue - Significant Injury Investigation Report

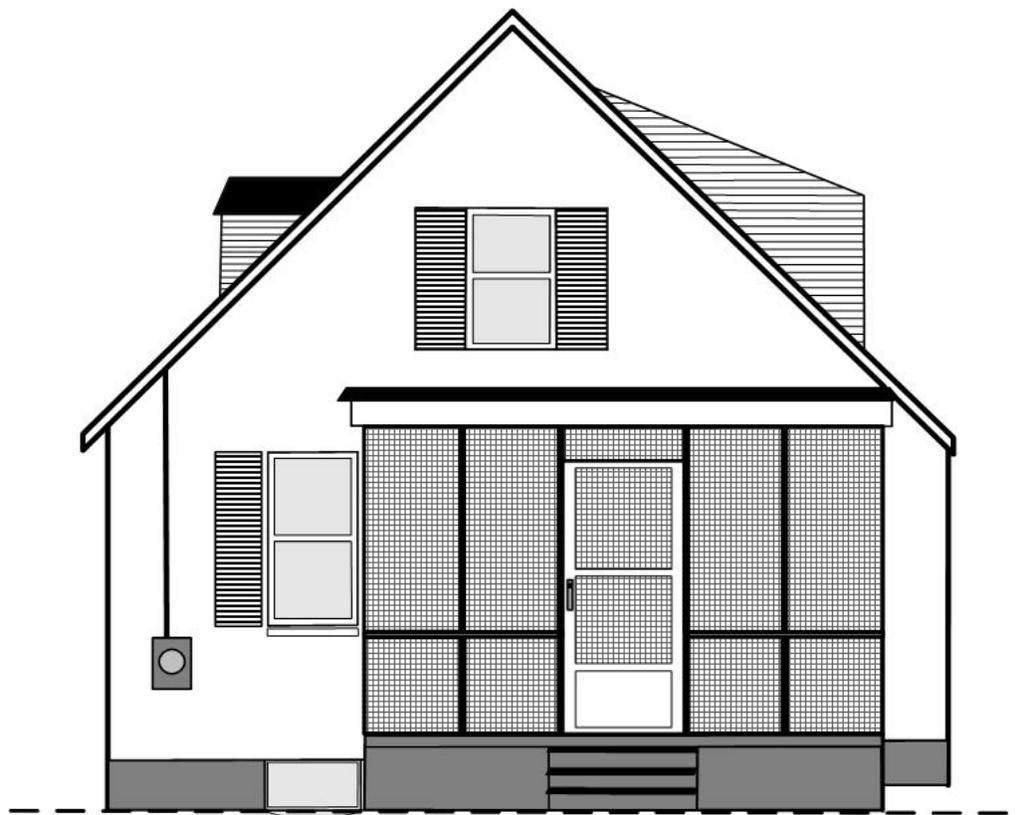
Figure 6: 219 Frederick Ave, SIDE DELTA profile

(dotted line indicates grade)

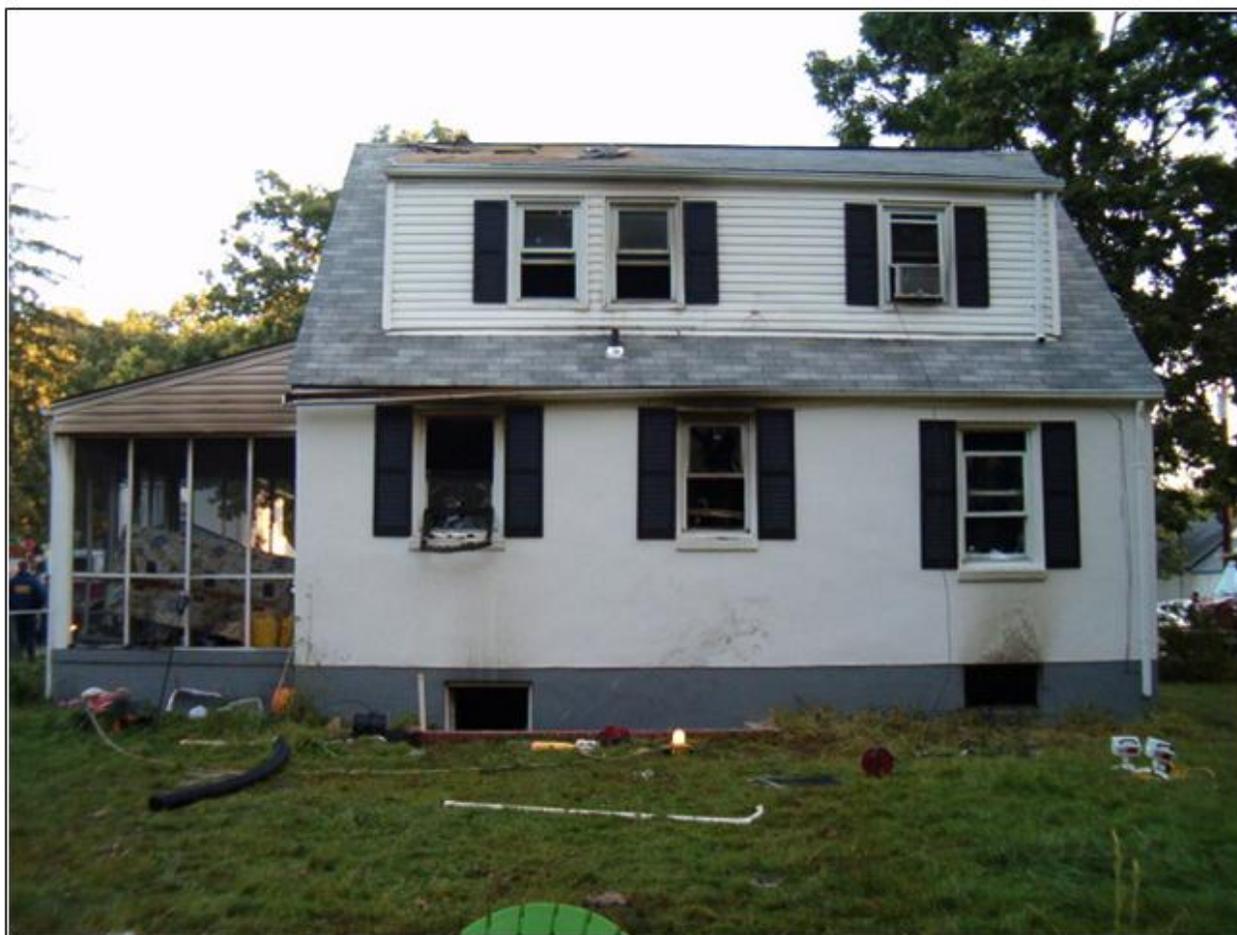
As noted earlier, the building lot was predominately flat and there was no elevation difference from SIDE ALPHA to CHARLIE. The exterior entrance to the basement was via a set concrete stairs with a brick/block support wall on SIDE CHARLIE. The stair entrance was level with the ground level and the open was not surrounded by a railing. See Figure 8: 219 Frederick Avenue, SIDE CHARLIE

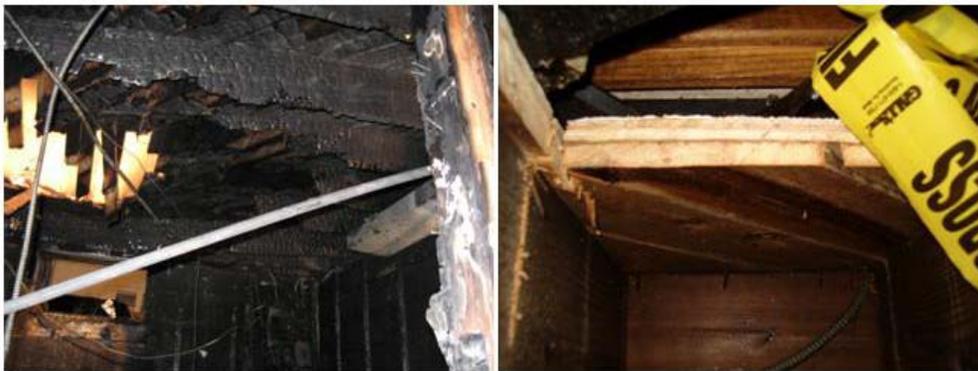
Figure 12: Floor Coverings

The sub floor consisted of 1x6 tongue flooring laid diagonal to the joist. The majority of the flooring material on the first floor was hardwood, with the exception of the kitchen, which had sheet vinyl flooring. The stairs and entire second floor were carpeted.

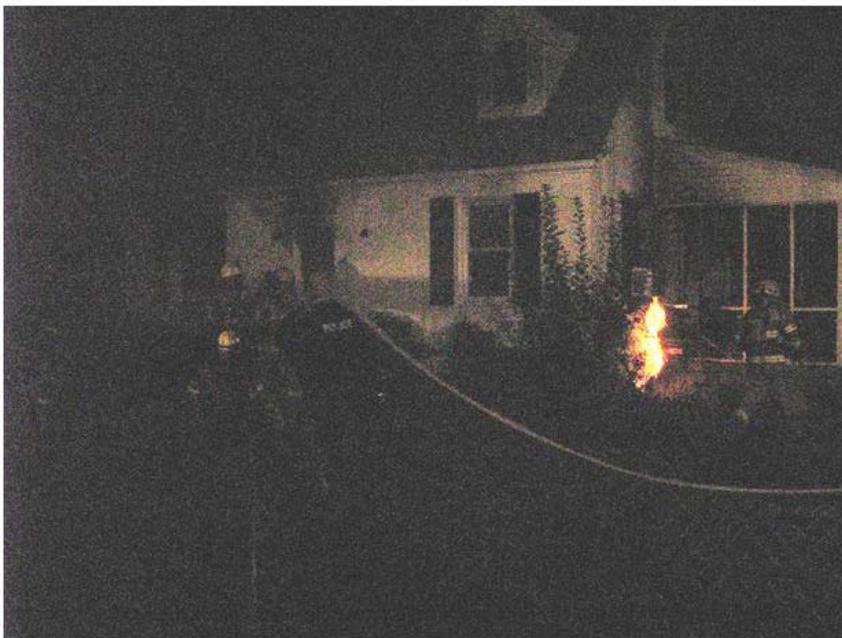
Figure 13: SIDE ALPHA - Approx Time 01:39 hrs

E703 Officer then performed a circle check and did not notice the SIDE CHARLIE exterior basement entrance due to the darkness, lack of a hand railing, and tall grass. Upon returning to SIDE ALPHA E703 Officer meet up with RS703 Officer. E703 Officer instructed the rescue squad crew to ventilate the building. E703 Officer then donned the SCBA face piece and proceeded to enter the structure along with E703 5th.

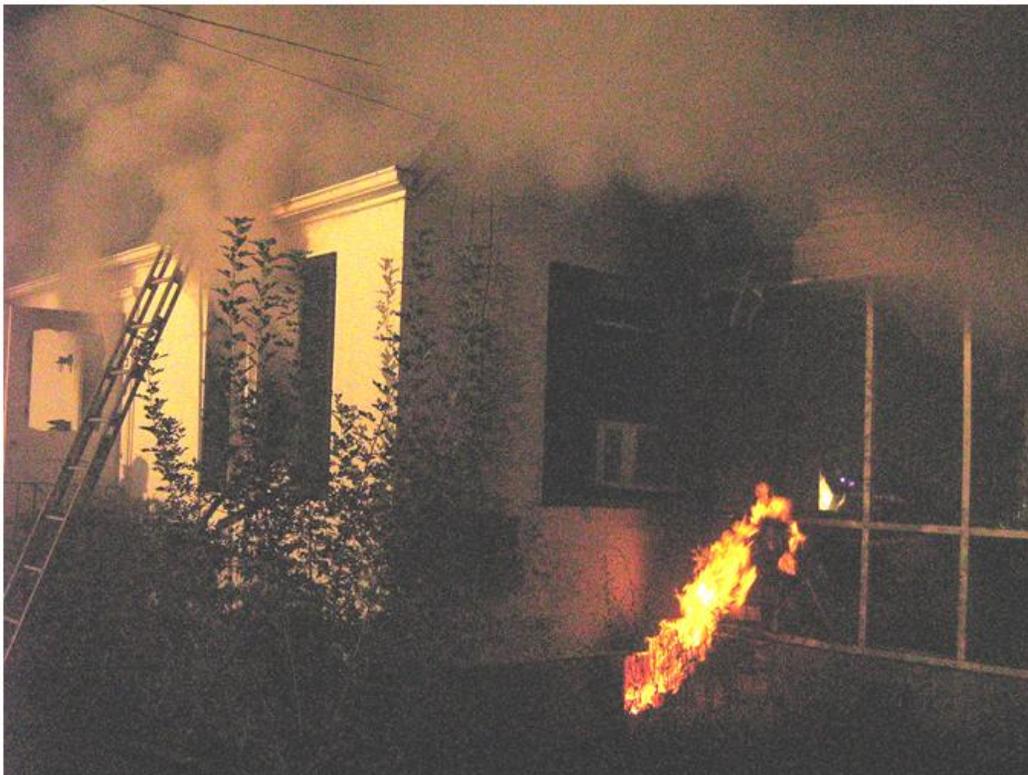
Figure 15: SIDE DELTA Basement Window - Approx Time 01:45

Engine 703 to command - we are at the top of the steps holding it in check right now with a hand line.

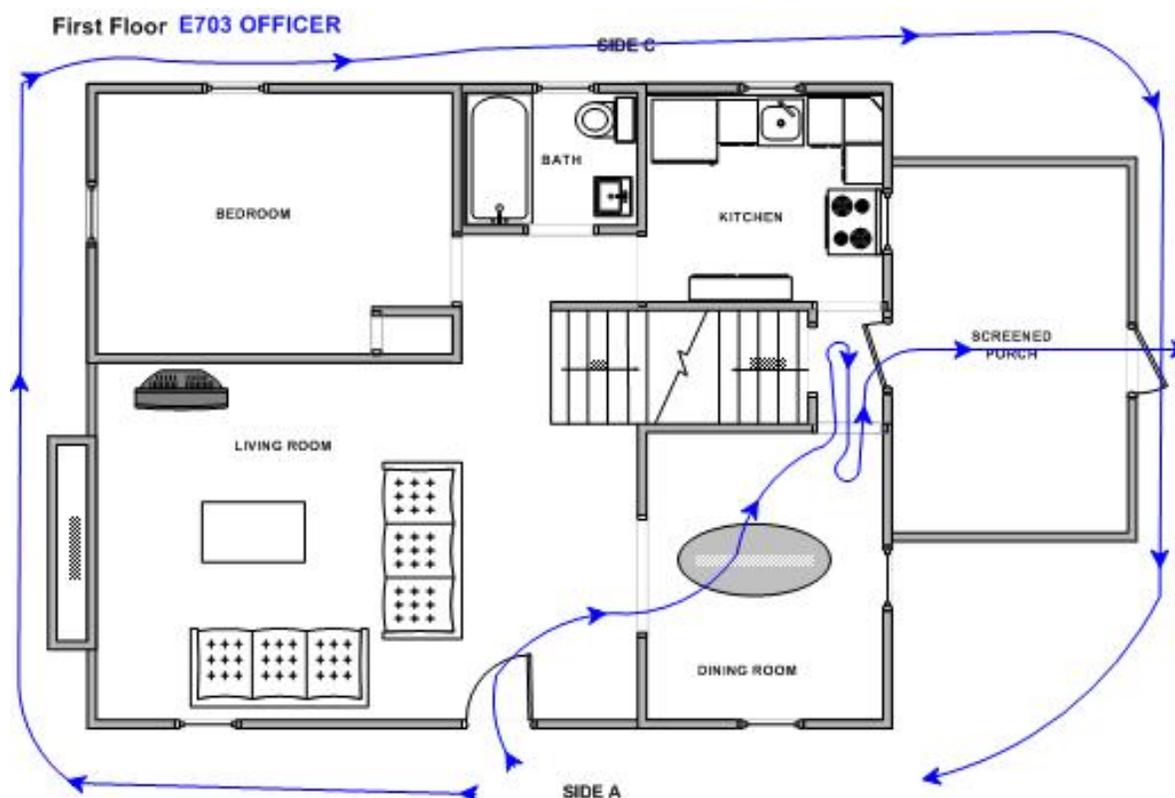
Figure 16: E703 Officer's Path

At that point, E703 Officer meets up with T703 Officer who is now in Quadrant Delta, close to the basement stairs. T703 Officer and E703 Officer confer and agree that the floor is getting spongy and that they should exit the structure. E703 Officer advises E703 Left and RS703 Driver that the floor is spongy and they must exit the structure.

As they were preparing to exit, T703 Officer transmits the first muffled mayday at 01:52:41 due to the floor collapse and unknown missing fire fighters. E703 Officer is pulled back by E703 Left, who believed that the Officer was falling into the hole. At that point both E703 Officer and E703 Left exit the structure via what they believe to be a window immediately behind them, at the top of the basement stairs between Quadrants Charlie and Delta.

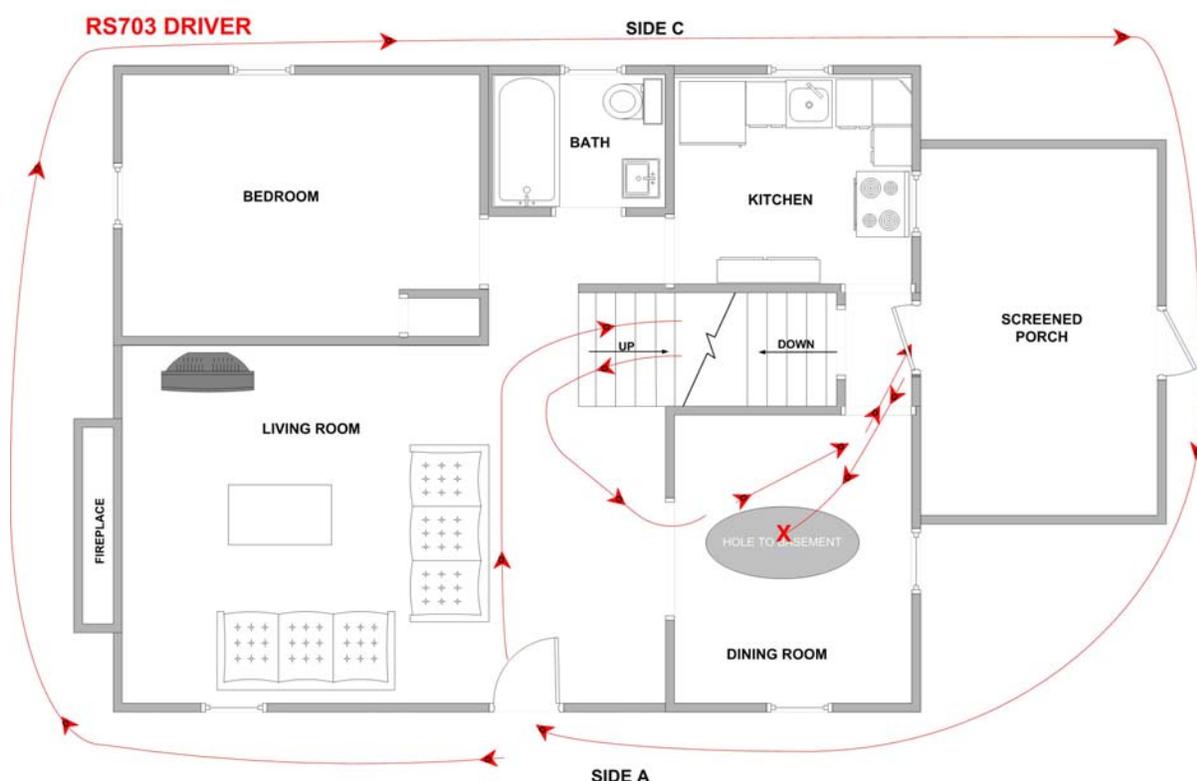
Figure 27: RS703 Driver's 1st Floor Path

RS703 Driver advised E703 Left if they have to rapidly exit the structure, there are two windows they can exit by. RS703 Driver advised E703 Officer there was heavy fire coming from the basement window right below E703 Officer's feet and that they all needed to back out of the building. E703 Officer advised the floor was spongy. RS703 Driver felt that as the hose line crew exited, RS703 Driver would be the last member out.

As RS703 Driver walked out across the dining room, RS703 Driver felt one foot go through the floor and then the other. RS703 Driver tried to head for the 1st floor SIDE DELTA window to bail out but could not get free from the hole. At that point, RS703 Driver yelled "MAYDAY." RS703 Driver tried to slowly self extricate from the hole but continued to sink into the hole, falling down to the armpit level. RS703 Driver tried to pull on the hose line to get out and summon help but was not successful. RS703 Driver decided to take the hose line down into the hole for protection.

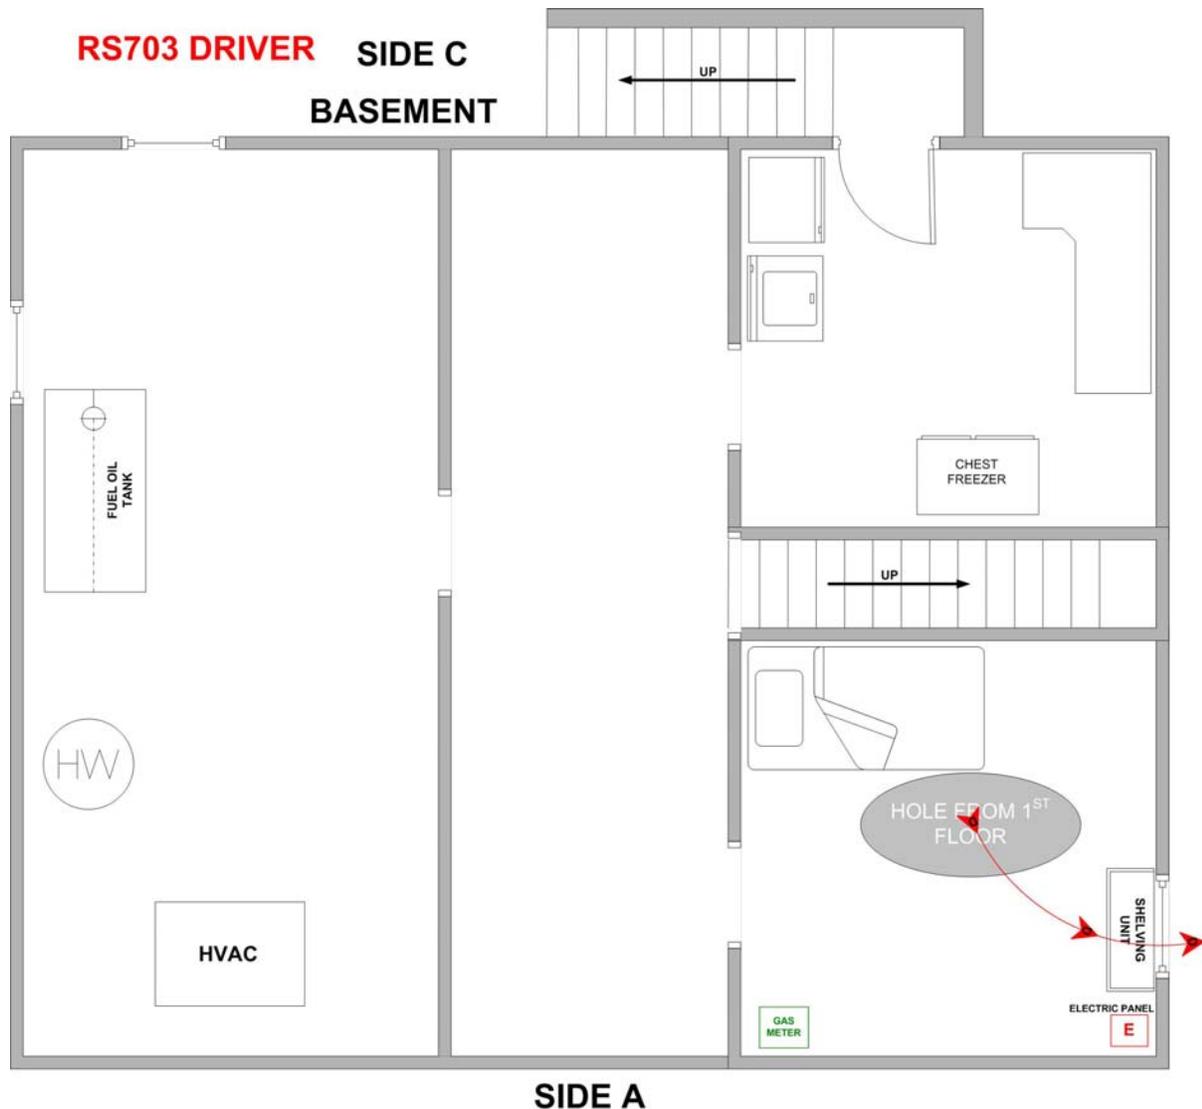
Figure 30: RS703 Driver's Basement Path

RS703 Driver tried to get out the window again after taking off the SCBA, but the helmet hit on the window opening. RS703 removed the helmet and again tried to exit the window by doing a “swim motion” through the window.

RS703 Driver was successful in getting half way out the window, ripped off the SCBA face piece and hood, and was yelling “MAYDAY.” A fire fighter, T703 6th, who had been throwing ladders, heard RS703 Driver and assisted the fire fighter out of the window assisted by others. RS703 Driver’s PPE was removed with the

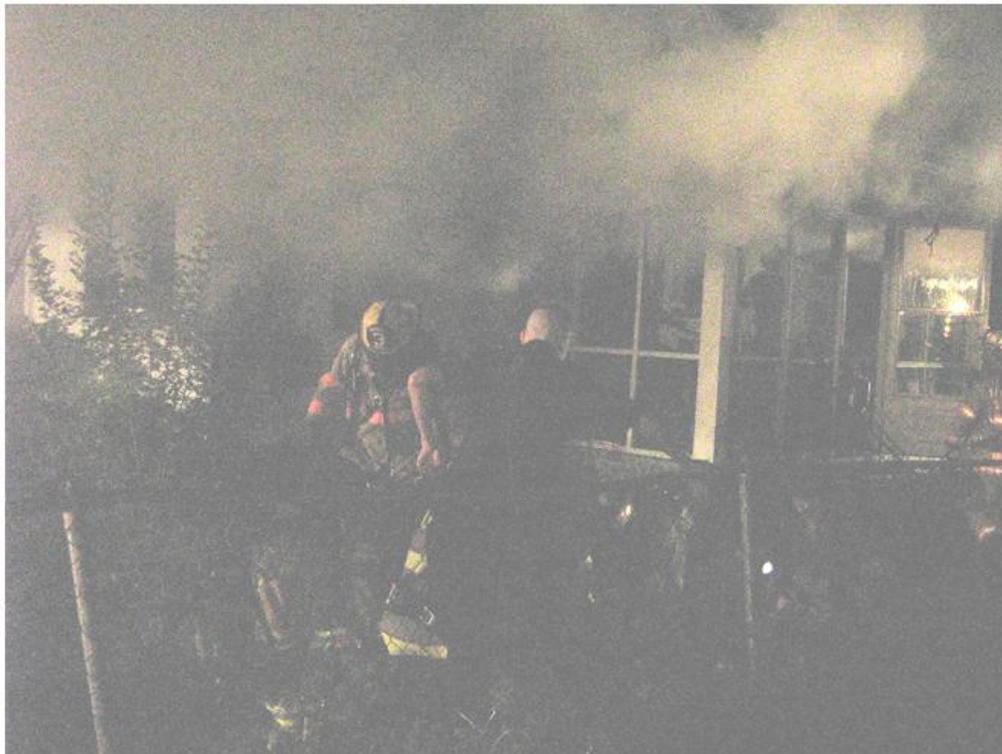
Note: During the incident E703 6th used the digital camera from E703 and documented the fire ground. The time/date function on the camera was not accurately set and thus the SIIG utilized these pictures to establish an “approximate” timeline. The picture shown in Figure 31: SIDE ALPHA/DELTA Corner - Approx Time 01:52 showing RS703 Driver on SIDE DELTA with only 2 personnel assisting was synchronized to 01:52.

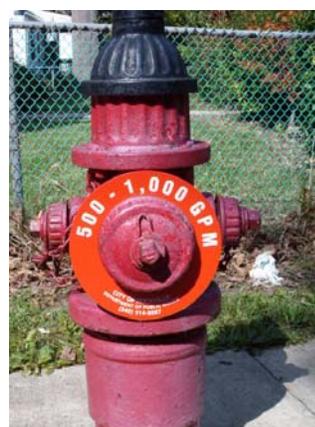
The hydrant at 715 Lenmore Avenue was designated on the supplied maps as being rated to flow between 500 and 1,000 gpm. At the time of the fire, the promised color coded hydrant flow rings had not been installed.

The hydrant that E703 hooked up to was rated to flow 633 gpm with a residual pressure of 20 psi. The known limited flow capacity combined with the snaking “curb to curb” of the supply line contributed to the reports from E703 Driver that after charging two hand lines that the residual intake pressure was insufficient to support additional hand lines from E703.

The apparatus based paper map alterations implemented by Battalion 703A and the stations surrounding the core Rockville area are sufficient for the routine events but units beyond this area are un-familiar with the limitations of the water supply system.

RECOMMENDATION: Notification from water utilities pertaining to hydrant status must be accurately entered into CAD. This data must then be readily available to all responding units via premise information or Altaris, CAD mapping software, flagging. Any hydrant rated to flow less than 1,000 gpm should be flagged. Also, those hydrants that cannot produce 500 gpm should be identified with a ring.

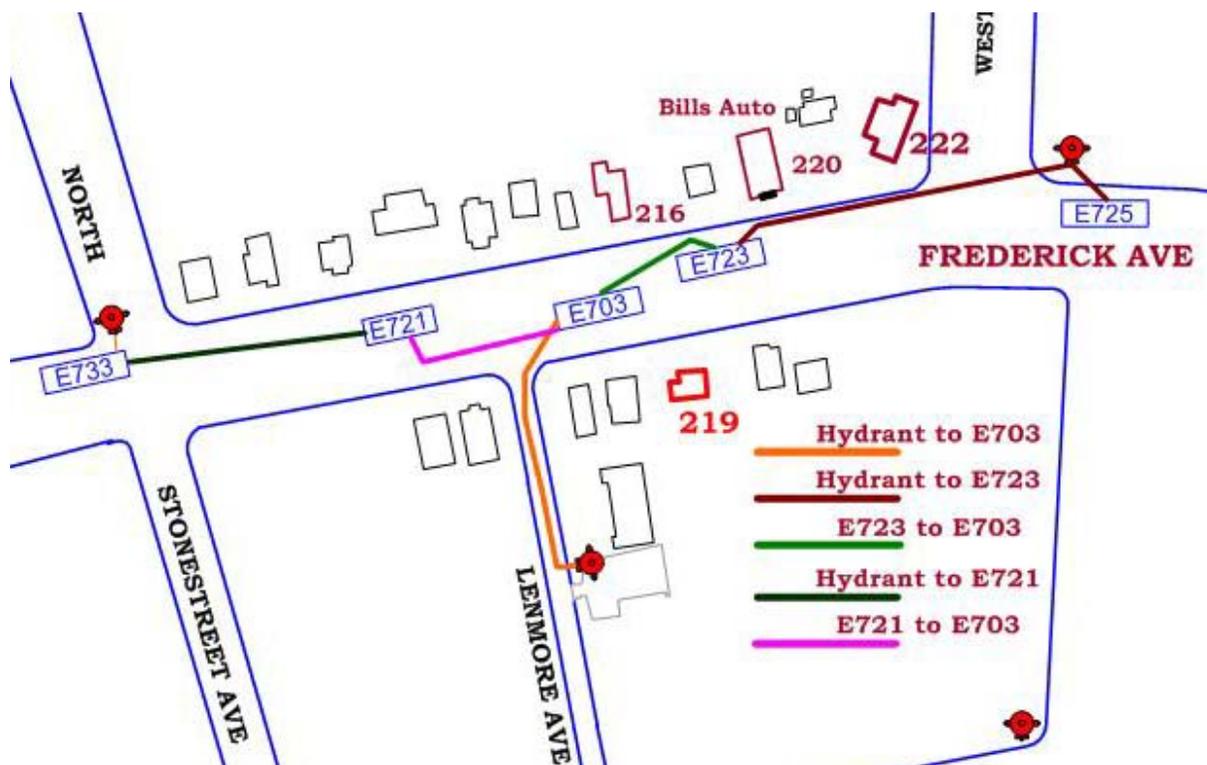
Figure 41: Water Supply Diagram

Once the actual problem had been identified, E703's Officer needed a water supply. E703 Officer then ordered E703 Right, E703 Left, and E703 5th to go look for a hydrant. E703 Driver proceeded down Frederick Avenue toward Westmore Avenue while the remaining crew from E703 looked down Frederick Avenue toward Lenmore Avenue. E703 6th found a hydrant in front of 715 Lenmore Ave. E703 crew members hand advanced 500 feet of 4-inch supply line up Frederick Avenue and then turned left onto Lenmore Avenue to the hydrant. They hooked it up using a Humat four-way valve, and charged it.

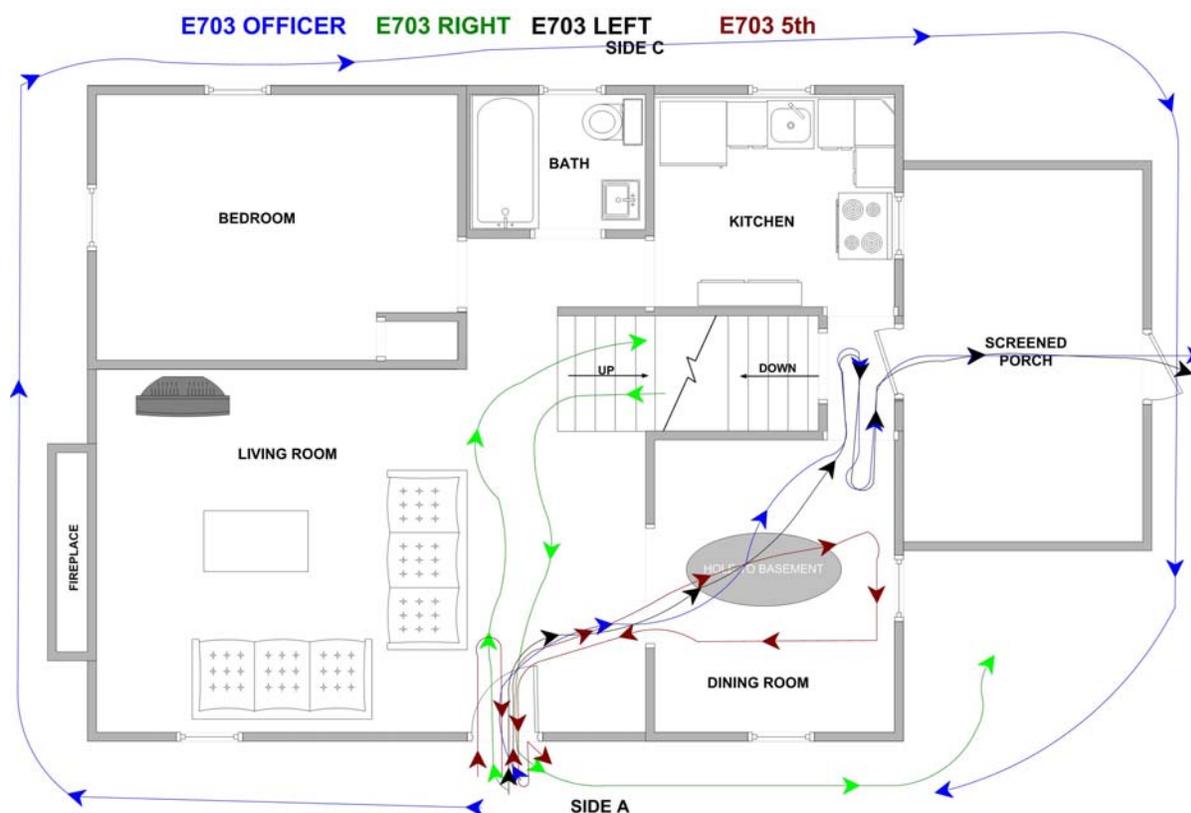
Figure 43: Combined Path of E703 Crew on First Floor

After assisting with the water supply operation, E703 Right entered the building (IDLH) at SIDE ALPHA alone and without assignment from E703 Officer. E703 Right met up with T703 Left, who had also entered the building (IDLH) alone and without assignment, and they proceeded to the 2nd floor as a team and performed a search operation. During the search operation, they spilt up, but remained in voice contact with each other. Upon completion of the search operation, they exited the 2nd floor as a team. E703 Officer was not aware of the location of E703 Right during this period of time.

After assisting with the water supply operation, E703 5th entered the building (IDLH) at SIDE ALPHA alone and without assignment from E703 Officer. E703 5th reported that “someone” gave direction to advance a second hose line, which had been pulled to the SIDE ALPHA entrance, into the building. E703 5th attempted to complete the assignment and was able to advance the hose line a few feet into the building. The hose line then appeared to catch on something, so E703 5th retreated

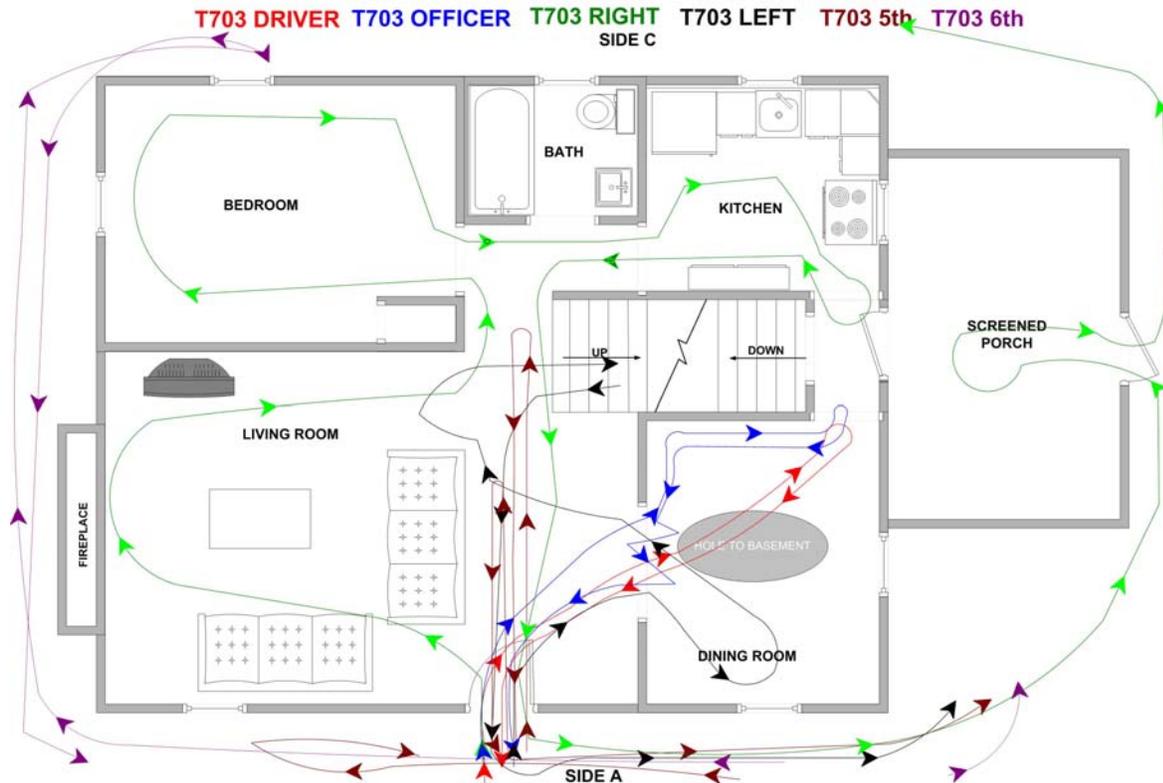
Figure 44: Combined Path of T703 Crew on First Floor

T703 Left entered the building (IDLH) alone and without assignment and then met up with the E703 Right in the downstairs hallway. They proceeded to the 2nd floor as a team where they performed a search operation. During the search operation, they spilt up, but remained in voice contact with each other. Upon completion of the search operation, they exited the second floor as a team. T703 Officer was not aware of the location of T703 Left during this period of time.

T703 5th assisted T703 Driver with exterior ladder placement and then entered the building (IDLH) at the SIDE ALPHA entrance alone and without assignment. T703 5th proceeded through the 1st floor hallway along the second hose line that had been advanced into the building from the SIDE ALPHA entrance. T703 5th remained at that location for approximately five minutes and then exited the building from the SIDE ALPHA entrance. T703 Officer was not aware of the location of the T703 5th during this period of time.

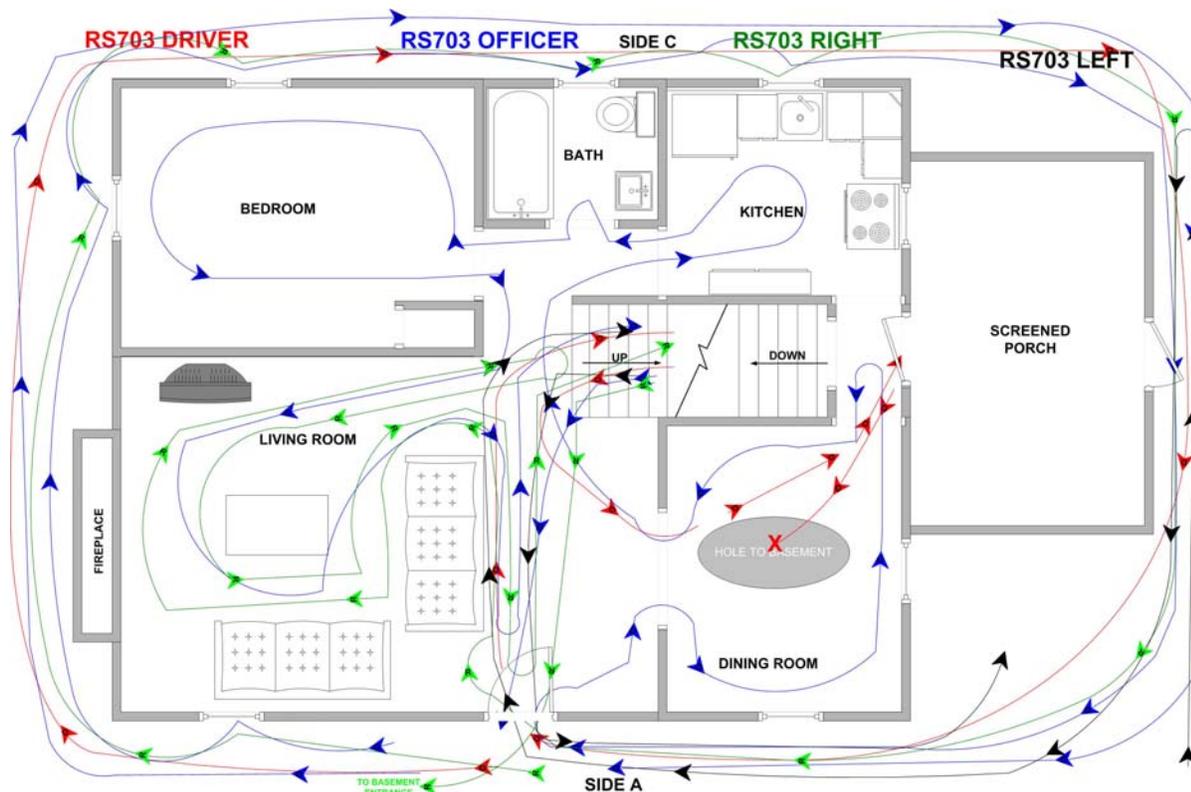
Figure 45: Combined Path of RS703 Crew on First Floor

Upon arriving at SIDE CHARLIE, RS703 Officer and RS703 Right enter the basement behind E723's crew and assist with searching the basement.

RS703 Driver did not collect the PAS Tags and place them on the primary collector ring in the cab of RS703. RS703 Driver entered the building (IDLH) at SIDE ALPHA alone after doing a circle check looking for the building utilities. RS703 Driver had not been given a specific assignment by RS703 Officer, however they had an "normal" working doctrine of performing opposite searches.

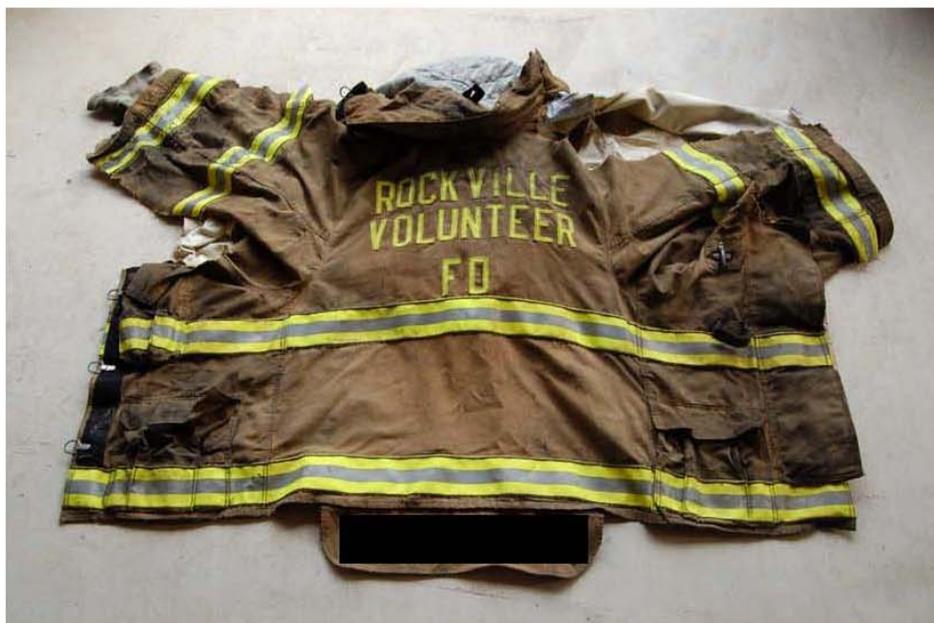
Figure 1 – Firefighter [REDACTED] Protective Coat Exterior (Cut Open)

The description of the incident states that the firefighter fell into the basement within the room where the fire originated. He was then able to escape through a window in a relatively short period of time. It is likely that the process of falling through the collapsing floor that portions of the firefighter preheated clothing were compressed against his body from debris that traveled to the basement with him or hot burning objects already in the basement room. Moreover, in the process of escaping through a window, the firefighter would have could have been exposed to any flames that were coming from burning debris in the basement room.

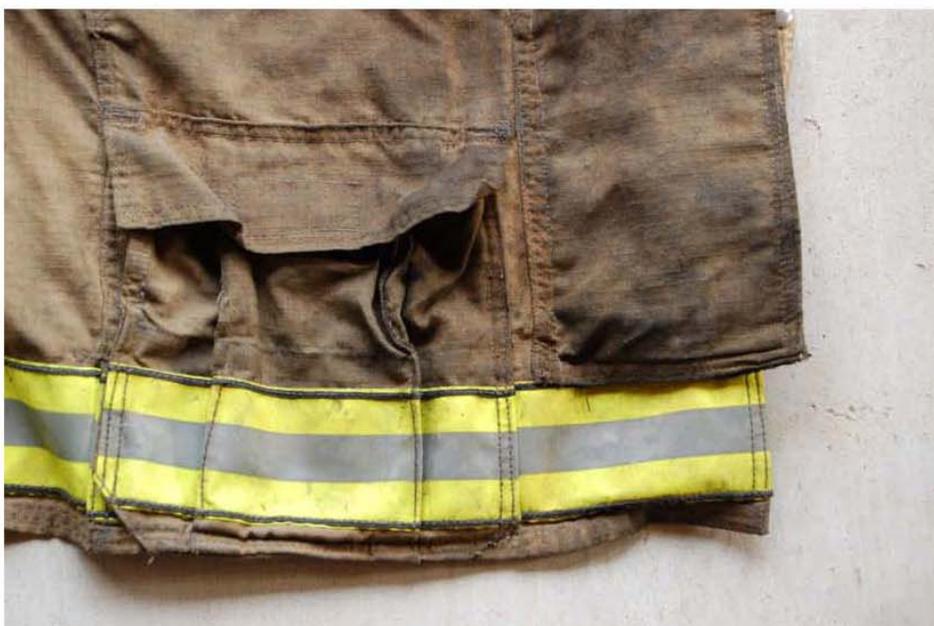
Figure 6 – Close-Up of Firefighter [REDACTED] Protective Coat Right Lower Front

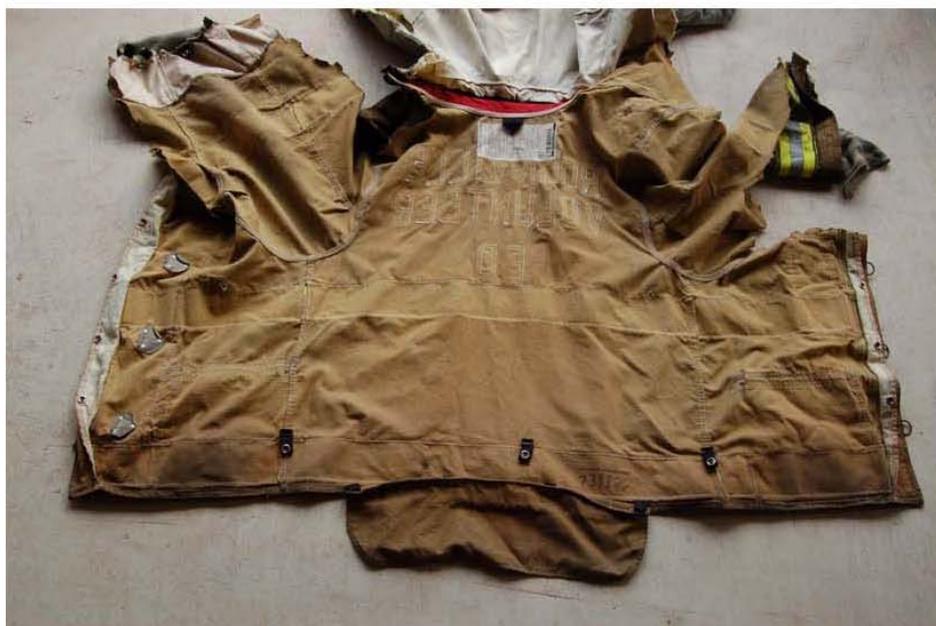
Figure 7 – Firefighter [REDACTED] Protective Coat Shell Interior (Cut Open)

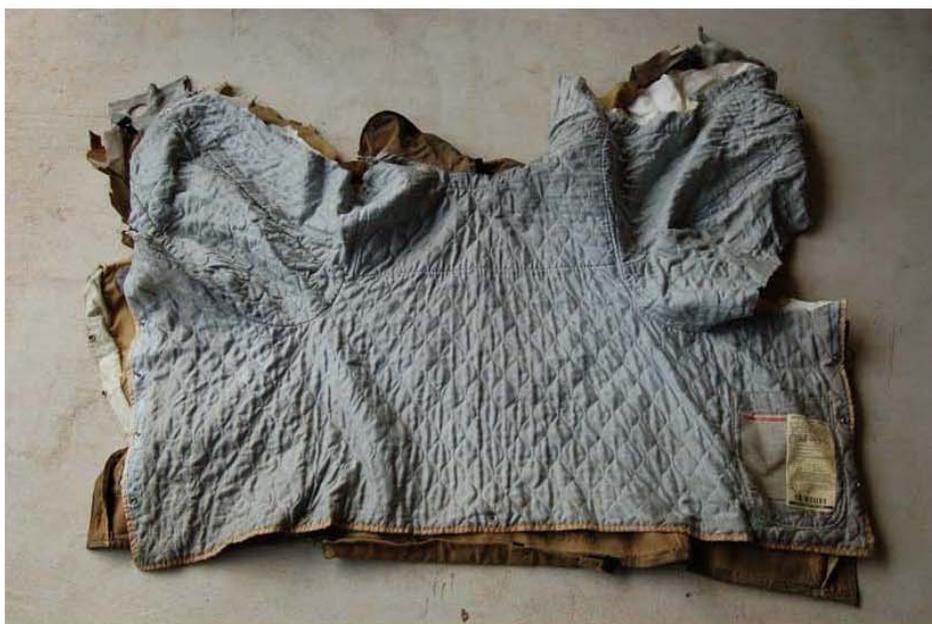
Figure 12 – Firefighter [REDACTED] Protective Coat Liner – Thermal Barrier Side

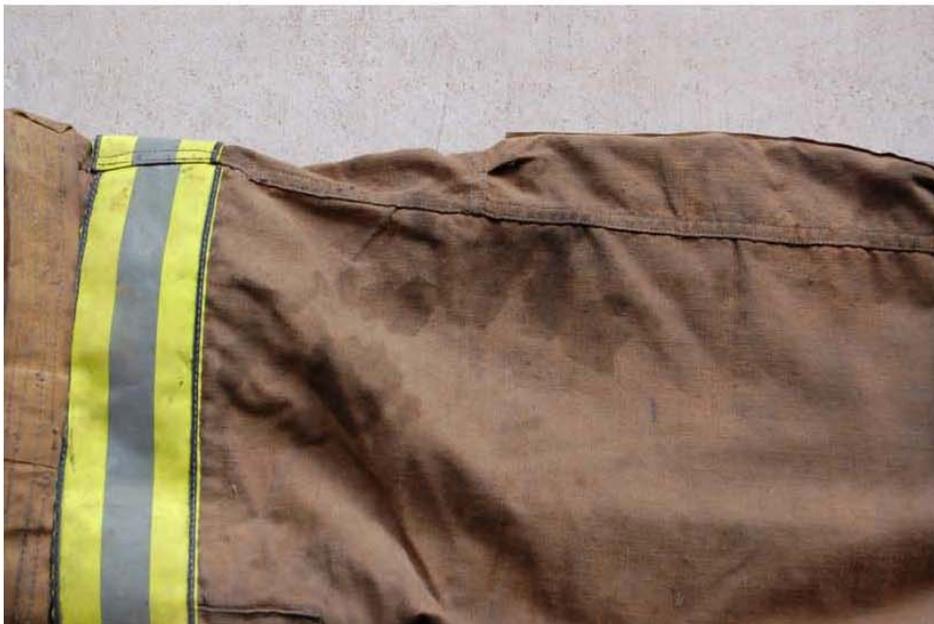
Figure 16 – Close-Up of Firefighter [REDACTED] Protective Pants Back Lower Left Le

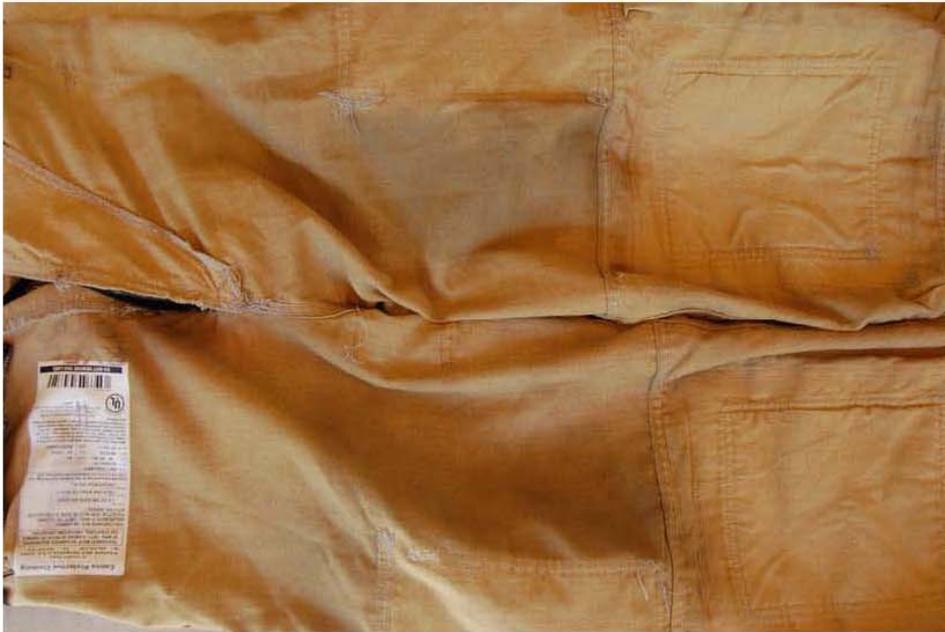
Figure 19 – Close-Up of Soiled Areas on Firefighter [REDACTED] Protective Pants Shell

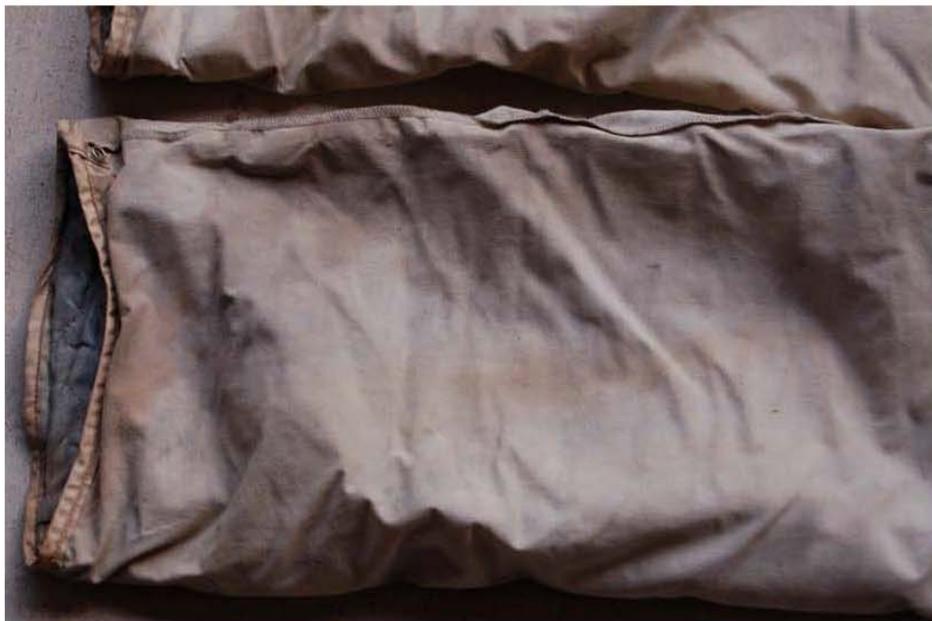
Figure 23 – Close-Up of Firefighter [REDACTED] Protective Pants Moisture Barrier Back Lower Right Leg

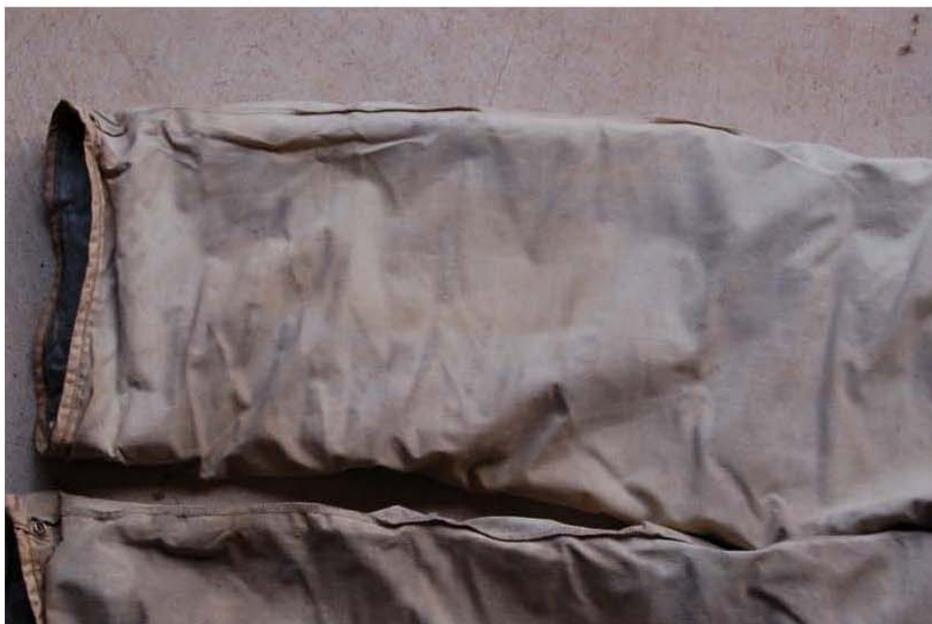
Figure 24 – Close-Up of Firefighter [REDACTED] Protective Pants Moisture Barrier Back Lower Left Leg

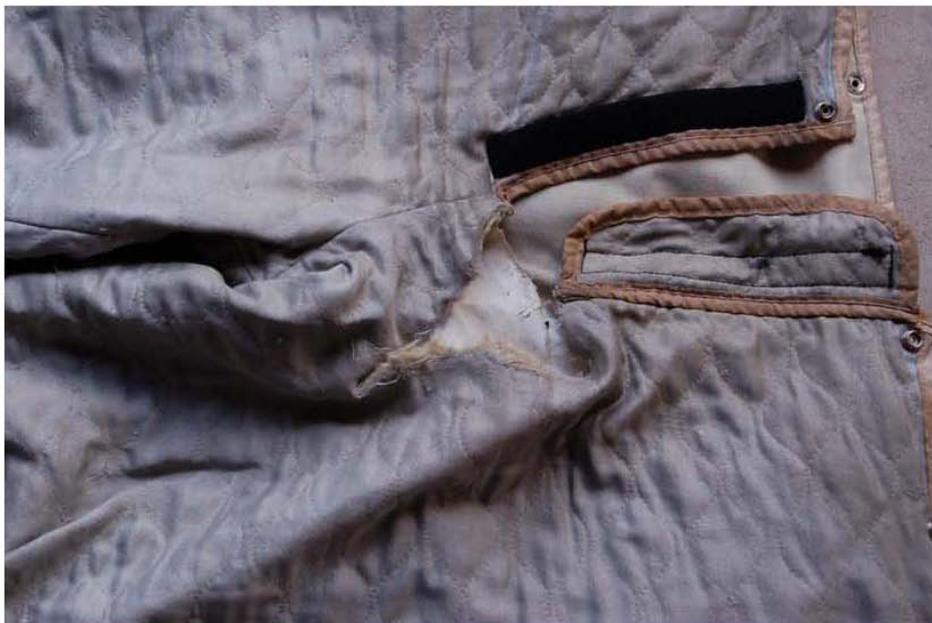
Figure 27 – Close-Up of Tear in Fly Area of Firefighter [REDACTED] Protective Pants Liner

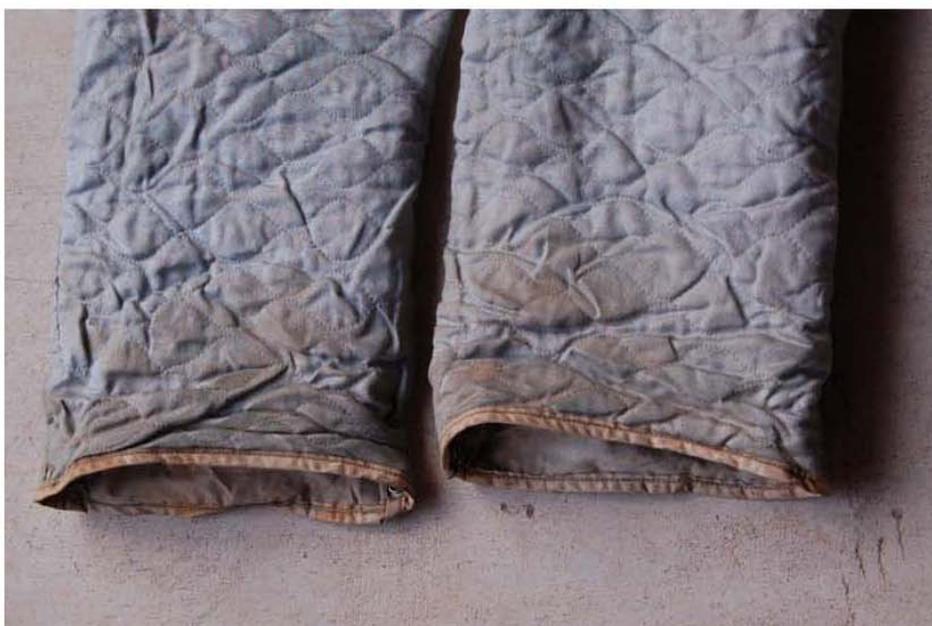
Figure 28 – Close-Up of Firefighter [REDACTED] Protective Pants Liner Cuff Area

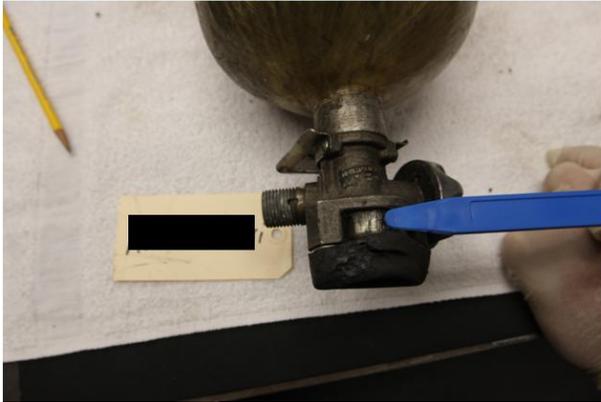
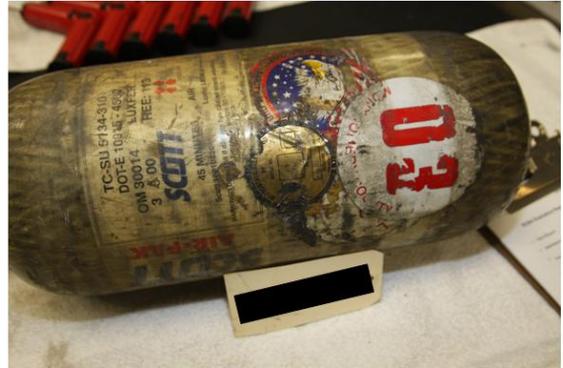
Cylinder received showing approximately **200 PSI** (EST) on the gauge.
Cylinder appears in good condition, minor smoke stains. Two new gouges in gel-coat through to the first layer of fiber wrap noted on the back side of cylinder three inches from cylinder neck.
Gauge cover broken.
Cylinder Bumper & Guard Assembly metal plate bent and rubber cut.

Two gouges in gel-coat through to the first layer of fiber wrap noted on back side of cylinder three inches from cylinder neck

Gauge cover broken and cylinder bumper & guard assembly bent

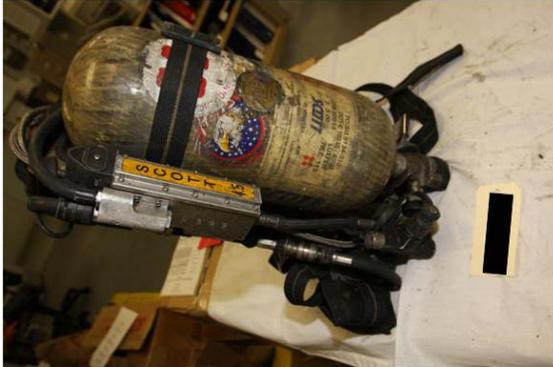
HUD hose found 180 degrees out from where it should be in the anti-rotation hose clamp

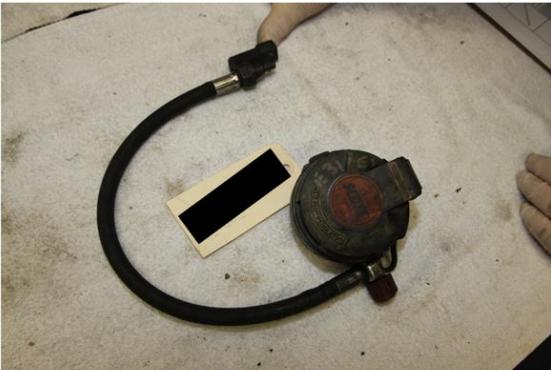
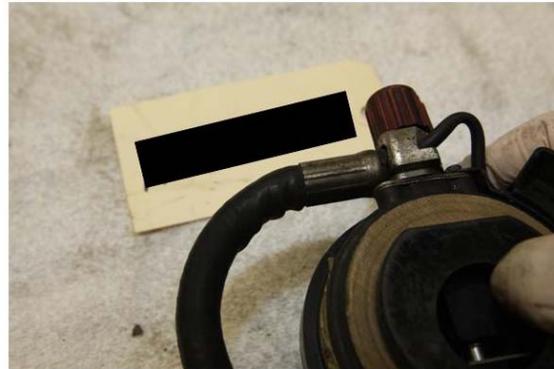
Appears in fair condition, air saver boot torn, Cover cracked on right side of cover at first support where the 1 is in E31/ is.
HUD display visor has cut in top of its left side.
Purge valve knob, lettering and arrow are not visible.
HUD hose shows signs of delaminating at couplings where bent.

HUD hose shows signs of delaminating at coupling where bent.

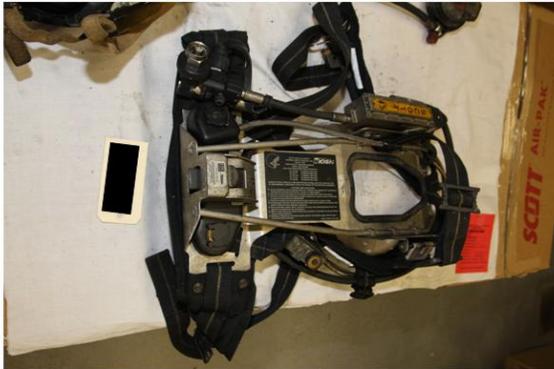
Appears in fair condition.
Only damage appears to be to the back frame gasket not seating in frame at bottom of frame opening. All straps are in good shape; waist strap buckle has some rust on it but works ok.

Only damage appears to be to the back frame gasket not seating in frame at bottom of frame opening. All straps are in good shape; waist strap buckle has some rust on it but works ok.

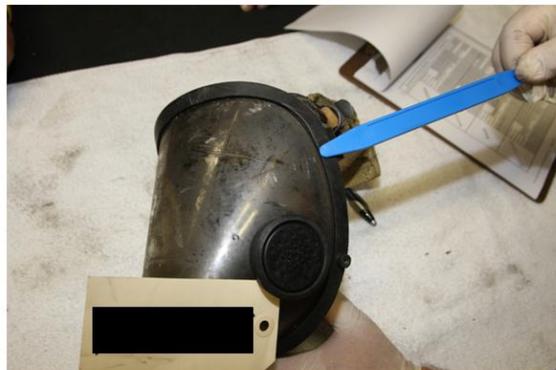
Deep scratch on left side of lens. Other scratches from general use.

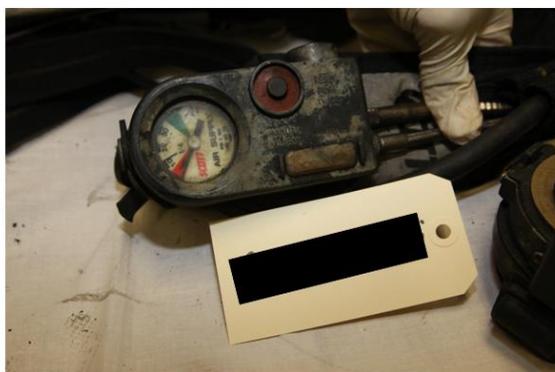
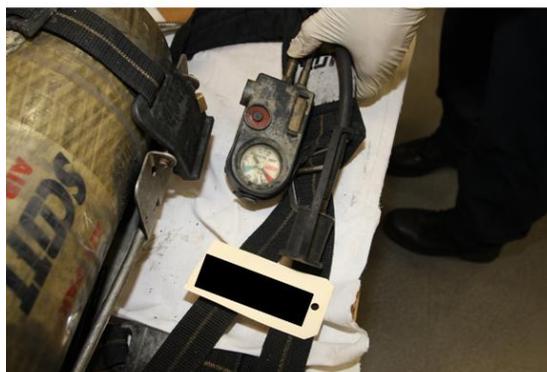
Both appear in good condition. Pak-Alert, Console, Console had some discoloration, still visible. gauge line connections appear good.
