CLOSE CALL/HAZARD REPORT

Swift Water Rescue Training Incident
9200 Old Dominion Drive, Great Falls
April 2, 2014

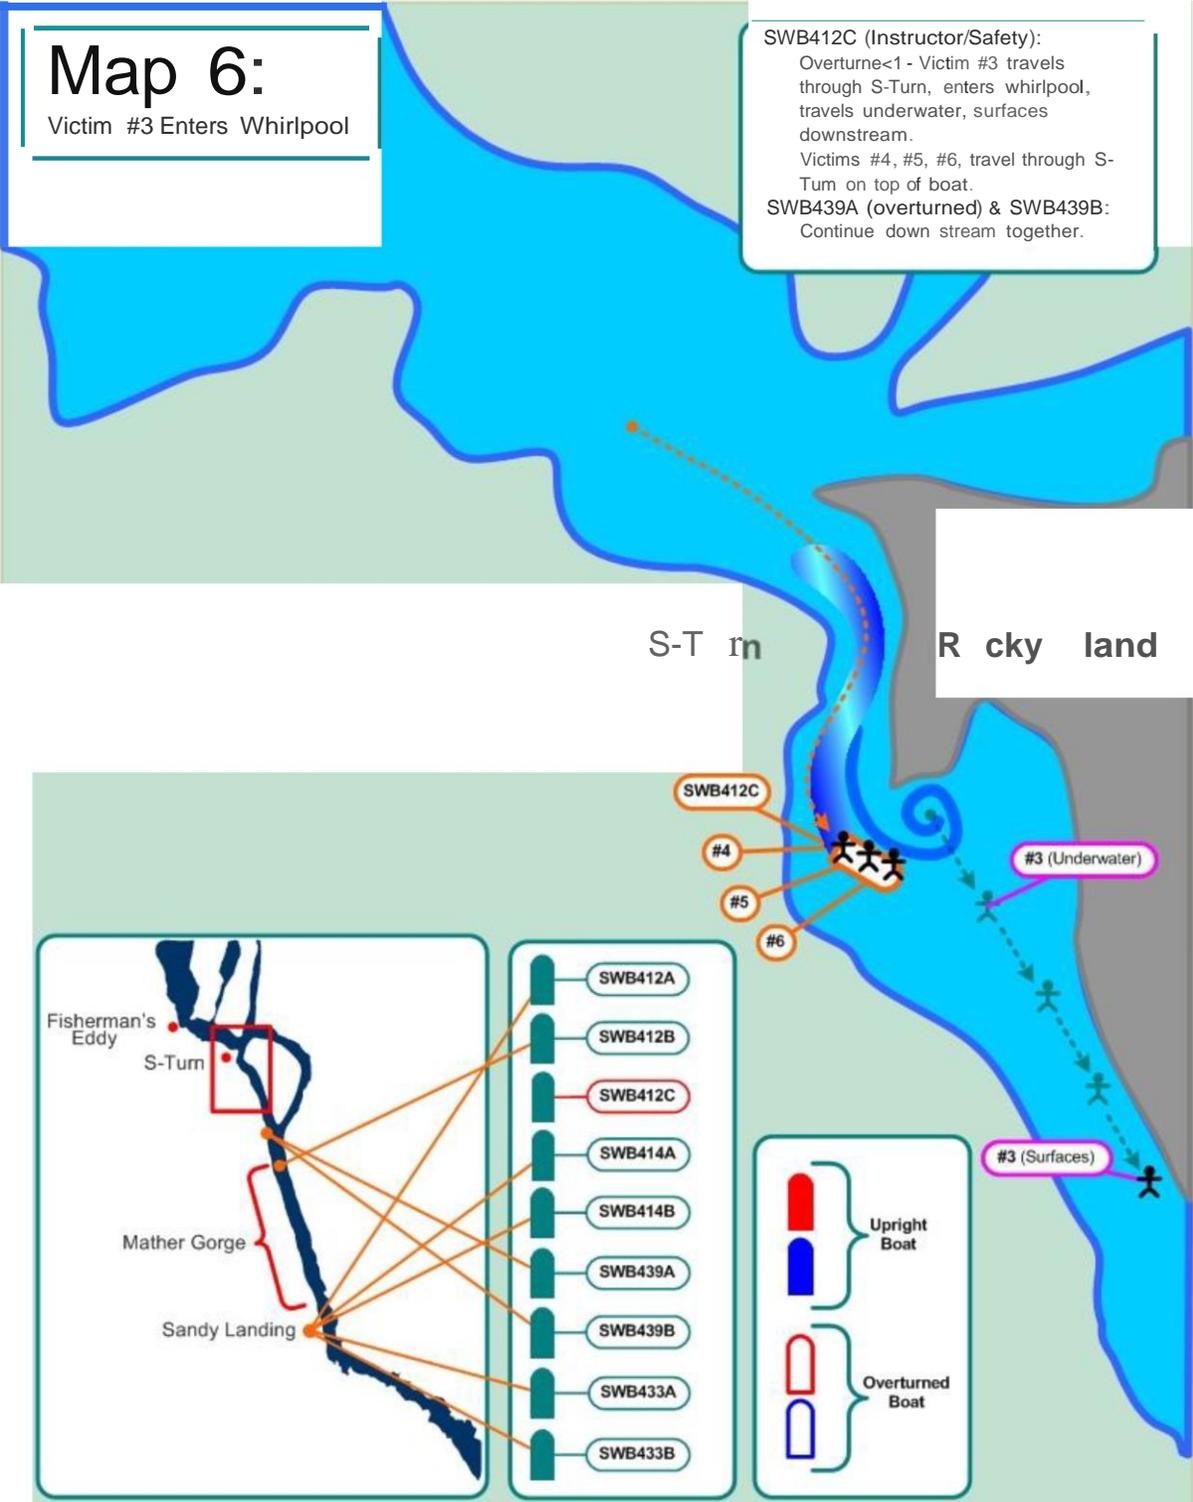
Victim #3 Enters Whirlpool

SWB412C (Instructor/Safety):
Overturne<1 - Victim #3 travels through S-Turn, enters whirlpool, travels underwater, surfaces downstream.
Victims #4, #5, #6, travel through S-Turn on top of boat.
SWB439A (overturned) & SWB439B: Continue down stream together.

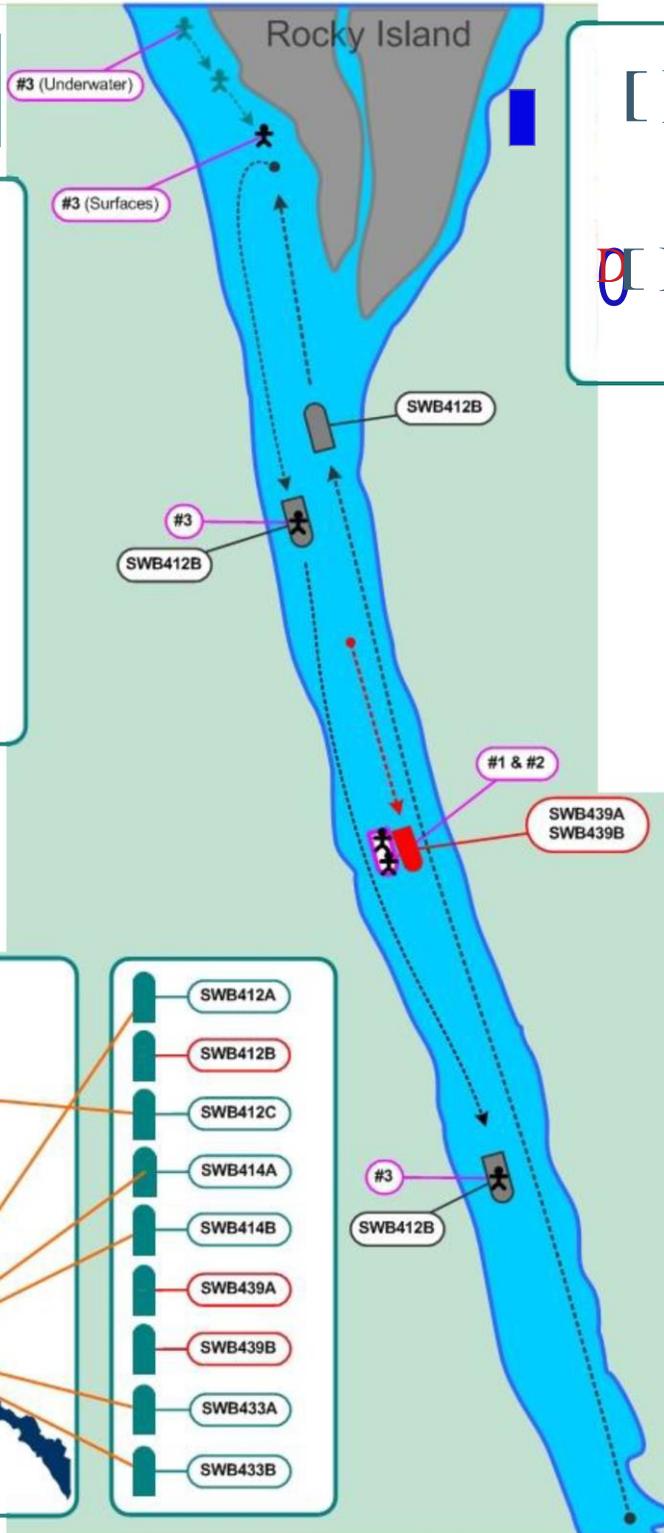
SWB414A:
Travel downstream in an attempt to retrieve the unstaffed and overturned boat.
They were able to locate the overturned boat, but lack enough power to navigate back upstream with the overturned boat
They are without a portable radio and operating out of sight from other staff.
The crew pulled into an eddy and tied their boats to a tree.
Additional boats crews are deployed and requested additional assistance.
With the help of crews riding in boats from 414, 433 and 412, the overturned boat was flipped back over and towed back to Sandy Landing.

SWB412C (Instructor/Safety):
Overturned with Victims #4, #5, #6 on top.
Arrives at Sandy Landing with assistance from SWB412A.

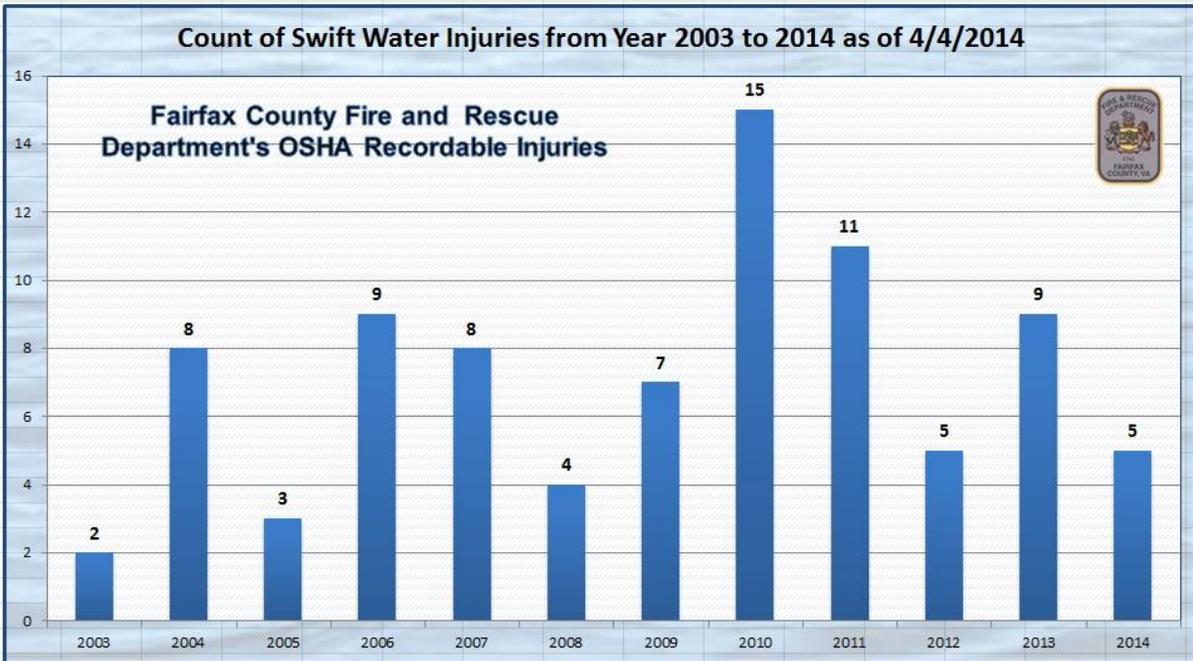
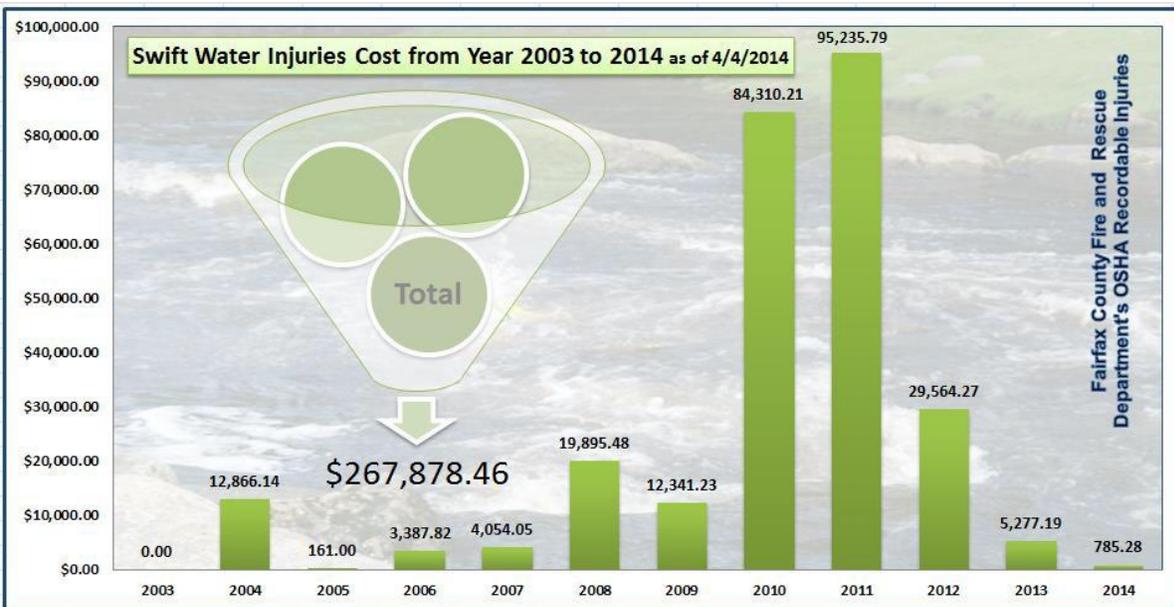
Attachment 1: Swift Water Training Injury Data 2003-2014

Research into swift water rescue training-related injuries and equipment damage (or loss) was completed for a 10-year period. Since 2003, there have been 82 injuries related to swift water training. The majority of the injuries were sprains and strains or lacerations and contusions. These injuries resulted in medical treatment expenses in excess of \$262,000. In addition, there were a total of 667 days of missed work. With associated backfill costs, swift water related injury and equipment damage costs are likely approaching \$1 million over the last decade (Attachment 1).
