MONTGOMERY COUNTY FIRE/RESCUE SERVICE
POST INCIDENT ANALYSIS

2-Alarm House Fire with Injuries
4610 Iris Street
Box Area 21-04
September 04, 2014
04:33 Hours
Incident # 14-0101041

Written By: Chief Jayme Heflin

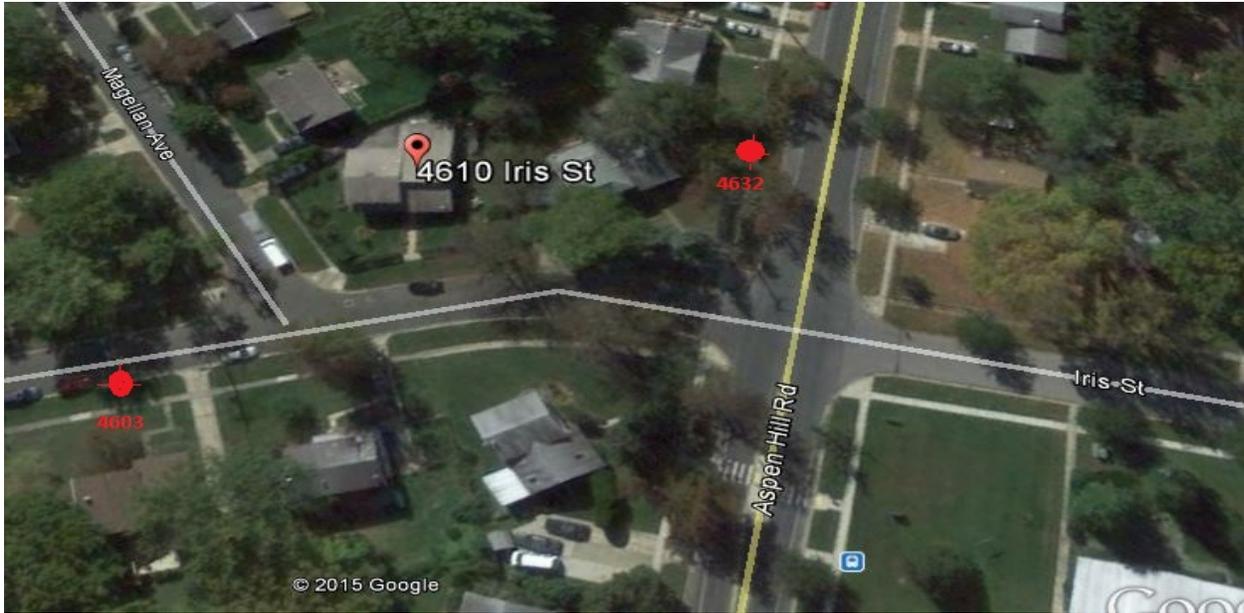
Figure 2 - Street View. Photo Credit: Beverly Jensen

The house is separated from the street by a hedge row (Figure 2). There are no other immediate exposure issues to the house. The driveway is located on the Bravo side and accessed from Magellan Avenue. The hydrants used on this incident are located at 4632 Aspen Hill Road and 4603 Iris St.
