POST INCIDENT ANALYSIS

Two-Alarm Arson Fire

Box 03-07 - 301 South Horners Lane

November 19, 2014

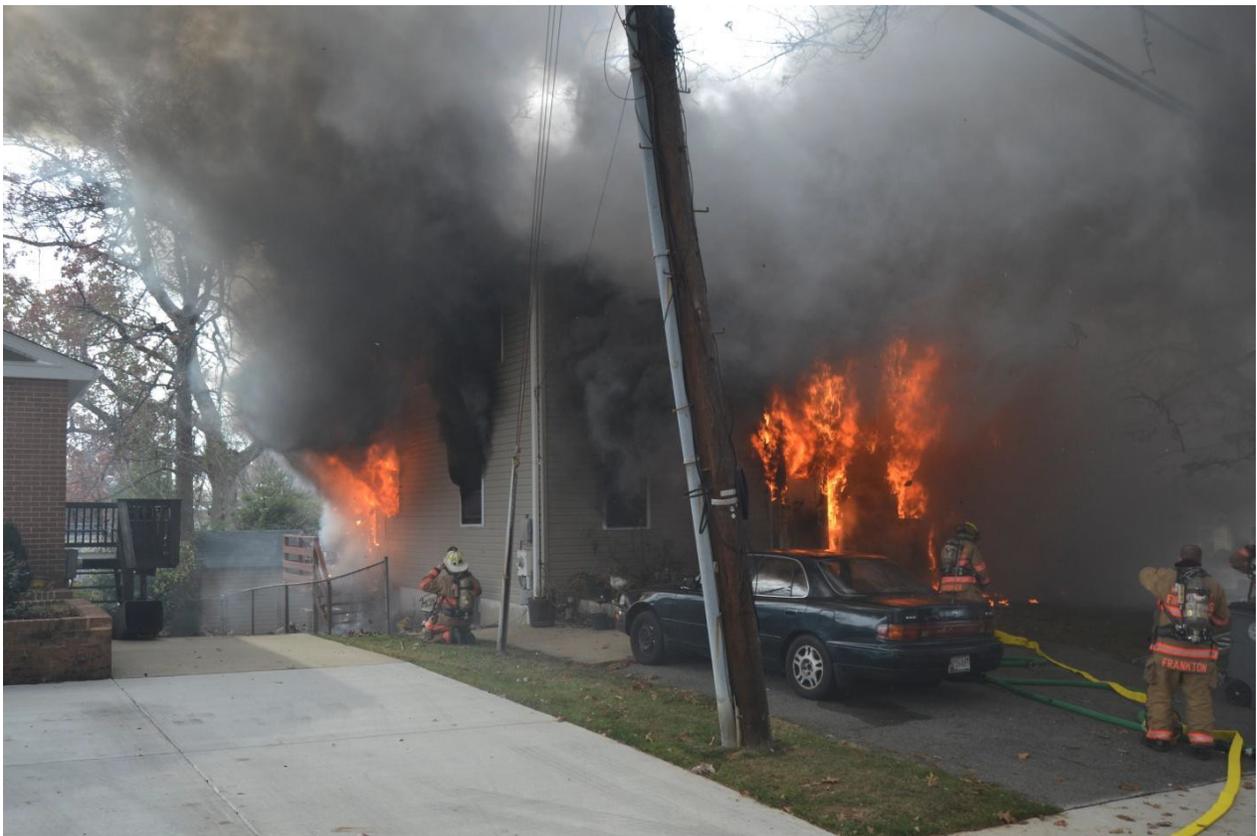
Personnel assembled quickly in the front yard and prepared to make a rapid exterior attack.

Personnel then began an attack with a rapid knock down at the front door working toward the Delta Quadrant and interior stairs. A quick primary search was also begun at this point. Additional units arrived and filled out the Fire Attack and Rescue Groups. Engine 705 approached from Seth Rd, and also established expanded water supply for Paramedic Engine 703.
