MONTGOMERY COUNTY FIRE/RESCUE SERVICE
POST INCIDENT ANALYSIS

40 Upper Rock Circle
April 1, 2014

Assistant Chief Charles Bailey

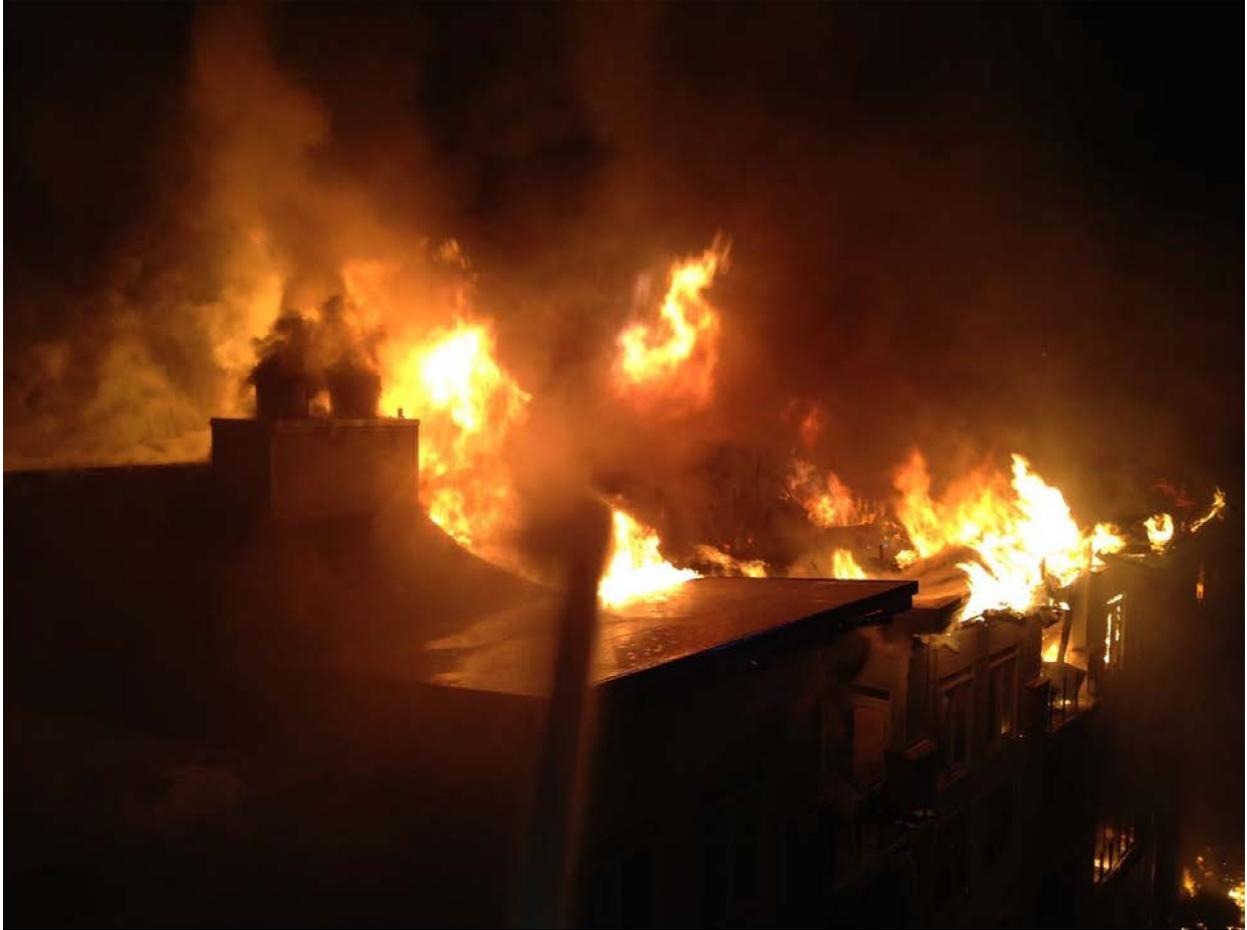
An early view from Aerial Tower 708

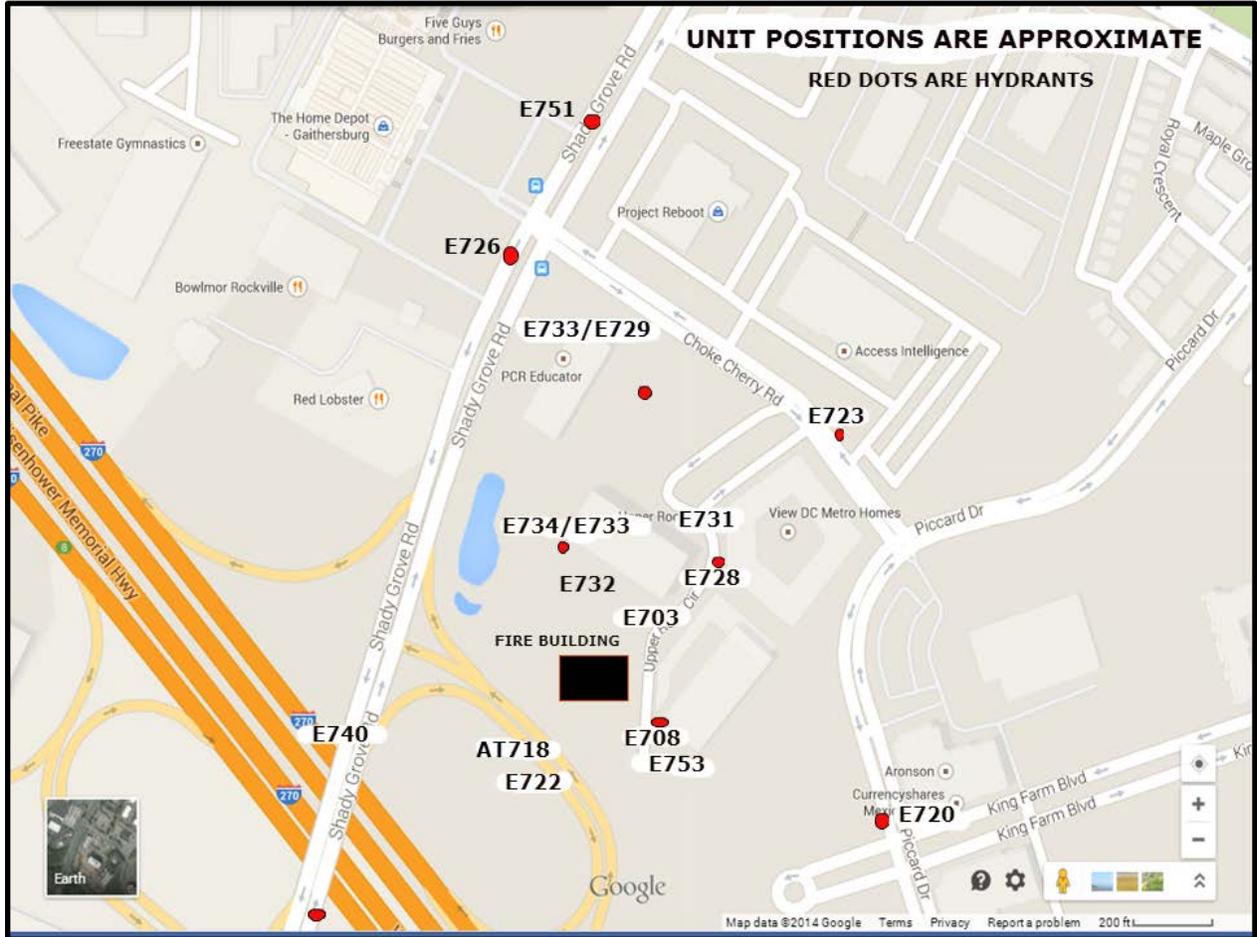
Map of Water Supply Engine Locations

Water supply operations were hampered by two main factors: The initial failure to complete the “heavy water hook up” and; the failure by a few companies to recognize the need for laying dual supply lines into the scene.

Paramedic Engine 708 took their own hydrant and did not complete a heavy water hook up. Engine 753, assigned to ensure and expand on their water supply was blocked in early and was not able to complete the “expansion” part of their task until well into the incident. This failure to secure all the available water from the hydrant limited the quick application of an effective fire flow.

Anytime that there is new construction in an area it is the responsibility of the first due company to make sure that adequate maps are available for fire service operations. It is understandable that water utility and County GIS maps are behind a few months but Fire Rescue personnel must create and update station maps as early as possible. It did not help that this complex was first in Fire Station 28's area and switched to Fire Station 32's area just two months before when Fire Station 32 opened. However, given the number and complexity of large construction projects like this, station mapping efforts must be improved.
