Montgomery County Fire & Rescue Service

POST INCIDENT ANALYSIS

9863 Brookridge Court
Gaithersburg, MD
F10-0037499

April 5th 2010

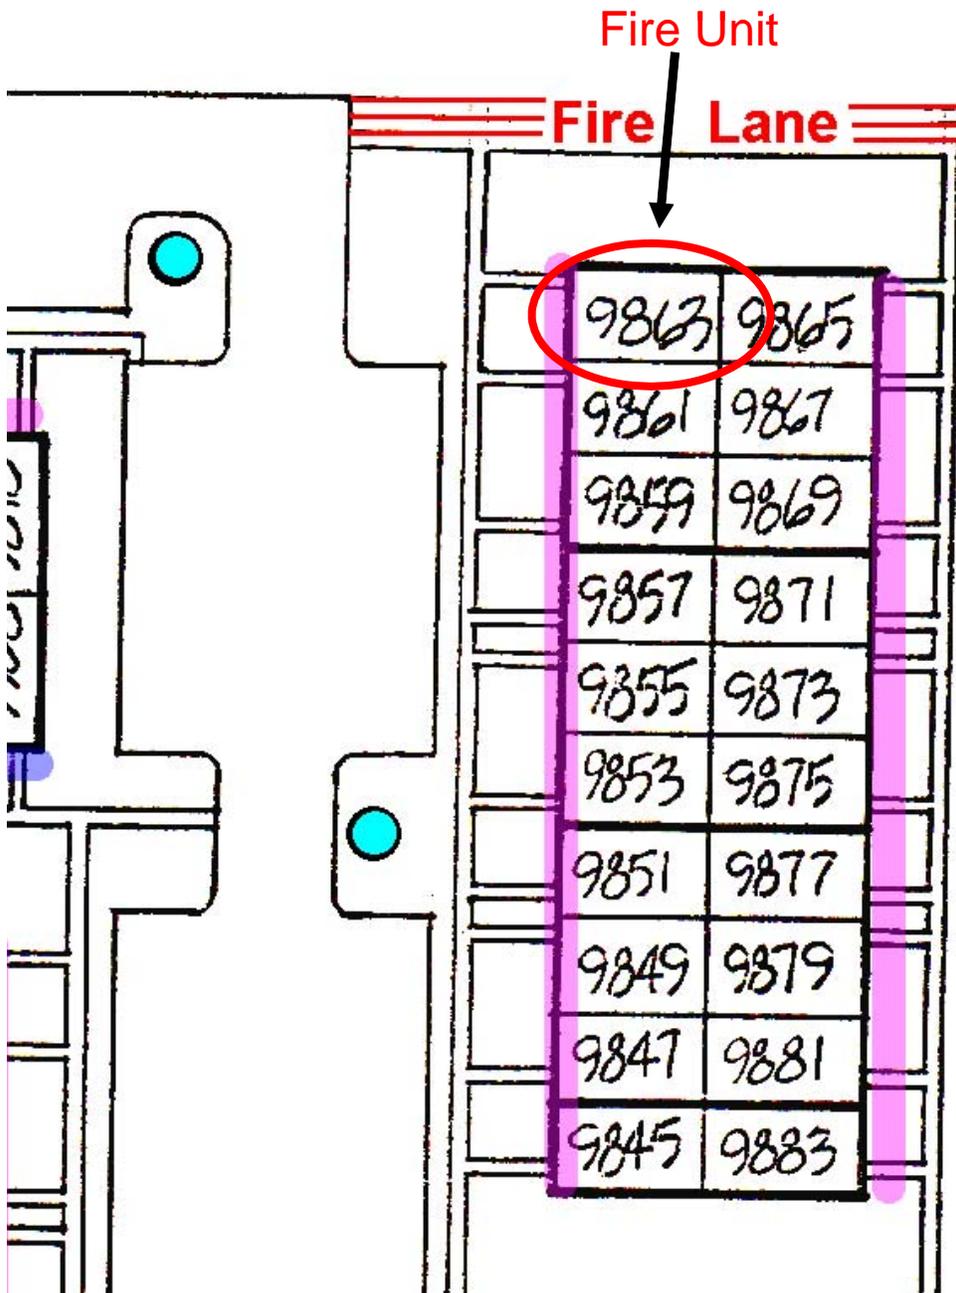
The townhouses in the McKendrie I development of Montgomery Village were constructed in 1977 and area of piggy-back design. The fire unit, 9863, was the end unit toward side bravo when looking from the street. The row of townhouse consisted of 10 units on side alpha and 10 on side Charlie.

The fire unit is of lightweight wood, type 5, construction on a concrete slab with three stories above grade. The unit is roughly 19 feet in width across side alpha and 25 feet in depth. The total floor space for this unit is roughly 1,200 square feet. Each level is connected via a staircase that abuts the exposure delta party-wall with 9861 Brookridge Court.

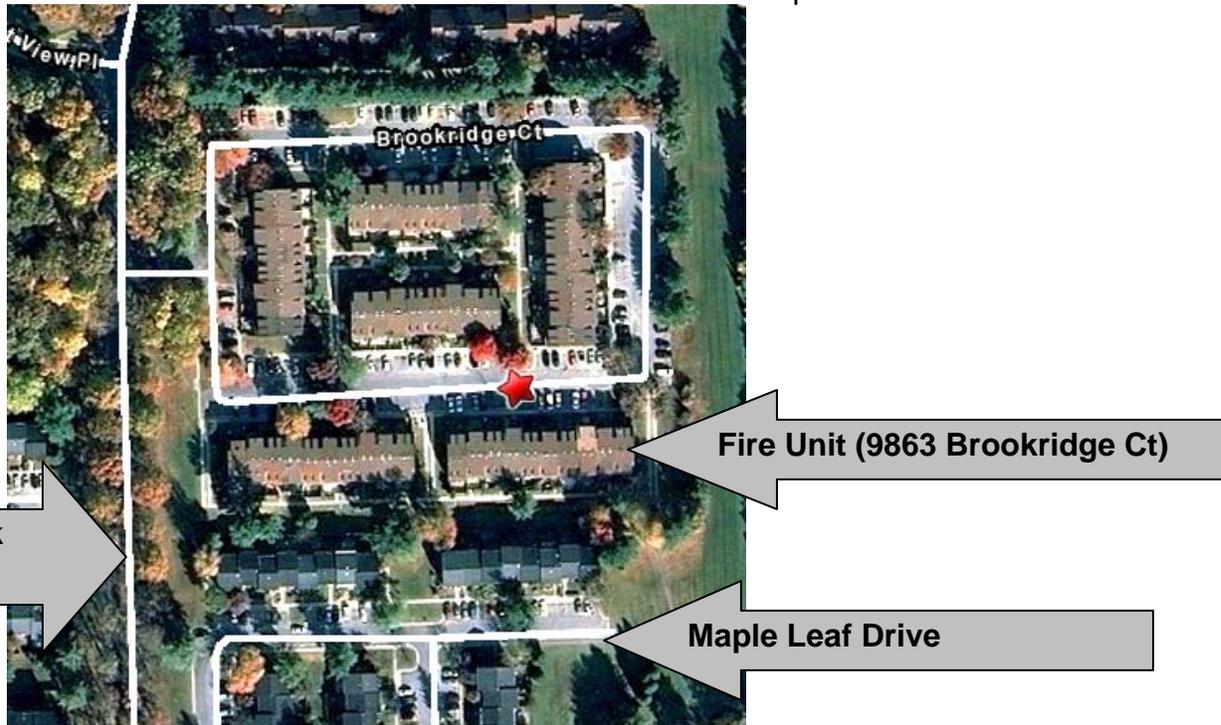
The fire unit/townhouse block is located in a rectangle-shaped development with parking on side alpha. Side Charlie of the townhouse block abuts a small common area and then the rear of townhouses from Maple Leaf Drive

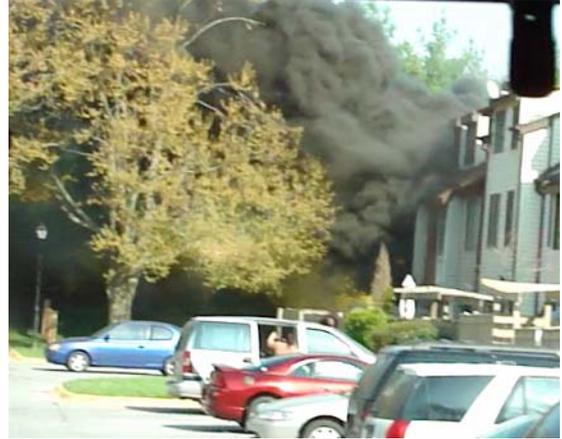
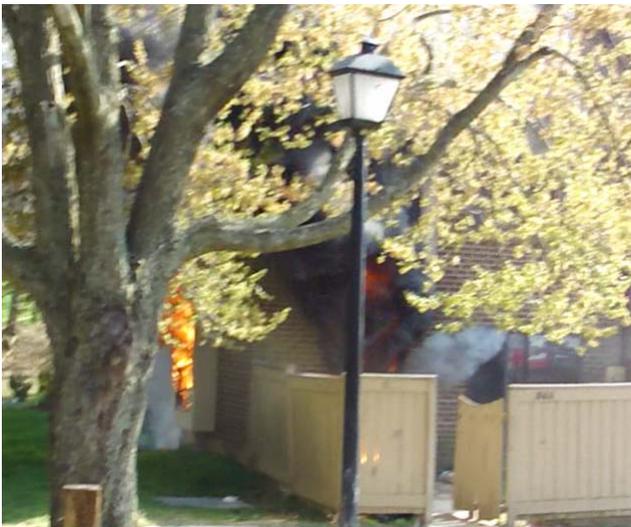
Upon arrival E708 was faced with a three-story, end of the row, piggyback style townhouse with heavy black smoke pushing out from all three levels. E708 positioned on side Alpha just past the fire unit while AT708 positioned on side Alpha with the turntable in front of exposure Delta, 9861. Battalion 705 (BC705) as well as the Special Operations Chief (SP700) followed the units from FS8. SP700 established command while BC705 performed a 360 degree assessment of the complex.
