Montgomery County Fire & Rescue Service

POST INCIDENT ANALYSIS

511 S. Frederick Avenue
Gaithersburg, MD
F10-0089987

August 12th 2010

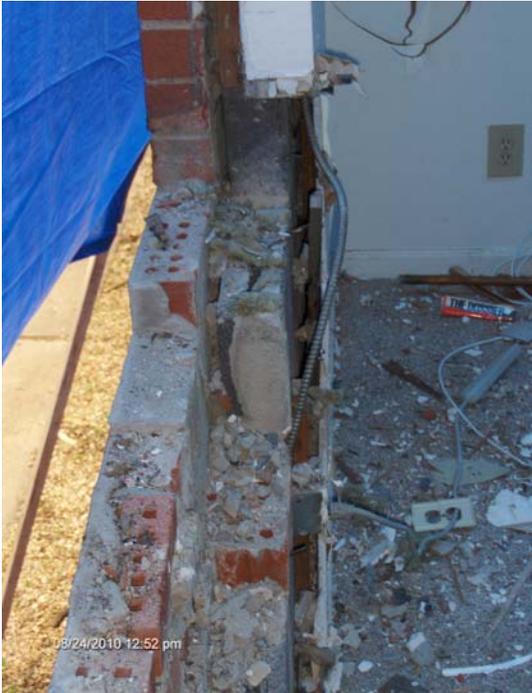
Brick and Block Wall

Building construction is brick and 3 ½ inch block, with 2" x 4" stud and drywall directly behind the block. Floor joists are recessed into pockets in the block. The roof is trussed gable style, added as an addition over a flat tar and gravel roof. The front of the building has 6 decorative balconies, one per floor for the apartments in the Alpha quadrant and the Delta quadrant. These balconies are designed for aesthetics only, and are not accessible from the interior apartments except by crawling through the bathroom window. Doors are metal fire doors set in metal frames, with steel lintels set overhead. Windows throughout the structure are single hung, either set alone or in pairs. Natural gas service enters the building on side Charlie, midway between side Bravo and Delta.

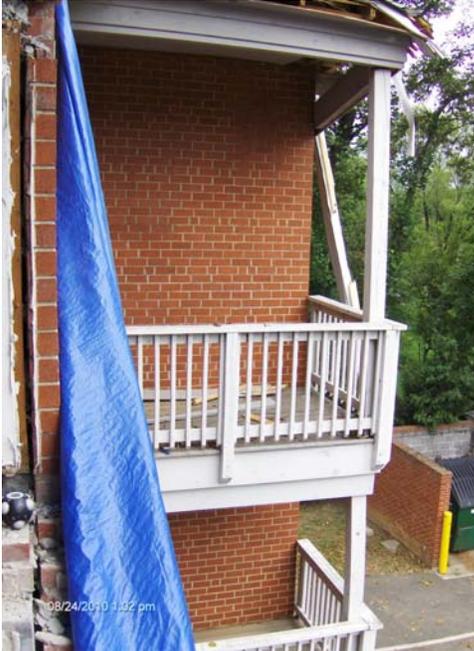
Decorative Balconies

These two windows were broken out and the frames were bent out of shape. The brick and block wall between these two windows was crushed and bowed, and the brick below the double window was folding in towards the apartment. The decorative balconies, which were located in the bumped-out section of the Alpha/Delta corner of the building, had obvious damage and the decks appeared unstable and were partially collapsed.
