Incident Summary
21200 Martinsburg Road – Box 14-08
Dickerson Generating Station– November 11, 2013

Incident Number 13-0126517

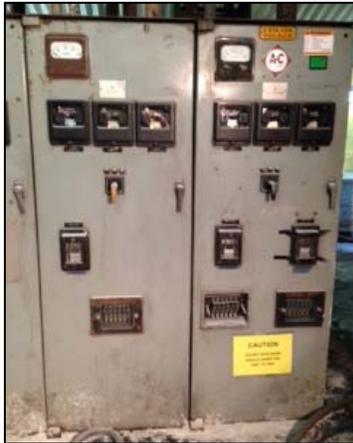
At 1627 hours Montgomery and Frederick County Fire and Rescue units responded to the 7-story Dickerson Generating Station for a report of a building fire in the facility. After arriving and meeting with plant supervisors, Paramedic Engine 714 confirmed that the facility had an active fire in the Echo quadrant, basement level. The plant fire brigade had attempted extinguishment of the fire for over an hour with ABC and CO2 fire extinguishers prior to calling 911 for help. The fire reportedly started because of an explosion in the “volt room” after a 4160-volt circuit breaker tripped. The fire started in circuit unit 212 and spread to the adjacent 211 and 213 units. This fire spread triggered

Plant personnel escorted Paramedic Engine 714 and Medic 714 deep within the structure to the volt room. The volt room is the size of a small classroom with two long rows of 4160-volt circuit breakers. Each row contained 28 circuit breakers. Each circuit breaker was the size of a small refrigerator. The 4160-volt circuit breakers worked in conjunction with a generator. The breakers controlled various functions of the generator (electric pumps, motors etc.). The plant floor supervisor and the control room supervisor confirmed the row involved in the fire had been de-energized. The row adjacent to the involved circuit breakers was energized and would take hours to de-energize by standard plant protocol.
