Potomac Direct

Little Falls

3.17 Little Falls I Mainstem Stream Restoration

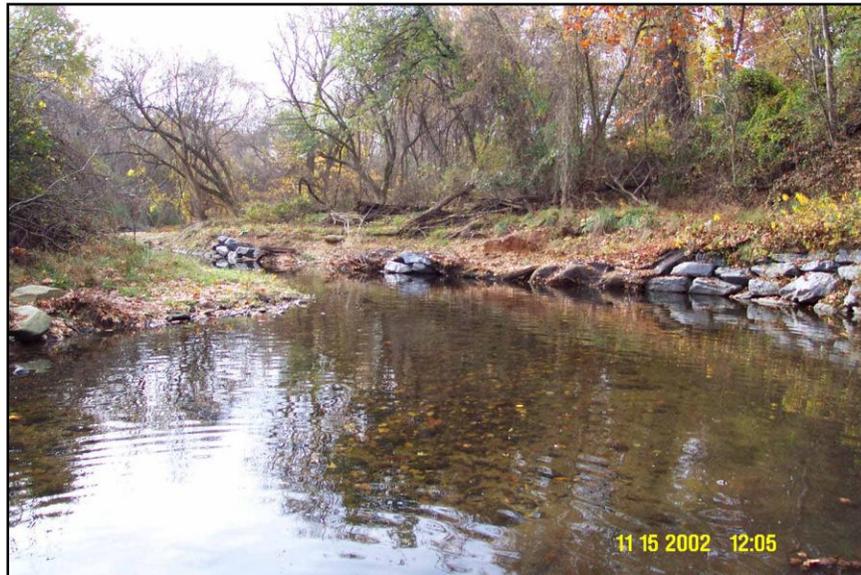
Figure 3.17.1 – Little Falls I Mainstem Stream Restoration in 2002

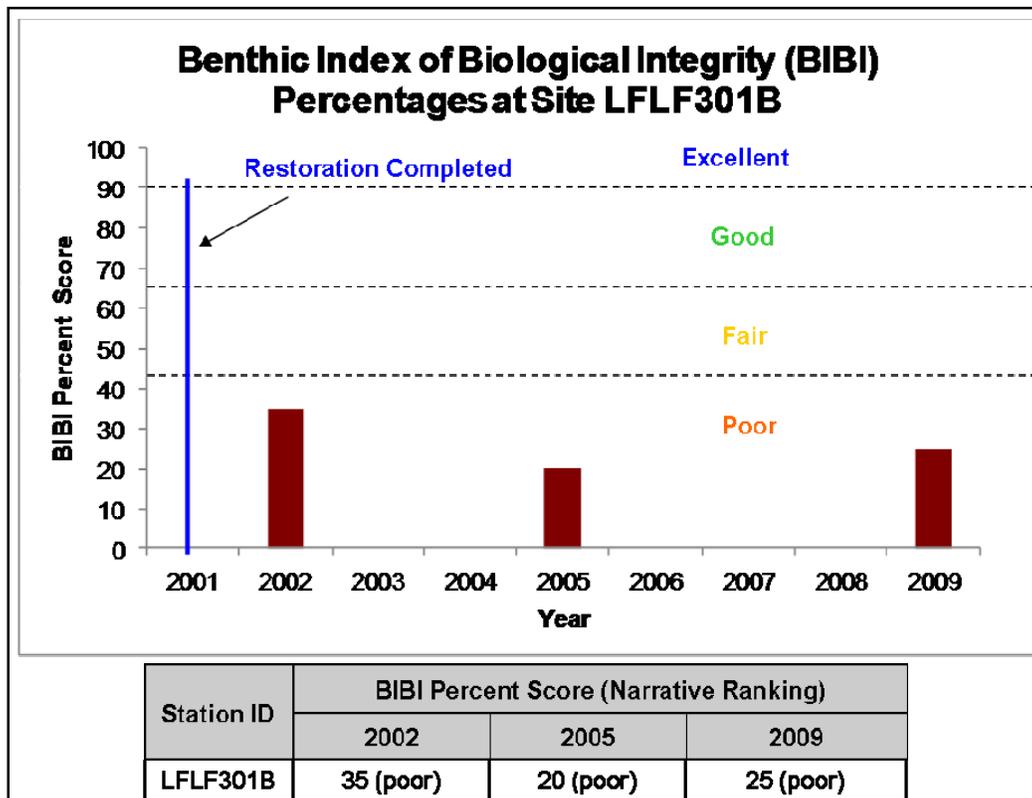
The benthic macroinvertebrate community at LFLF301B, as assessed using the MCDEP Benthic Index of Biological Integrity (BIBI), was Poor during each monitoring year in the post-restoration period, with percentages ranging from 20 to 35 (**Figure 3.17.5**). The highest BIBI percentage was observed in 2002 (35). In 2005, too few individuals were collected to calculate an accurate BIBI, thus this site was given the lowest possible score for that year (20). The decline in BIBI percentage from 2002 to 2009 was due to a decline in the biotic index, a measure of community sensitivity, and a decline in the ratio of scrapers. Field data sheets from 2009 benthic macroinvertebrate monitoring are included in *Appendix D*.

Figure 3.17.5 – Pre- and Post-Restoration Benthic Index of Biological Integrity (BIBI) Percentages at LFLF301B

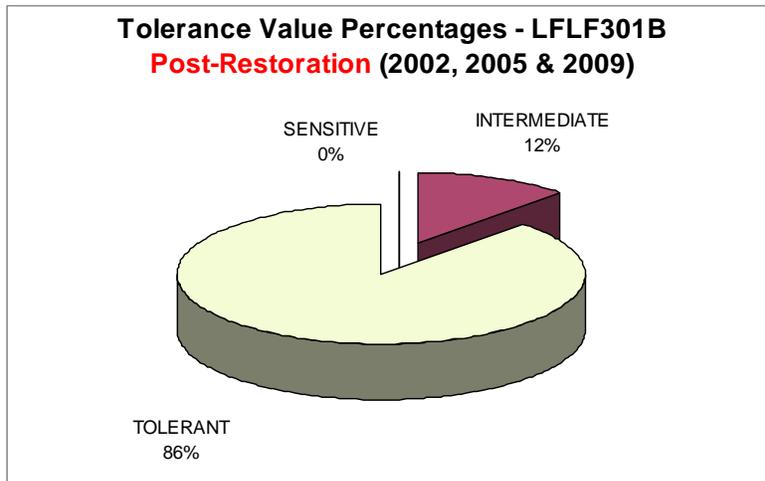
Site LFLF301B was dominated by tolerant taxa (86 percent) following restoration, with the remaining 12 percent represented by taxa intermediate in sensitivity (**Figure 3.17.6**). No sensitive taxa were collected at LFLF301B following restoration. The tolerant taxa were dominated by midges, aquatic sowbugs, and several families of aquatic worms in the Subclass Oligochaeta. Intermediate taxa were dominated by *Hydropsyche* sp. and *Cheumatopsyche* sp. (net spinning caddisflies) and *Simulium* sp. (blackflies).

Figure 3.17.6 – Benthic Macroinvertebrate Tolerance Composition at LFLF301B After Restoration

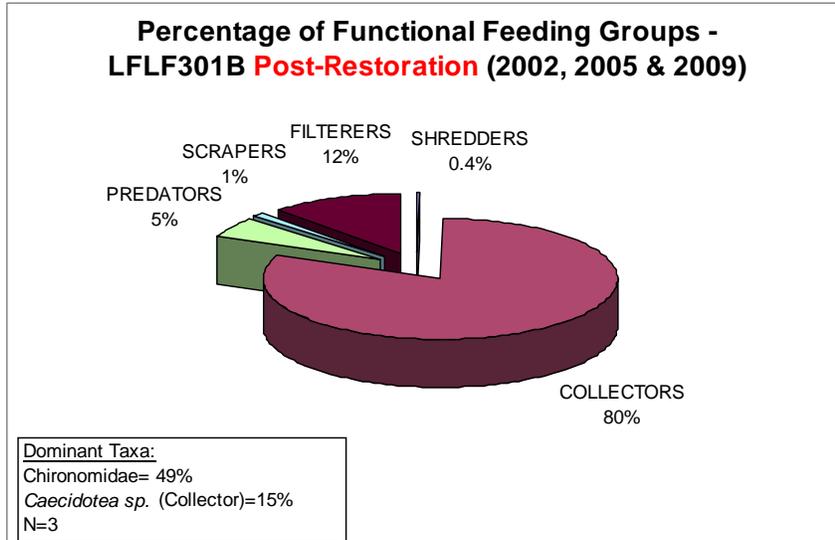
Collectors were the most dominant functional feeding group at LFLF301B after restoration, representing 80 percent of the community. Filterers were the second most dominant group, comprising 12 percent of the community. Predators were next most dominant, comprising five percent of the community. More specialized feeders, including scrapers (one percent) and shredders (0.4 percent) that require less degraded stream conditions or specific habitat features were much less abundant (**Figure 3.17.7**).

Figure 3.17.7 – Benthic Macroinvertebrate Functional Feeding Group Composition and Dominant Species at LFLF301B After Restoration

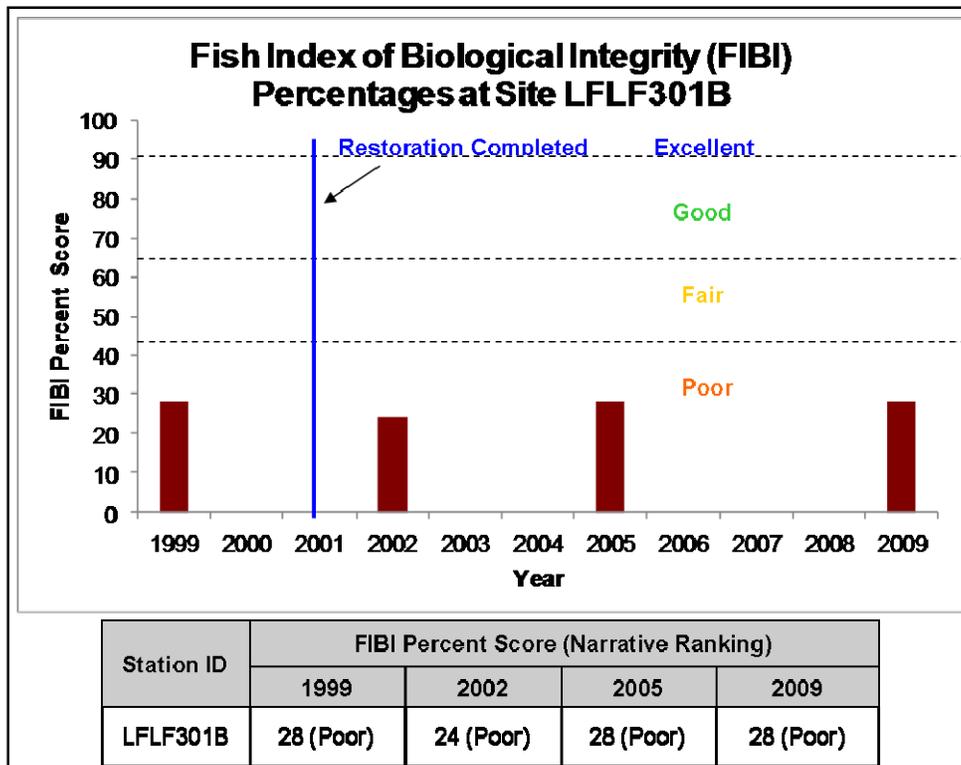
The fish community, as assessed by the MCDEP Fish Index of Biological Integrity (FIBI), was Poor in all years prior to and after restoration (**Figure 3.17.8**). During the 1999 pre-restoration monitoring, this site had a FIBI percentage of 28. In 2002, following restoration, the FIBI percentage decreased to 24 but increased to the pre-restoration percentage of 28 in 2005 and 2009. Although the FIBI did not improve over time, both fish density and species diversity increased at this site after restoration (**Figure 3.17.9**). A total of 35 individuals representing one species were collected in 1999 prior to restoration. Following restoration, fish density and diversity increased each year to 95 individuals of three species in 2002, 478 individuals of four species in 2005, and 2,309 individuals of four species in 2009. Field data sheets from the 2009 fish monitoring are included in **Appendix D**.

Figure 3.17.8 – Pre- and Post-Restoration Fish Index of Biological Integrity (FIBI) Percentages at LFLF301B

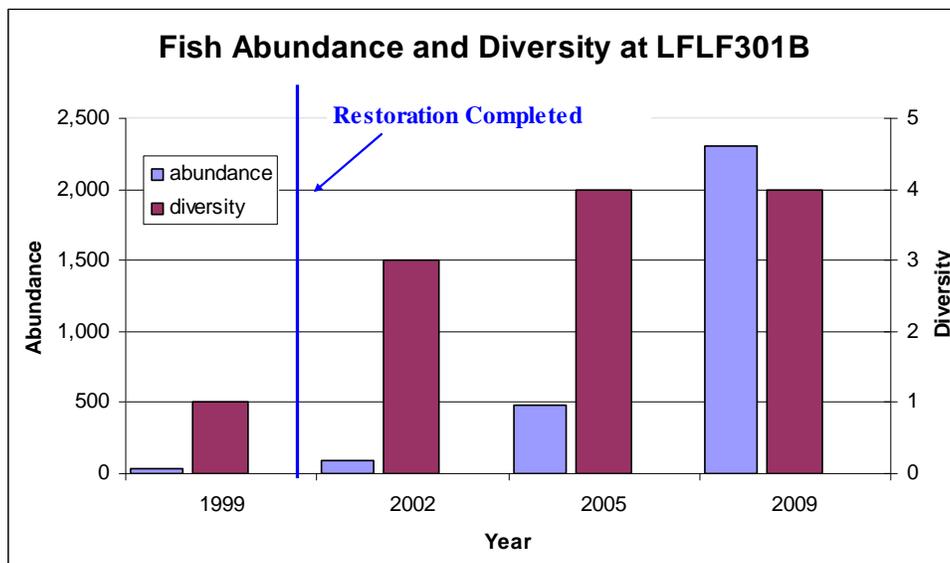
Figure 3.17.9 – Pre- and Post-Restoration Fish Abundance and Diversity at LFLF301B

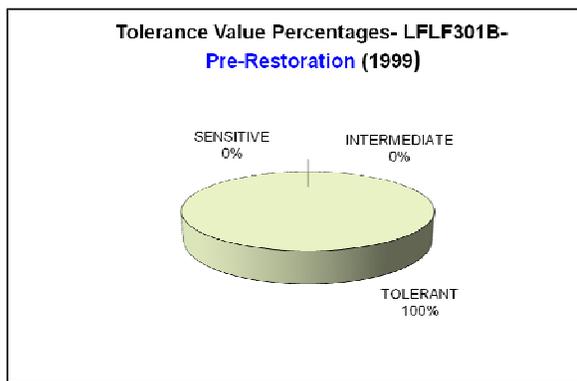
Tolerant fish species heavily dominated LFLF301B prior to and following restoration. Site LFLF301B was represented by 100 percent tolerant species (blacknose dace) prior to restoration. Following restoration, the proportion of tolerant species decreased slightly to 99 percent. The only fish species collected that is not considered tolerant to stressors was central stoneroller, which is considered intermediate in sensitivity. **Figures 3.17.10** and **3.17.11** show the differences in percentages of tolerance values between pre- and post-restoration sampling periods at LFLF301B.

Figure 3.17.10 – Fish Tolerance Composition at LFLF301B Prior to Restoration

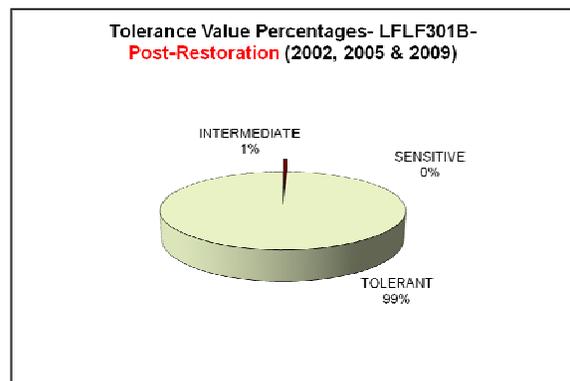
Figure 3.17.11 – Fish Tolerance Composition at LFLF301B After Restoration

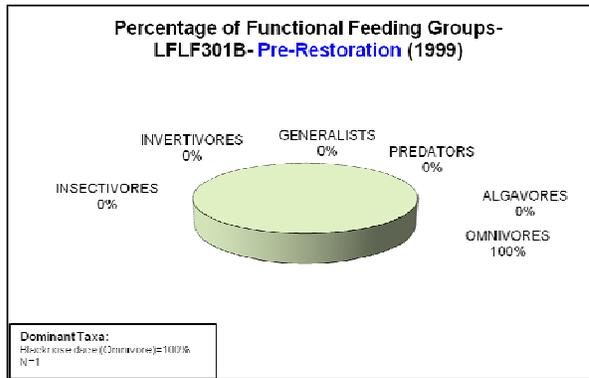
Prior to restoration, omnivores (blacknose dace) comprised 100 percent of the fish community. Following restoration, the proportion of omnivores (blacknose dace and fathead minnow) decreased to 97 percent. Generalists (creek chub and redbreast sunfish) were the second most dominant group, comprising two percent of the community. The remainder of the community was made up of more specialized feeding groups that were not observed prior to restoration. These included algavores (central stoneroller), invertivores (bluegill), and predators (largemouth bass), which comprised 0.6, 0.4, and 0.2 percent of the community, respectively. **Figures 3.17.12** and **3.17.13** show the percentages of each functional feeding group at LFLF301B for the pre- and post-restoration monitoring periods, respectively.

Figure 3.17.12 – Fish Functional Feeding Group Composition and Dominant Species at LFLF301B Prior to Restoration

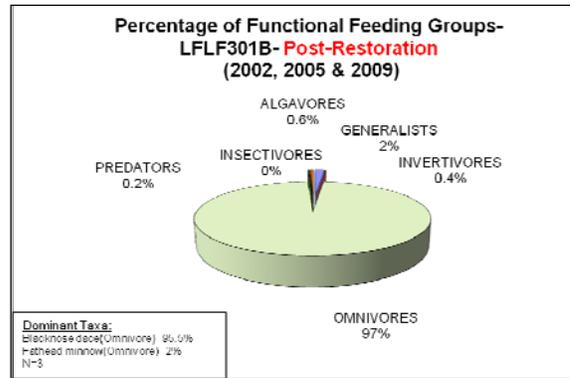
Figure 3.17.13 – Fish Functional Feeding Group Composition and Dominant Species at LFLF301B After Restoration

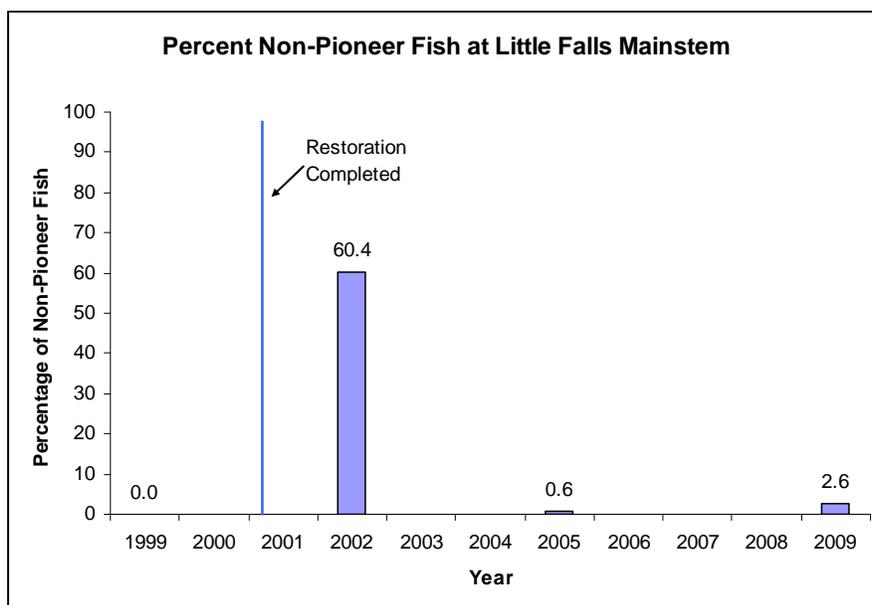
Non-pioneer fish were absent from the Little Falls mainstem site prior to restoration and increased every year after restoration (**Figure 3.17.14**). Species that are considered non-pioneers are generally more sensitive to urbanized aquatic habitats than pioneer species. The most drastic increase in non-pioneer fish occurred in 2002 when over 60 percent of the community was comprised of non-pioneer fish. *Pimephales promelas* (fathead minnow) was the dominant non-pioneer species present in this year and was absent from this site in all other years. In the other years post-restoration, less than three percent of the community was comprised of non-pioneer fish.

Figure 3.17.14 – Non-Pioneering Fish Present at Little Falls Mainstem Site (LFLF301B) Before and After Restoration LFLF301B

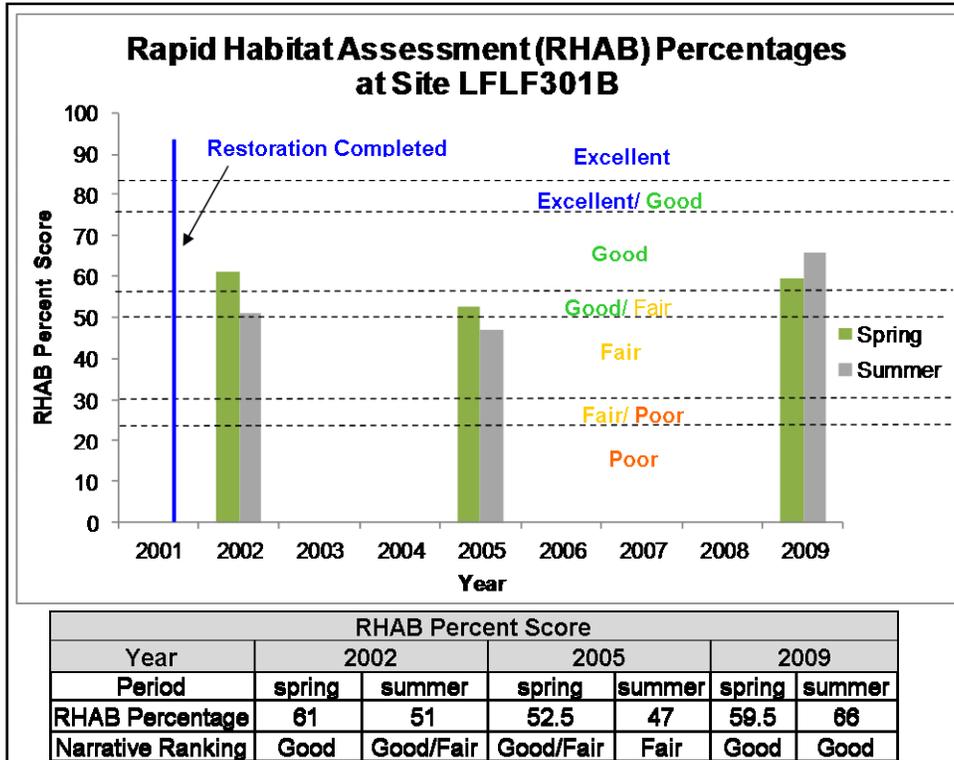
Post-restoration aquatic habitat was evaluated at LFLF301B in the spring and summer in 2002, 2005, and 2009. During these years, aquatic habitat percentages were Fair to Good, ranging from 47 to 66. This site generally had sub-optimal habitat for fish and benthic macroinvertebrates, moderate to heavy sediment deposition, and greater than 50 percent embeddedness. Aquatic habitat improved between 2005 and 2009, due to an increase in sediment deposition and bank stability. *Figure 3.17.15* shows aquatic habitat scores after restoration at LFLF301B.

Figure 3.17.15 – Pre- and Post-Restoration Rapid Habitat Assessment (RHAB) Percentages at LFLF301B
