Potomac River Direct

Little Falls

3.4 Little Falls III Mall Tributary Stream Restoration

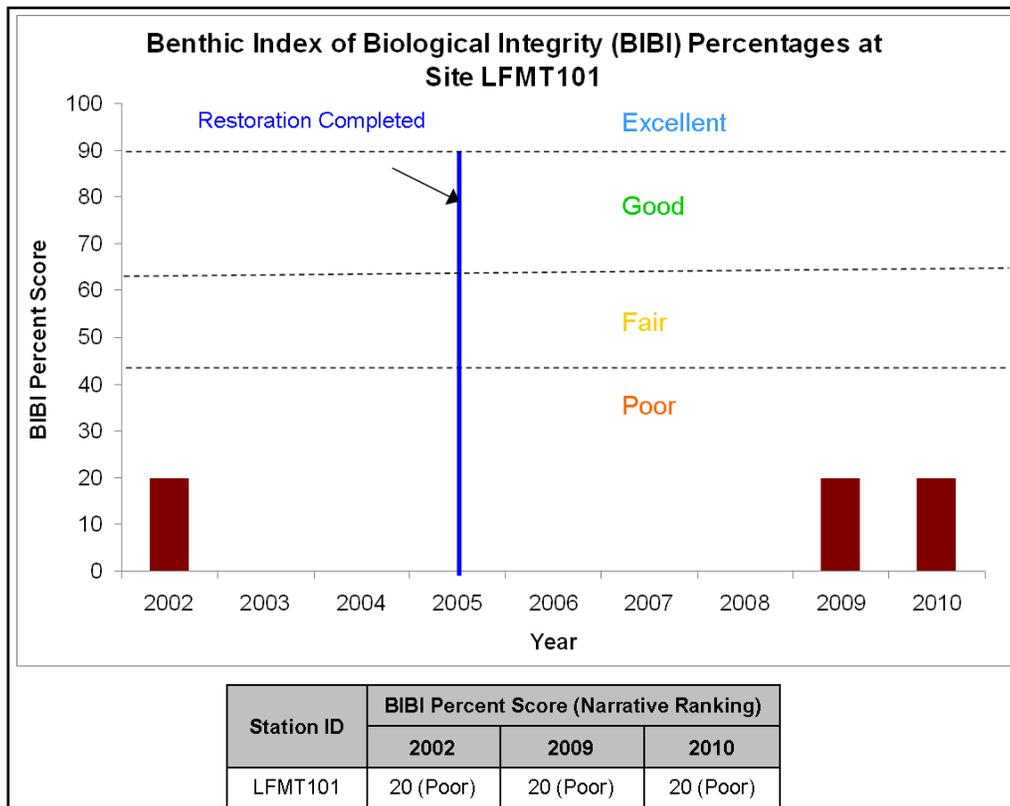
Figure 3.4.7 – Pre- and Post-Restoration Benthic Index of Biological Integrity (BIBI) Percentages at LFMT101

The benthic macroinvertebrate community at LFMT101, as assessed using the MCDEP Benthic Index of Biological Integrity (BIBI), was Poor in both the pre- and post-restoration periods (**Figure 3.4.7**). The baseline BIBI percentage prior to restoration was 20, which is the lowest possible BIBI percentage. Note that prior to restoration, the number of individuals collected was 29, which is below the threshold for calculating the BIBI, thus the lowest possible BIBI score was assigned at this site in 2002. Following restoration in 2009 and 2010, the number of individuals increased above the BIBI threshold, but the BIBI percentage remained at 20. Field data sheets from 2010 benthic macroinvertebrate monitoring are included in **Appendix D**.

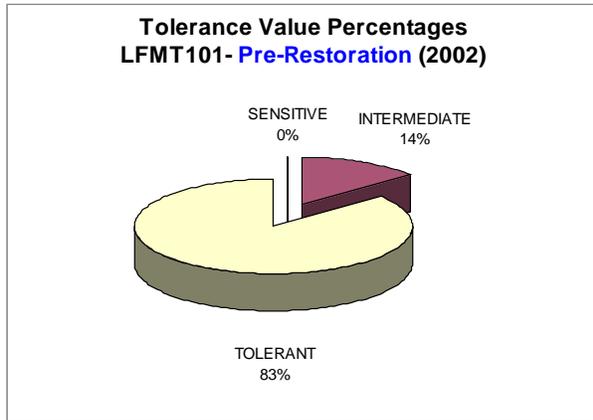
Figure 3.4.8 – Benthic Macroinvertebrate Tolerance Composition at LFMT101 Prior to Restoration

Site LFMT101 was dominated by tolerant taxa (83 percent) prior to restoration, with the remaining 14 percent represented by taxa intermediate in sensitivity (*Figures 3.4.8 and 3.4.8*). Following restoration, the site experienced an increase in the proportion of tolerant benthic macroinvertebrate taxa to 99 percent, and a decrease in the proportion of taxa intermediate in sensitivity to one percent.

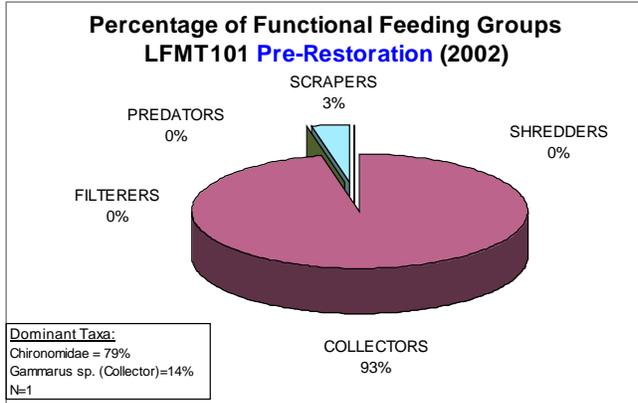
Figure 3.4.10 – Benthic Macroinvertebrate Functional Feeding Group Composition and Dominant Species at LFMT101 Prior to Restoration

Collectors were the most dominant functional feeding group at LFMT101 both before and after restoration. Prior to restoration, the community was dominated by collectors (93 percent). Scrapers represented the only other functional feeding group present prior to restoration, comprising three percent of the community (*Figures 3.4.10 and 3.4.11*). After restoration the percentage of collectors decreased to 89 percent. The remainder of the community was represented by predators (10 percent), filterers (0.7 percent), and shredders (0.3 percent). Scrapers, a specialized feeding group that requires less degraded stream conditions or specific habitat features were absent from the benthic macroinvertebrate community following restoration.

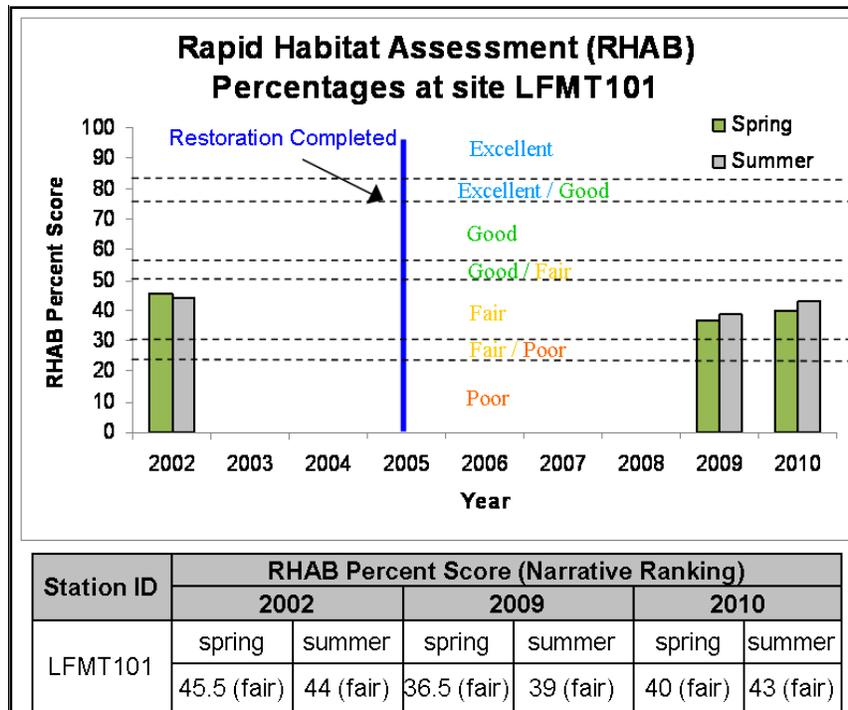
Figure 3.4.12 – Pre-Restoration (2002) and Post-Restoration (2009 and 2010) Rapid Habitat Assessment (RHAB) Percentages at LFMT101

Pre-restoration aquatic habitat was evaluated at LFMT101 in the spring and summer in 2002. During this period, percentages were in the Fair range with percent scores of 45.5 and 44.0, respectively (**Figure 3.4.12**). Following restoration, aquatic habitat was evaluated in the spring and summer of 2009 and 2010. During this time, aquatic habitat percentages ranged from 36.5 to 43 and remained within the Fair range. Generally, this site scored in the poor range for fish habitat and sediment deposition, had marginal habitat for benthic macroinvertebrates, and moderately stable to moderately unstable streambanks. Field data sheets for this task are located in **Appendix D**.
