FACILITY ASSESSMENT FOR Chevy Chase Library

Contract No. 1082489
Sheladia & Associates Project No. 5522.004

Final Report

Date: 03/02/2021

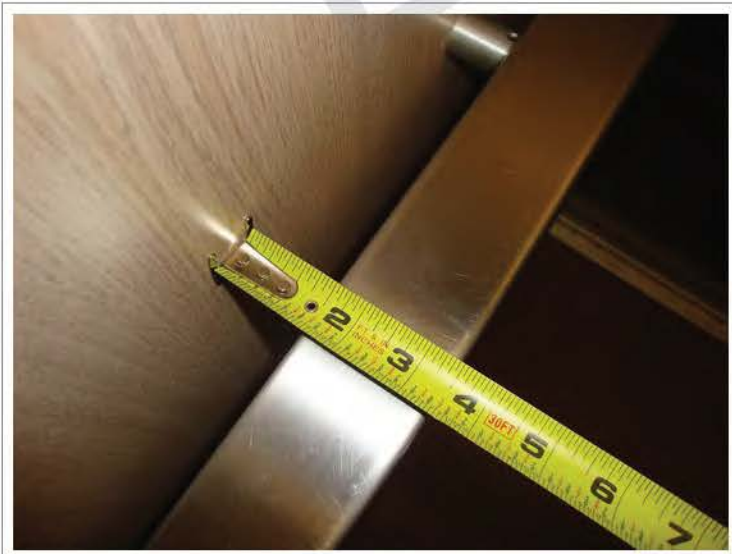
Chevy Chase Library - (113)

Line Item #	Location	Element	Photo	Non-Compliant Feature Description	Action	2010 Standards	1991 Standards	Unit	Unit Cost*	Qty	Estimated Cost*	Comment
67	Elevator											
68	Elevator Car	Size	113-115	The elevator car is 68-1/2 inches wide overall between the car wall panels. There are metal grab panels at either side of the car that reduce the overall width by 3-1/2 inches at either side.	The elevator car size is compliant per 2010 ADA Standards 407.4.1, as measured to the interior wall panels of the car. We recommend modifying or removing the grab bar panels at the car interior as, due to their atypical size, they effectively reduce the overall width of the elevator car to 61-1/2 inches, which is non-compliant.	407.4.1	4.10.9	Operations	\$0	1	\$0	
69	Elevator Car	Phone - Door Hardware	116-120	The hardware on the door to the emergency phone required tight grasping to operate.	Provide a loop or other accessible type pull handle on the door to the emergency communication device.	309	4.27	door	\$169	1	\$169

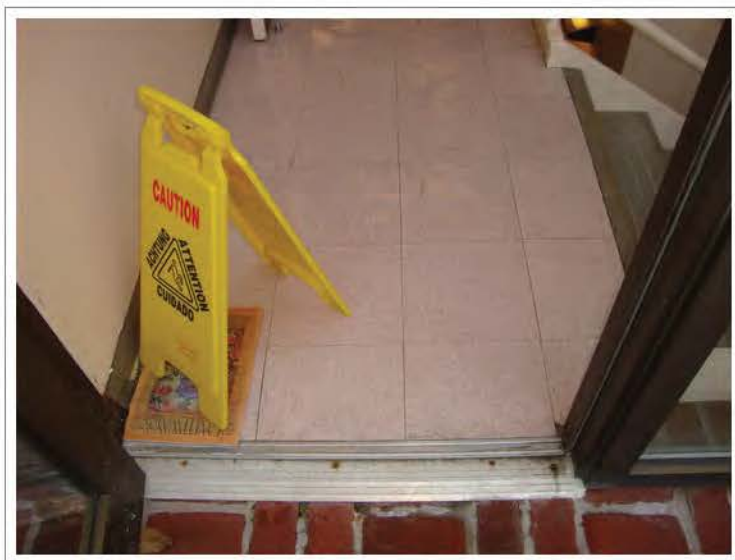
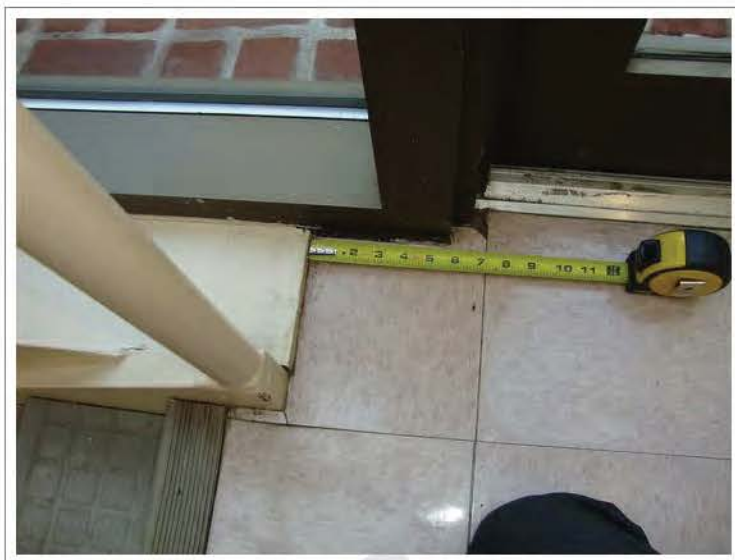
Chevy Chase Library

27	Entrances											
28	Connecticut Avenue Entrance	Door - Threshold	146-147 149-150	At the automatic door leaf at the exterior door, the threshold is 3/4 inch high adjacent to the hinge, due to settling of the grout. There is cracking of the tile at the threshold, creating gaps at the threshold.	Replace or modify the threshold to have a maximum abrupt vertical level change of 1/4 inch with a maximum overall rise of 1/2 inch sloped 1:2 maximum.	404.2.5	4.13.8	door	\$221	1	\$221	
29	Connecticut Avenue Entrance	Door - Automatic Operator	151 - 153	The push button at the interior vestibule area, to operate the exterior automatic door leaf, was not working at the time of the survey.	Maintain accessible features in operable working condition.	28 CFR 35.133	28 CFR 35.133	Operations	\$0	1	\$0	
30	Connecticut Avenue Entrance	Door - Push Side Smooth Surface	152, 156, 160	The push side smooth surface at both the interior and exterior entry doors is 6-3/4 inches high.	Provide a 10 inches minimum AFF kick plate or smooth surface along the full width of the push side of the door.	404.2.10	...	door	\$343	1	\$343	Compliant with the 1991 ADA Standards; must be made compliant with the 2010 ADA Standards at the time the element is next altered.

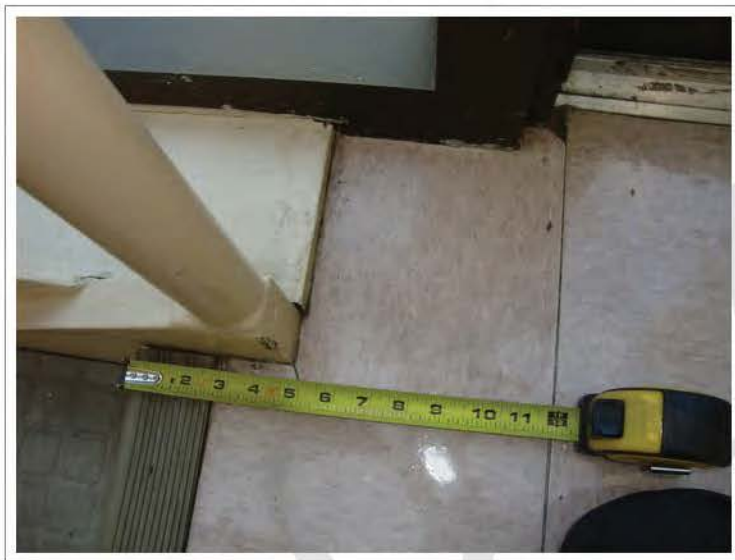
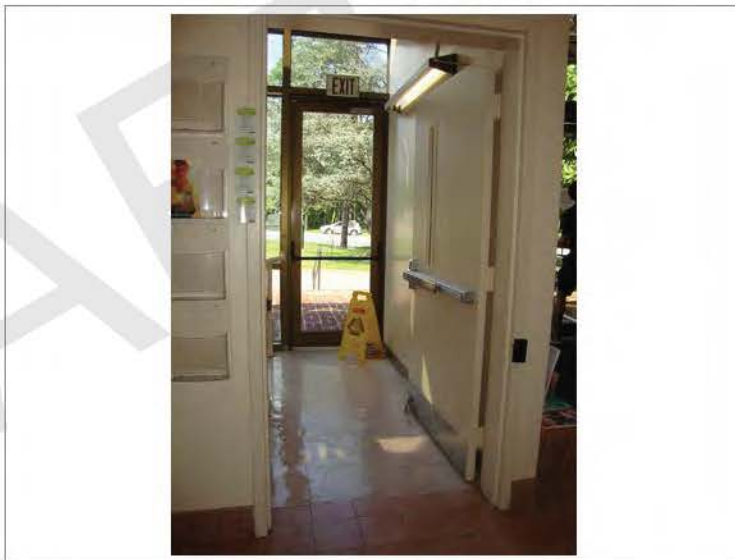
Chevy Chase Library - (140)

66	Stair	Emergency Exit - Door Maneuvering Clearance	139-141	The push side door maneuvering clearance is 6-1/2 inches wide at the latch side, to the handrail base, and 12 inches wide, to the edge of the top step. The door has both a closer and a latch.	Install an automated power operator with push button control. The clear floor space adjacent to the control (centered on the control recommended) must be located beyond the arc of the door swing. Assure automatic and power-assisted doors and gates comply with provisions found in ANSI/BHMA A156.10 [(ANSI/BHMA A156.19 for low-energy doors)]. Use of an automatic door operator eliminates the requirement for maneuvering clearance space at both sides of the door, provided that the door has standby power, or that it remains open in the power-off condition.	404.3	4.13.12	exterior door (entrance door)	\$13,108	1	\$13,108

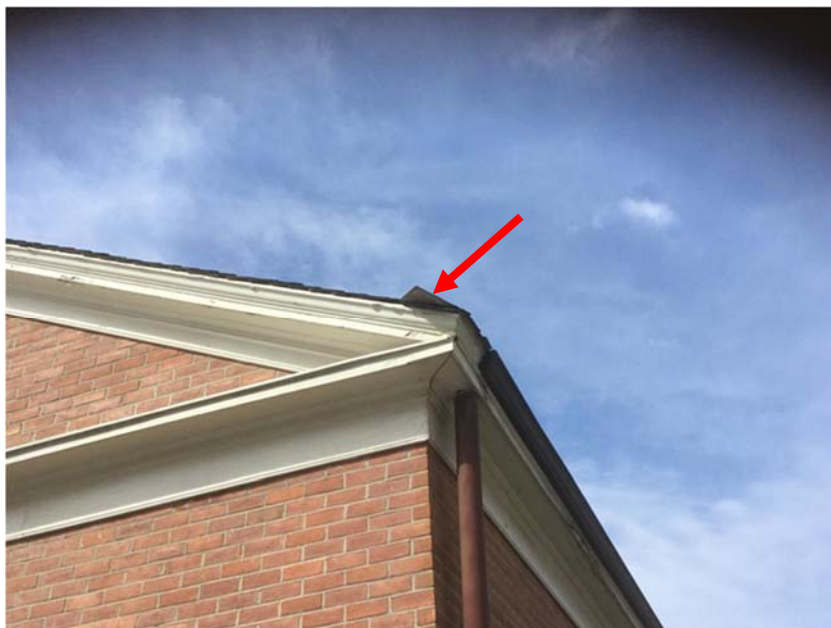
- The roof consists of random-sized purple and green slate shingles. Isolated slate shingles were observed to be broken or displaced, mostly along roof edges (Photos 3, 4, 5, and 6). In general, the slate shingles appear to be in fair condition given their age.
- EPDM repairs were observed at isolated valleys (Photos 7 and 8).
- Peeling paint and isolated rot was noted throughout the wood dormers, fascia, and dental molding. (Photos 3, 8, 9, and 10).
- The gutters assemblies vary between built-in and hung assemblies. The gutters and downspouts appear to be in generally fair condition (Photos 4 and 7). Repair attempts were noted at a downspout on the east elevation (Photo 10).

Photo 6: Slate shingle displacement along the roof edge (red arrow).

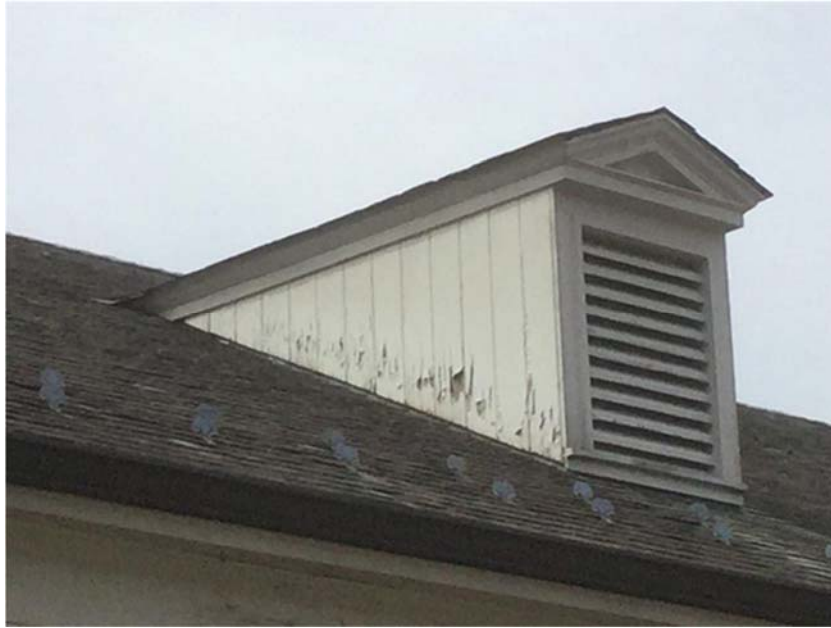
Photo 9: Dormer shown in Photo 8. Note the peeling paint.

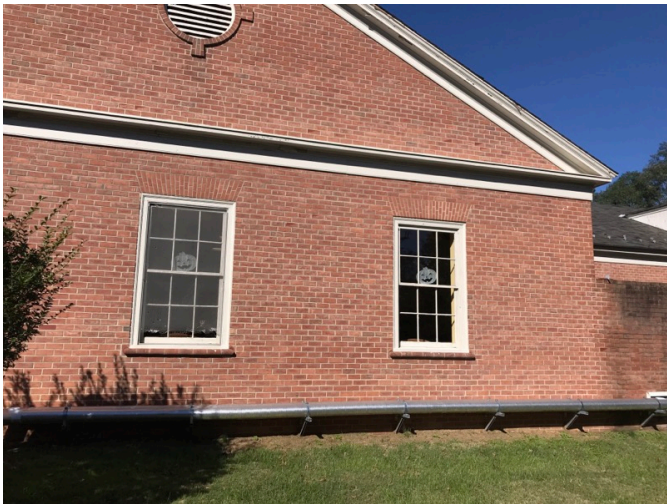
Photograph 3
Description: HA-01: Beige exterior window caulking.
ACM.
4% Chrysotile.

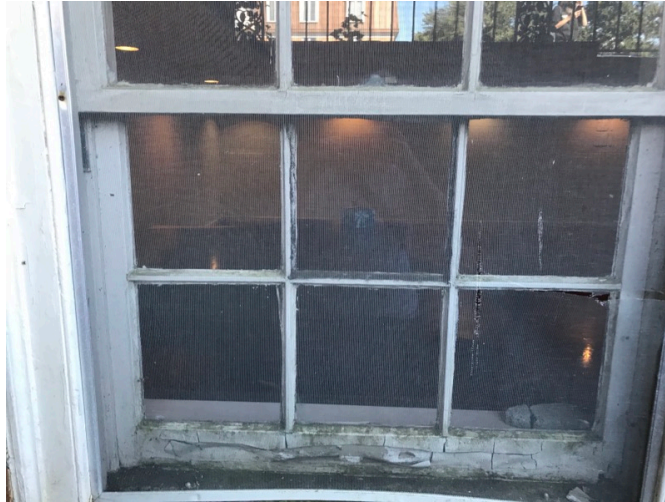
Photograph 4

Description: HA-02: White exterior window glazing.

Non-Detect for the presence of Asbestos.

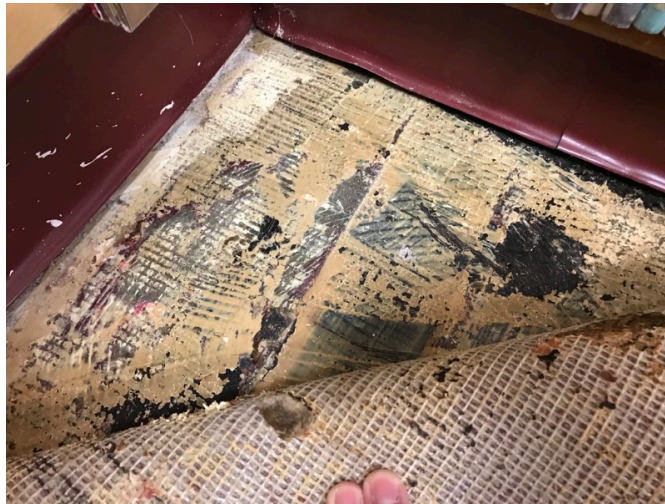
Photograph 5

Description: HA-03: Yellow carpet mastic with residual black mastic.

ACM.

2-3% Chrysotile.

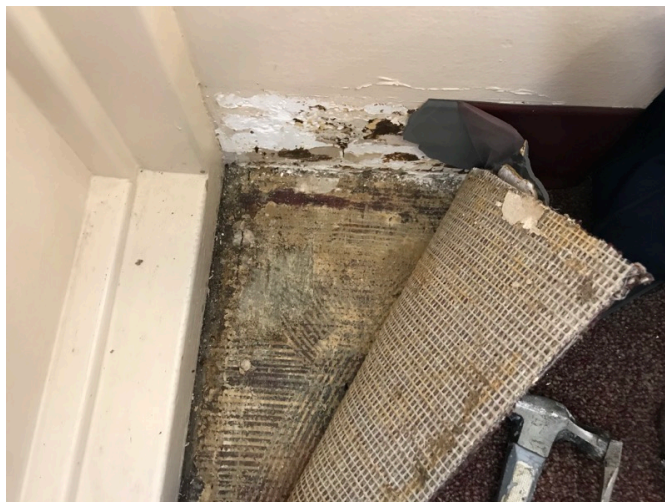
Photograph 6

Description: HA-04: Yellow carpet mastic.

Non-Detect for the presence of Asbestos.

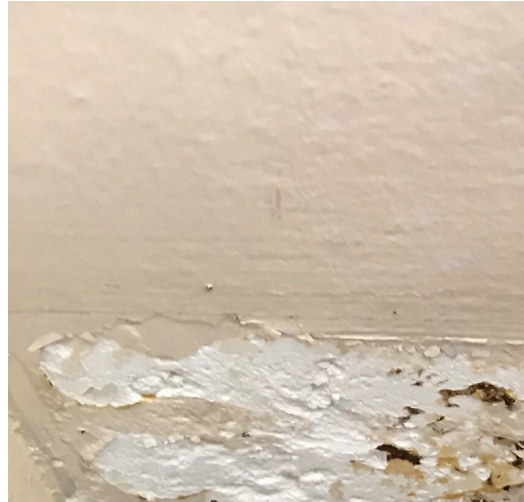
Photograph 7

Description: HA-05 & 06: White drywall associated with white joint compound.

Non-Detect for the presence of Asbestos.

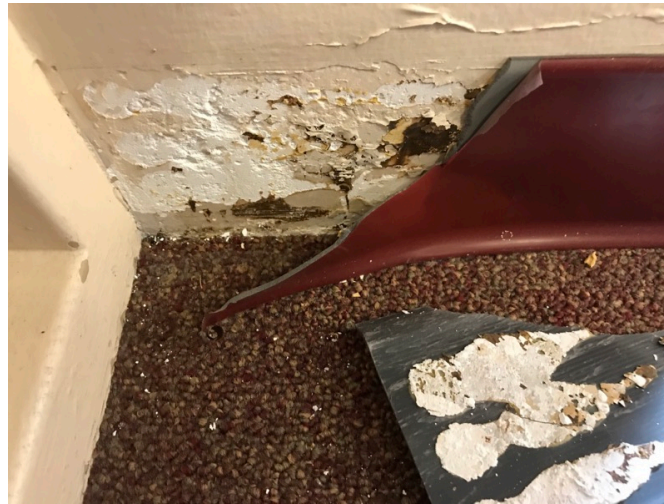
Photograph 8

Description: HA-07: Brown and yellow cove base mastic.

Non-Detect for the presence of Asbestos.

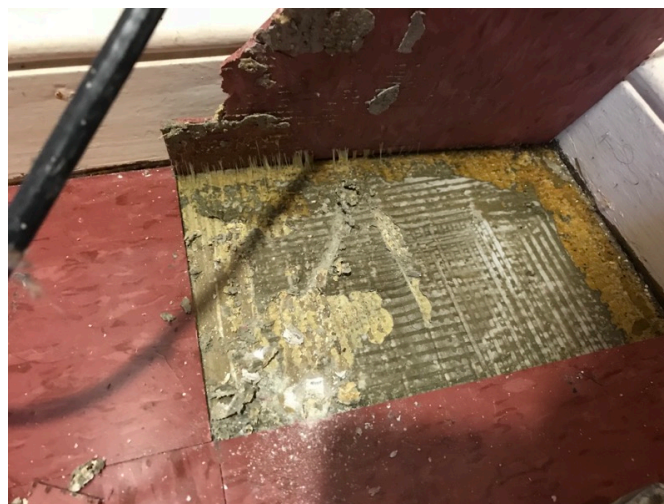
Photograph 9

Description: HA-08: Red 12x12 floor tile with grey level compound over HA-09.

Non-Detect for the presence of Asbestos.

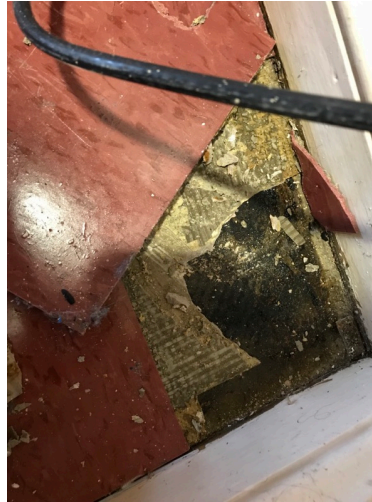
Photograph 10

Description: HA-09: Grey floor tile
with black mastic
under HA-08.

ACM, Mastic Only

3% Chrysotile.

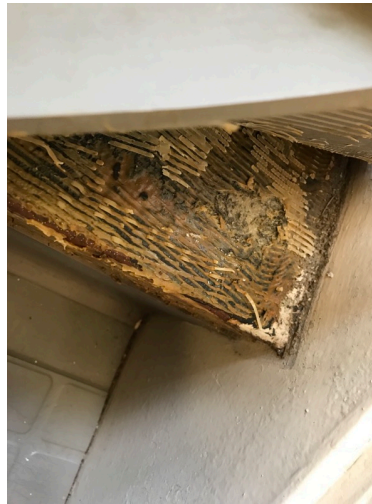
Photograph 11

Description: HA-10: Brown and
yellow mastic
under grey rubber
stair tread.

Non-Detect for
the presence of
Asbestos.

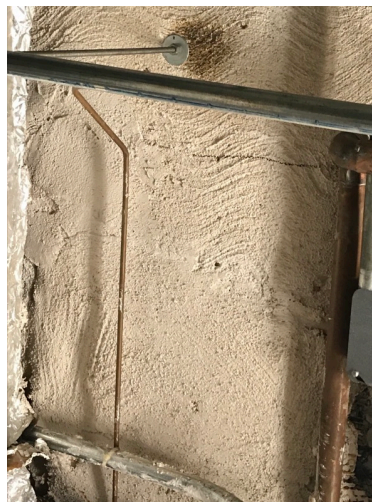
Photograph 12

Description: HA-11: White rough
textured ceiling plaster.

Non-Detect for the
presence of Asbestos.

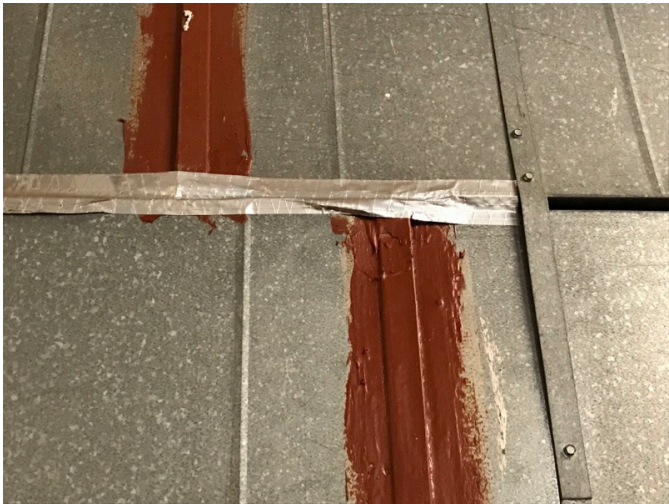
Photograph 13
Description: Red seam sealant on metal HVAC duct.

Non-Detect for the presence of Asbestos.

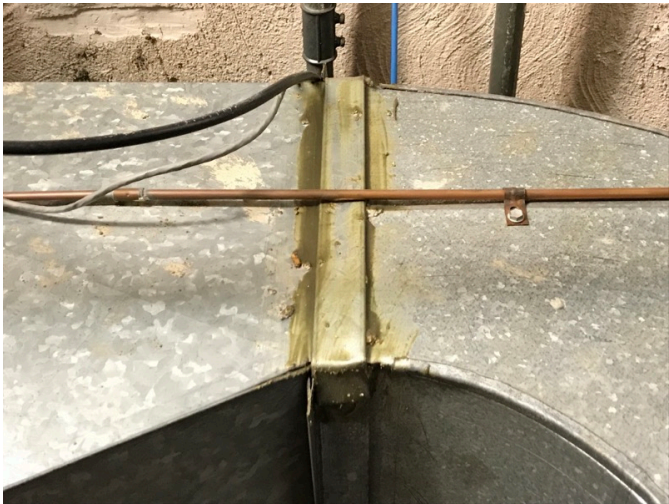
Photograph 14
Description: HA-13: Green seam sealant on metal HVAC duct.

Non-Detect for the presence of Asbestos.

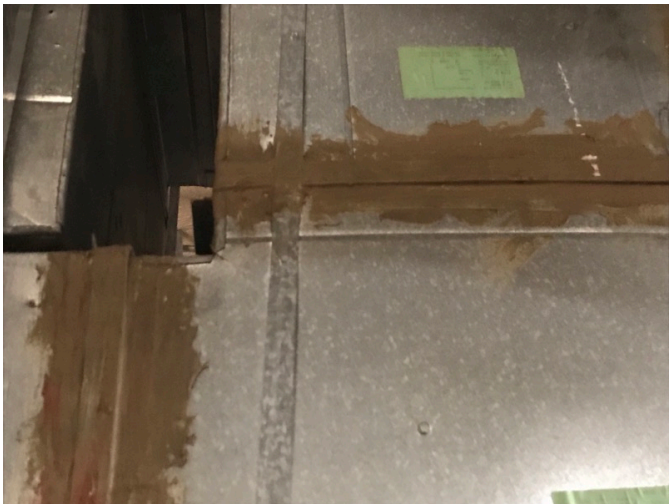
Photograph 15
Description: HA-14: Brown seam sealant on HVAC metal duct.

Non-Detect for the presence of Asbestos.

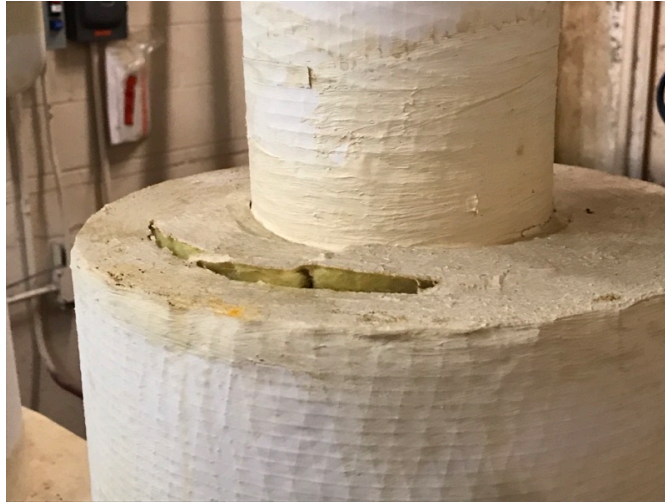
Photograph 16

Description: HA-15: White seam sealant on fiberglass pipe insulation.

Non-Detect for the presence of Asbestos.

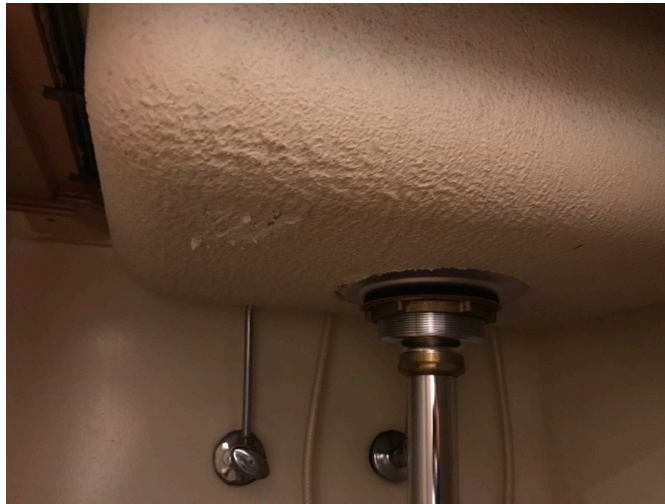
Photograph 17

Description: HA-16: White sink undercoating.

Non-Detect for the presence of Asbestos.

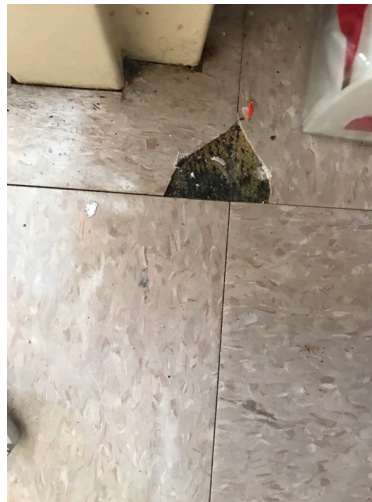
Photograph 18

Description: HA-17: Beige 12x12 vinyl floor tile with streaks associated with black mastic.

ACM, Mastic Only.

3-4% Chrysotile.

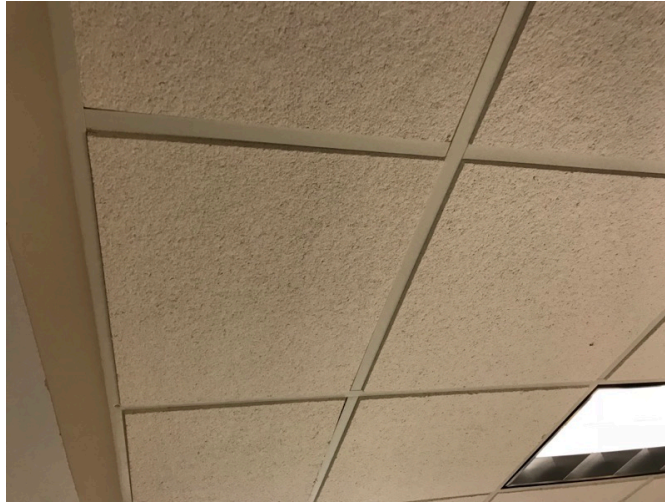
Photograph 19
Description: HA-18: White 2x2 textured ceiling tile.

Non-Detect for the presence of Asbestos.

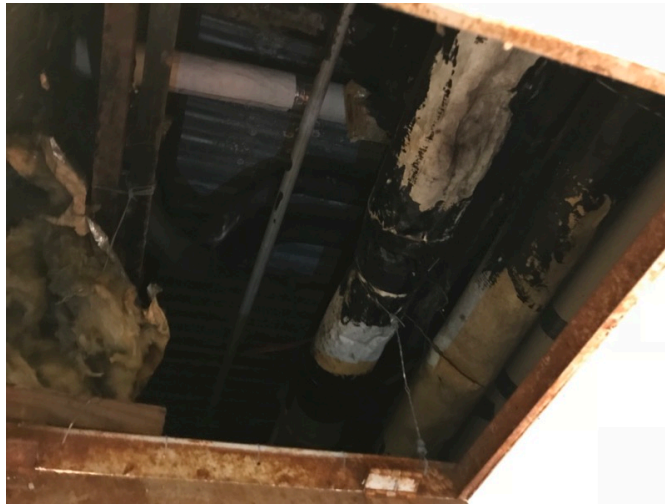
Photograph 20
Description: HA-19: Black seam sealant on silver foil fiberglass pipe.

ACM.
4-5% Chrysotile.

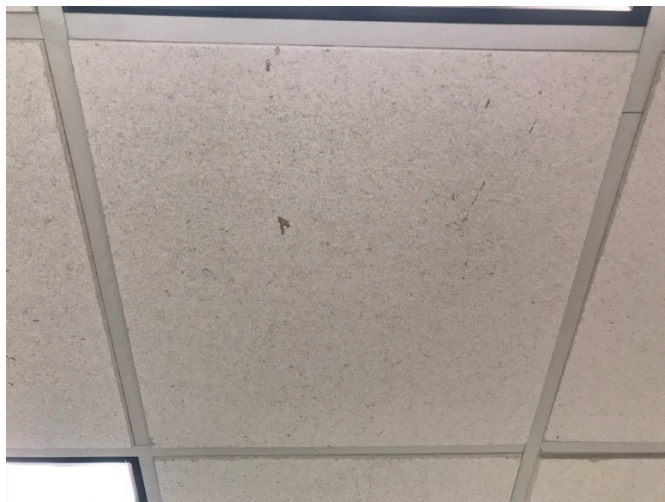
Photograph 21
Description: HA-20: White 2x4 ceiling tile with striations and small pinholes.

Non-Detect for the presence of Asbestos.

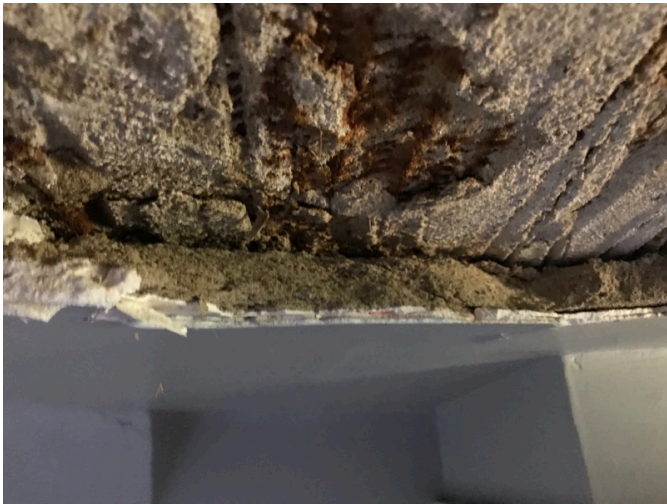
Photograph 22
Description: HA-21: White and brown coat plaster.

Non-Detect for the presence of Asbestos.

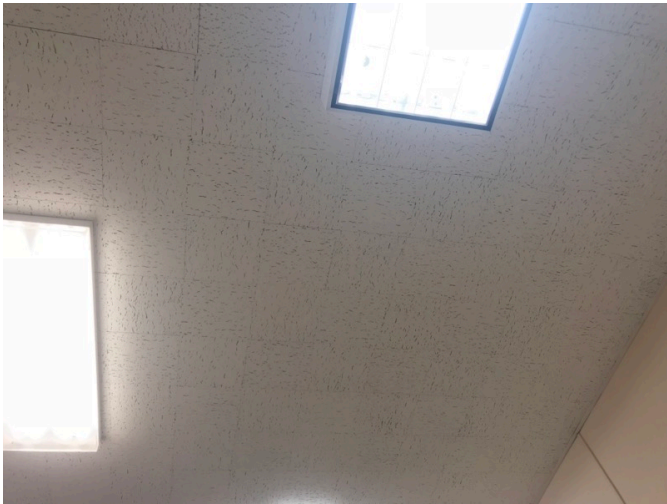
Photograph 23
Description: HA-22: White 1x1 ceiling tile.

Non-Detect for the presence of Asbestos.

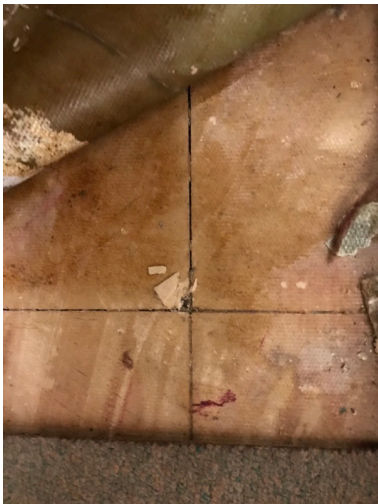
Photograph 24
Description: HA-23: Pinkish beige 12x12 floor tile with white blotches and associated black mastic.

ACM, Mastic Only.
3-4 % Chrysotile.

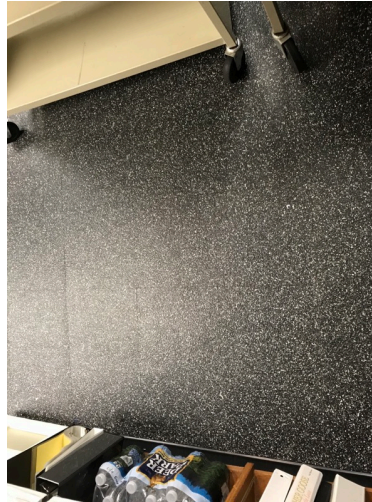
Photograph 25
Description: HA-24: Black granite pattern 12x12 floor tile with green leveling compound.

Non-Detect for the presence of Asbestos.

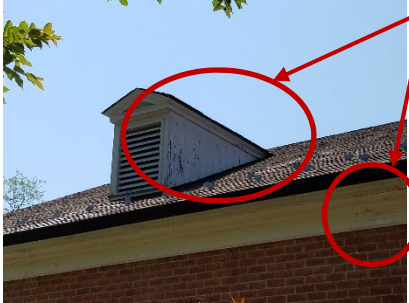
Picture #	Image	Description	Timeline		
			Immediate	Necessary	Extended
#7-A, A1.1 Roof

Condition of exposed painted wood in poor condition.	●		
Recommendation:	Isolated slate and sheet metal repairs to include edges and valleys, will likely be required to maintain the roof in serviceable condition. Scraping, priming, and painting all wood trim, and a contingency for replacing isolated rotted areas should be carried. Alternately, the Gale report recommends replacing the roof (slate tiles).				
#7-A, A1.2 Roof

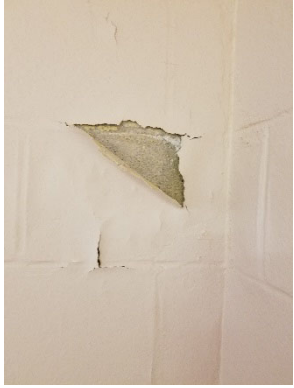
<p>#7-A, A2.1</p> <p>Foundation / Waterproofing</p>

<p>Moisture presence and peeling paint in Lower level, are likely caused by moisture penetrating the CMU walls due to the lack of an appropriate waterproofing membrane.</p>	<p>●</p>		
<p>Recommendation:</p>	<p>Re-grading the landscaped areas and providing provisions for drainage on the Northwest side will likely mitigate the moisture intrusion being experienced. Excavation and installation of a waterproofing membrane should be considered.</p>				
<p>#7-A, A2.2</p> <p>Foundation / Waterproofing</p> <p>West side of the building</p>

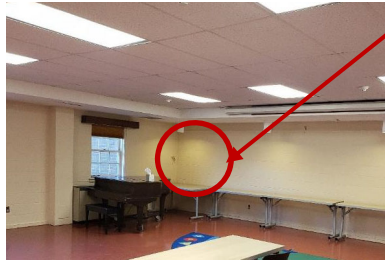
Peeling paint at interior face of northeast corner of basement wall.

Excavate the backfill against the basement walls along the east and west side of the building following the footprint of the existing foundation drainage system highlighted in Figure 1. Remove the existing damp-proofing (if necessary or if excess damage is observed) and provide new waterproofing membrane covered by protection board or rigid insulation. Also, provide a free-draining membrane over the waterproofing membrane. Gravel backfill may be used in place of draining membrane. Condition of the tile drain shown on existing drawings and highlighted in Figure 1. is to be evaluated upon excavation. It is anticipated that the tile foundation drain is clogged or moved such that its functionality is compromised on both the east and west walls of the basement level. If the tile foundation drain is found to be dysfunctional, it shall be removed and replaced with 4 inch perforated drainpipe below floor slab level. Also, remove the peeled paint from the interior face of the walls and repaint to match the existing wall color.

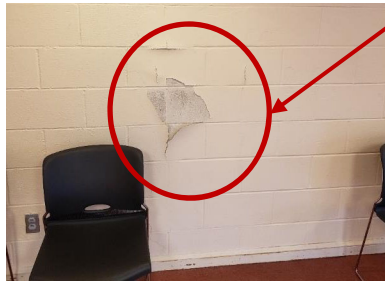
Peeling paint at interior face of west basement wall.

Recommendation:

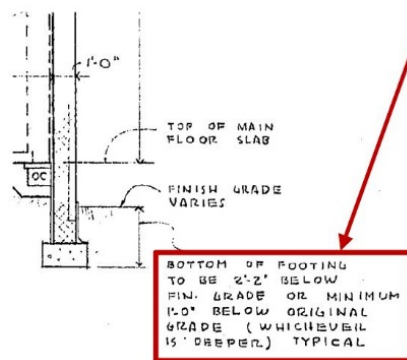
#7-A, A2.9

Existing design frostline depth.

Recommendation:

Verify existing frostline depth by excavating one spot along each line of wall highlighted in Figure 2. If the frost line depth is confirmed to be less than 30" as required by the Montgomery County, it's recommended to increase the grade line adjacent to the building by 6" (or as needed to reach minimum 30" depth) for a width of 4'-0".

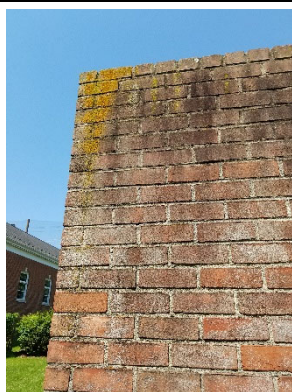
#7-A, A3.1

Lack of sheet metal parapet cap. Stained & deteriorated mortar joints.

Recommendation:

Install a sheet metal parapet cap and repointing repairs on the south screenwall to prevent further deterioration.

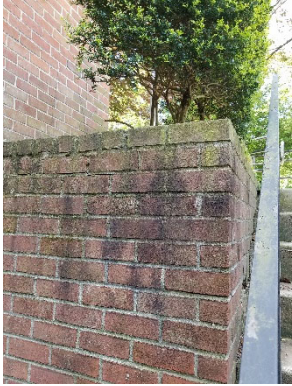
<p>#7-A, A3.2</p> <p>Perimeter Skin</p>

<p>Stained & deteriorated mortar joints.</p>	<p>●</p>		
<p>Recommendation:</p>	<p>Repoint the retaining wall on the north elevation.</p>				
<p>#7-A, A3.3</p> <p>Perimeter Skin</p>

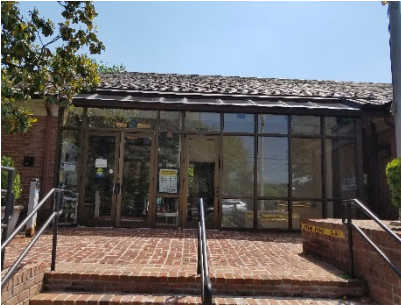
<p>The storefront system and glazed roof at the West entrance vestibule is in generally poor condition and appears to be a source of moisture intrusion.</p>		<p>●</p>	
<p>Recommendation:</p>	<p>Replace the storefront system and glazed roof with a new storefront system and a new standing seam metal roof.</p>				
<p>#7-A, A4</p> <p>Exterior Glazing</p>

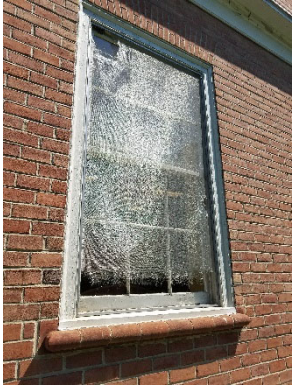
<p>The window systems (and doors) appear to be in poor condition.</p>		<p>●</p>	
<p>Recommendation:</p>	<p>Replace the exterior doors and windows throughout.</p>

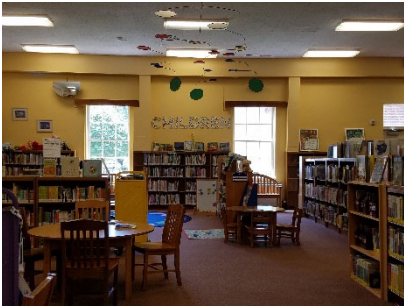
<p>#7-A, A5</p> <p>Interior Partitions</p>

<p>The condition of the drywalls were noted to be good throughout, but required new wall painting.</p>	<p>●</p>		
<p>Recommendation:</p>	<p>Overall the entire facility required new wall painting. Areas missing wall base requires replacement with new wall base.</p>				
<p>#7-A, A6</p> <p>Interior Glazing</p>

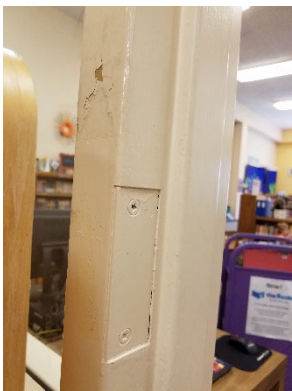
<p>Interior glazed partitions are in poor condition.</p>	<p>●</p>		
<p>Recommendation:</p>	<p>Replace interior glazed partitions new.</p>				
<p>#7-A, A7</p> <p>Door / Entranceways</p>

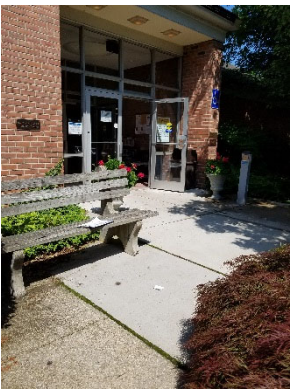
<p>Acceptable but poor.</p>	<p>●</p>		
<p>Recommendation:</p>	<p>Replace the exterior doors (and windows) throughout.</p>

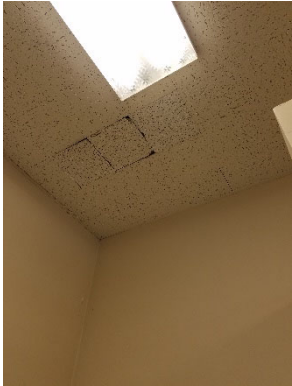
#7-A, A8.1 Ceilings & Soffits

Random and crudely cut ceiling tiles were observed.

Recommendation:	Replace the entire ceiling with an exposed grid system. Refer to cost estimate section A-8				
#7-A, A8.2 Ceilings & Soffits

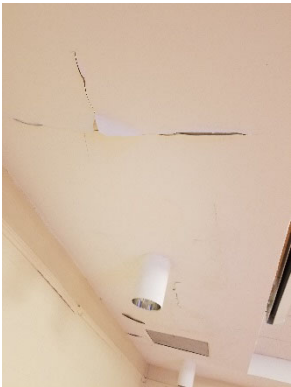
Paint peeling likely caused by moisture presence.

Recommendation:	Controlling the humidity levels on the Lower floor, and repainting the soffits would help resolve the issue.				
#7-A, A9 Flooring

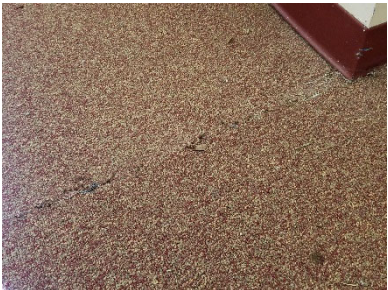
Flooring condition was noticed to be poor throughout the facility.

Recommendation:	Replace with new flooring material.

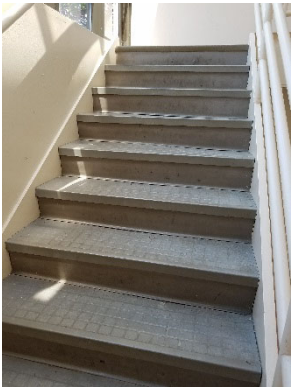
<p>#7-A, A10.1</p> <p>Stairs & Ramps</p>

<p>Egress stair material finish conditions are poor, and Requires other ADA improvements.</p>	<p>●</p>		
<p>Recommendation:</p>	<p>Replace flooring material and provide recommended ADA improvements.</p>				
<p>#7-A, A10.2</p> <p>Stairs & Ramps</p>

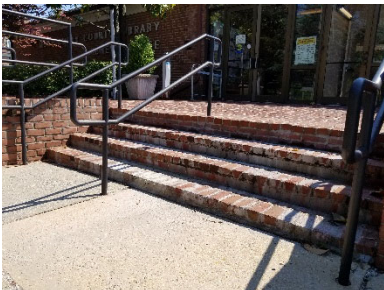
<p>West façade exterior entrance steps are in poor condition.</p>	<p>●</p>		
<p>Recommendation:</p>	<p>Replace entrance steps and entrance podium (and flag pole).</p>				
<p>#7-A, A10.3</p> <p>Stairs & Ramps</p>

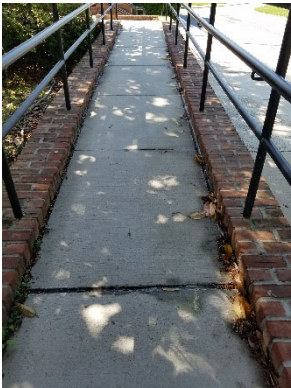
<p>The exterior ramp currently isn't fully ADA compliant.</p>	<p>●</p>		
<p>Recommendation:</p>	<p>Replace ADA ramp for full compliance.</p>

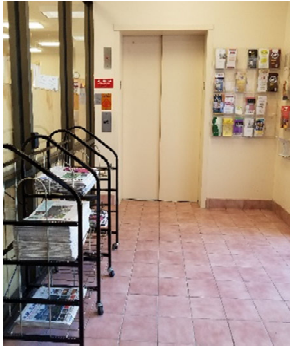
<p>#7-A, A11</p> <p>Elevator System</p>

<p>The current elevator is satisfactory, but requires resolving existing maintenance deficiencies.</p>

<p>Recommendation:</p>	<p>Resolve as recommended in the VDA, detailed report.</p>				
<p>#7-A, A12</p> <p>Potential Environmental & Hazardous Materials</p>

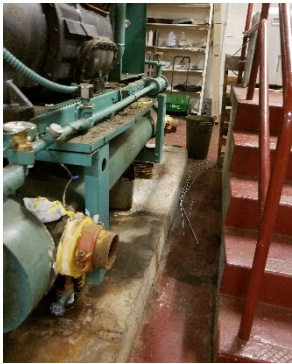
<p>Asbestos.</p>

<p>Recommendation:</p>	<p>Apex recommends using their report as a guide and contracting the services of an abatement contractor whose activities comply with applicable local, state and federal requirements.</p>				
<p>#7-A, A13.1</p> <p>Miscellaneous Hazards / Inefficiencies</p>

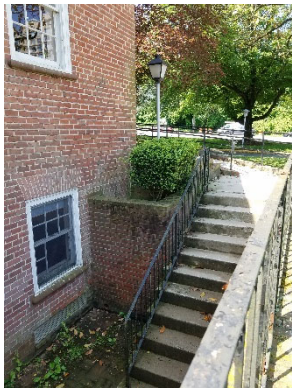
Moss build up on brick retaining wall.	●		
Recommendation	Clean brick joints. Treat for moss build up. Repoint brick.

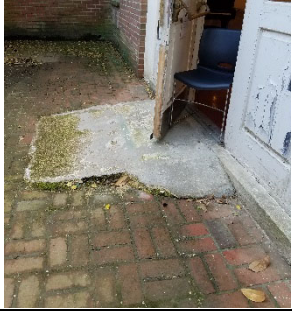
Exterior ramp.		<input checked="" type="checkbox"/>	
Recommendation	Replace with new ADA compliant landing & ramp.				
#8-A, N7.2 Exterior Brick Facade

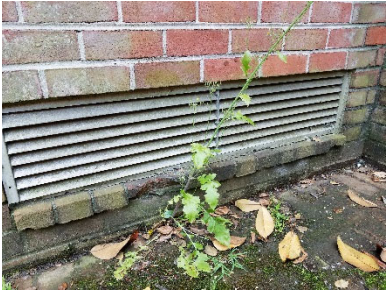
Exterior brick façade.		<input checked="" type="checkbox"/>	
Recommendation	Clean façade and paved surface. Replace broken brick with new. Treat efflorescence.

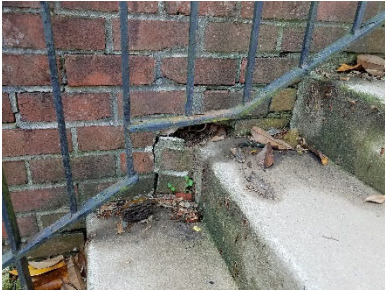
<p>#8-A, N8.</p> <p>Exterior Brick Retaining Wall</p>

<p>Cracked and missing bricks on exterior retaining wall.</p>

<p>Recommendation</p>	<p>Repair cracks, repoint brick, and replace cracked brick with new. Clean and repaint exterior handrail.</p>				
<p>#8-A, N9.</p> <p>Exterior Stair</p>

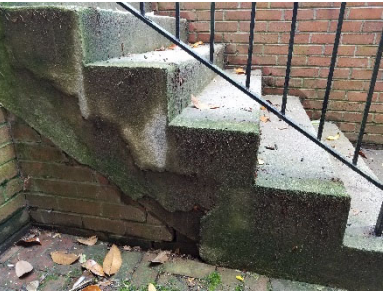
<p>Exterior stair.</p>

<p>Recommendation</p>	<p>Treat moss built area. Repair concrete stairway.</p>				
<p>#8-A, N10.</p> <p>Exterior Metal Handrails</p>

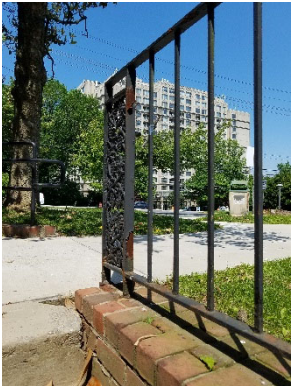
<p>Exterior metal handrails.</p>

<p>Recommendation</p>	<p>Clean and remove rust. Repaint with exterior paint.</p>

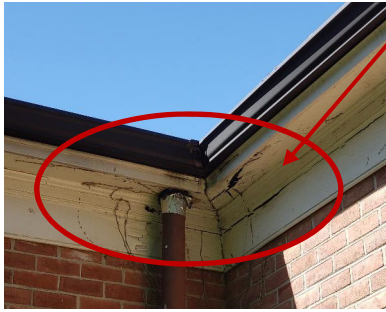
Building Facade & Category ID.	Image	Description	Timeline		
			Immediate	Necessary	Extended
#8-A, E1 Wood Trim

Condition of exposed painted wood at downspout	●		
Recommendation	All rotten wood to be replaced and weathered paint to be restored to match existing.				
#8-A, E2. Exterior Paving

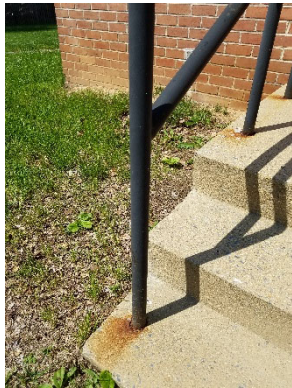
Metal handrail.	●		
Recommendation	Clean handrail and pipe surface. Repaint with exterior grade rust resistant paint. Provide escutcheon at post base.

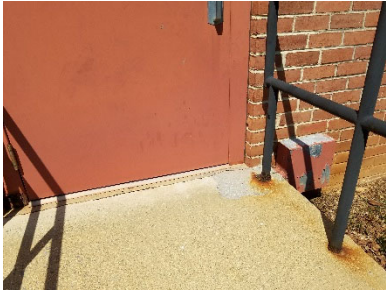
<p>#8-A, E4.</p> <p>Metal Handrail</p>

<p>Metal handrail.</p>

<p>Recommendation</p>	<p>Clean handrail and pipe surface. Repaint with exterior grade rust resistant paint. Provide escutcheon at post base.</p>				
<p>#8-A, E5.</p> <p>Exterior Utility Box(s)</p>

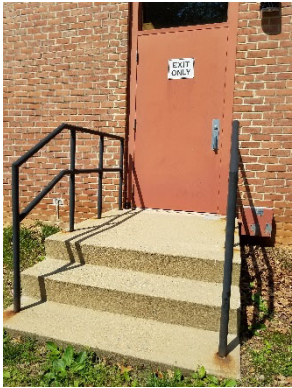
<p>Paint peeling off the exterior utility box.</p> <p>Exterior doors in poor condition.</p>

<p>Recommendation</p>	<p>Clean surface and repaint with exterior paint. Replace exterior doors.</p>				
<p>#8-A, E7.</p> <p>Bike Rack</p>

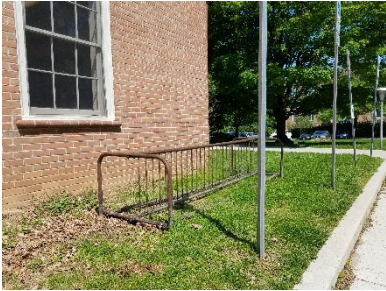
<p>Bike rack, old and corroded.</p>

<p>Recommendation</p>	<p>Provide with new bike rack.</p>

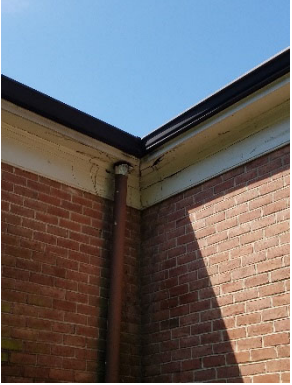
<p>Rain leads observed to be old.</p>	<p>●</p>		
<p>Recommendation</p>	<p>Replace with new rain leaders.</p>				
<p>#8-A, E10.</p> <p>Exterior Building Maintenance Pathways</p>

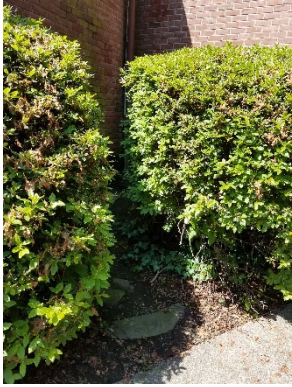
<p>Building maintenance path.</p>	<p>●</p>		
<p>Recommendation</p>	<p>Trim shrubs and maintain access building maintenance path, as part of regular facility maintenance item.</p>

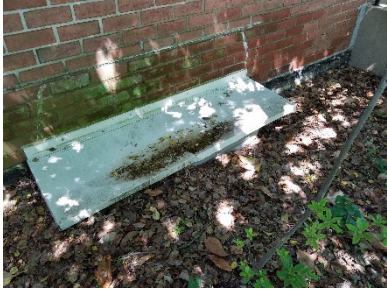
<p>#8-A, E11.</p> <p>Metal Awning</p>

<p>Water ponding at utility unit metal awning.</p> <p>Note: Stagnant water may cause corrosion and mosquito breeding.</p>

<p>Recommendation</p>	<p>Resolve issue.</p>				
<p>#8-A, E12.</p> <p>Exterior Building Lighting</p>

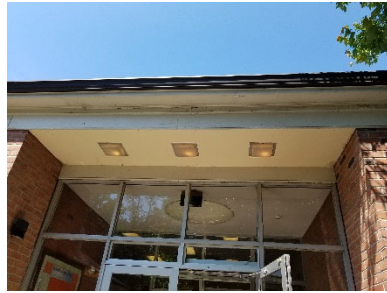
<p>Exterior building lighting.</p> <p>Note: Light fixtures working during daytime.</p>

<p>Recommendation</p>	<p>Resolve issue, as part of regular facility maintenance item.</p>				
<p>#8-A, E13.</p> <p>Egress Door(s).</p>

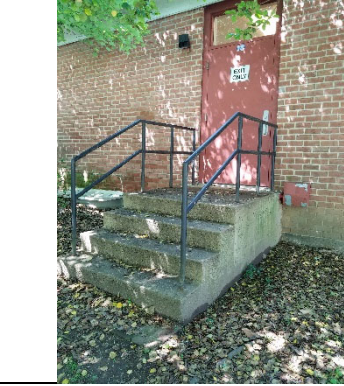
<p>Egress door.</p>

<p>Recommendation</p>	<p>Keep egress stair and landing area clean and clear as part of regular facility maintenance item.</p>

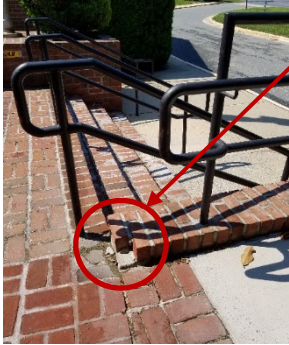
Location Identity: West					
Building Facade & Category ID.	Image	Description	Timeline		
			Immediate	Necessary	Extended
#8-A, W1. Entrance Podium

Brick curb.	●		
Recommendation	Redesign and replace the entrance podium.				
#8-A, W2. Flag Pole

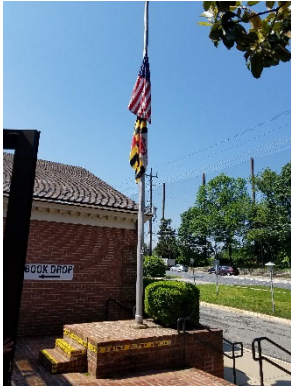
Flag pole.			●
Recommendation	Relocate/re-design flag pole podium.				
#8-A, W3. Exterior Egress Door

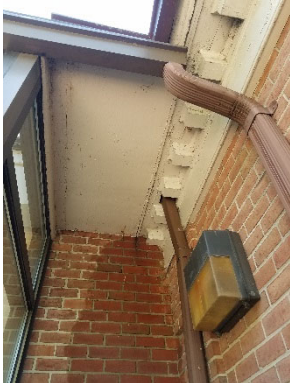
<div>#8-A, W2.</div> <div>Exterior Soffit</div>

Exterior soffit leakage.	<div><div></div></div>		
Recommendation	Investigate leak. Resolve issue. Repaint weathered exterior soffit surfaces.				
<div>#8-A, W7.</div> <div>Rain Leader(s)</div>

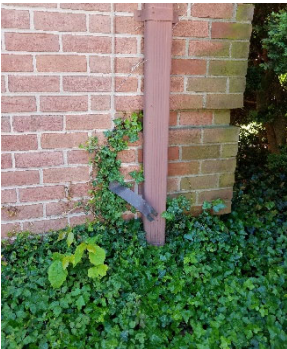
Rain leader.	<div><div></div></div>		
Recommendation	Replace rain leaders with new.

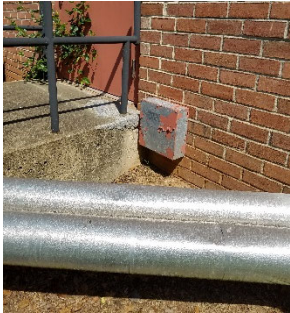
Exterior utility box, paint peeling off.			<input checked="" type="radio"/>
Recommendation	Clean and repaint with exterior grade paint.

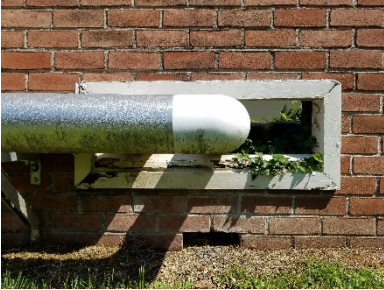
<p>Exterior wood trim.</p>			<p>●</p>
<p>Recommendation</p>	<p>Replace with new.</p>				
<p>#8-A, S4.</p> <p>Exterior Facade</p>

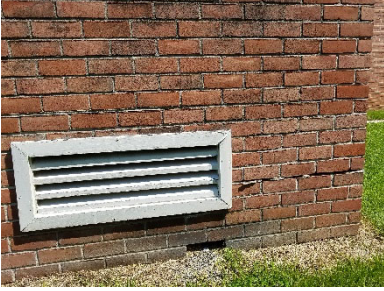
<p>Exterior facade.</p>			<p>●</p>
<p>Recommendation</p>	<p>Clean brick façade and treat for mold. Repoint and re-caulk brick joints.</p>				
<p>#8-A, S5.</p> <p>Exterior Brick Wall</p>

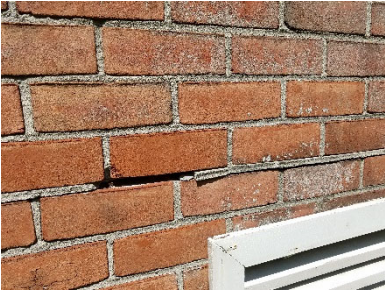
<p>Exterior brick wall.</p>			<p>●</p>
<p>Recommendation</p>	<p>Clean brick façade and treat for mold. Repoint and re-caulk brick joints.</p>

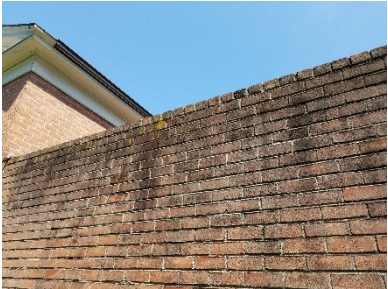
#8-A, S6. Exterior Brick Wall

Exterior brick wall.	<div></div>		
Recommendation	Clean brick façade and treat for mold. Repoint and re-caulk brick joints. Provide new coping at parapet.

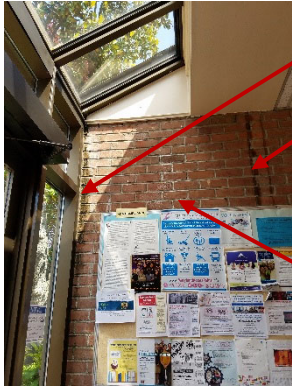
Water leakage. Discolored brick. Efflorescence on brick due to moisture creep.	●	●	●
Recommendation	Provide new storefront system and new standing seam metal roof. Clean and treat mold and mildew growth on interior brick.				
#9-A, 101-A5. Interior Partitions

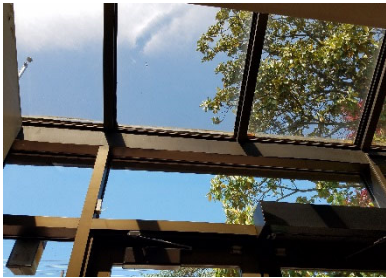
Entrance Vestibule Glazing is causing glare.		●	
Recommendation	Replace existing vestibule with new storefront system and new metal roof.

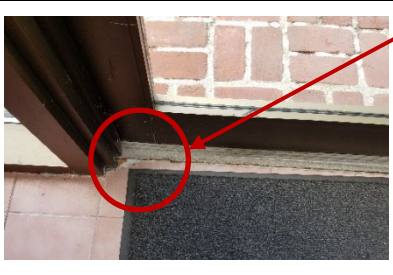
#9-A, 101-A7. Doors / Entranceways

Damaged floor tile and door threshold.		<input checked="" type="radio"/>	
Recommendation	Replace existing threshold with new.				
#9-A, 101-A8. Ceilings & Soffits

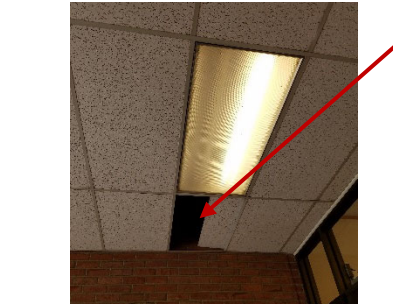
Ceiling tile out of place.	<input checked="" type="radio"/>		
Recommendation	Re-position ceiling tile within grid, as part of facility maintenance.				
#9-A, 101-A8. Ceilings & Soffits

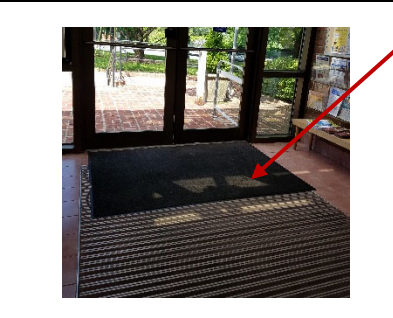
Add on mat placed on entry matting system – visually unpleasing and may cause a tripping hazard.	<input checked="" type="radio"/>		
Recommendation	Removing the loose mat. Check issues with existing entry matting system. If required replace with new.

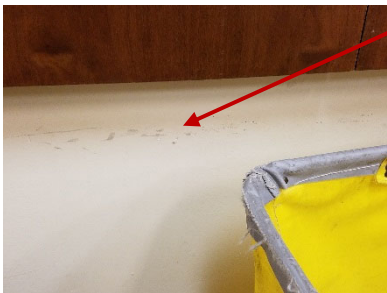
Paint peeling off.	●		
Recommendation	Clean affected area. Patch and paint to match adjacent color and finish.				
#9-A, 102-A8. Ceilings & Soffits

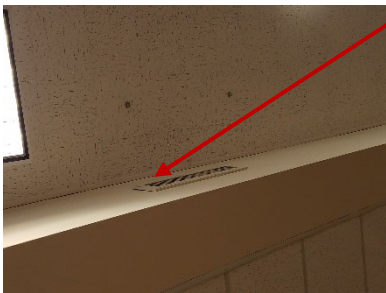
Mechanical grille not flush with wall. Grille looks old and dirty.	●		
Recommendation	Replace as appropriate.				
#9-A, 102-A8. Ceilings & Soffits

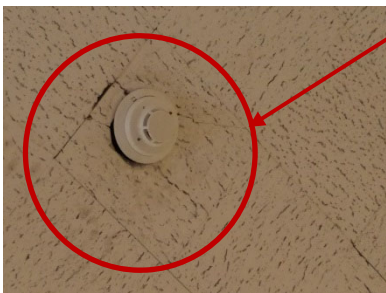
Lose smoke detector. Damaged ceiling tile.		●	
Recommendation	Replace ceiling tile and secure smoke detector. Recommend installing a new ceiling system with ceiling grid.

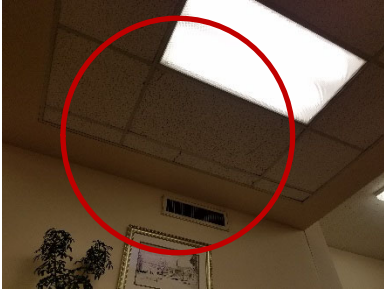
#9-A, 102-A8. Ceilings & Soffits

Damaged ceiling tiles.			<input checked="" type="radio"/>
Recommendation	Replace ceiling tile. Recommend installing a new ceiling system with ceiling grid. Ref. cost estimate section				
#9-A, 102-A9. Flooring

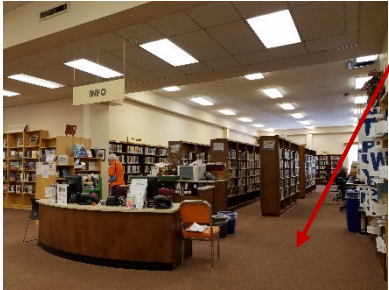
Worn-out carpet.	<input checked="" type="radio"/>		
Recommendation	Replace as appropriate with new flooring material.

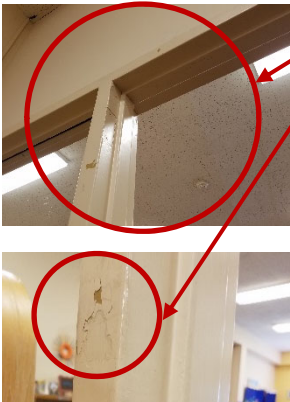
Paint peeling.	<input checked="" type="radio"/>		
Recommendation	Replace existing glazed partition with new.

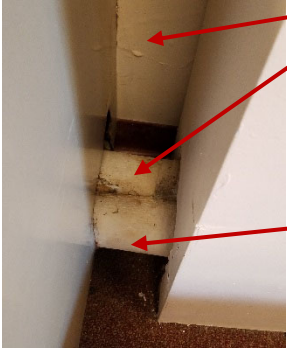
Paint peeling on the walls (and the A/C piping). Area under exposed pipes are causing dirt and dust collection.	●	●	
Recommendation	Replace fan coil unit with new (see mechanical report for additional information).				
#9-A, 103-A5. Interior Partitions

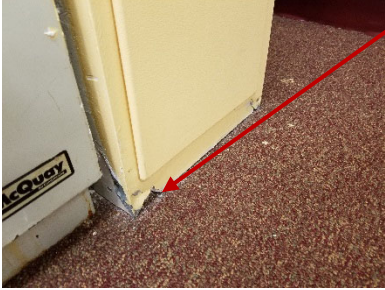
Paint peeling.	●		
Recommendation	Clean affected area. Patch and paint to match adjacent color and finish.				
#9-A, 103-A5. Interior Partitions

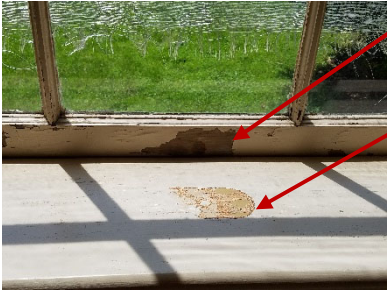
#9-A, 103-A6. Interior Glazing

Paint peeling. Dirty window sill(s).		● ●	
Recommendation	Replace windows and sills with new.				
#9-A, 103-A7. Doors / Entranceways

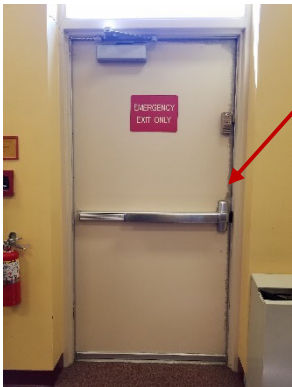
Emergency exit door paint is weathered.	●		
Recommendation	Replace with new egress doors.				
#9-A, 103-A7. Doors / Entranceways

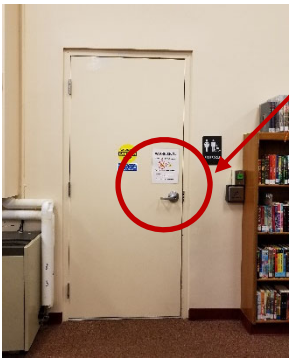
Uni-sex/family restroom door lock broken.	●		
Recommendation	Repair/replace lock.

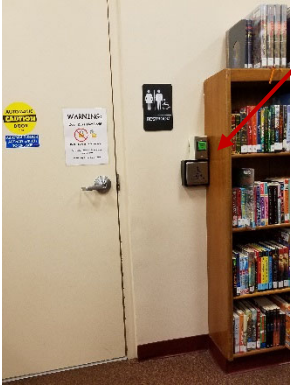
#9-A, 103-A7. Doors / Entranceways

ADA door activator clearance blocked by furniture.	<input checked="" type="checkbox"/>		
Recommendation	Clear area.				
#9-A, 103-A8. Ceilings & Soffits

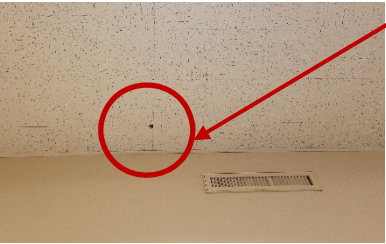
Chipped ceiling tile.			<input checked="" type="checkbox"/>
Recommendation	Installing a new ceiling system on a ceiling grid.				
#9-A, 103-A8. Ceilings & Soffits
