FACILITY ASSESSMENT FOR Chevy Chase Library

Contract No. 1082489
Sheladia & Associates Project No. 5522.004

Final Report

Date: 03/02/2021

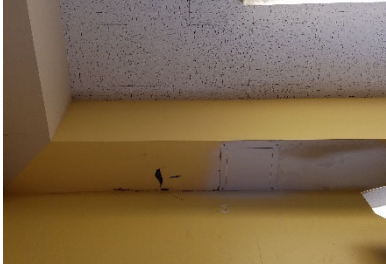
Cracked soffit, peeling paint, Unmatched paint colors.	<input checked="" type="checkbox"/>		
Recommendation	Clean affected area. Patch and paint to match adjacent color and finish.				
#9-A, 103-A9. Flooring

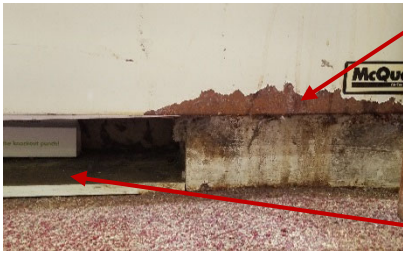
<p>#9-A, 103-A12.</p> <p>Potential environmental & hazardous materials</p>

<p>A/C unit is corroded and dirty. Area looks hazardous to children.</p> <p>Pest control placed under the unit.</p>	<p>●</p> <p>●</p>		
<p>Recommendation</p>	<p>Replace A/C units with new. Address pest control issues.</p>				
<p>#9-A, 103-A13.</p> <p>Miscellaneous Hazards / Inefficiencies</p>

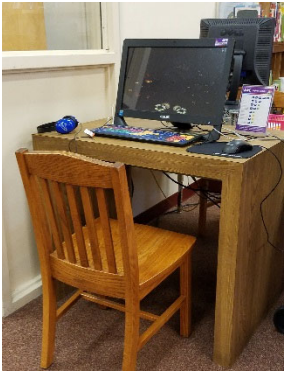
<p>Furniture is non-adjustable and unsuitable for child size use, i.e., table, chair, keyboard tray.</p>	<p>●</p>		
<p>Recommendation</p>	<p>Replace with new adjustable user-friendly computer stations.</p>				
<p>#9-A, 103-A13.</p> <p>Miscellaneous Hazards / inefficiencies</p>

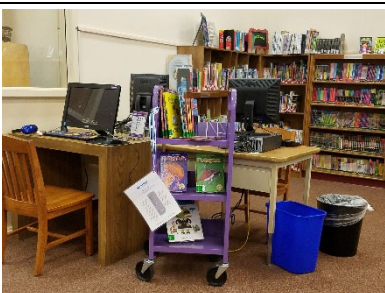
<p>Exposed wires and adjacent loose furniture may cause tripping and other dangerous conditions to children.</p>	<p>●</p>		
<p>Recommendation</p>	<p>Reconsider furniture arrangement and wire management.</p>				
<p>#9-A, 103-A13.</p> <p>Miscellaneous Hazards / inefficiencies</p>

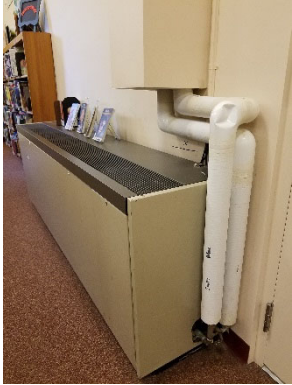
<p>Exposed pipes.</p>	<p>●</p>		
<p>Recommendation</p>	<p>Install new system (see Mechanical report for additional information).</p>				
<p>#9-A, 103-A13.</p> <p>Miscellaneous Hazards / inefficiencies</p>

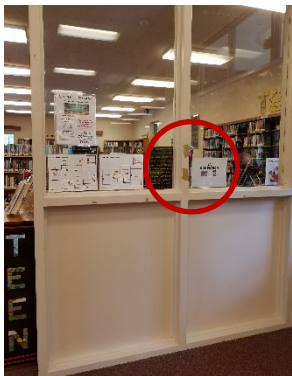
Peeling paint.	●		
Recommendation	Replace existing with new glazed partition.				
#9-A, 104-A5. Interior Partitions

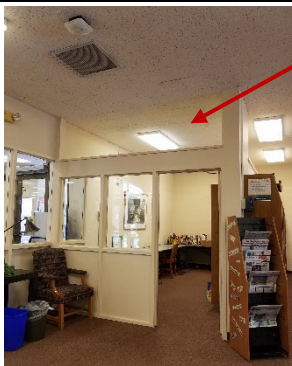
Sound tends to travel out of this room due to low walls.	●		
Recommendation	Extend partition above ceiling.

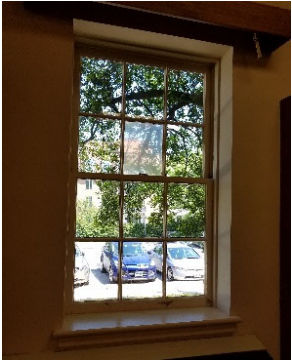
#9-A, 104-A6. Window blinds

Window blinds seem to have been provided, but are currently missing.	<input checked="" type="checkbox"/>		
Recommendation	Investigate if window glare is caused in this space and provide window blinds if required.				
#9-A, 104-A8. Ceilings & Soffits

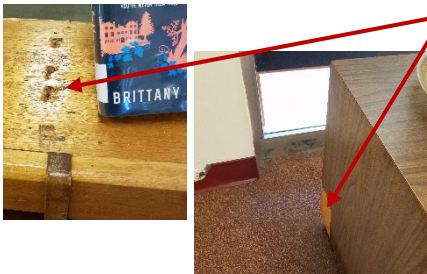
Damaged wood.		<input checked="" type="checkbox"/>	
Recommendation	Refurbish or replace with new.

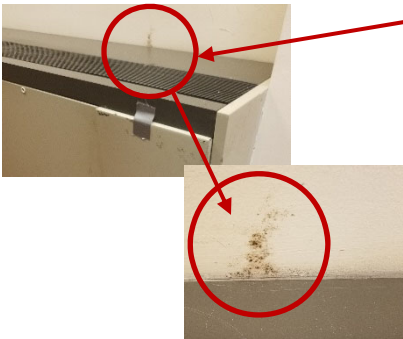
RM # & Architectural System	Image	Description	Timeline		
			Immediate	Necessary	Extended
#9-A, 105-A5. Interior Partitions

Mold growth on wall.	●		
Recommendation	Investigate moisture source. Repair issue. Patch and paint to match adjacent color and finish.				
#9-A, 105-A5. Interior Partitions

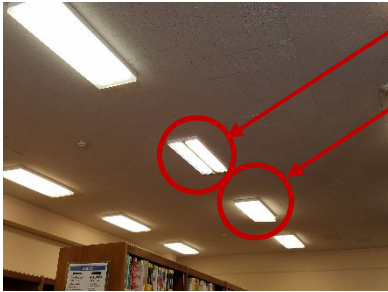
<p>#9-A, 105-A8.</p> <p>Ceilings & Soffits</p>

<p>Missing light fixture cover.</p> <p>Lose light fixture cover</p>	<p>●</p> <p>●</p>		
<p>Recommendation</p>	<p>Provide new cover to missing area. Secure the cover in the other fixture. Suggest replacing surface mounted light fixtures with new recessed type as part of new ceiling replacement.</p>				
<p>#9-A, 105-A9.</p> <p>Flooring</p>	 	<p>Existing carpet is old and battered.</p>	<p>●</p>		
<p>Recommendation</p>	<p>Replace with new flooring material.</p>				
<p>#9-A, 105-A13.</p> <p>Miscellaneous Hazards / inefficiencies</p>

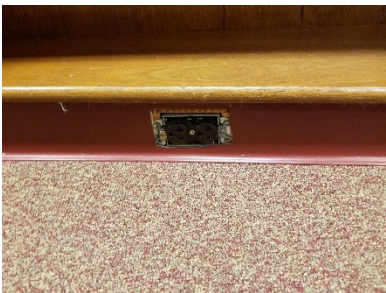
<p>Missing electrical outlet cover plate.</p>	<p>●</p>

<p>Recommendation</p>	<p>Provide new cover to missing area.</p>

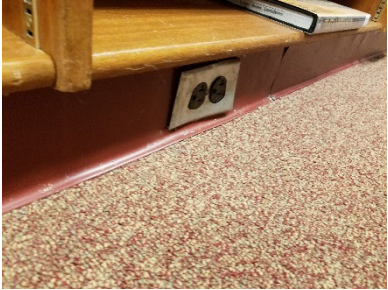
Damaged electrical outlet cover plate.	<input checked="" type="radio"/>		
Recommendation	Replace with new.				
#9-A, 105-A13. Miscellaneous Hazards / inefficiencies

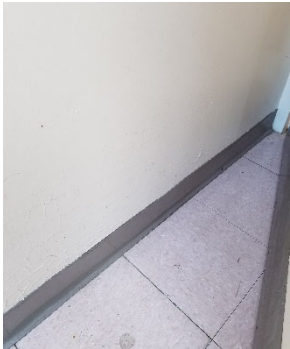
RM # & Architectural System	Image	Description	Timeline		
			Immediate	Necessary	Extended
#9-A, 107-A5. Interior Partition

Cracked wall paint behind main level interior door.	<input checked="" type="radio"/>		
Recommendation	Clean area, re-paint to match existing color and finish. Refer to the cost estimate section

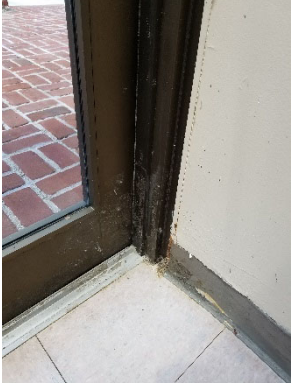
<p>Damaged wall base.</p>	<p>●</p>		
<p>Recommendation</p>	<p>Remove existing rubber base. Replace with new to match adjacent existing base. Refer to the cost estimate section</p>				
<p>#9-A, 107-A5.</p> <p>Interior Partition</p>

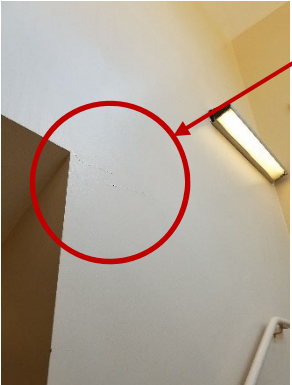
<p>Hairline cracks in wall.</p>	<p>●</p>		
<p>Recommendation</p>	<p>Identify settlement issue if any. Patch, repair and paint to match adjacent color and finish. Refer to the cost estimate section</p>				
<p>#9-A, 107-A5.</p> <p>Interior Partition</p>

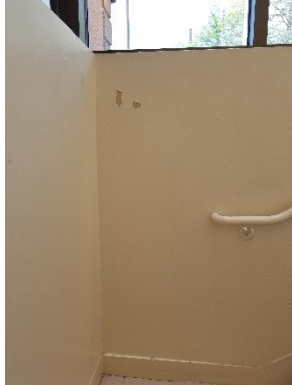
<p>Peeling paint.</p>	<p>●</p>		
<p>Recommendation</p>	<p>Clean area, re-paint to match existing color and finish. Refer to the cost estimate section</p>

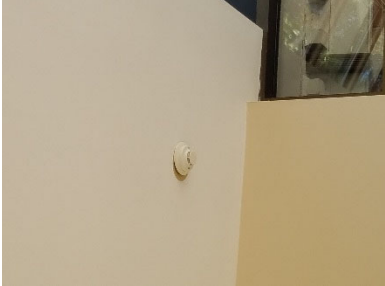
#9-A, 107-A5. Interior Partition

Missing paint area.

Recommendation	Clean area, re-paint to match existing color and finish. Refer to the cost estimate section				
#9-A, 107-A7. Doors / Entranceways

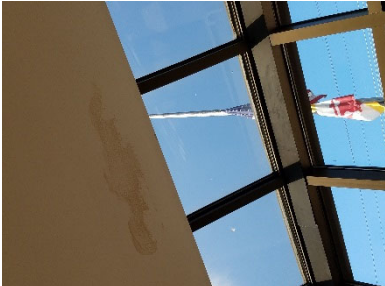
Moisture damaged soffit.

Recommendation	Identify moisture causing source. Repair issue. Clean area, re-paint to match existing color and finish. Refer to the cost estimate section

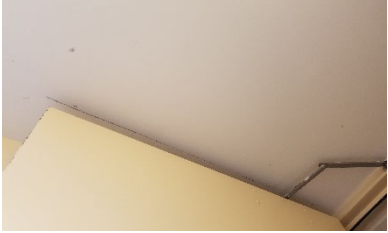
#9-A, 107-A8. Ceilings & Soffits

Pen/pencil marks on ceiling.	 		
Recommendation	Clean area, re-paint to match existing color and finish. Refer to the cost estimate section				
#9-A, 107-A9. Flooring	 	Weathered flooring material.	 		
Recommendation	Replace with new VCT. Refer to the cost estimate section				
#9-A, 107-A9. Flooring

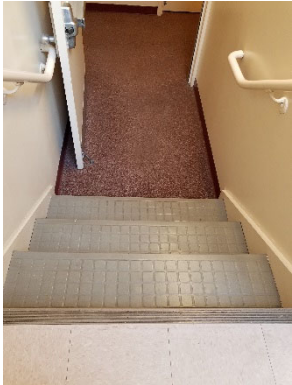
Old and weathered carpet material.

Recommendation	Replace with new flooring material. Refer to the cost estimate section

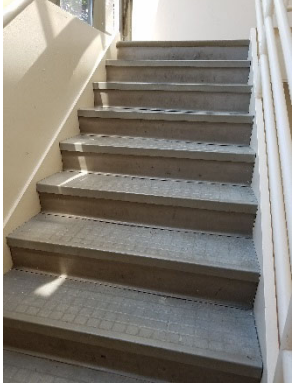
Weathered flooring material on steps.	<input checked="" type="radio"/>		
Recommendation	Replace with new non-skid flooring material. Refer to the cost estimate section				
#9-A, 107-A10. Stairs & ramps

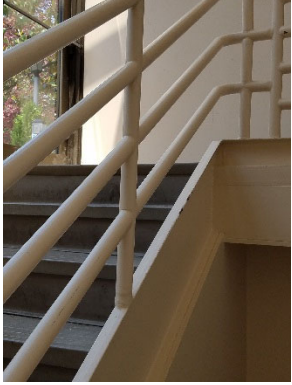
Missing paint.	<input checked="" type="radio"/>		
Recommendation	Clean area, re-paint to match existing color and finish. Refer to the cost estimate section				
#9-A, 107-A10. Stairs & ramps

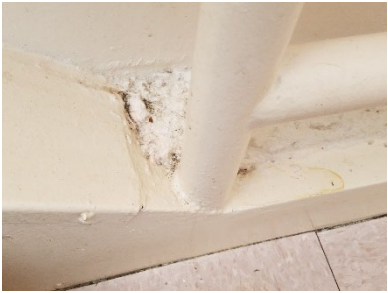
Paint coat applied over crude concrete/rust.		<input checked="" type="radio"/>	
Recommendation	Clean area, re-paint to match existing color and finish. Refer to the cost estimate section

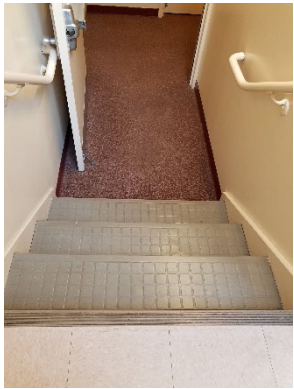
In sufficient space for an area of refuge within stair wall.

Recommendation	Suggest investigating options to improve existing condition. Refer to the cost estimate section				
#9-A, 107-A13. Miscellaneous Hazards / inefficiencies

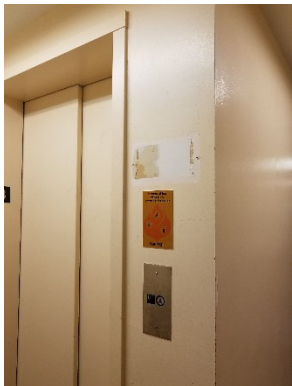
RM # & Architectural System	Image	Description	Timeline		
			Immediate	Necessary	Extended
#9-A, G101-A5. Interior Partitions

Area requires paint touch up and new signage.	●		
Recommendation	Clean area. Patch and repaint surface to match adjacent color & finish. Refer to the cost estimate section				
#9-A, G101-A5. Interior Partitions

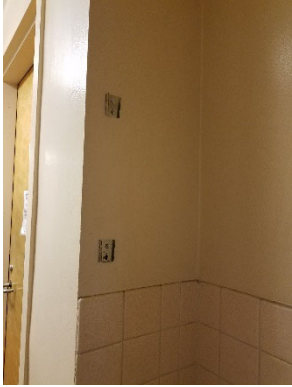
<p>#9-A, G101-A5.</p> <p>Interior Partitions</p>

<p>Unused wall attachments.</p>	<p>●</p>		
<p>Recommendation</p>	<p>Remove unused wall attachments.</p>				
<p>#9-A, G101-A7.</p> <p>Doors / entranceways</p>

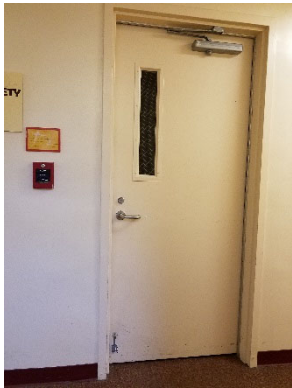
<p>Dirty door bottom.</p>	<p>●</p>		
<p>Recommendation</p>	<p>Provide a door kick plate.</p>				
<p>#9-A, G101-A7.</p> <p>Doors / entranceways</p>

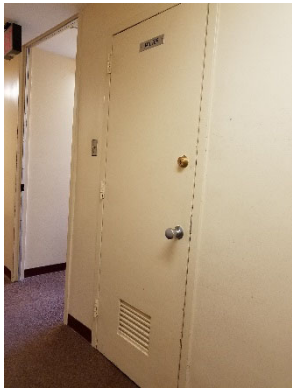
<p>Janitor room door bottom damaged.</p>	<p>●</p>		
<p>Recommendation</p>	<p>Replace door with new to match existing. Provide a door kick plate.</p>

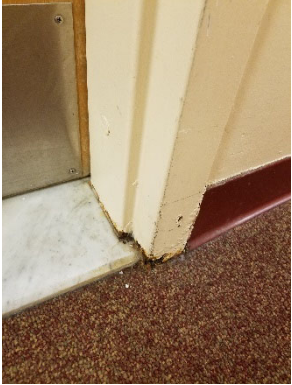
<p>#9-A, G101-A7.</p> <p>Doors / entranceways</p>

<p>Corrosion presence at door frame bottom.</p>	<p>●</p>		
<p>Recommendation</p>	<p>Clean area. Patch dents and repaint to match adjacent color & finish.</p>				
<p>#9-A, G101-A8.</p> <p>Ceilings & soffits</p>

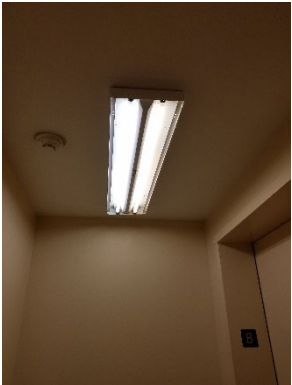
<p>Missing light fixture cover.</p>	<p>●</p>		
<p>Recommendation</p>	<p>Suggest installing new light fixture cover.</p>				
<p>#9-A, G101-A8.</p> <p>Ceilings & soffits</p>

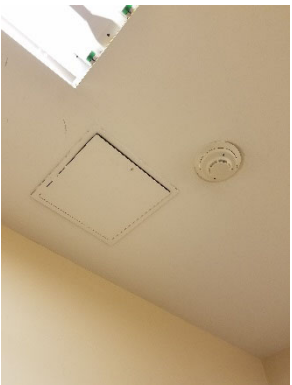
<p>Lose access panel.</p>	<p>●</p>		
<p>Recommendation</p>	<p>Install new access panel flushed with ceiling surface.</p>

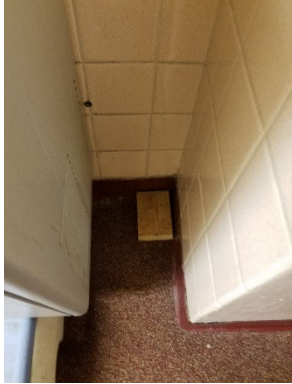
Lose wood block on floor.	<input checked="" type="radio"/>		
Recommendation	Remove and clean floor surface.				
#9-A, G101-A9. Flooring

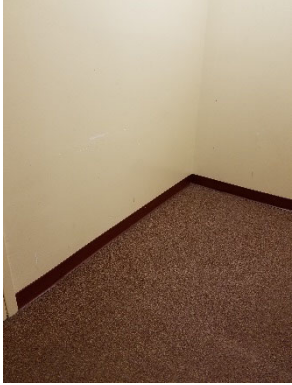
Carpet looks old.	<input checked="" type="radio"/>		
Recommendation	Replace with new floor finish.

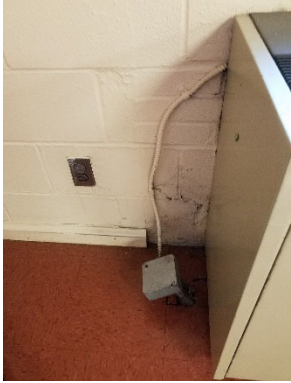
<p>#9-A, G102-A7.</p> <p>Miscellaneous Hazards / inefficiencies</p>

<p>Dirty walls.</p>	<p>●</p>		
<p>Recommendation</p>	<p>Clean surface.</p>				
<p>#9-A, G104-A5.</p> <p>Interior Partitions</p>

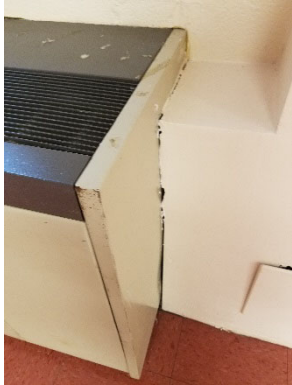
<p>Partition to mechanical unit transition/seal.</p>	<p>●</p>		
<p>Recommendation</p>	<p>Replace crude work with clean transition joint/seal.</p>				
<p>#9-A, G104-A5.</p> <p>Interior Partitions</p>

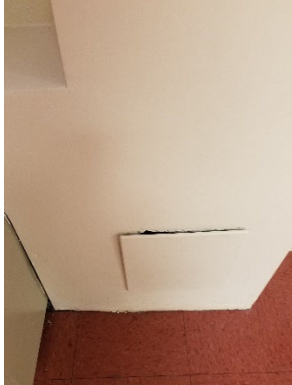
<p>Access panel on partition.</p>	<p>●</p>		
<p>Recommendation</p>	<p>Replace with new to type installed flushed with wall.</p>

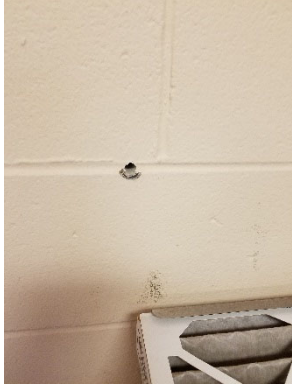
#9-A, G104-A5. Interior Partitions

Hole in CMU wall.	<input checked="" type="checkbox"/>		
Recommendation	Caulk hole in CMU wall. Paint to match adjacent color & finish.				
#9-A, G104-A6. Interior Glazing

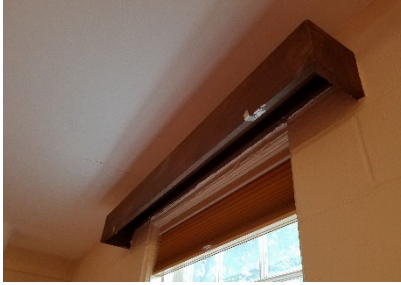
Window blind trim.	<input checked="" type="checkbox"/>		
Recommendation	Remove dirt and refinish.				
#9-A, G104-A7. Doors / entranceways	 	Door frame and sash requires new paint coat.	<input checked="" type="checkbox"/>		
Recommendation	Clean surface. Paint to match adjacent color & finish.				
#9-A, G104-A7. Doors / entranceways

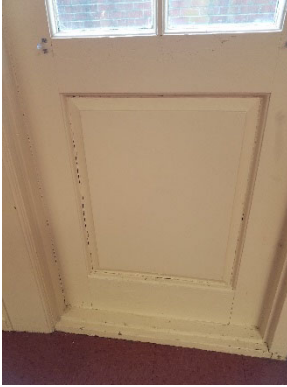
Old exterior door sidelite.	<input checked="" type="checkbox"/>		
Recommendation	Replace with new.

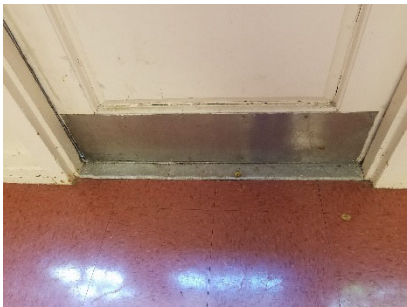
<p>Door threshold.</p>		 	
<p>Recommendation</p>	<p>Replace with new.</p>				
<p>#9-A, G104-A8.</p> <p>Ceilings & soffits</p>

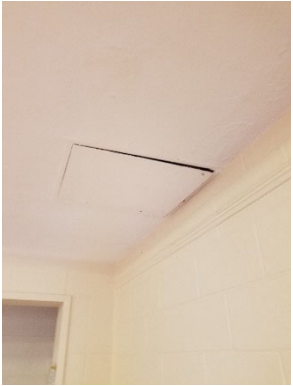
<p>Old and lose access panel.</p>		 	
<p>Recommendation</p>	<p>Replace with new.</p>

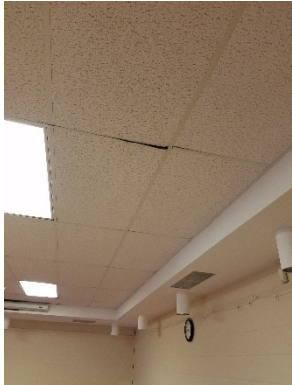
<p>Ceiling grid detaching.</p>

<p>Recommendation</p>	<p>Replace with new.</p>				
<p>#9-A, G104-A8.</p> <p>Ceilings & soffits</p>

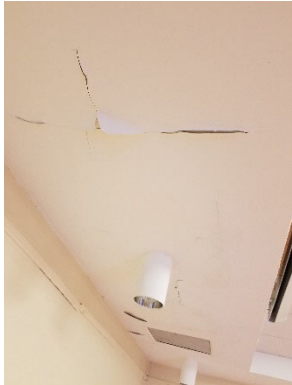
<p>Paint peeling off ceiling.</p>

<p>Recommendation</p>	<p>Resolve moisture presence with adequate damp proofing methods. Clean and repaint surface.</p>				
<p>#9-A, G104-A9.</p> <p>Flooring</p>

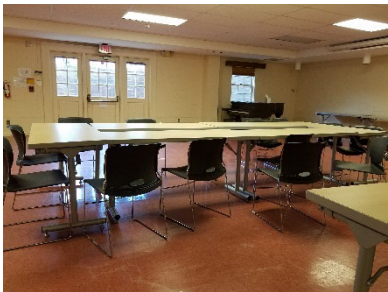
<p>Old flooring material.</p>

<p>Recommendation</p>	<p>Replace with new.</p>

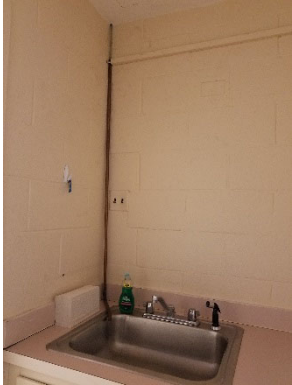
<p>A/C condensation water released to hand sink.</p>

<p>Recommendation</p>	<p>Resolve existing condition.</p>				
<p>#9-A, G104-A13.</p> <p>Miscellaneous Hazards / inefficiencies</p>

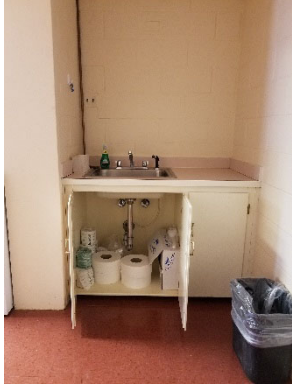
<p>Sink is not ADA accessible.</p>

<p>Recommendation</p>	<p>Resolve condition to provide ADA accessible sink and millwork.</p>				
<p>#9-A, G104-A13.</p> <p>Miscellaneous Hazards / inefficiencies</p>

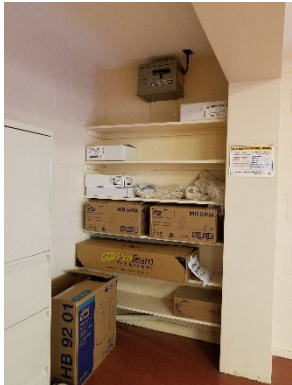
<p>Exposed storage shelves.</p>

<p>Recommendation</p>	<p>Provide storage closet doors to conceal storage.</p>

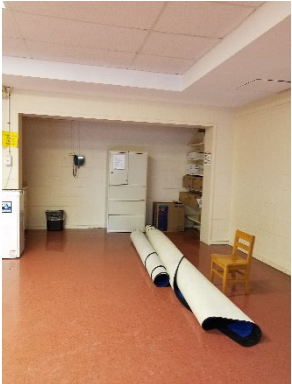
Random items, i.e. lose carpet role, stored in room.

Recommendation	Resolve existing condition. Proper long-term storage required for lose furniture.				
#9-A, G104-A13. Miscellaneous Hazards / inefficiencies

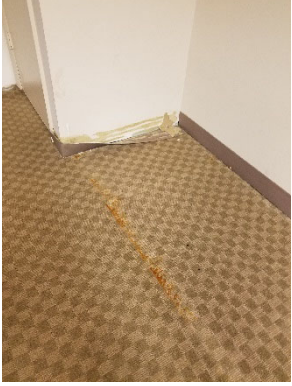
Wall base peeling off.	<input checked="" type="radio"/>		
Recommendation	Replace with new.				
#9-A, G105-A5. Interior Partitions

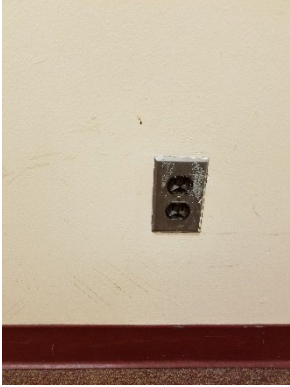
Dirty walls and electrical outlet.	<input checked="" type="radio"/>		
Recommendation	Provide new paint coat. Replace electrical face plate with new.				
#9-A, G105-A5. Interior Partitions

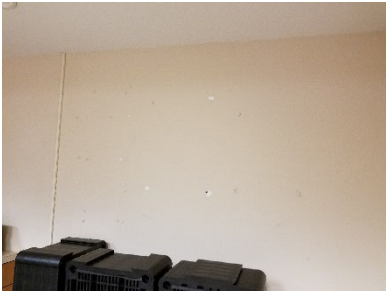
Dirty walls.	<input checked="" type="radio"/>		
Recommendation	Repaint existing walls.

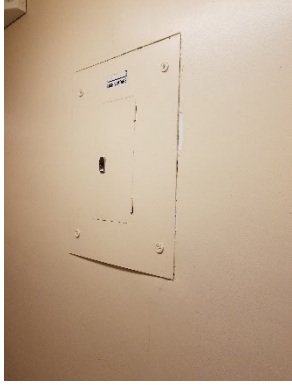
<p>High voltage electrical panel.</p>	<p>●</p>		
<p>Recommendation</p>	<p>Provide prominent sign noting 'high voltage'. Current sign is small. Patch and paint area around face panel.</p>				
<p>#9-A, G105-A5.</p> <p>Interior Partitions</p>

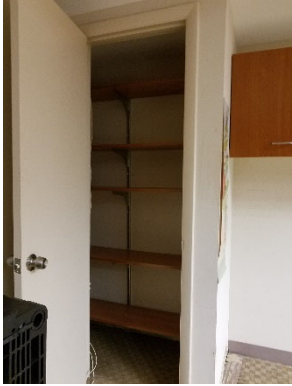
<p>Current storage closet in fully accessible due to inefficient layout.</p>	<p>●</p>		
<p>Recommendation</p>	<p>Redesign the storage closet for better use.</p>				
<p>#9-A, G105-A7.</p> <p>Doors / entranceways</p>

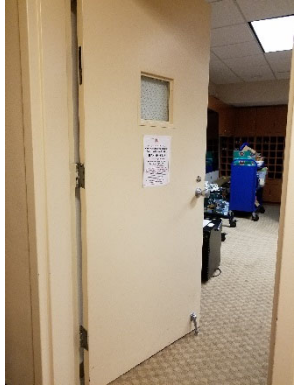
<p>Door not provided with foot plate.</p> <p>Room requires signage indicating room name.</p>	<p>●</p> <p>●</p>		
<p>Recommendation</p>	<p>Provide new foot plate.</p>

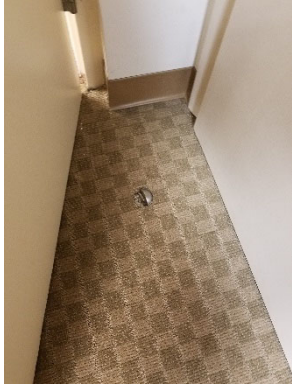
<p>#9-A, G105-A7.</p> <p>Doors / entranceways</p>

<p>Old door stop.</p>	<p>●</p>		
<p>Recommendation</p>	<p>Replace with new.</p>				
<p>#9-A, G105-A8.</p> <p>Ceilings & soffits</p>

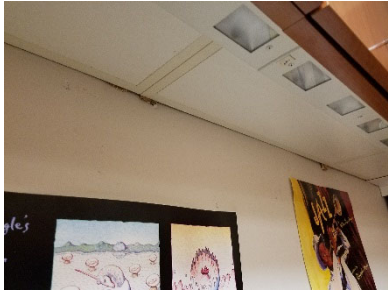
<p>Unsightly wood wedges inserted between face of wall and edge of ceiling.</p>	<p>●</p>		
<p>Recommendation</p>	<p>Investigate reason, fix issue and remove temporary wood wedges.</p>				
<p>#9-A, G105-A9.</p> <p>Flooring</p>

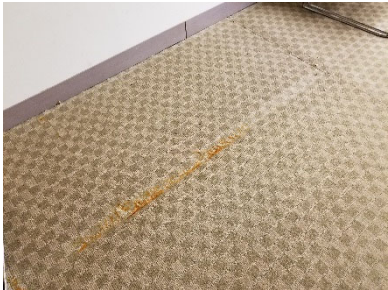
<p>Stained carpet.</p>	<p>●</p>		
<p>Recommendation</p>	<p>Deep clean carpet. Alternately replace with new flooring.</p>

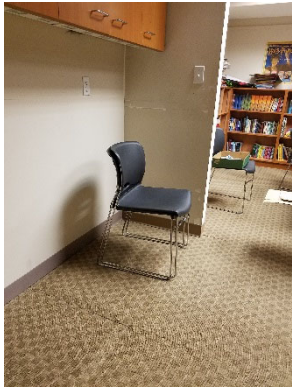
<p>Missing base cabinet.</p>	<p>●</p>		
<p>Recommendation</p>	<p>Provide new base cabinet. Current condition if unnoticed may cause head injury from sitting to standing position.</p>				
<p>#9-A, G105-A13.</p> <p>Miscellaneous Hazards / inefficiencies</p>

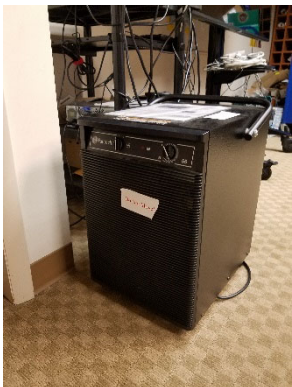
<p>Dehumidifier in room.</p>	<p>●</p>		
<p>Recommendation</p>	<p>This equipment functions 24/7. Investigate moisture presence and fix issues to create space and energy efficiency.</p>				
<p>#9-A, G105-A13.</p> <p>Miscellaneous Hazards / inefficiencies</p>

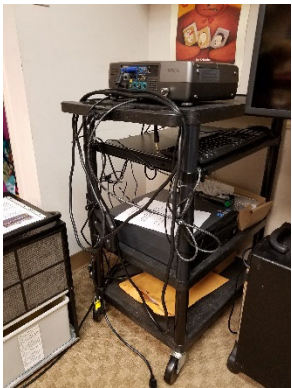
<p>Unightly technology equipment storage.</p>	<p>●</p>		
<p>Recommendation</p>	<p>Organize room for better space efficiency.</p>

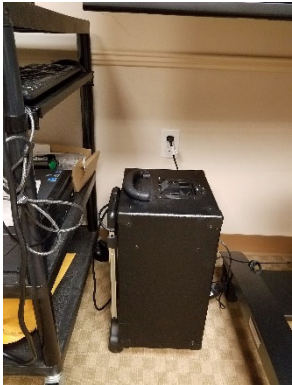
<p>Additional equipment placed at room perimeter seems to reduce usable room space.</p>	<p>●</p>		
<p>Recommendation</p>	<p>Organize room for better space efficiency.</p>				
<p>#9-A, G105-A13.</p> <p>Miscellaneous Hazards / inefficiencies</p>

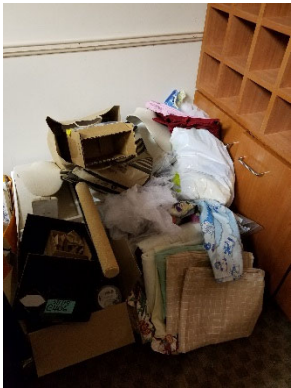
<p>Random storage.</p>	<p>●</p>		
<p>Recommendation</p>	<p>Organize room for better space efficiency. Create efficient storage areas.</p>				
<p>#9-A, G105-A13.</p> <p>Miscellaneous Hazards / inefficiencies</p>	 	<p>Lose trash and recycling bins.</p>	<p>●</p>		
<p>Recommendation</p>	<p>Create designated area, i.e., built-in millwork to house trash & recycling bins in lieu of lose bins which is unsightly and creates clutter.</p>

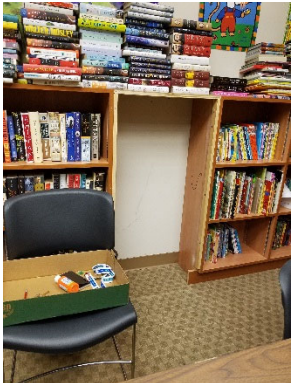
Book storage shelves.	<input checked="" type="radio"/>		
Recommendation	Provide efficient book storage shelves and re-organize room for better space efficiency.				
#9-A, G105-A13. Miscellaneous Hazards / inefficiencies

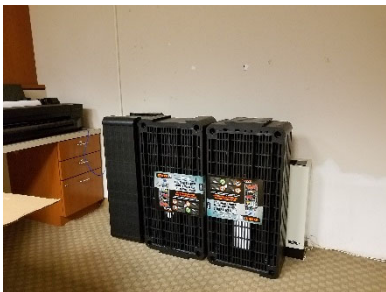
Random storage items blocking A/C unit.	<input checked="" type="radio"/>		
Recommendation	De-clutter room. Re-organize room for better space efficiency.

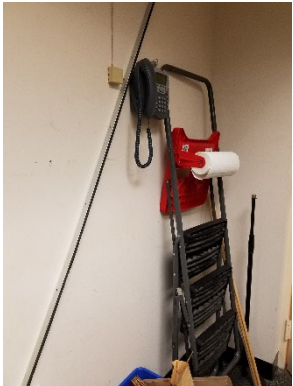
<p>Lose material and equipment randomly placed.</p> <p>Storage room is very cluttered and disorganized.</p>	<p>●</p>		
<p>Recommendation</p>	<p>Create designated storage areas to efficiently use available storage.</p>				
<p>#9-A, G106-A13.</p> <p>Miscellaneous Hazards / inefficiencies</p>

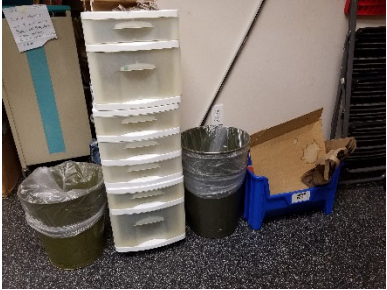
<p>Lose material and equipment randomly placed.</p> <p>Storage room is very cluttered and disorganized.</p>	<p>●</p>		
<p>Recommendation</p>	<p>Provide efficient book storage shelves and re-organize room for better space efficiency.</p>				
<p>#9-A, G106-A13.</p> <p>Miscellaneous Hazards / inefficiencies</p>

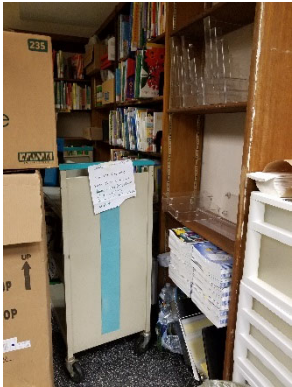
<p>Book storage shelves inaccessible.</p> <p>Storage room is very cluttered and disorganized.</p>	<p>●</p>		
<p>Recommendation</p>	<p>De-clutter room. Provide designated and efficient storage racks. Re-organize room for better space efficiency.</p>

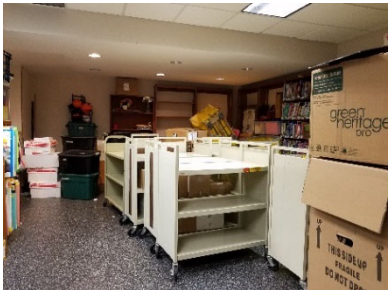
Lose material and equipment randomly placed. Storage room is very cluttered and disorganized.	<input checked="" type="radio"/>		
Recommendation	Create designated storage areas to efficiently use available storage.				
#9-A, G106-A13. Miscellaneous Hazards / inefficiencies

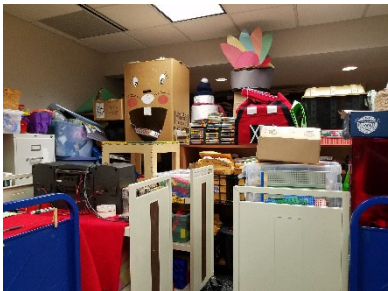
Lose material and equipment randomly placed. Storage room is very cluttered and disorganized.	<input checked="" type="radio"/>		
Recommendation	Create designated storage areas to efficiently use available storage.

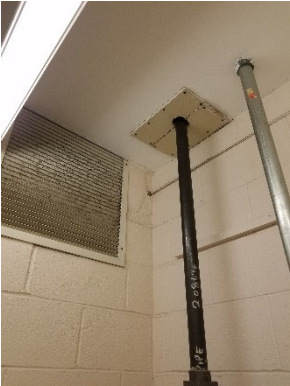
<p>Dirty air grille.</p>	<p>●</p>		
<p>Recommendation</p>	<p>Clean grille as part of regular facility maintenance program.</p>				
<p>#9-A, G107-A7.</p> <p>Doors / entranceways</p>

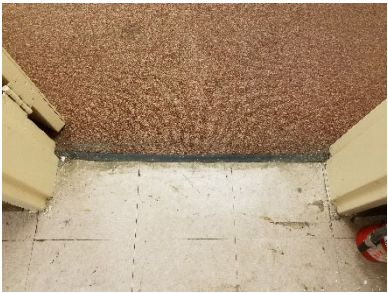
<p>Dirty door threshold area.</p>	<p>●</p>		
<p>Recommendation</p>	<p>Replace flooring material with new.</p>

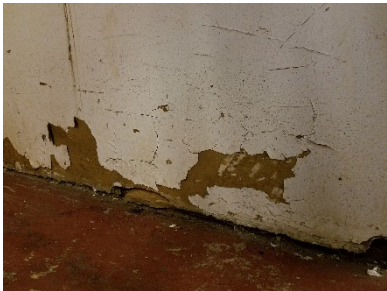
RM # & Architectural System	Image	Description	Timeline		
			Immediate	Necessary	Extended
#9-A, G108-A5. Interior Partitions

Peeling paint. Missing drywall at bottom of wall. No wall base.	<input checked="" type="radio"/>		
Recommendation	Repair wall. Re-paint walls with appropriate paint type.				
#9-A, G108-A5. Interior Partitions

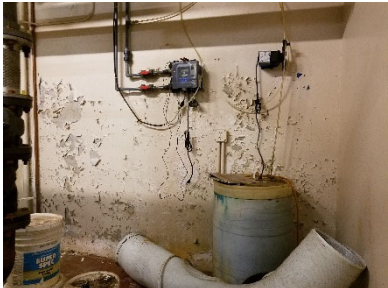
Peeling paint due to possible moisture presence. Condition is consistent throughout wall perimeter walls and interior walls in the space.	<input checked="" type="radio"/>		
Recommendation	Investigate and fix issue. Re-paint walls with appropriate paint type.

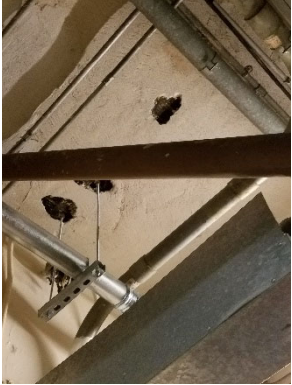
<p>Un-caulked ceiling/soffit penetrations.</p>

<p>Recommendation</p>	<p>Re-caulk ceiling openings with fireproofed caulking.</p>				
<p>#9-A, G108-A9.</p> <p>Flooring</p>

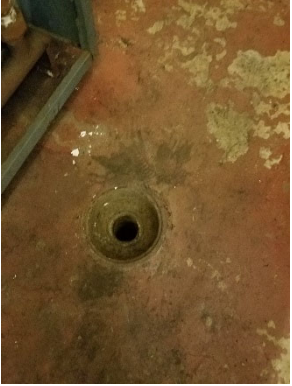
<p>Floor paint peeling.</p> <p>Missing floor drain grate.</p>

<p>Recommendation</p>	<p>Re-paint floor with appropriate paint type. Provide floor drain grate.</p>

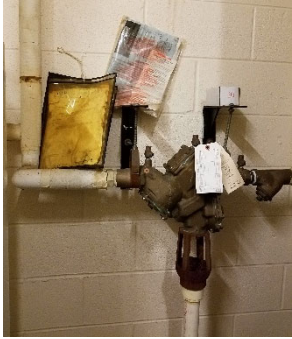
<p>Equipment and maintenance manuals.</p>			●
<p>Recommendation</p>	<p>Appropriately store these, as part of regular facility maintenance item.</p>				
<p>#9-A, G108-A13.</p> <p>Miscellaneous Hazards / inefficiencies</p>

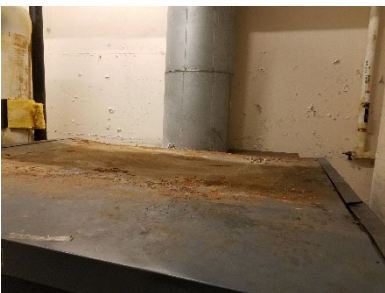
<p>Rust damage on Equipment.</p>			●
<p>Recommendation</p>	<p>Clean surface areas and maintain Equipment, as part of regular facility maintenance item.</p>

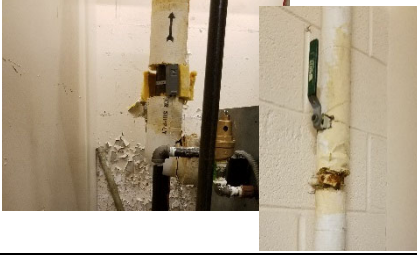
<p>#9-A, G108-A8.</p> <p>Ceilings & soffits</p>

<p>Pipe insulation opened up.</p> <p>Wall clamps rusting</p>			●
<p>Recommendation</p>	<p>Fix as appropriate, as part of regular facility maintenance item.</p>				
<p>#9-A, G108-A9.</p> <p>Flooring</p>

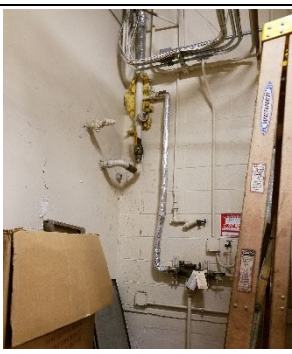
<p>Storage items.</p>			●
<p>Recommendation</p>	<p>Re-consider how lose items are stored within the mechanical room, as part of regular facility maintenance item.</p>

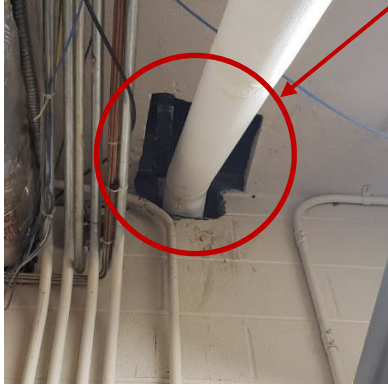
Picture #	Image	Description	Timeline		
			Immediate	Necessary	Extended
#10-B, B1.3 Mechanical and Equipment Room

Pipe penetration through the wall without proper fire proofing	●		
#10-B, B1.4 Mechanical and Equipment Room

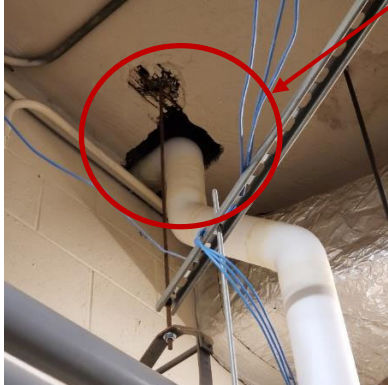
Pipe penetration through the wall without proper fire proofing.	●		
#10-B, B1.5 Mechanical and Equipment Room

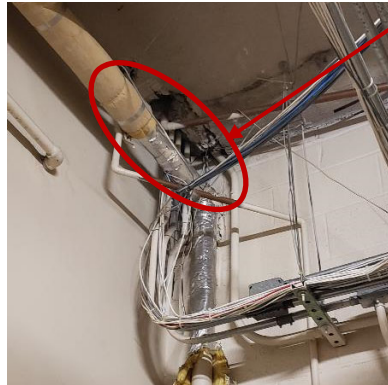
Pipe penetration through the wall without proper fire proofing.	●

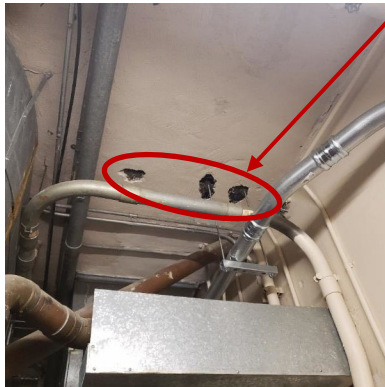
Picture #	Image	Description	Timeline		
			Immediate	Necessary	Extended
#10-B, B1.6 Mechanical and Equipment Room

Holes made in the ceiling without proper fire proofing.	●		
#10-B, B1.7 Mechanical and Equipment Room

Holes made in the ceiling without proper fire proofing.	●		
Recommendation:	Properly fill and patch existing holes in ceiling and walls to meet building fireproofing requirements. Also, see architectural recommendations.

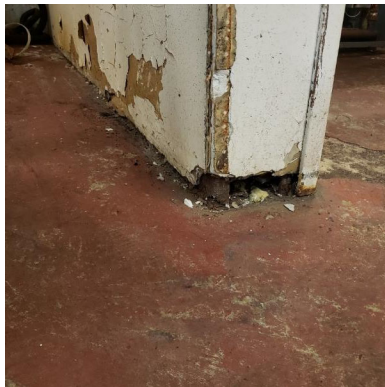
Picture #	Image	Description	Timeline		
			Immediate	Necessary	Extended
#10-B, B1.8 Mechanical and Equipment Room

Damage to base of partition wall.	●		
#10-B, B1.9 Mechanical and Equipment Room

Damage to base of partition wall.	●		
Recommendation:	Patch the wall at the base using cement plaster and paint to match with the existing wall color.

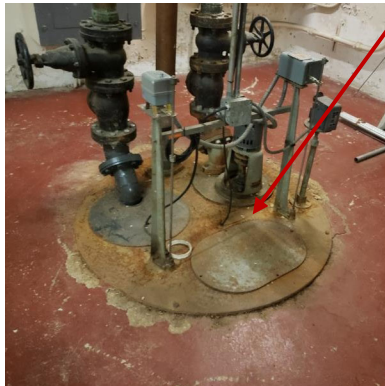
Picture #	Image	Description	Timeline		
			Immediate	Necessary	Extended
#10-B, B1.10 Mechanical and Equipment Room

Rust on sump cover.	●		
Recommendation:	Test to verify functionality of the sump pump (see MEP report for additional details). Clean the rust from sump cover and paint with rust proof primer.

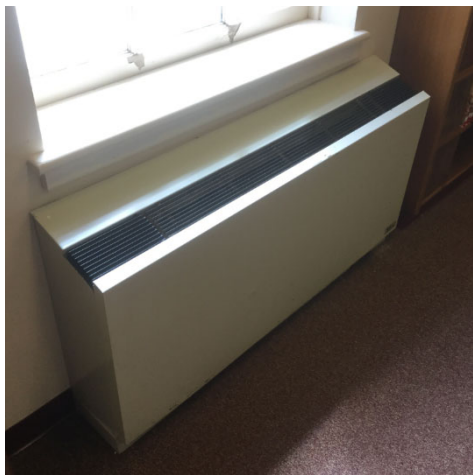
<p>#11-C, C3.3</p>	<p>The cooling system implements 8 unit ventilators and 10 fan coil units scattered throughout the library. These units are old and in many cases original to the building. However, all still appear in adequate physical and mechanical condition.</p>

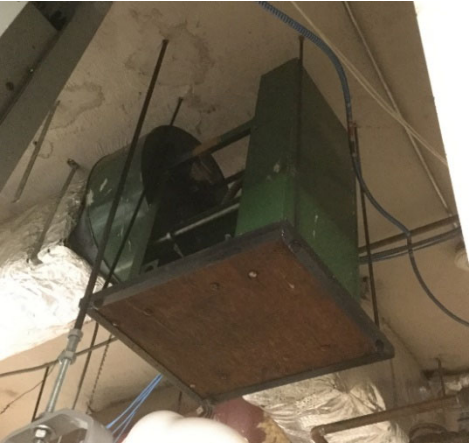
#11-C, C5.1 Exhaust / Relief Air System	<p>Exhaust fan EF-3 possessed no visible manufacturer tag but is believed to be original to the building. This unit displayed noticeable signs of aging.</p>

Recommendations:	All the fans present throughout the building proved to be in adequate working condition and do not require immediate replacement. However, due to dwindling service life, these units should be replaced during the next system renovation. New fans shall utilize ECM motors for improved motor efficiency. Further breakdown of exact replacement requirements can be found in category C5 of the cost estimate.

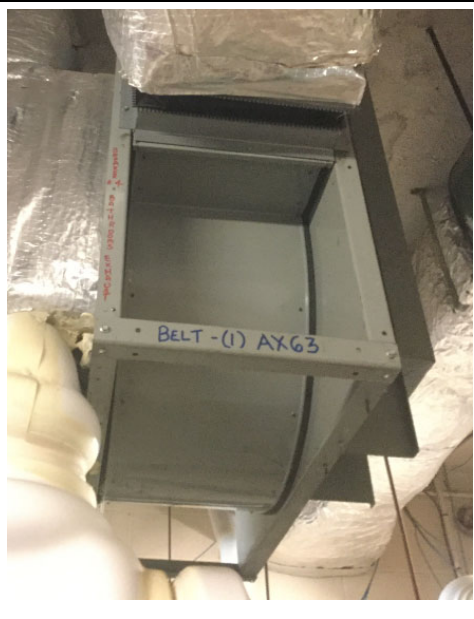
#11-C, C5.2	Exhaust fan EF-4 was installed during the 1990 renovation project but still appeared in sufficient mechanical condition.

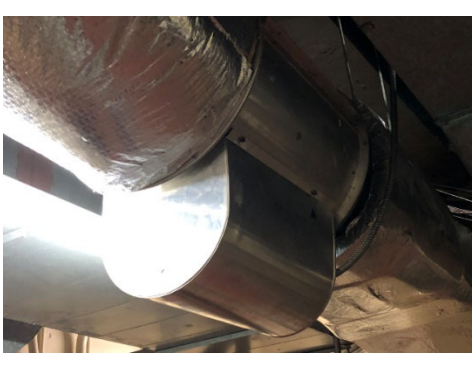
#11-C, C5.3	Supply fan SF-6 is a Penn Ventilator Co. unit dating back to the 1990 renovation project. This fan still operates as intended and is in good working order.

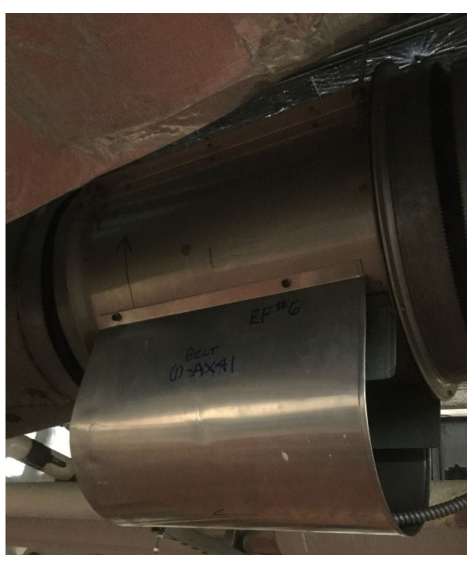
#11-C, C5.4	Exhaust fan EF-7 is a Penn Ventilator Co. unit dating back to the 1990 renovation project. This fan still operates as intended and is in good working order.

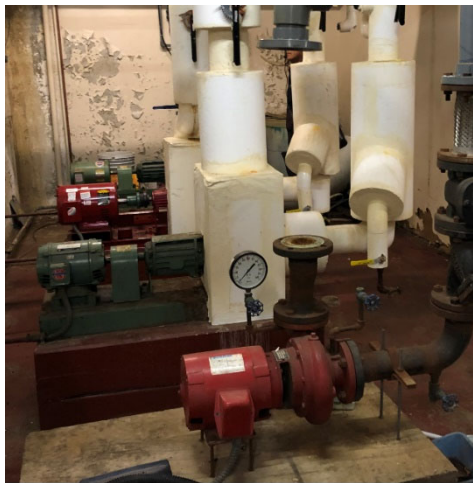
#11-C, C6.1 Water Distribution System	The system implements two circulating pumps of different motor sizes, a 5 HP and a 10 HP motor. The pumps appear to be in satisfactory working condition. However, equipment tags indicated 1992 as the newest unit production date.

X		
Recommendations:	The system's circulating pumps and corresponding pipes and valves are aging but retain adequate operation. The shortcomings of the 2-pipe system could be contributing to the musty smell in the basement due to lack of dehumidification when chilled water is not available. These components and system should be updated to provide improved temperature control during the shoulder seasons and, most importantly, dehumidification capability during times of high humidity. Further breakdown of exact replacement requirements can be found in category C6 of the cost estimate.

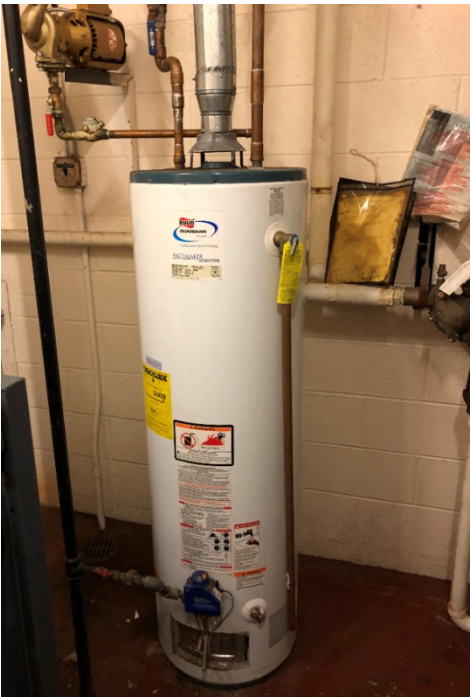
<p>#12-D, D2</p> <p>Domestic Hot Water Heating System</p>	<p>The existing gas fired domestic water heater is outdated and inefficient.</p>

<p>Water heater temperature setting at “Low” limits the temperature desired at staff pantry</p>

<p>Recommendations:</p>	<ul style="list-style-type: none"> • A new condensing gas fired water heater is recommended for replacement of the existing unit within the basement. The unit should be supplied with all new trim, valves, and controls. • Adjusting the water heater setting to “HOT” is recommended in order to increase the output temperature of the water heater.

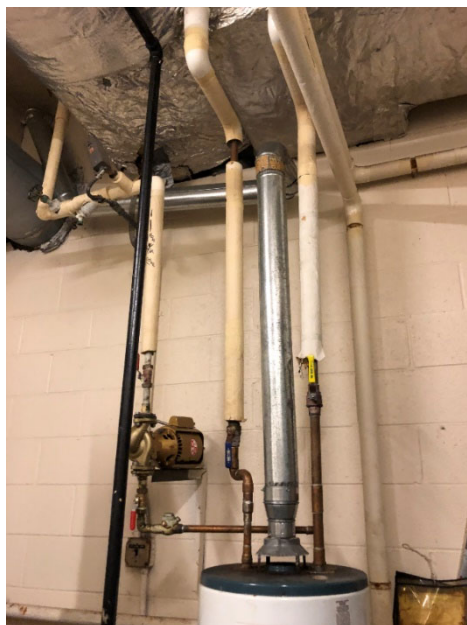
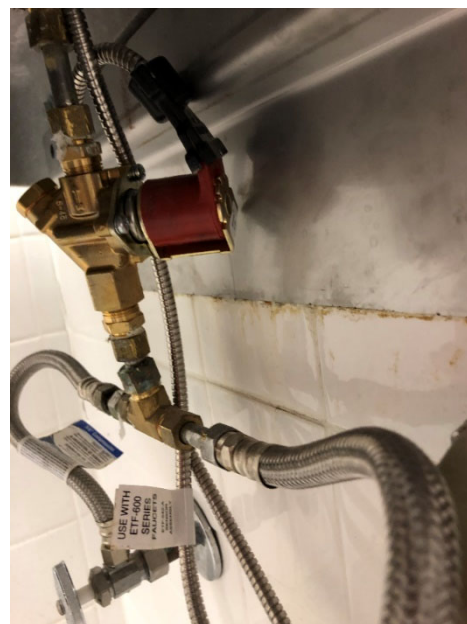
Currently there are no mixing valves installed at the source (ASSE 1017) or at the individual fixtures (ASSE 1070).

**Recommendations:**

- As per current code a master mixing valve (ASSE 1017) is required on systems implementing a recirculating pump. This would require a 1-inch inlet/outlet thermostatic mixing valve to be installed at the hot water heater in the basement.
- For public handwashing fixtures, a thermostatic mixing valve (ASSE 1070) is required at the hot water supply to the respective fixture. This valve would prevent temperatures from reaching or exceeding 110°F. The mixing valves would be installed at each lavatory and set at 105°F.

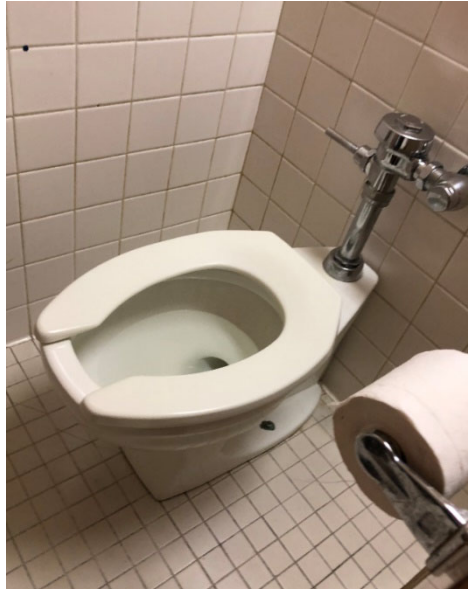
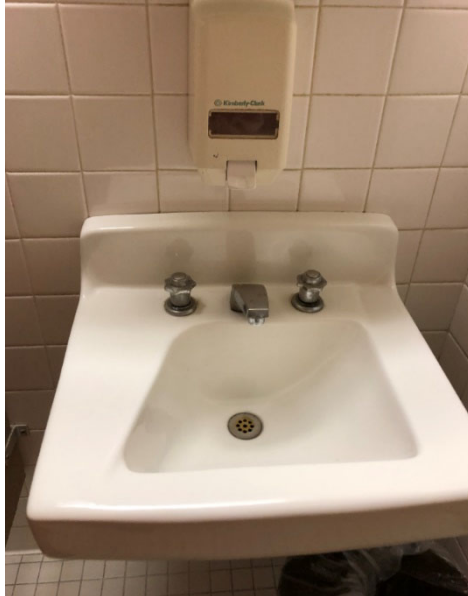
A variety of plumbing fixtures are installed throughout the library. The existing first floor staff restroom is not ADA compliant and has outdated fixtures.

Recommendations:	<ul style="list-style-type: none"> • The first floor staff restroom should be fully renovated with a new toilet and lavatory. Priority Class 1. • Replace first floor pantry sink. Priority Class 2 • Replace basement pantry sink. Priority Class 2 • Replace mop sink. Priority Class 2 • Rearrange and upgrade basement group restrooms for ADA compliance. • Replace existing drinking fountain with new high-low unit and with bottle filler. 				
#12-D, D5 Sanitary Waste	Current force main piping passes ovetop existing electrical panels.

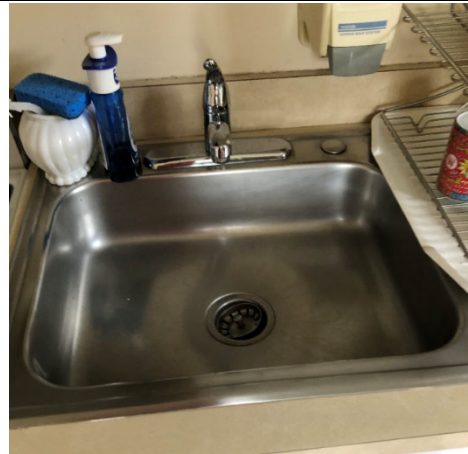
Existing first floor pantry sink.

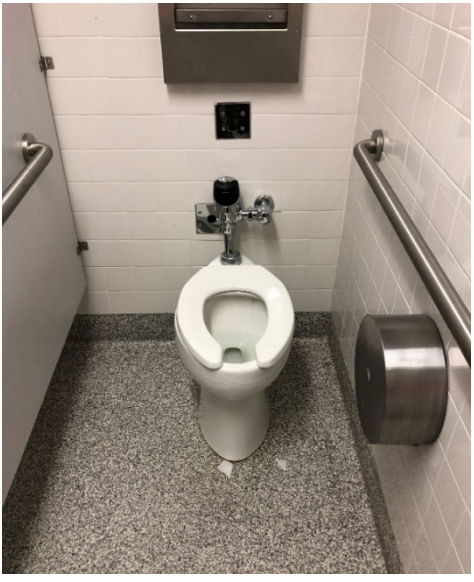
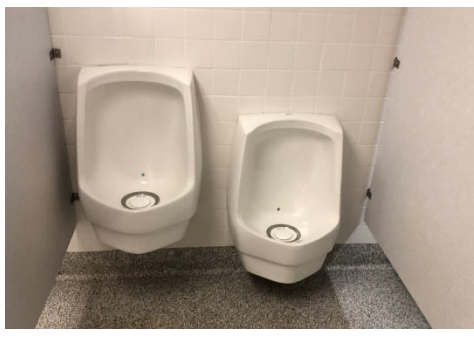
Existing basement group restroom is in good condition, however the space and fixtures are not arranged to comply with code and ADA requirements.

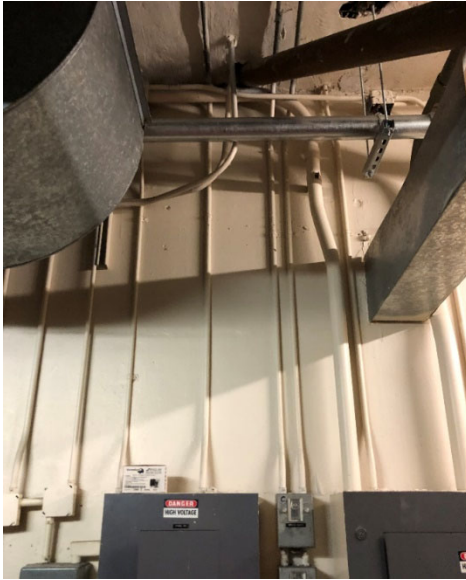
Due to the age, pit condition, and current piping configuration, the existing sewage ejector should be replaced.

●
Recommendations:	<ul style="list-style-type: none"> • Perform dye test to determine exactly which fixtures are draining into the ejector basin. • Remove and replace existing ejector pumps (duplex) along with new controller, discharge piping, and sump basin. • Reroute force main from ejector pump to avoid electrical panels. • Connect new force main to the gravity sewer in the crawl space. 				
#12-D, D6 Storm Drainage System	To ensure good rainwater flow through the storm piping, a hydro-jet flush of the piping system is recommended.

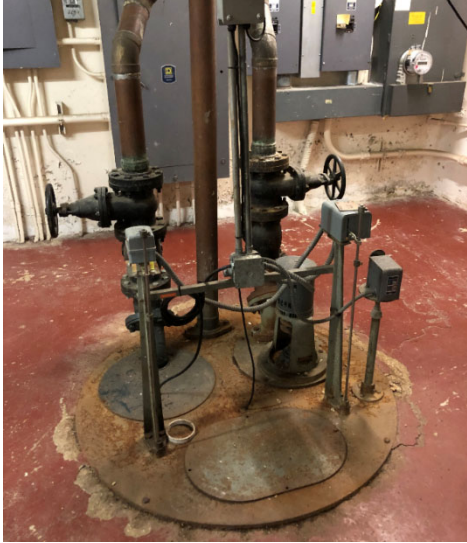
●		
	Existing mechanical room floor drains

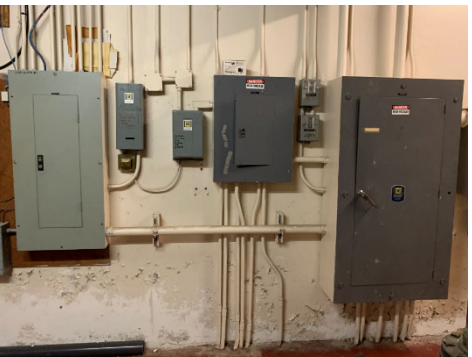
●		
#13-E, E1.2	Distribution panels are beyond their life expectancy and are recommended to be replaced.

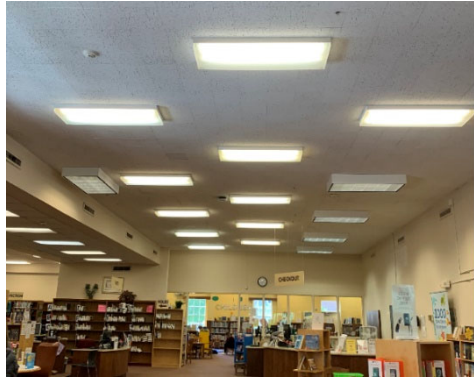
<p>●</p>		
<p>#13-E, E3.1</p> <p>Lighting System and Controls</p>	<p>Surface mounted lighting in the Library controlled through manual override switches.</p>

<p>●</p>
<p>Recommendations:</p>	<p>While the existing lighting system is in good operational condition, LED lighting shall be considered as the basis of design for all future fixtures in order to enhance energy savings. Existing controls to be demolished and provide automatic control including occupancy and daylight sensors. An occupancy sensor control system will be used with manual override switches to control all interior non-emergency light fixtures in the building. Further breakdown of exact replacement requirements can be found in category E3 of the cost estimate.</p>

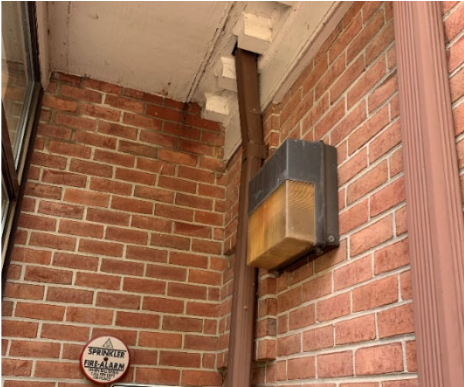
#13-E, E5.1 Exterior Lighting and Control	Wall mounted exterior lighting.

Recommendations:	Since the majority of the building mounted and all of the pole mounted fixtures appear to be original to the building, we are recommending they be replaced with more efficient LED exterior fixtures. Further breakdown of exact replacement requirements can be found in category E5 of the cost estimate.

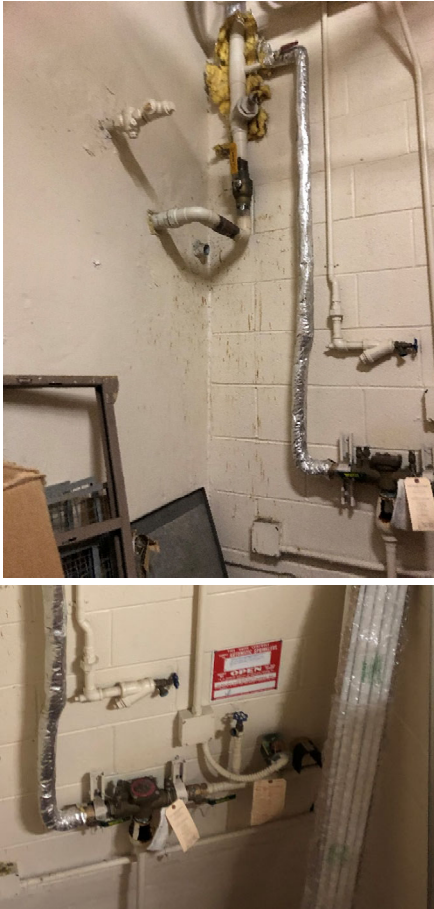
Equipment or System	Description	Image	Timeline		
			Immediate	Necessary	Extended
#14-F, F2 Sprinkler System	Existing 2" incoming water service without backflow preventer.

Recommendations:	<ul style="list-style-type: none">• Provide a new 4-inch fire service• A 4-inch backflow preventer (DCDA – ASSE 1048) would be installed on the new incoming service• Full wet/automatic sprinkler system throughout the entire structure.• Anticipate 2 wet sprinkler zones (basement and first floor)• Anticipate 1 dry sprinkler zone (attic)• System shall be supervised by a central fire alarm system.• A riser-mount air compressor installed in the basement mechanical room to maintain pressure for the dry system.
-------------------------	---

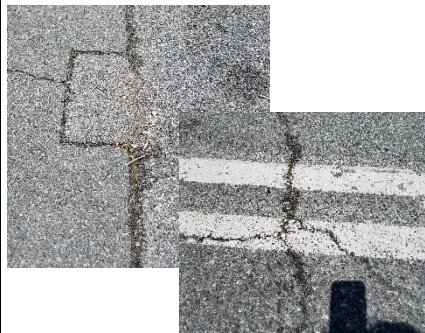
Cracks appearing on the parking lot asphalt surface.	●		
Recommendation	Re-seal or refinish to resolve issue.				
#15-G, G2. Site Lighting

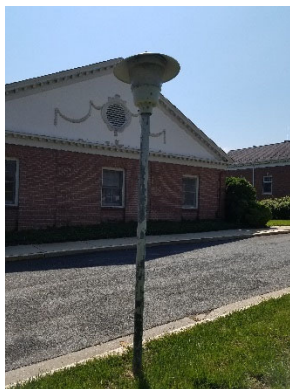
Exterior lamp post old.			●
Recommendation	Re-finish existing lamp post and fixture with new paint coat. Alternately replace exiting with new energy efficient lamp fixture.				
#15-G, G3a. Sidewalks & Curb Cuts

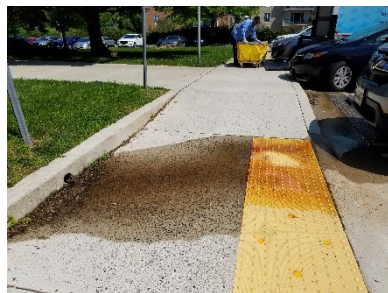
Sidewalks & Curb Cuts Note: Stormwater released to sidewalk/curb cut. Water ponding may cause slippery condition to library user.	●		
Recommendation	Replace curb cuts and sidewalks to meet ADA code compliance. Relocate storm water drainage pipe.

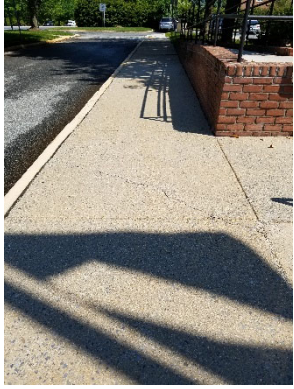
<p>#15-G, G3b.</p> <p>Sidewalks & Curb Cuts</p>

<p>Cracked, worn out and none ADA compliant sidewalks present at site.</p>

<p>Recommendation</p>	<p>Replace sidewalks, curb cuts in the building perimeter and parking area.</p>				
<p>#15-G, G4.</p> <p>Site Paving & Seating</p>
