FACILITY ASSESSMENT FOR Chevy Chase Library

Contract No. 1082489
Sheladia & Associates Project No. 5522.004

Final Report

Date: 03/02/2021

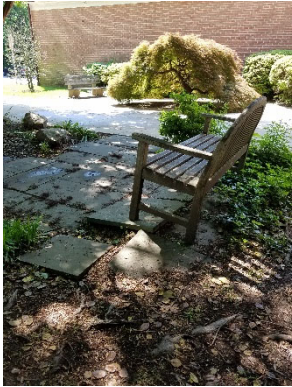
<p>Old exterior courtyard seating. Exterior courtyard paving has moved. Seating placed on uneven paved surface.</p>

<p>Recommendation</p>	<p>Repave area to create a flat paved surface, providing consideration to tree root growth.</p>				
<p>#15-G, G5.</p> <p>Wood Plant Bed</p>

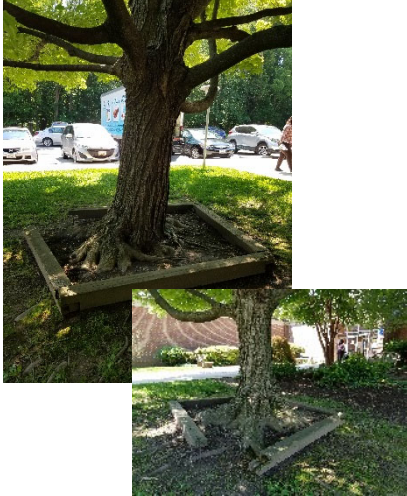
<p>Wood plant bed surrounding tree.</p>

<p>Recommendation</p>	<p>Large tree has outgrown plant bed. Remove wood edging. Recommend providing new landscape in the surrounding area.</p>

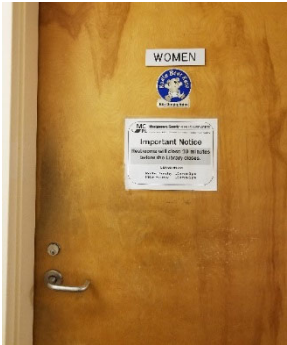
Insufficient odor exhaust in female restroom.	<input checked="" type="radio"/>		
Recommendation	Installing exhaust fan in restroom.

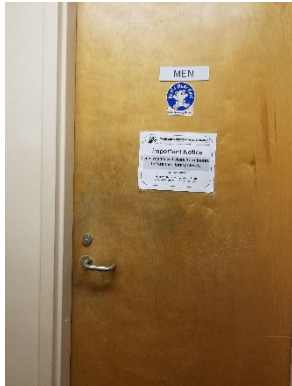
Door requires push plate. Insufficient odor exhaust in male restroom.	<input checked="" type="radio"/>		
Recommendation	Suggest installing new stainless steel push plate. Refinish door. Installing exhaust fan in restroom.

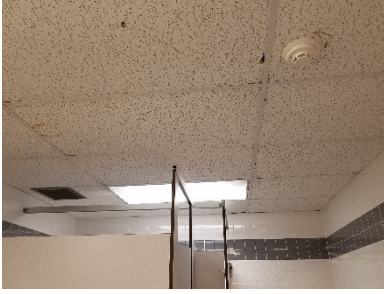
#12-H.1, G103-A8a. Ceilings & soffits

Chipped and cracked ceiling tiles.

Recommendation	Investigate cause and fix issue. Replace stained tiles with new to match adjacent ceiling tile type, color and finish. Recommend redesigning the restrooms to meet ADA and resolve other existing issues.				
#12-H.1, G103-A8b. Ceilings & soffits

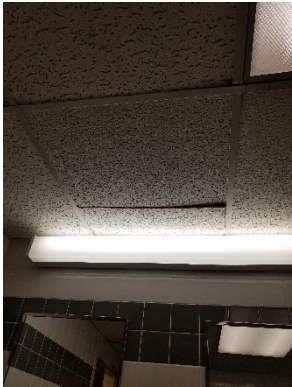
Inconsistent ceiling tile size.

Recommendation	Replace existing mismatched ceiling tile with full 2x4 inch tile.				
#12-H.1, G103-A8c. Ceilings & soffits

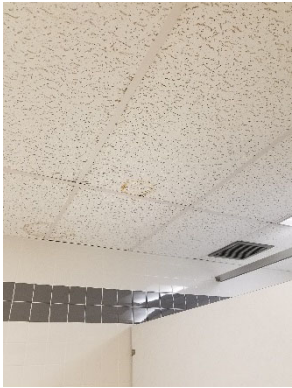
Stained ceiling tiles.

Recommendation	Investigate cause and fix issue. Replace stained tiles with new to match adjacent ceiling tile type, color and finish. Recommend redesigning the restrooms to meet ADA and resolve other existing issues.

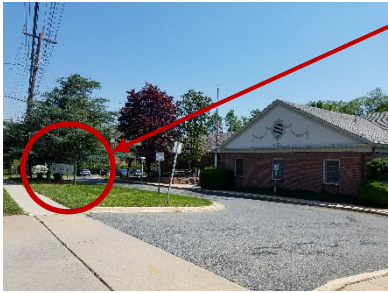
Library sign not fully visible from the main road.			●
Recommendation:	Trim the tree branches. Suggest moving the sign away from the large tree and placing mid-point on grass median.				
#17-I, I1.2 Signage Building West

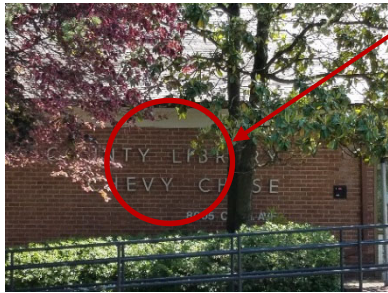
Building mounted signage not visible.			●
Recommendation:	Relocate exterior signage to new location on west façade.

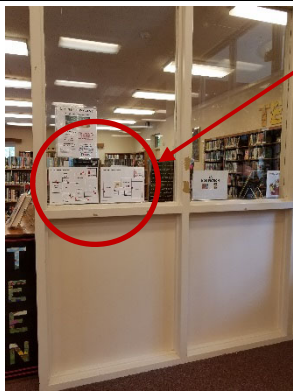
Life safety and egress signage not prominently visible. Note: Consistant throughout building.	●		
Recommendation:	Redesign and reconsider signage mounting locations.				
#17-I, I1.4 Signage Building Interior

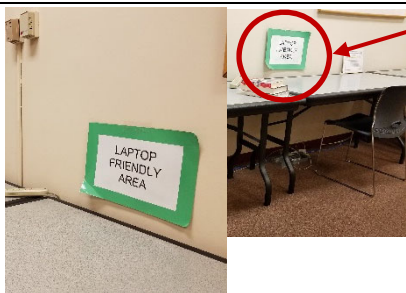
Interior signage. Note: Consistant throughout building.	●		
Recommendation	Replace temporary signage with coherent and consistent graphics.				
#17-I, I1.5 Signage Building Interior

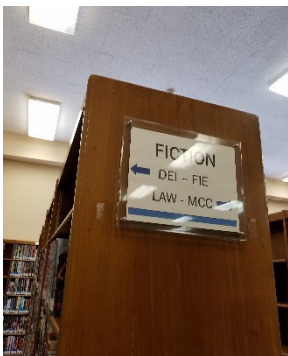
Book shelving identity signage.	●		
Recommendation:	Redesign and install book shelving identity signage with coherent and consistent graphics.

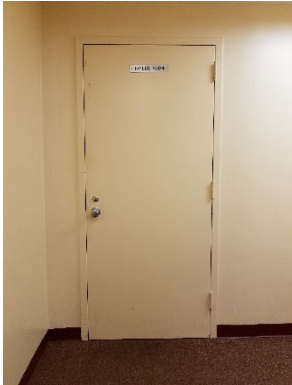
#17-I, I1.6 Signage Building Interior

Room names and numbers. Note: Currently the existing rooms have no room numbers. Some rooms have no room identification signage.	<div></div>	<div></div>	<div></div>
Recommendation:	Redesign signage with coherent and consistent graphics for the entire facility.

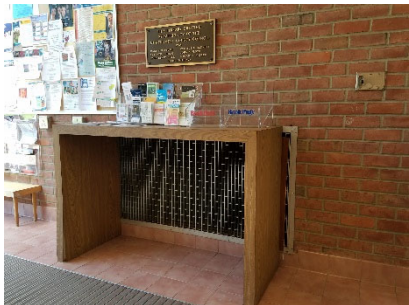
RM # & Architectural System	Image	Description	Timeline		
			Immediate	Necessary	Extended
#17-I, I2.1 Display Areas

Uncoordinated display surfaces.	<div></div>	<div></div>	<div></div>
Recommendation:	Provide new display surfaces.				
#17-I, I2.2 Display Areas

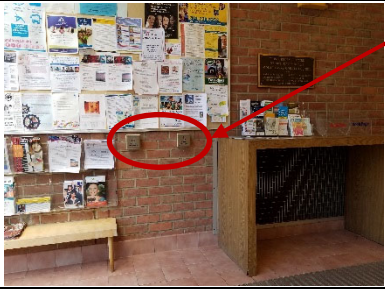
<p>#17-I, I2.3</p> <p>Display Areas</p>

<p>ADA door activator buttons are blocked by furniture and visibility defused by background display surfaces.</p>	<p>●</p>		
<p>Recommendation:</p>	<p>Re-evaluate display methods and provide unobstructed ADA accessibility to door activator.</p>				
<p>#17-I, I2.4</p> <p>Display Areas</p>

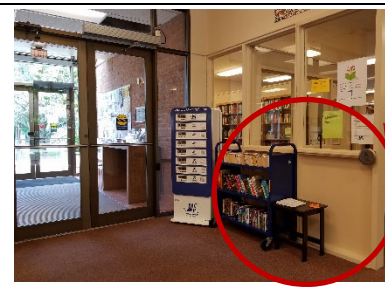
<p>ADA door operator blocked by furniture arrangement.</p>	<p>●</p>		
<p>Recommendation:</p>	<p>Remove furniture obstructions. Reconsider information display areas.</p>				
<p>#17-I, I2.5</p> <p>Display Areas</p>

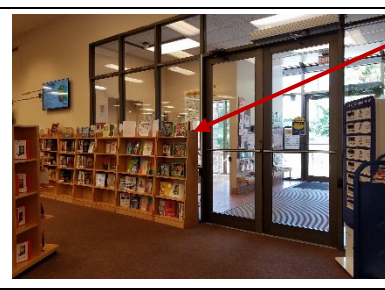
<p>Visibility blocked.</p>	<p>●</p>		
<p>Recommendation:</p>	<p>Remove furniture obstructions. Reconsider information/book display areas.</p>				
<p>#17-I, I2.6</p> <p>Display Areas</p>

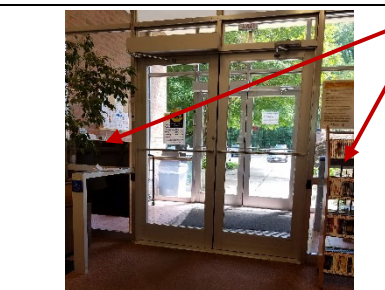
<p>Visibility blocked.</p>	<p>●</p>		
<p>Recommendation:</p>	<p>Remove furniture obstructions. Reconsider information/book display areas.</p>
