CONDITION SURVEY
of
MONTGOMERY COUNTY
GARAGE 47/47A
at
7401 WAVERLY STREET,
BETHESDA, MARYLAND

DECEMBER 17, 2015

HAA Project No. 15-198

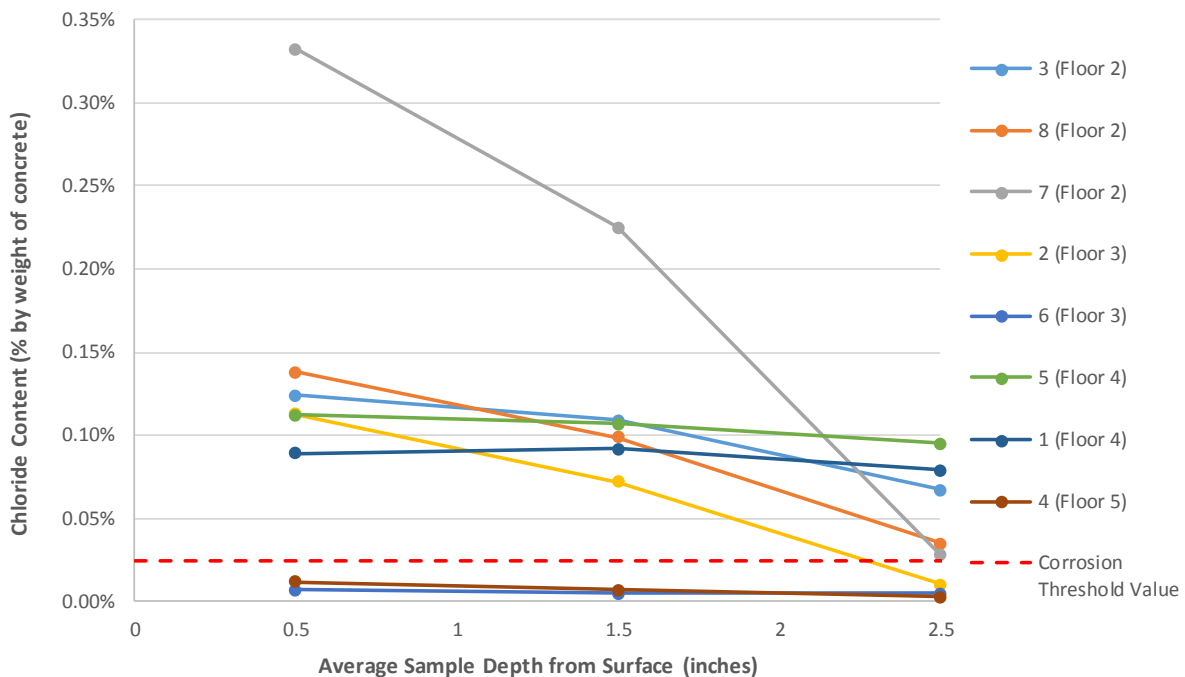
Based on the graph above, a variation in the amount of chloride-ion contamination can be observed throughout the collected samples. This variation can be attributed to any one of the following: varying

amounts of de-icing salts deposited based on location in the garage; effect of existing cracks allowing faster penetration of chloride-ions; localized differences in the concrete quality leading to different rates of penetration; and the effect of ponding, rain, and power-washing in removing chlorides from the surface. These localized variations may be able to explain the high contamination in sample 7 and the much lower contamination in samples 6 and 4. The main conclusions that can be observed from this analysis are as follows:
