Old Georgetown Road Pedestrian Road Safety Audit Montgomery County, Maryland

Prepared For:
Department of Transportation
Montgomery County, Maryland

November 2014

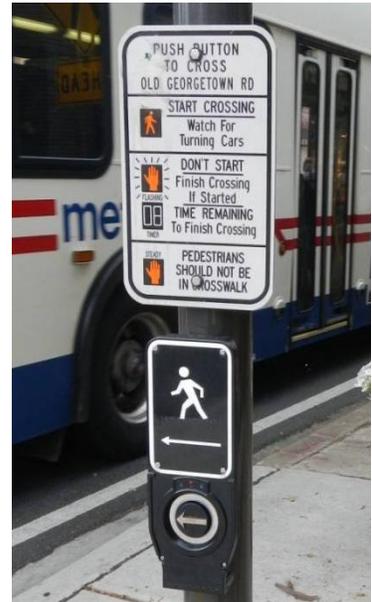
- **Accessible pedestrian signals (APS):** Accessible pedestrian signals are provided at the intersection of Old Georgetown Road at Arlington Road/St. Elmo Avenue/Wilson Lane. Accessible pedestrian signals provide direction through audible and tactile signals which improve the ability of pedestrians with hearing and visual impairments to cross the street safely.

Accessible Pedestrian Signal

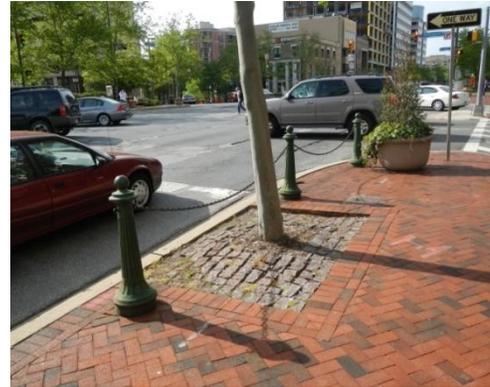
- **Non-traversable Features:** Chain and bollards are present on the southeast corner of the intersection of Old Georgetown Road at Wisconsin Avenue/East West Highway to enforce the prohibited crossing of the south leg of Wisconsin Avenue. Pedestrian traffic can either utilize the below-grade access tunnel or the marked pedestrian crossing from the East-West Highway median to traverse the south leg of Wisconsin Avenue.

Chain and Bollards
