Final  
Report of  
Inspection

Project Management  
Deficiencies in Constructing  
the Paul S. Sarbanes  
Silver Spring Transit Center

Report # OIG-14-007

April 15, 2014

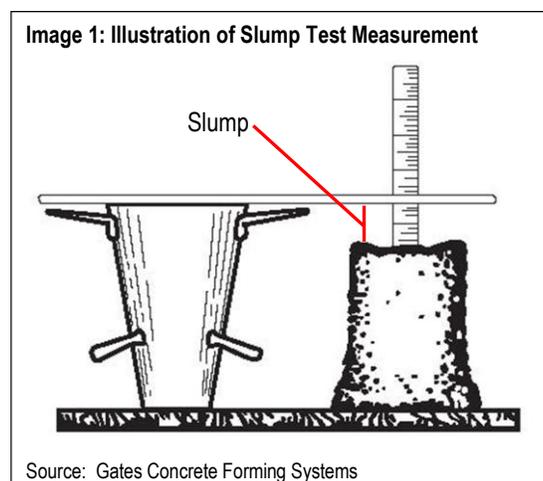
Absent a field test for  $w/c$ , an indicator of the amount of water in a mix may be its workability, and workability can be field measured by means of a slump test.<sup>21</sup> There is no established direct relationship between  $w/c$  and slump, but slump should be less (less workable) after a period of time than it was when it arrived on site unless water has been added. As an example, concrete with slump of 7" would be expected to contain less water than would concrete with a slump of 8" but an otherwise equal amount of admixture, cementitious material, and age.

As represented in Image 1, a standardized conical shape is filled with fresh concrete. When the mold is removed, the fresh concrete subsides and is measured against the original conical shape. Fresh concrete that is more viscous would contain a greater amount of water or admixture, and would have a greater tendency to collapse in height. Conversely, concrete would tend to stay close to its conical shape if lesser water and admixture are present or if the concrete has had an opportunity to age and commence the curing process.

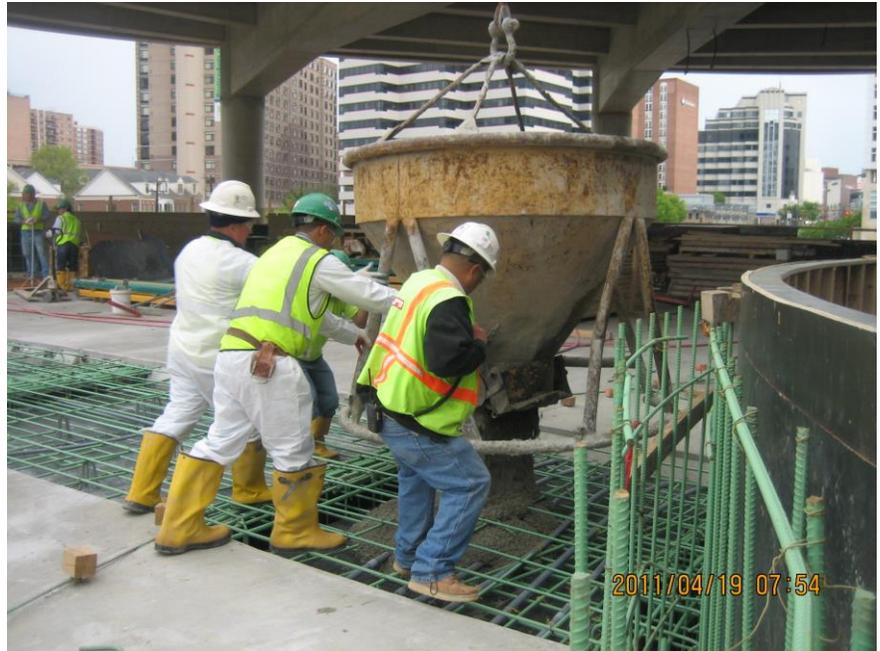
Image 6: West Level 330 Pour Strip Concrete Pour – April 19, 2011

330 level strip was poured in January 2011 while the west strip was poured in April. The level 350 strip was poured in June 2011. The SSTC Pour Strips are substantially wider than the normal industry practice of 3-4 feet. Both pour strips at the 330 level are 760 square foot

Drawings in the Construction Documents appear to require mild steel and post-tensioning tendons within the three pour strips on the 330 and 350 levels. A photograph taken by the County (see Image 6)

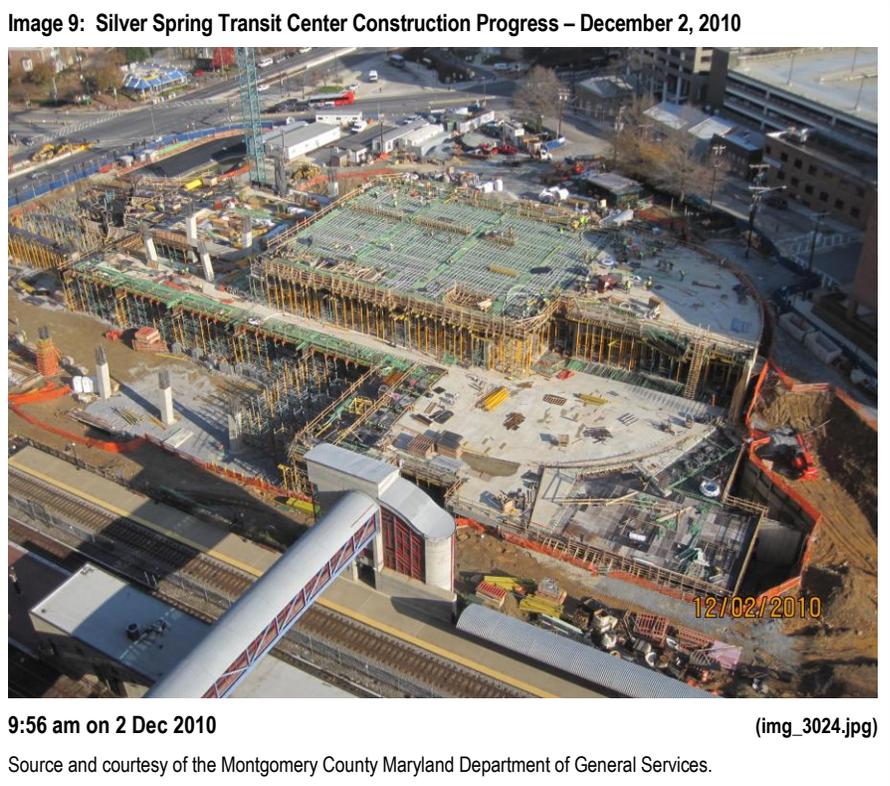
At the point in time of the November PMT meeting, less than half the slab concrete had been placed, and the structure was less than 50 percent complete (see Image 9).<sup>99</sup> The meeting minutes indicate that the issues were not unusual or unexpected in a complex structure like the SSTC and that the SEOR was working to address each one. Although the construction schedule and completion date were discussed during the meeting, there was no suggestion that these issues might further delay the completion of the SSTC.
