2021 BIENNIAL BRIDGE INSPECTION REPORT
September 13, 2021

BRIDGE NO. M-0229001
BRIGHTON DAM ROAD
OVER
BRIGHTON DAM & TRIADELPHIA RESERVOIR
Prepared by

Roadway	BRIGHTON DAM ROAD
Bridge Orientation	East-West
Crossing	BRIGHTON DAM & TRIADELPHIA RESERVOIR
Crossing Orientation	North-South
Inspection Date	9/13/2021
Inspected By	Whitman, Requardt, and Associates, LLP
Spans	15
Type	Prestressed concrete solid slab beams
Structure Organization	The numbering convention for reporting purposes is from the south and the west.
Deck	N/A
Railing	Rectangular concrete parapet
Abutments	Concrete buttresses
Wing Walls	Concrete cantilever
Piers	Concrete buttresses (Odd Buttresses 3-29)
Overall Length	601'-6"
Clear Roadway	28'-0"
No. of Lanes	2
Out-to-Out Width	36'-4"
Year Built	1944
Year Reconstructed	1999 - superstructure and top 4' of buttresses were reconstructed
Approach Section	28'-0"
Shoulders	No
Alignment	Moderate curve from the north on both approaches.
Profile	Moderate downgrade to the bridge on the west approach. Steep downgrade to the bridge on the east approach.
Guardrail	W-Beam

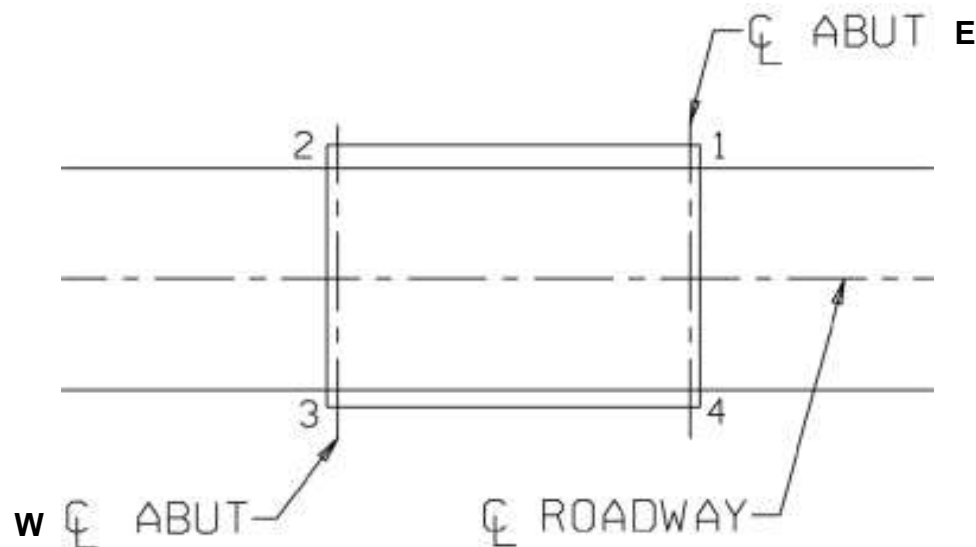
Comments: There is no traffic barrier on the northwest approach due to the access road gate for Brighton Azalea Garden park. The southwest approach traffic barrier terminates with a MDOT SHA Type-K end treatment at an entrance to a parking lot. The southeast and northeast approach traffic barriers terminate with MDOT SHA Type-A end treatments.
