# Morningwood Drive Safety Analysis

July 2021

This study conducts a traffic safety analysis for this corridor to determine existing safety conditions, potential safety impacts that the proposed North High Street connection would need to address, and strategies for addressing safety challenges moving forward.

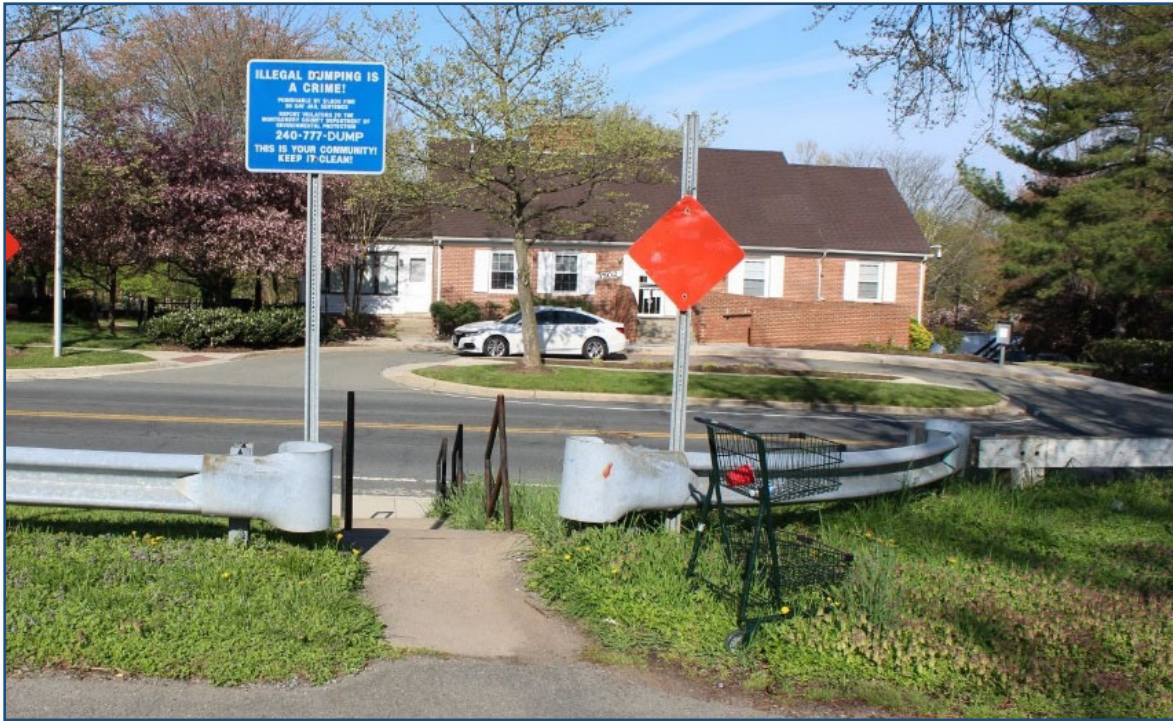
Figure 2-2: Community Maintenance Building from N. High Street

A vehicular North High Street connection to Morningwood Drive is proposed between Bantry Way (north) and Bantry Way (south). An apartment/condo community (Towne Centre Place) with 49 units is located along Bantry Way, and its maintenance office building is located opposite to the existing North High Street steps, as shown in Figure 2-2. The two Bantry Way access points function as the apartment community entrances.

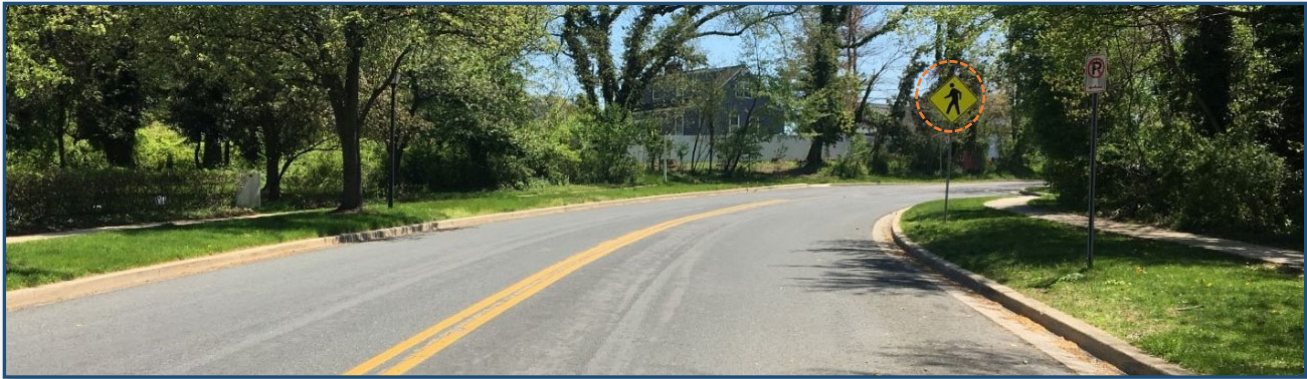
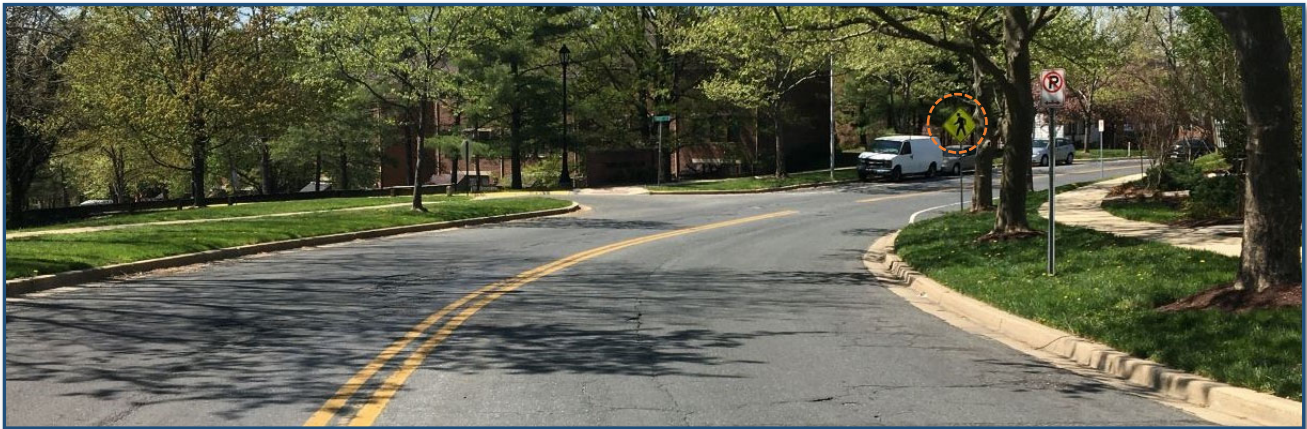
**Figure 2-5: Horizontal Curves and Pedestrian Traffic Signs before N. High Street**

Figure 2-5 shows the Morningwood Drive horizontal curves approaching the proposed connection in both directions. As shown in the figures, pedestrian traffic signs are posted in each direction.

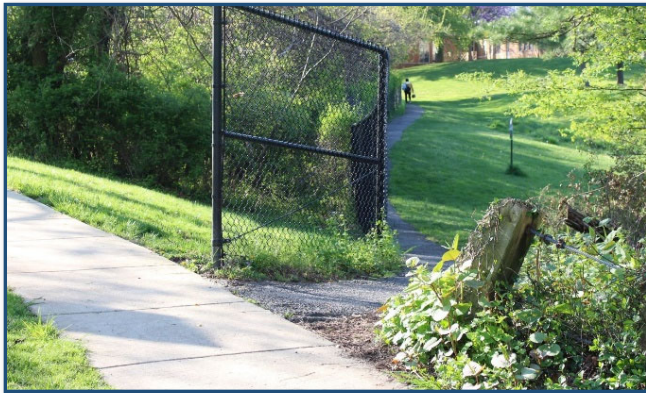
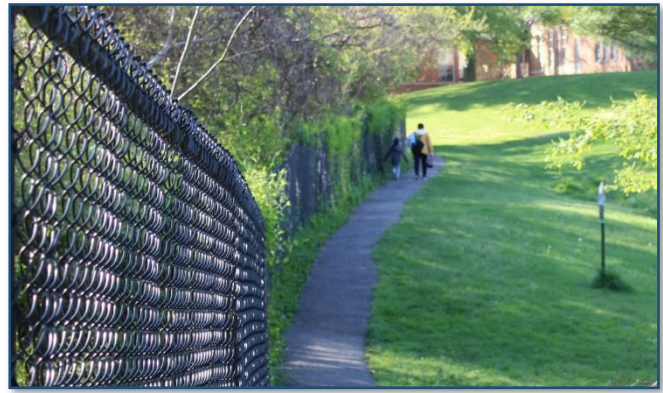
**Figure 2-6: Elementary School Trail Entrance**

Many pedestrians were seen along the study corridor, especially near the North High Street steps and the intersections with Bantry Way (south and north). In the morning and afternoon, most of the pedestrian traffic at these locations are related to the access to/from Olney Elementary School. There is a trail of approximately 4-feet in width connecting Morningwood Drive and the elementary school building; the trail entrance is located along Morningwood Drive between Bantry Way (south) and the 1<sup>st</sup> driveway (3420 Block of Morningwood Drive) south of Bantry Way (Figures 2-1 and 2-6). Olney Elementary School is located on Queen Mary Drive accessible by automobile via MD 97. However, it appeared that many of the students were using the trail to enter from Morningwood Drive and exit the school onto Morningwood Drive, as commented on by the community in the public meeting.

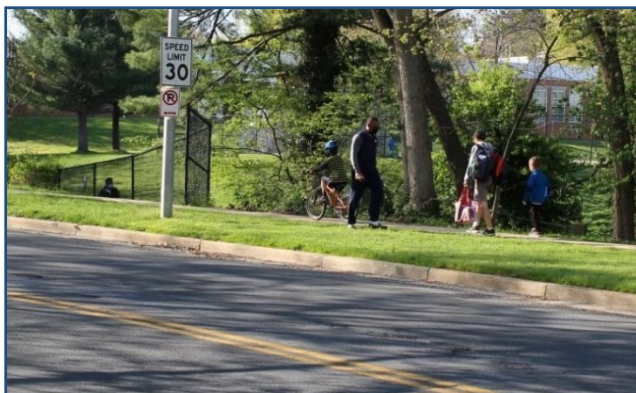
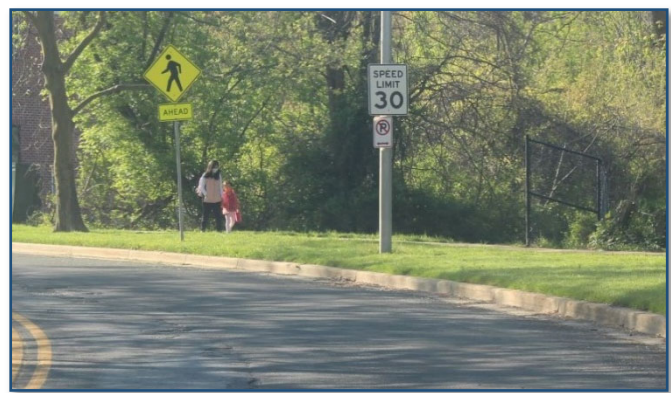
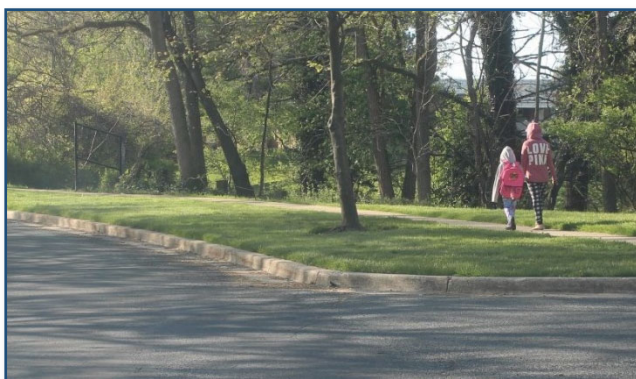
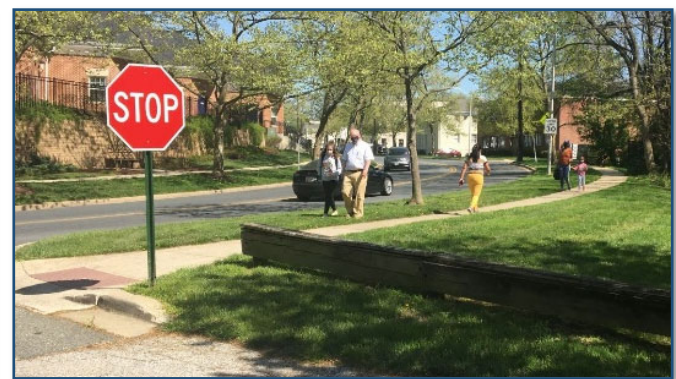
**Figure 2-7: School Children and Parents/Guardians accessing School Trail**

It was noted in the field review that a dozen child/parent/guardian groups got to the entrance by walking along the sidewalk on Morningwood Drive, mostly from the north, in the morning (8:10 – 9:00 AM). Some groups were observed crossing Morningwood Drive near the North High Street steps. Some parents took their child to the entrance and turned around, and others accompanied them along the trail to the school building and came back several minutes later. Around 3:00 PM, parents came to the entrance by walking along the sidewalk, went into the trail/school to take their children, and later parents and children came out of the school/trail. Some of parents/guardians came by driving and waited near the trail entrance

until their children got out of the trail, parking or standing their vehicles on Bantry Way (south) or on the shoulder on Morningwood Drive. This pattern lasted up to around 4:00 PM. In Figure 2-7, the photos (a) to (c) are of the morning pedestrian traffic, and (d) is of the afternoon pedestrian traffic. Some parents with young children walking along the sidewalk passed the trail entrance in the morning, and were most likely going to the Goddard School, though most of the Goddard School trips were likely made by vehicle. The afternoon Goddard School trips occurred much later than the public school (around/after 5:00 PM).

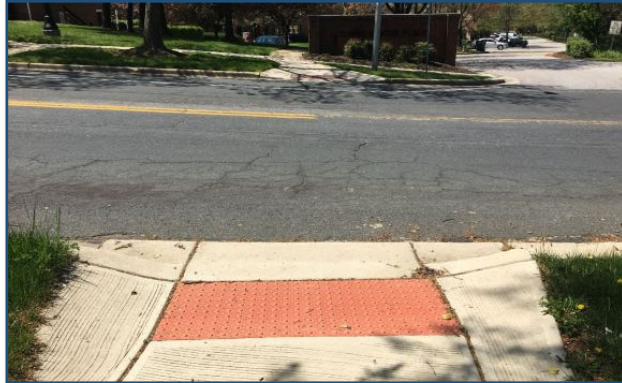
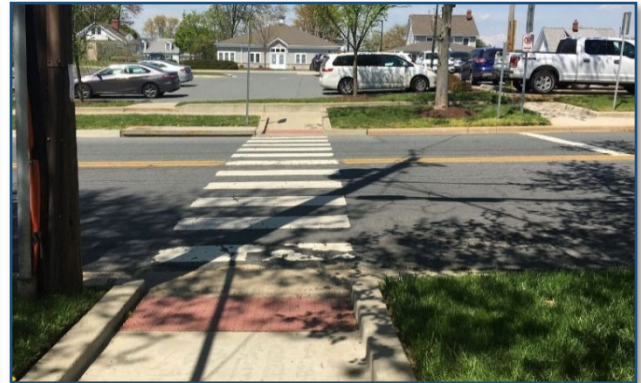
**Figure 2-8: Pedestrian Crossing Facility on Morningwood Drive**

No crosswalks are provided along this section of Morningwood Drive, except near the Goddard School (Figure 2-8b). However, ADA (Americans with Disabilities Act) pedestrian ramps to cross Morningwood Drive are provided south of Bantry Way (north), as shown in Figure 2-8(a), supported by pedestrian crossing signs near the two Bantry Way intersections. The crosswalk provided near the Goddard School entrance is the only marked crosswalk on Morningwood Drive (Figure 2-8(b)).

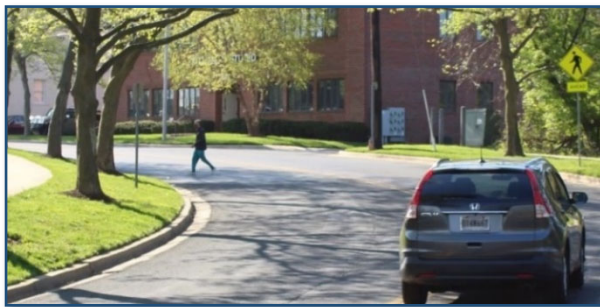
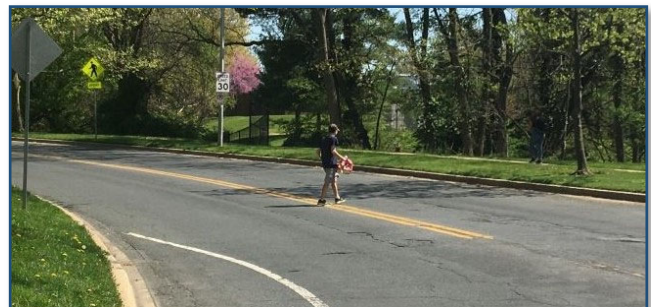
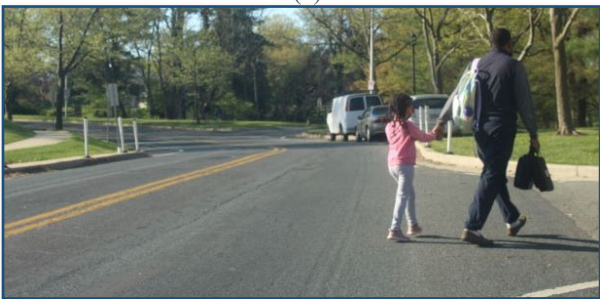
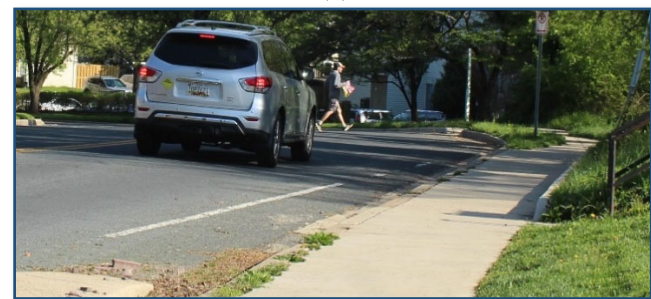
**Figure 2-9: Pedestrians Crossing Morningwood Drive**

Numerous pedestrians were seen crossing Morningwood Drive at locations other than the marked crosswalk or the ADA ramp locations. Most of the pedestrian crossings, including school trips, were made near Bantry Way (south), the North High Street steps, or Bantry Way (north), as shown in Figure 2-9, where (a) and (b) are near the Bantry Way (south), (c) is near the apartment office driveway, and (d) is near the Bantry Way north access. Additional information regarding ADA compliance for pedestrian facilities is discussed in Section 6.

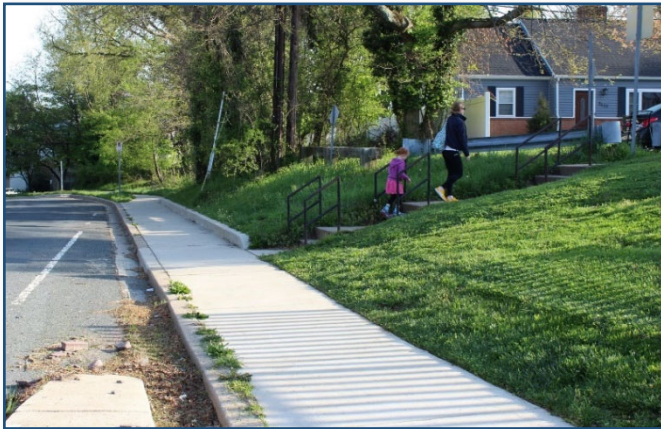
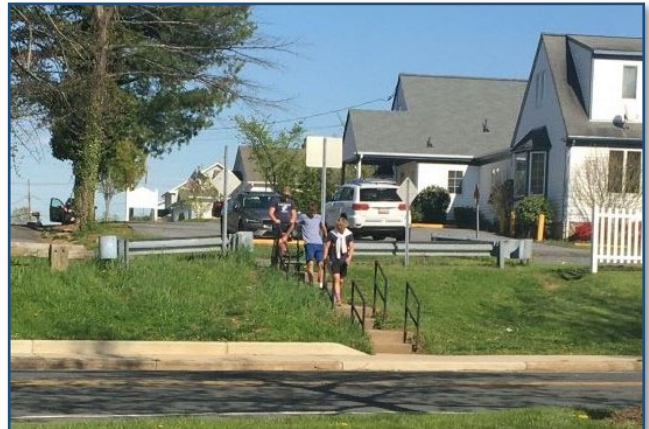
**Figure 2-10: Pedestrians using the N. High Street Steps**

Figure 2-10 shows pedestrians using the North High Street steps. The 1st photo (a) shows a parent and child going up to the steps, possibly toward for the Goddard School in the morning. The 2nd photo (b) shows a group of pedestrians going down the steps in the afternoon. In the recent public meeting, one resident described teenagers crossing over to North High Street as an after-school pattern typically seen in the corridor. The resident assumed that they were likely going to the McDonald's restaurant or other businesses in the adjacent shopping district.

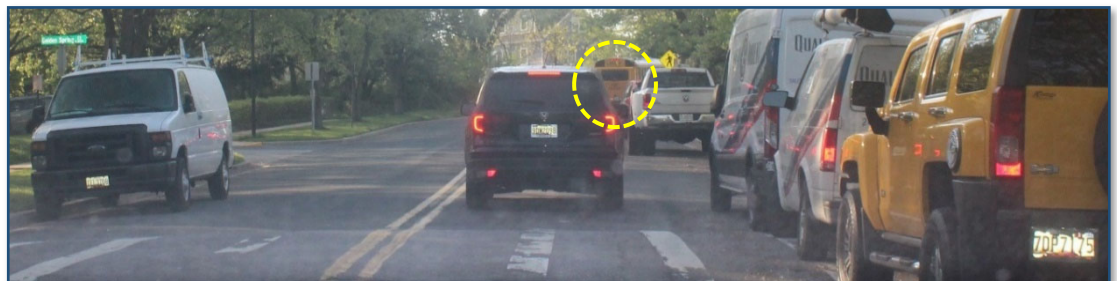
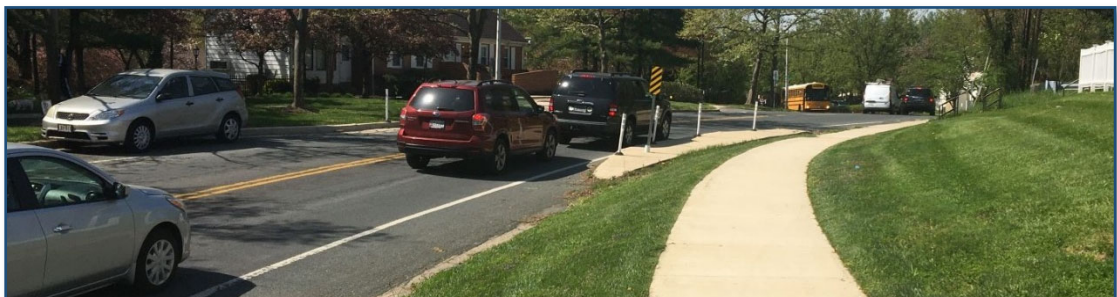
**Figure 2-13: Traffic Stopped for School Bus**

Several school buses were seen along the corridor in the morning and afternoon. Some school buses were entering Bantry Way (south) for the bus riders in the apartment community and exiting Bantry Way (north) after a few minutes, and other school buses were stopping for riders on Morningwood Drive between Bantry Way (north) and Golden Spring Court, thereby causing other traffic to stop, as shown in Figure 2-13.

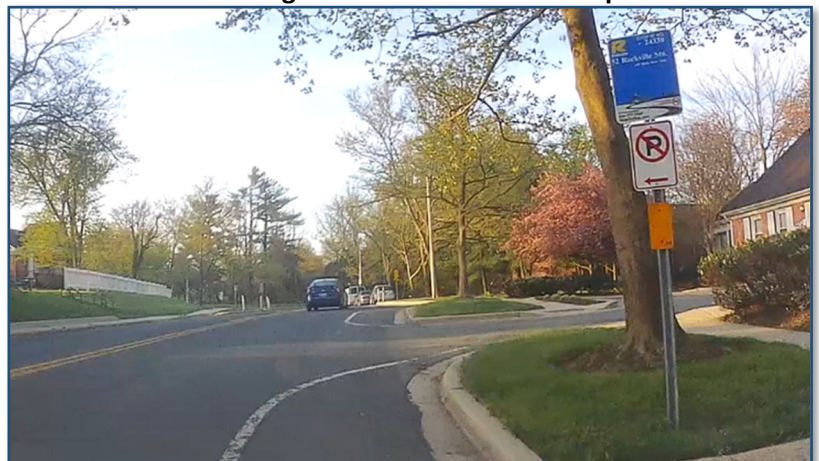
**Figure 2-15: Ride On Bus Stop**

There are four Ride On bus stop signs along the study corridor section. A couple of Ride On buses (#52) were seen on Morningwood Drive but were not seen stopping at these locations on the field review. Figure 2-15 shows the bus stop between Bantry Way (north) and the apartment office driveway.

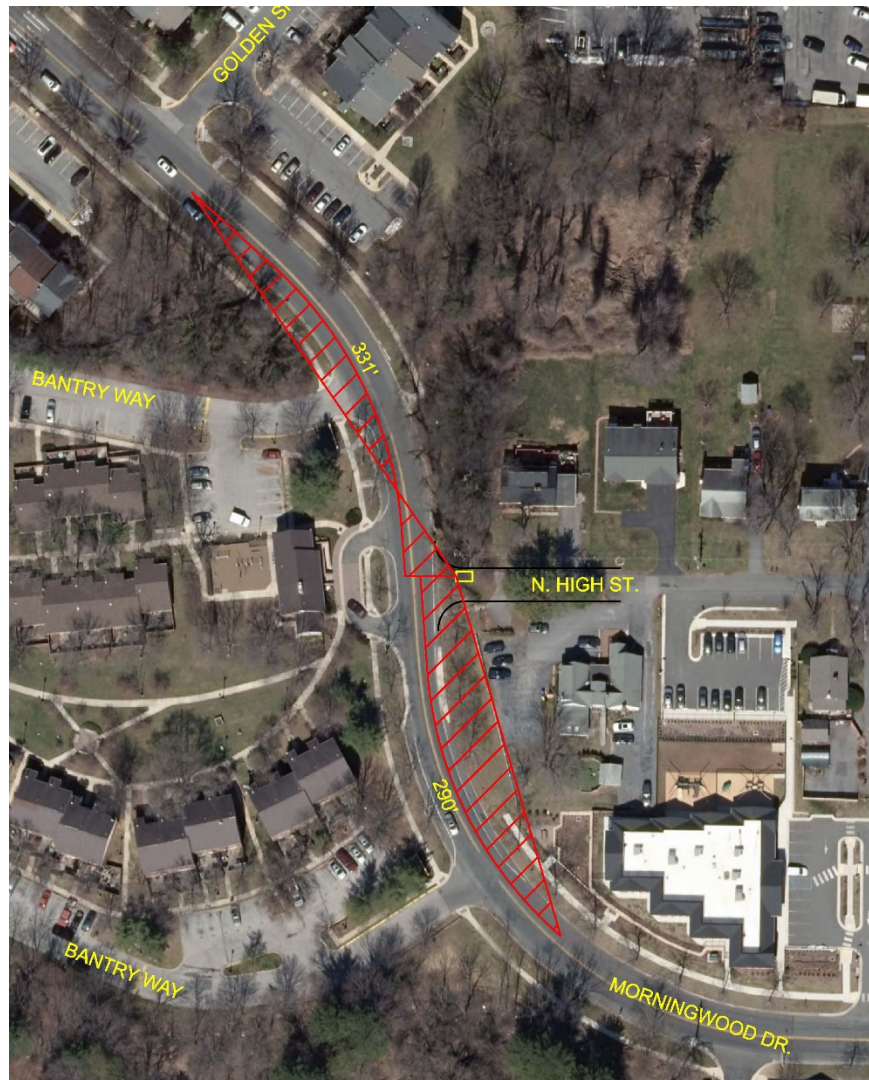
**Figure 5-1: North High Street Intersection Required Sight Distance**

Figure 5-1 shows sight triangles from an imaginary car looking from the proposed connection of North High Street to Morningwood Drive. Looking left from North High Street, the required minimum sight line potentially cuts into the hillside and white picket fence (see Figure 5-2), establishing a sight distance of about 250 feet. Looking right from North High Street, the needed sight line could cut through a wooded area and fence (see Figure 5-3), establishing a sight distance of about 250 feet. Additionally, before the end of the sightline is the start of the parking lane allowed along southbound Morningwood Drive, creating another visual obstruction.

In order to achieve the required intersection sight distance for the proposed connection of North High Street to Morningwood Drive, extensive grading and Right-of-Way impacts may be required. Existing utilities would also need to be investigated for potential impacts in this area. Potential solutions to avoiding these impacts would be to implement a right-in/right-out configuration or an all-way stop condition at the proposed North High Street connection. The right-in/right-out configuration would eliminate the intersection sight distance requirement for left turning vehicles. The intersection sight distance requirement for right turning vehicles would still need to be achieved. The all-way stop condition would eliminate all intersection sight distance requirements because the turning vehicles would be protected by the stop condition of all vehicles. A Synchro analysis of this intersection with an all-way Stop shows that it would operate at a LOS A in the AM and PM peaks (Appendix 5).

- Consider possible consolidation of access points to Morningwood Drive for the commercial properties near the MD 97 intersection. The connection of N. High Street may provide additional opportunities for access consolidation. It should be noted that consolidation is only possible with the desire to cooperate by the impacted property owners.
- For the proposed vehicular connection to N. High Street, consider making the new intersection an all-way Stop or a right-in/out connection to limit movements with limited sight distance.

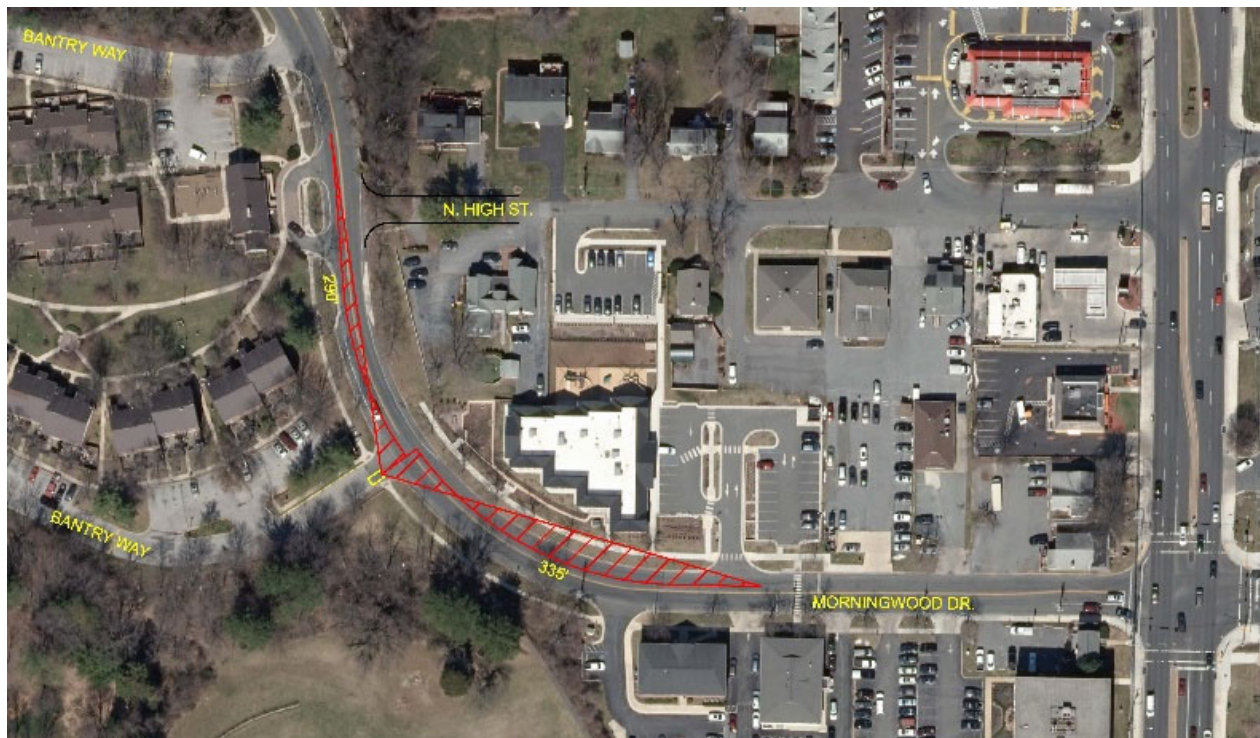
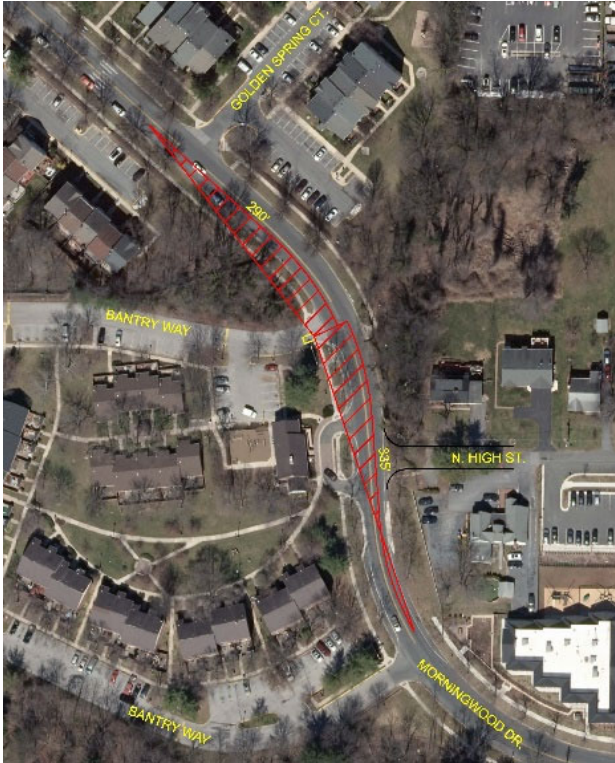
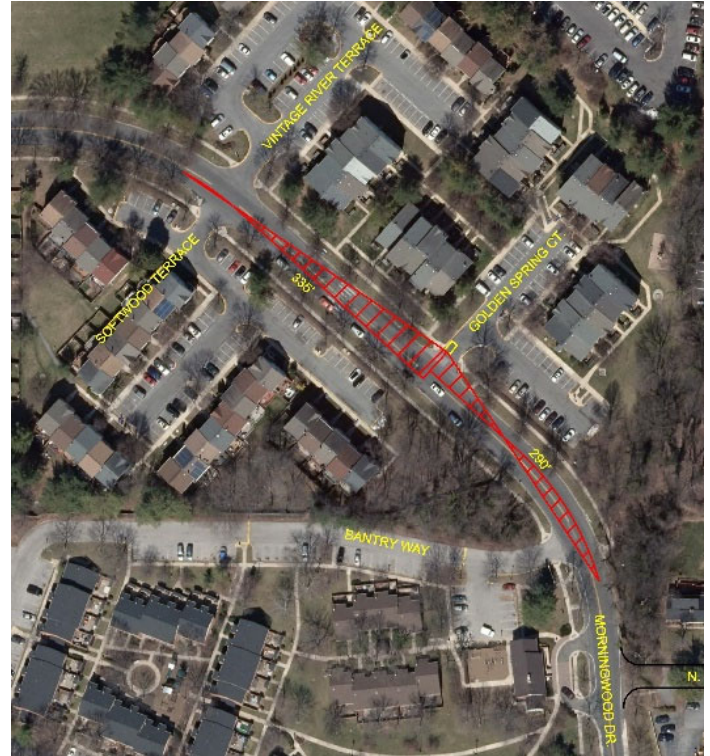
**Figure 5-4: Existing Intersections Intersection Sight Distance**

Figure 5-4 shows intersection sight distance sight triangles for the remaining five existing intersections within the study area.

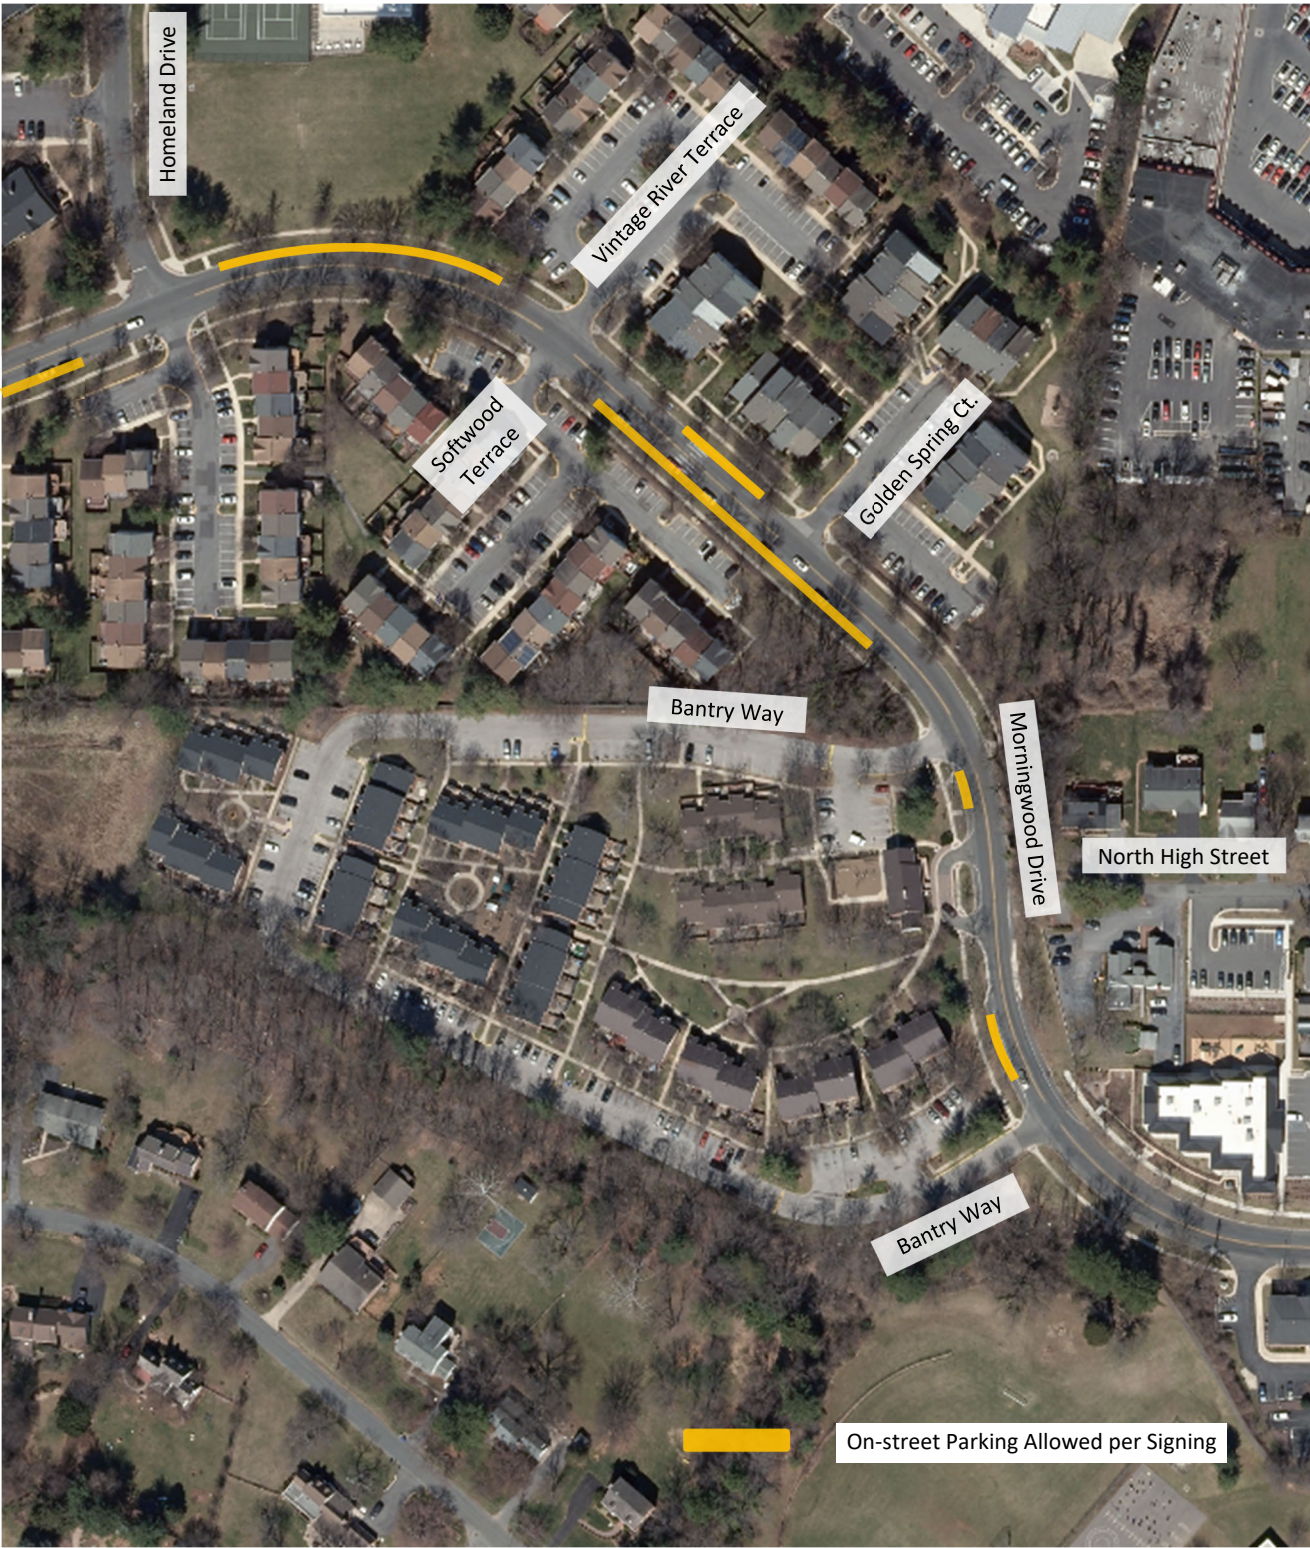
Figure 7-7: Current On-Street Parking Locations

On-street parking is available on the straight segment of eastbound Morningwood Drive between Softwood Terrace and Bantry Way (north), and some part of the westbound Morningwood Drive between Vintage River Terrace and Homeland Drive (Figure 7-7). “No Parking” signs regulate the street parking locations. There are no marked bicycle facilities along the roadway or sidepaths.

The draft Montgomery County Complete Streets guide recommended design parameters for Neighborhood Connector roadways state that lanes should be striped to 10.5 feet wide. The lane widths along the corridor are typically 17-18 feet where shoulders are not marked, and 12 feet where they are marked. Marking the lanes for the recommended 10.5 feet could be a method for traffic calming and provide more defined parking and/or bicycle facilities where allowed.
