# **Glen Echo Heights**

## **Roadway and Drainage Study**

MONTGOMERY COUNTY, MARYLAND

**August 2007**

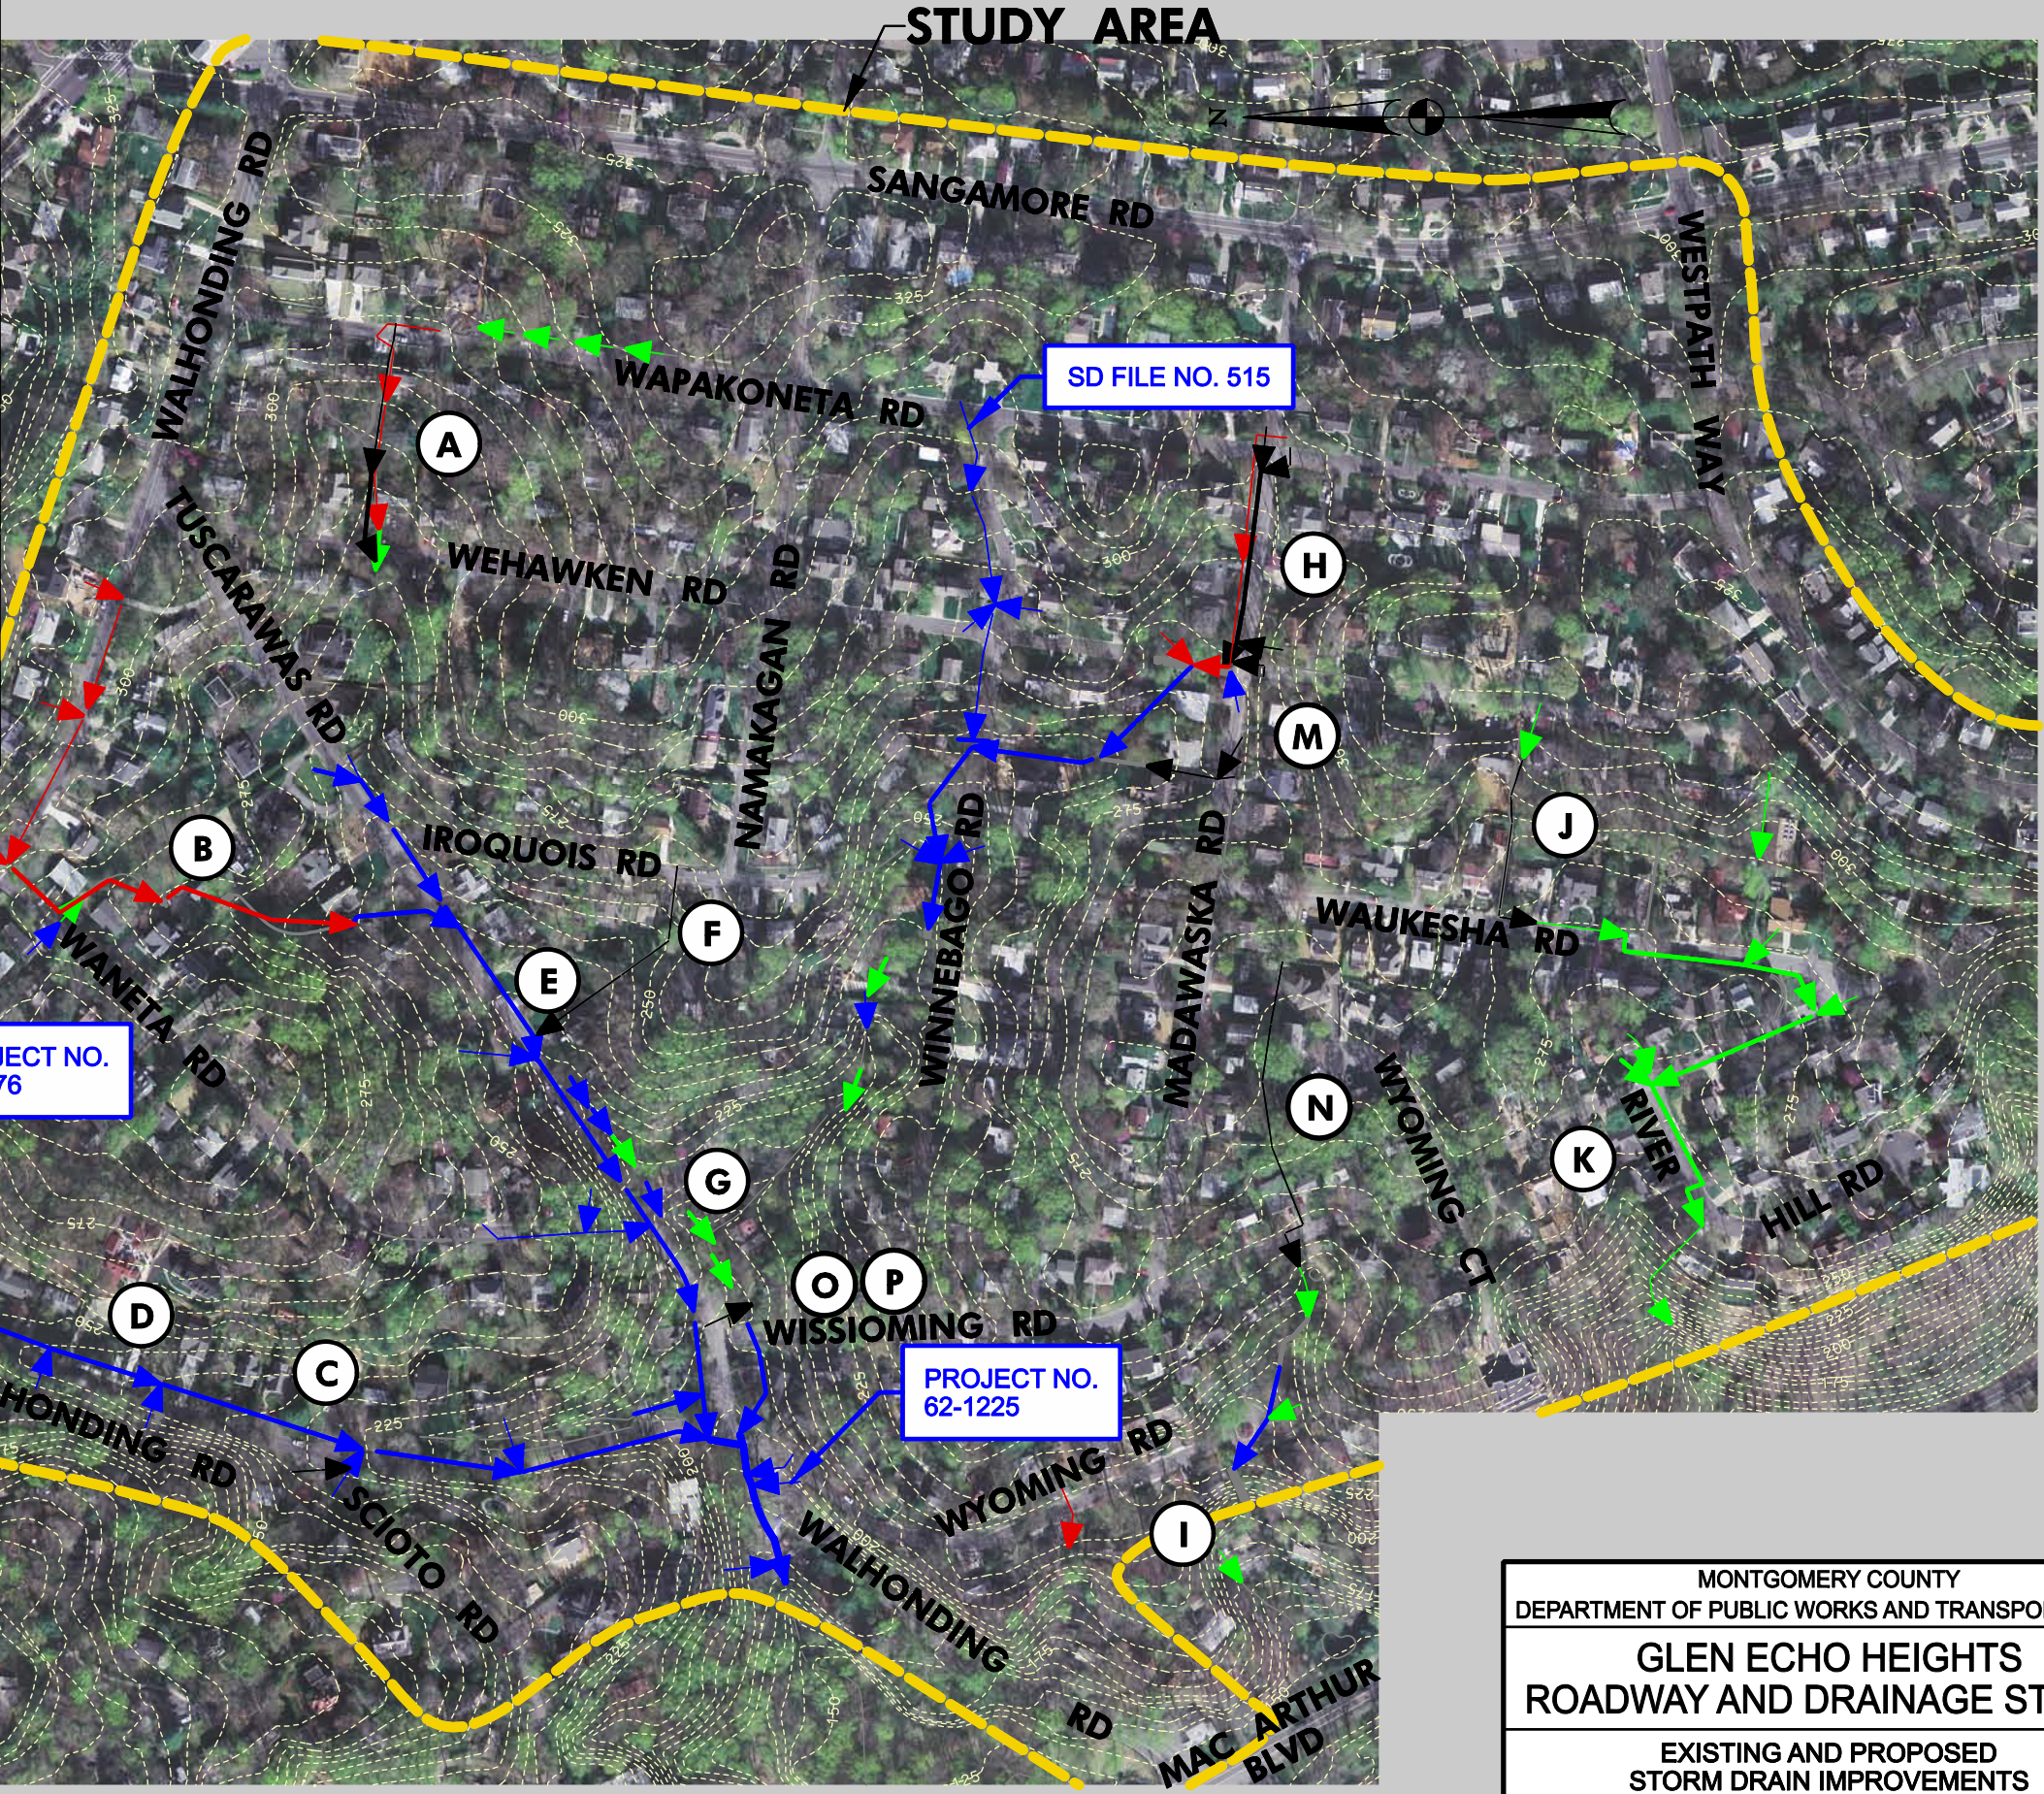
One of the main issues encountered during the analysis of the study area was the lack of drainage systems, either open or closed, for the Eastern half of Glen Echo Heights. Specifically, the following areas were found to be without a comprehensive drainage system:

Out of a total of 18 roads that comprise the study area, only 4 of the roads were found to have a comprehensive drainage system (open or closed).

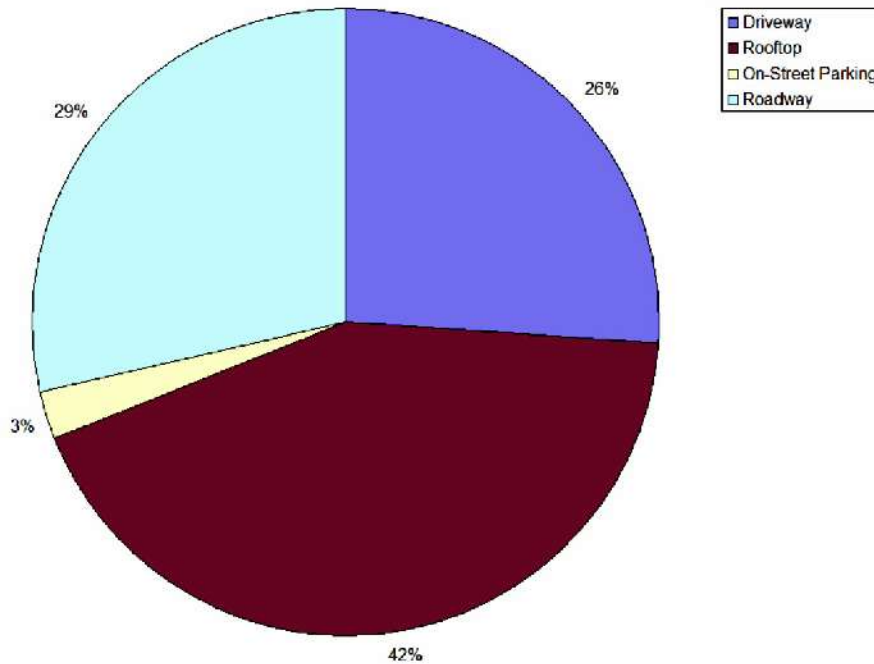
**Chart 1 – Analysis of Impervious Area along Walhonding Road**

During the hydrologic analysis of Glen Echo Heights, the contribution of storm runoff from rooftops, driveways and on-street parking pads was analyzed to determine the effect of redevelopment in the study area. Older homes are being replaced with larger houses with larger driveways on the same quarter acre lots. With the increase in the size of the houses, the increase in rooftop areas also increased. For example, on Walhonding Road, the main road connecting MacArthur Boulevard to Massachusetts Avenue, the total impervious area from the rooftops was calculated to be 3.83 acres. Further analysis of Walhonding Road showed that as a percentage of total impervious area, the County roadway only contributed approximately 29%, as compared to the rooftop area that contributed 42%(see **Chart 1**). For more information regarding the statistics used to create Chart 1, refer to Appendix A – Appendix E.

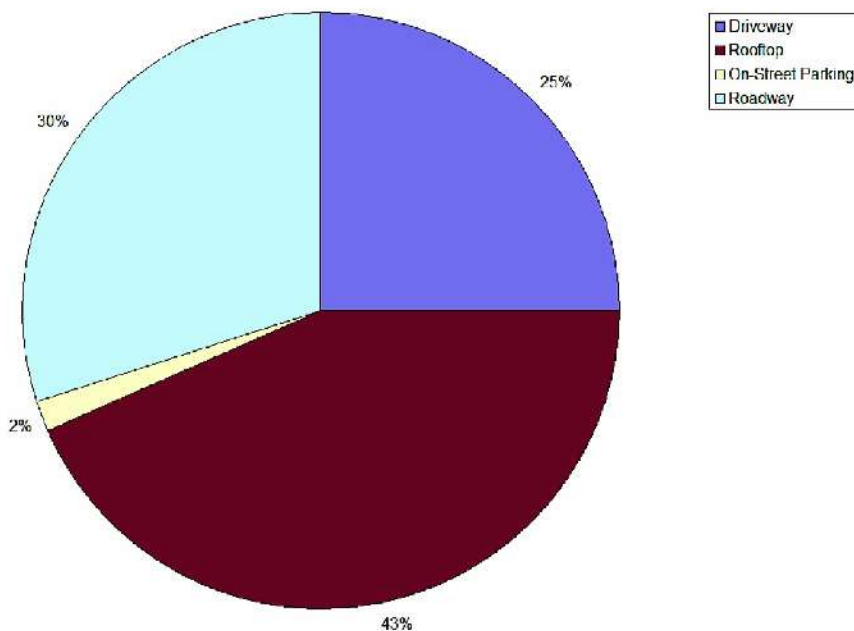
**Chart 2 – Analysis of Impervious Area along Tuscarawas Road**

As a check to insure that the analysis of the impervious area of Walhonding Road is representative of Glen Echo Heights, Tuscarawas Road was also analyzed. The analysis of Tuscarawas Road also showed that the roadway itself contributed only 30% to the total impervious area present on Tuscarawas Road (**see Chart 2**). For more information regarding the statistics used to create Chart 2, refer to Appendix F – Appendix J.

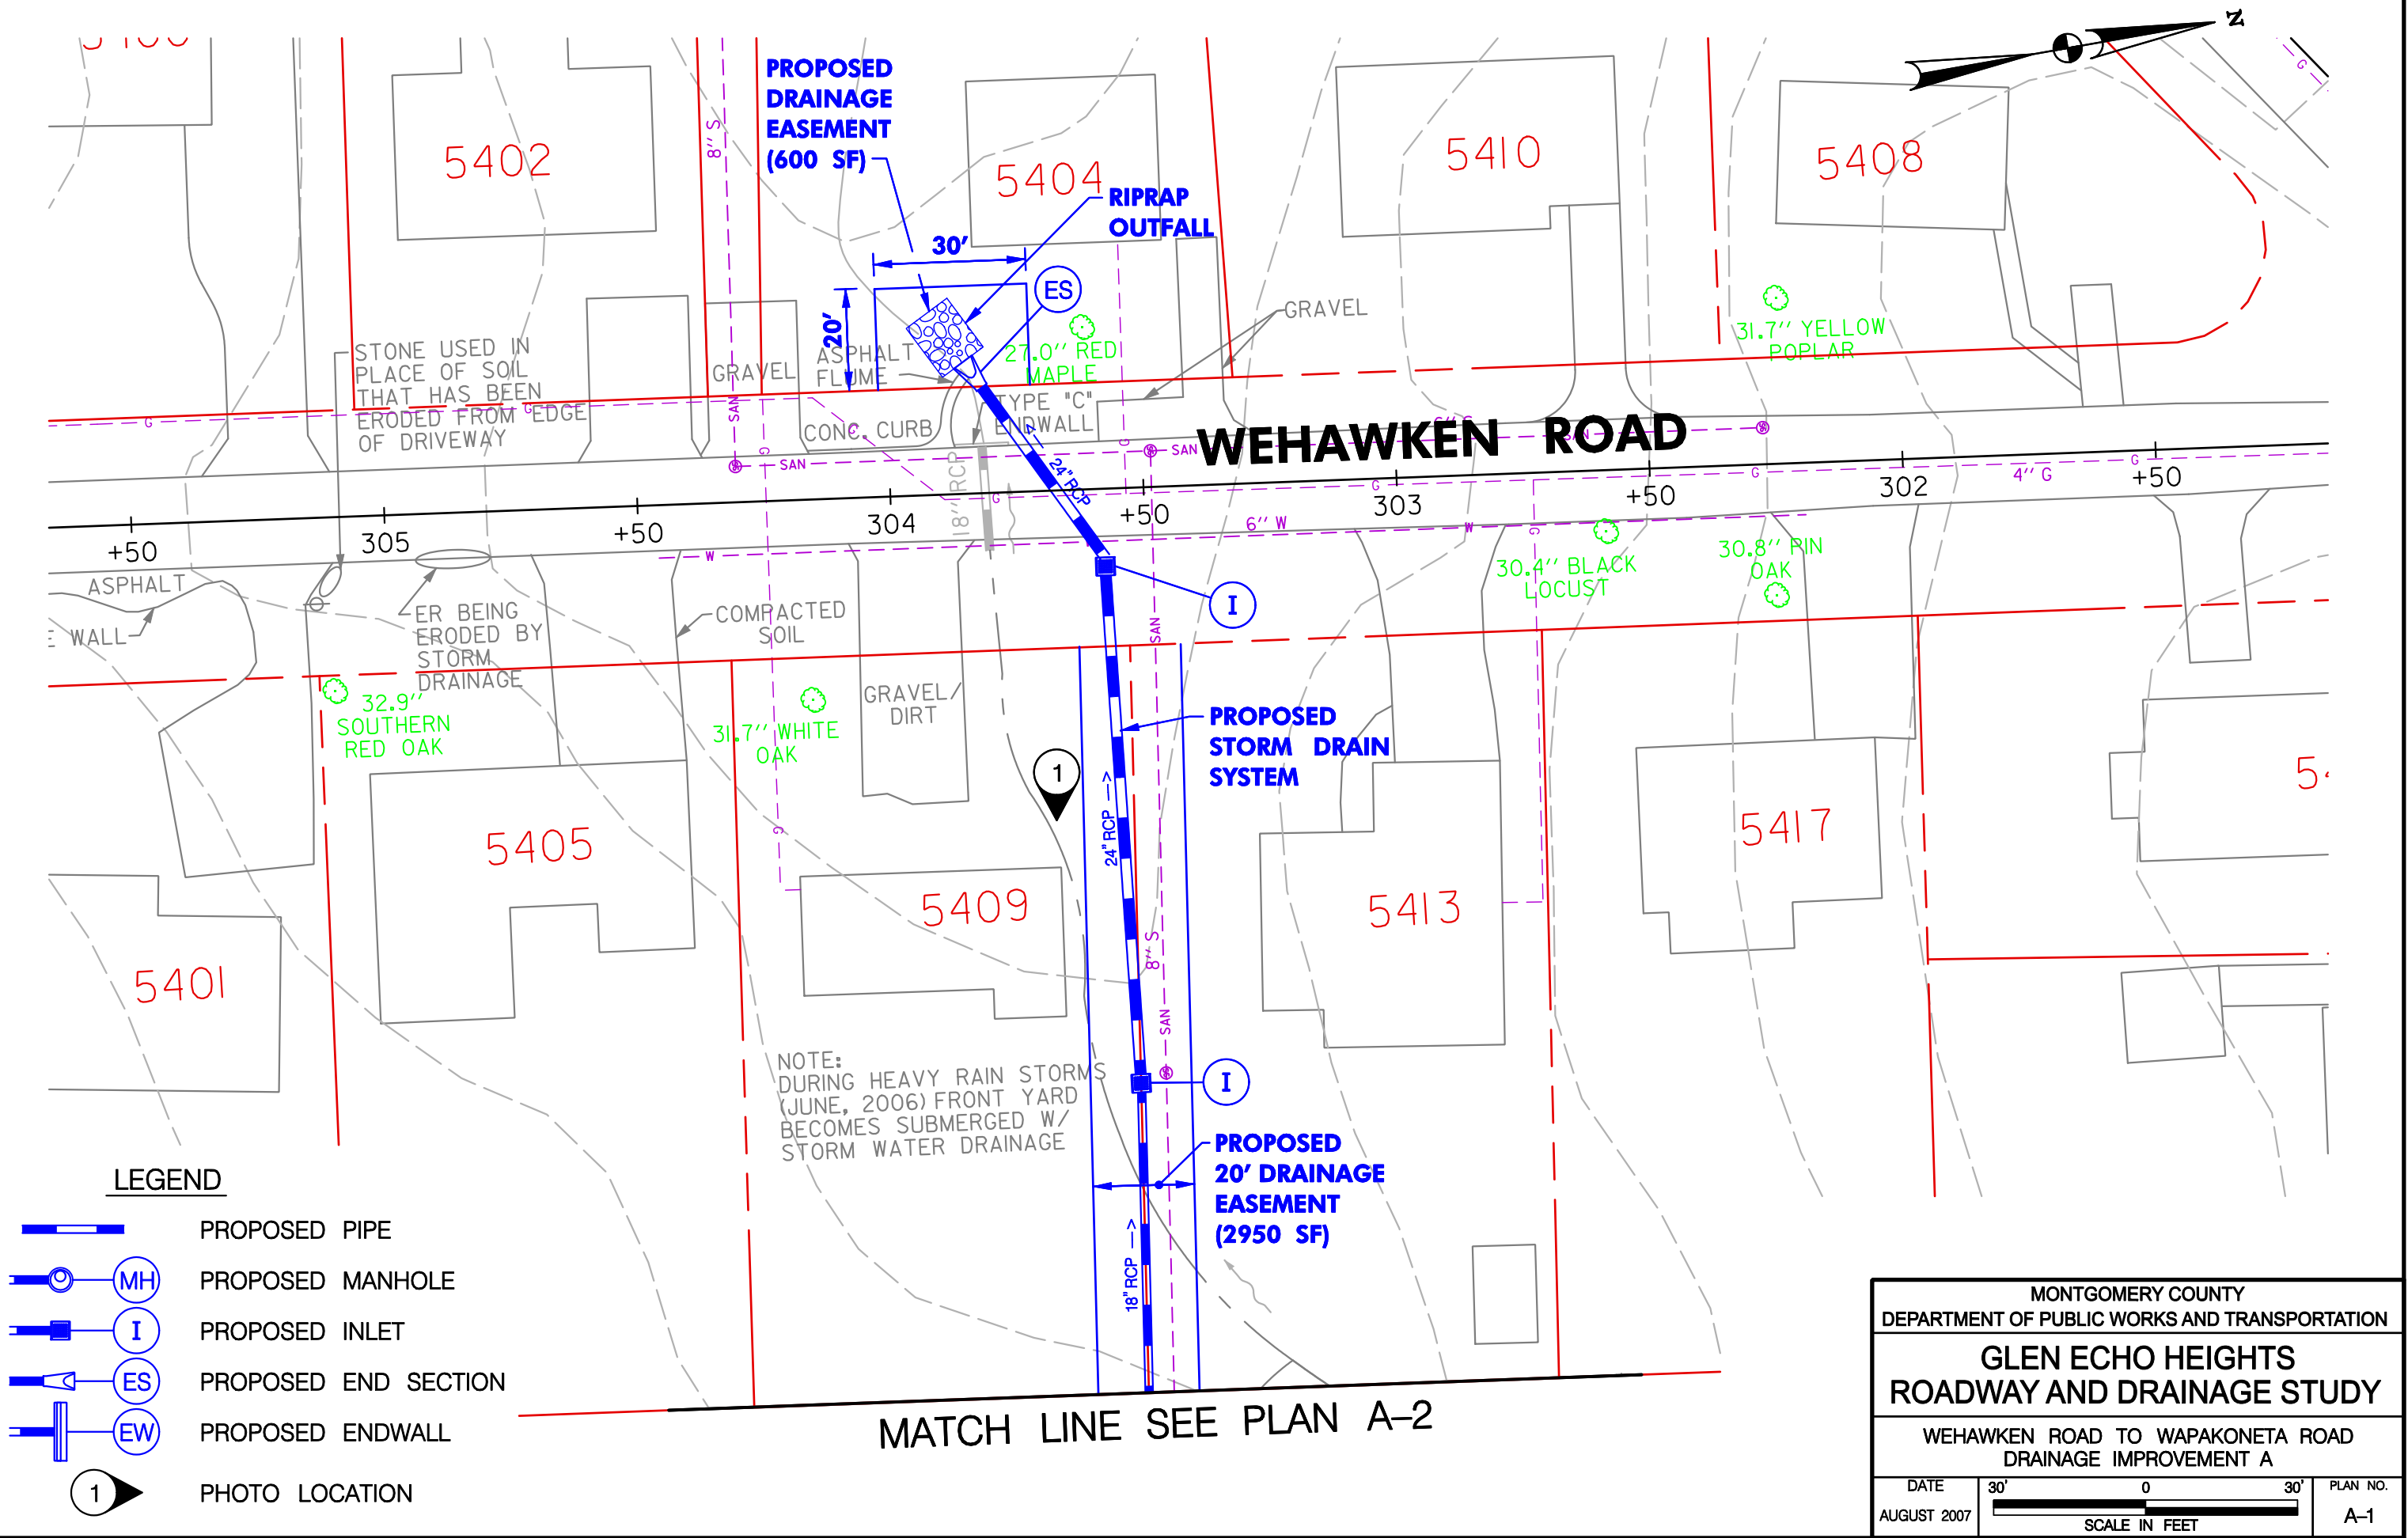
This drainage improvement consists of two problem areas. The first area is located at 5328 Wapakoneta Road. The issue at this location is the ponding of storm runoff in front of the asphalt flume located in the front yard of this property. In large rain events, the ponding water could create a driving hazard. Also, storm runoff from the opposite side of Wapakoneta Road is crossing the surface of the roadway, creating a safety concern for drivers. The second problem area is at 5409 Wehawken Road. The issue at this location is the surface runoff of water from Wapakoneta Road through the property at 5328 Wapakoneta. This water is carried in an asphalt swale to the backyard of 5332 Wapakoneta. The swale then ends in a dirt channel onto 5409 Wehawken Road and continues down very close to the house at 5409 Wehawken. Further downstream, the undersized and blocked 18" pipe under Wehawken Road

contributes to an undesirable ponding situation in the front yard of 5409 Wehawken Road. Additionally, the surface watercourse adjacent to 5409 Wehawken Road is within a few feet of the building, and has caused flooding and water damage to the structure (see **Plan A**).

While conducting the field investigation during a nominal rain event (approximately 1 – 2 inches of rain within a 24 hour period), ponding was observed in front of the property at 5328 Wapakoneta Road. Subsequent analysis of the area revealed two factors contributing to the drainage issue at this location. The first contributing factor is the lack of storm drainage structures on this segment of Wapakoneta Road. This segment of Wapakoneta Road begins at the intersection with Walhonding Road and ends at the intersection with Namakagan Road; approximately 950 ft of roadway without one storm drain structure. The second factor causing this drainage issue is the natural topography of the area in which the property at 5328 Wapakoneta is located at the natural low point for this segment of the road.

The upstream drainage problem could be remedied through the construction of a closed drainage system beginning in front of 5319 Wapakoneta Road and outfalling near 5404 Wehawken Road. Two grate inlets would be installed on the low point of Wapakoneta Road and connected by an 18" RCP to two grate inlets placed between 5409 and 5413 Wehawken Road. A 24" RCP would connect the two grate inlets to a new cross culvert on Wehawken Road. In addition, the existing ditch at 5409 Wehawken Road should be regraded to provide more depth and increased offset from the existing home located on this property. This work would require right-of-way or easement for the entire length of the proposed pipe and may impact existing water and gas facilities along both Wehawken and Wapakoneta Roads as well as have potential Waters of U.S. impacts. For plan view, refer to Plans A-1 and A-2.

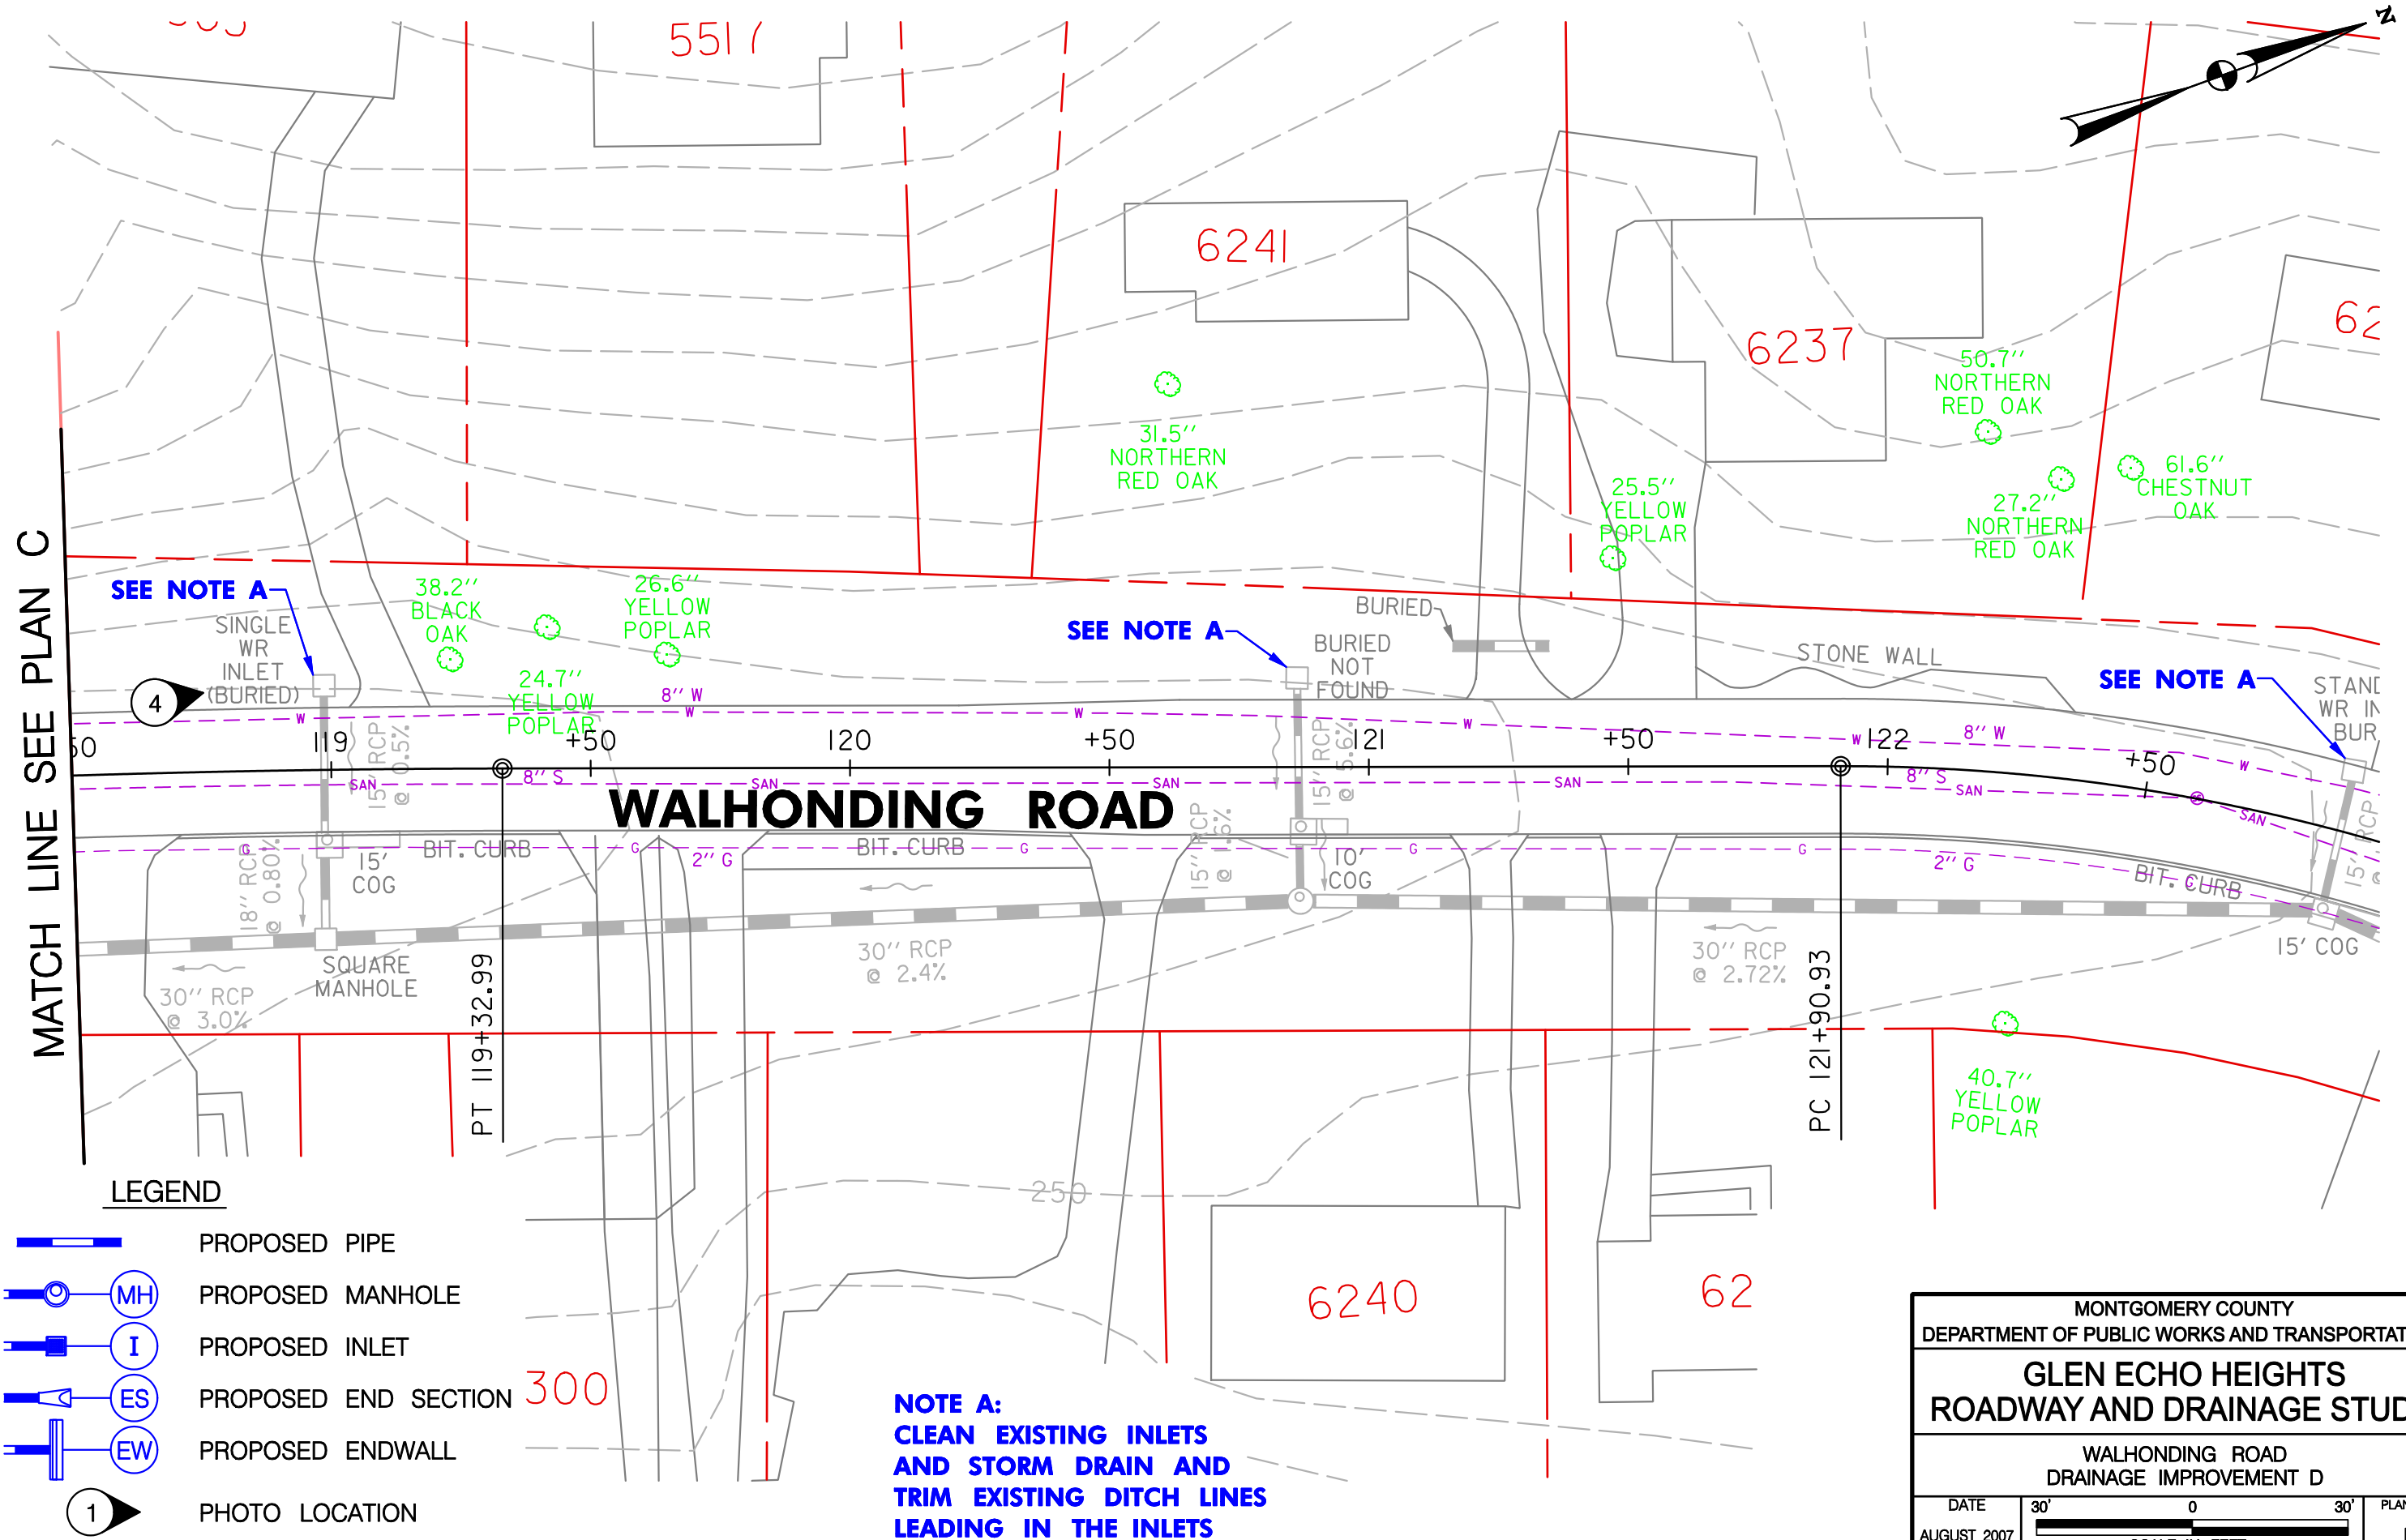
The grate inlets near each of these properties was found to be buried underneath several inches of topsoil, with the exception of the inlet at 6241 Walhonding Road, which the survey crew could not locate.

covering of these inlets. For plan view, refer to Plan D.

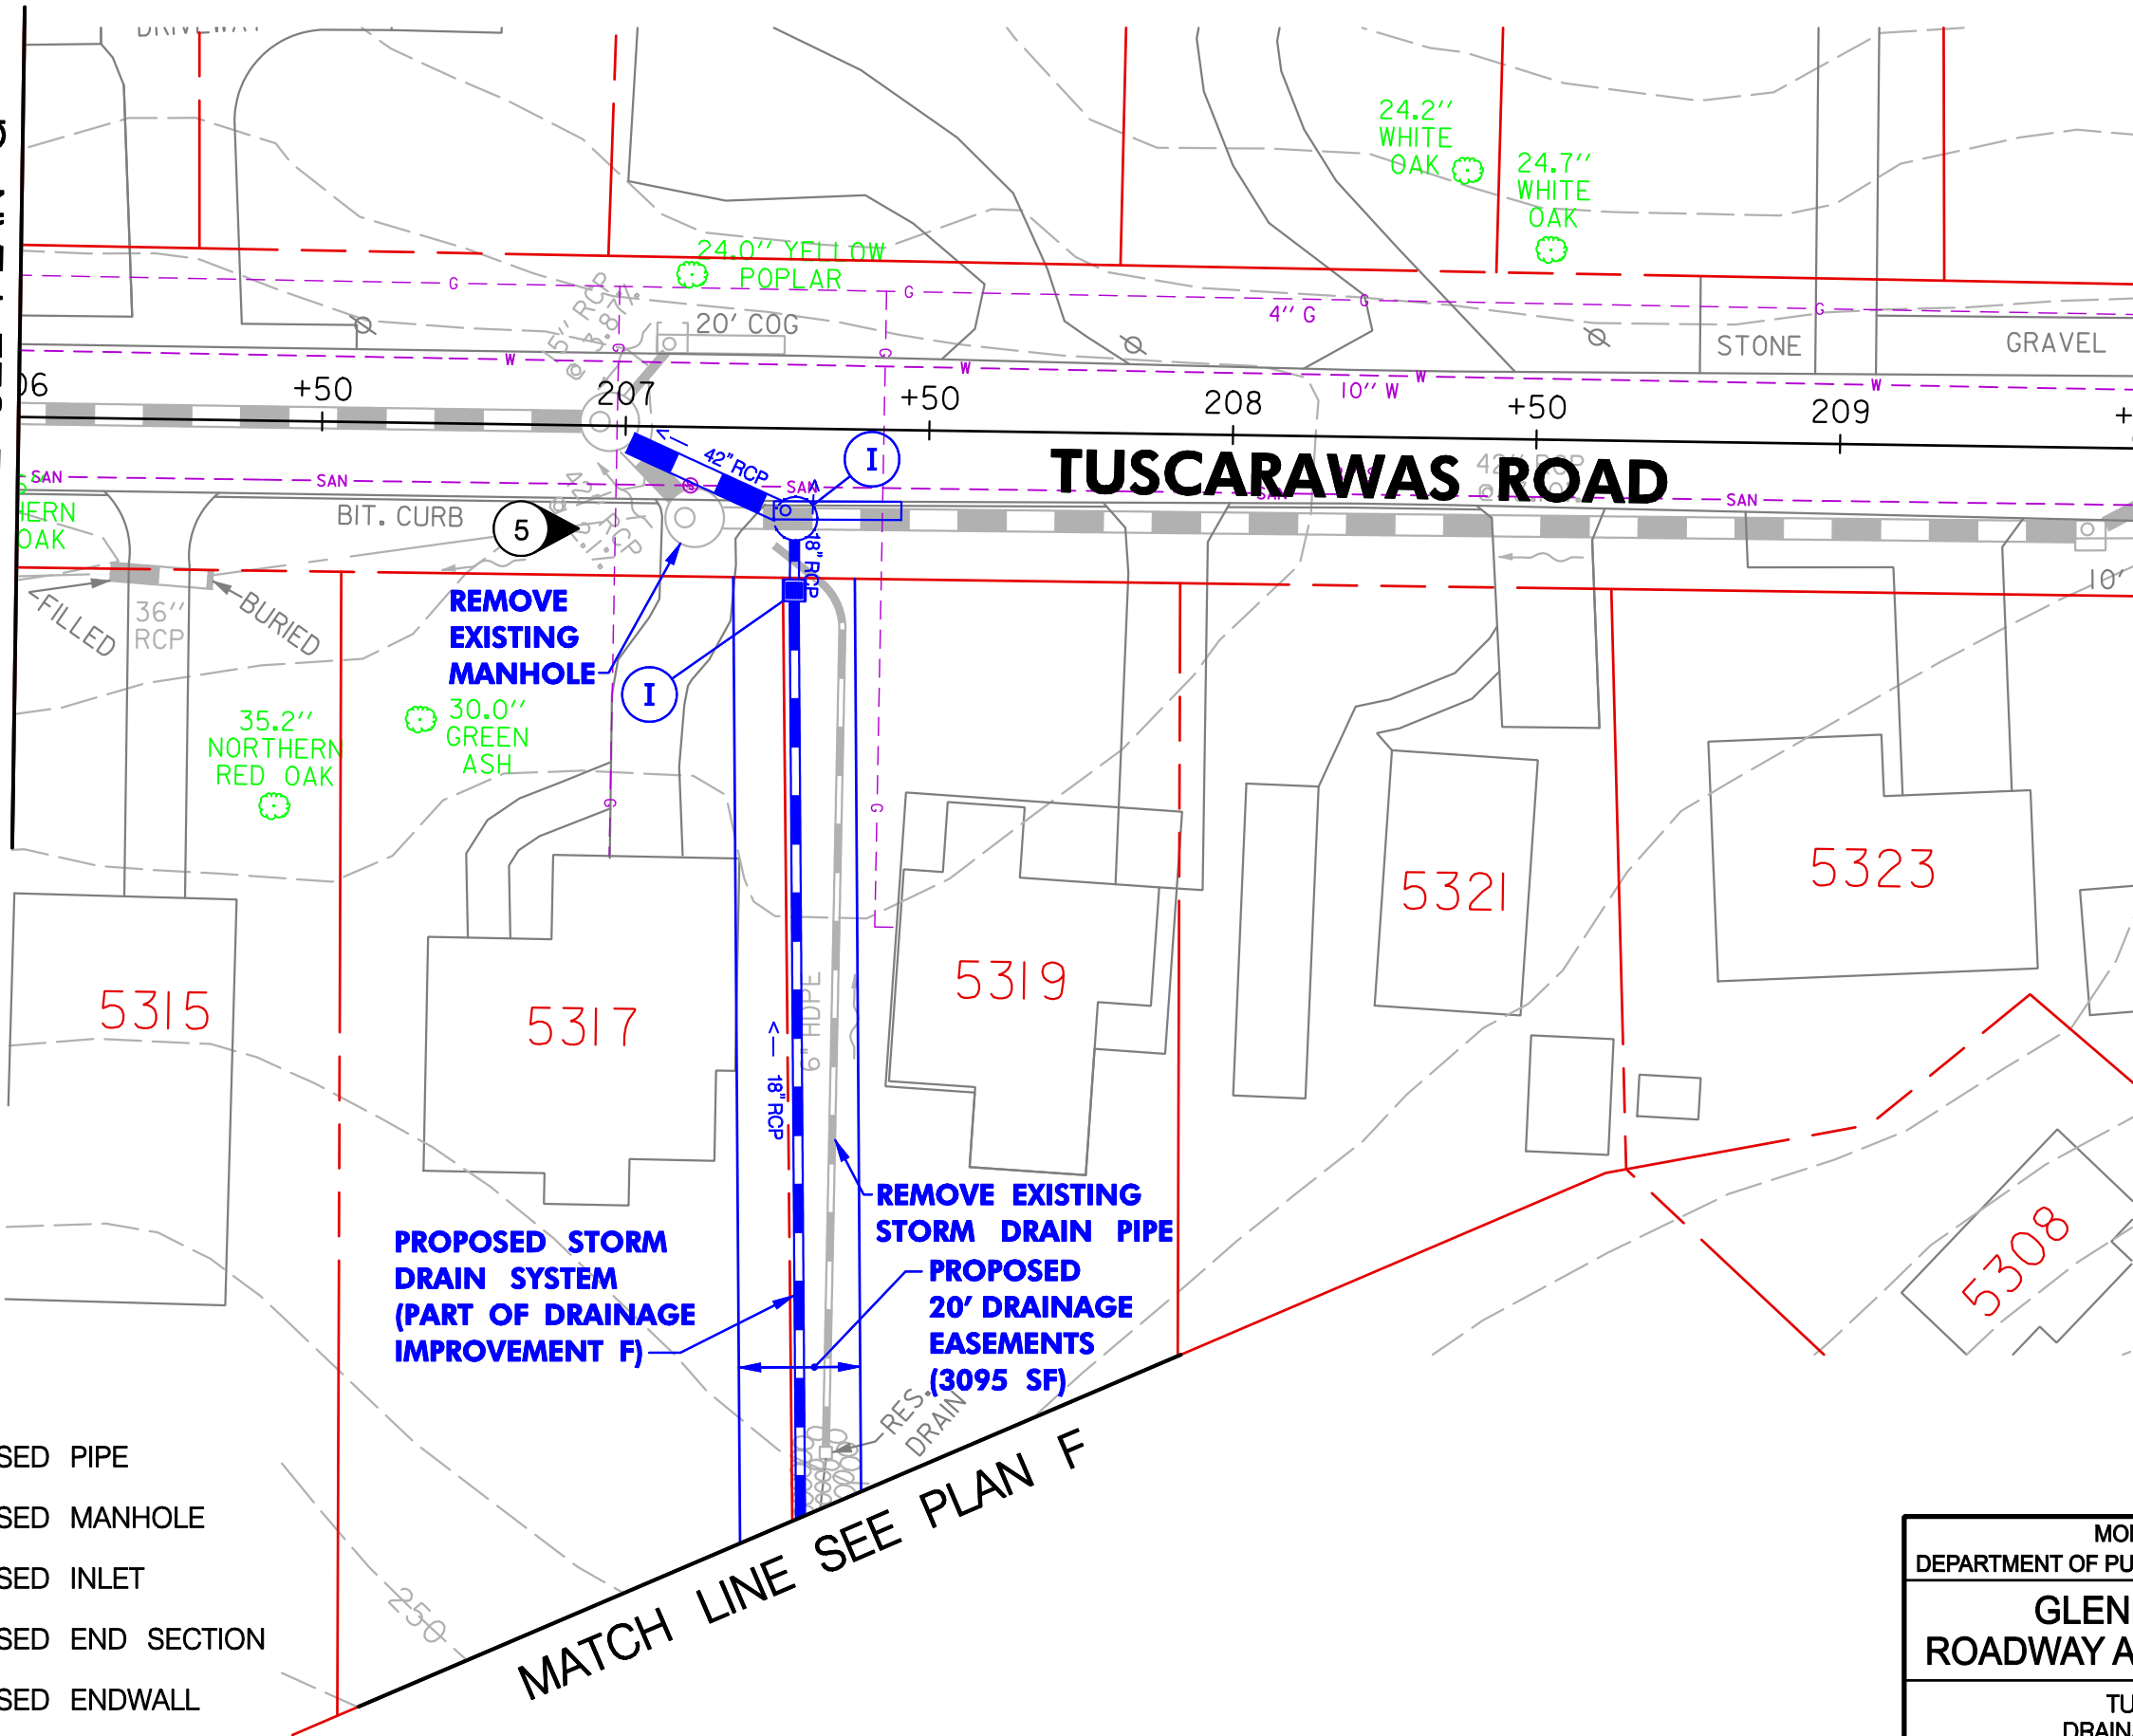
In the front yard of 5317 Tuscarawas Road, the existing manhole, previously converted from a curb on grade (COG) type inlet, has experienced a wall failure and is contributing to a sinkhole adjacent to the roadway (see **Photo 5**). Due to the sinkhole, ponding occurs during storm events which appears to have increased the size of the sinkhole.

structure to the rest of the SD system on Tuscarawas Road. The second factor is that the pipe or under-drain structure located at the end of the trough is allowing the storm runoff to pond in the trough section of the inlet. It is likely that there is a leak in the trough of the inlet causing the sinkhole that is located at the end of the trough section of the inlet. This sinkhole has been repaired multiple times, and the same issue has returned.

1. Remove the existing manhole and replace it with a COG inlet located approximately 17 feet east of the existing manhole along the existing curb. In addition to improving the drainage at this location, the amount of water flowing along the edge of Tuscarawas Road would be reduced significantly, which was contributing to drainage issues at 5311 Tuscarawas Road (**see Plan G**)
2. Construct a grate inlet between 5317 and 5319 Tuscarawas Road to capture surface runoff.

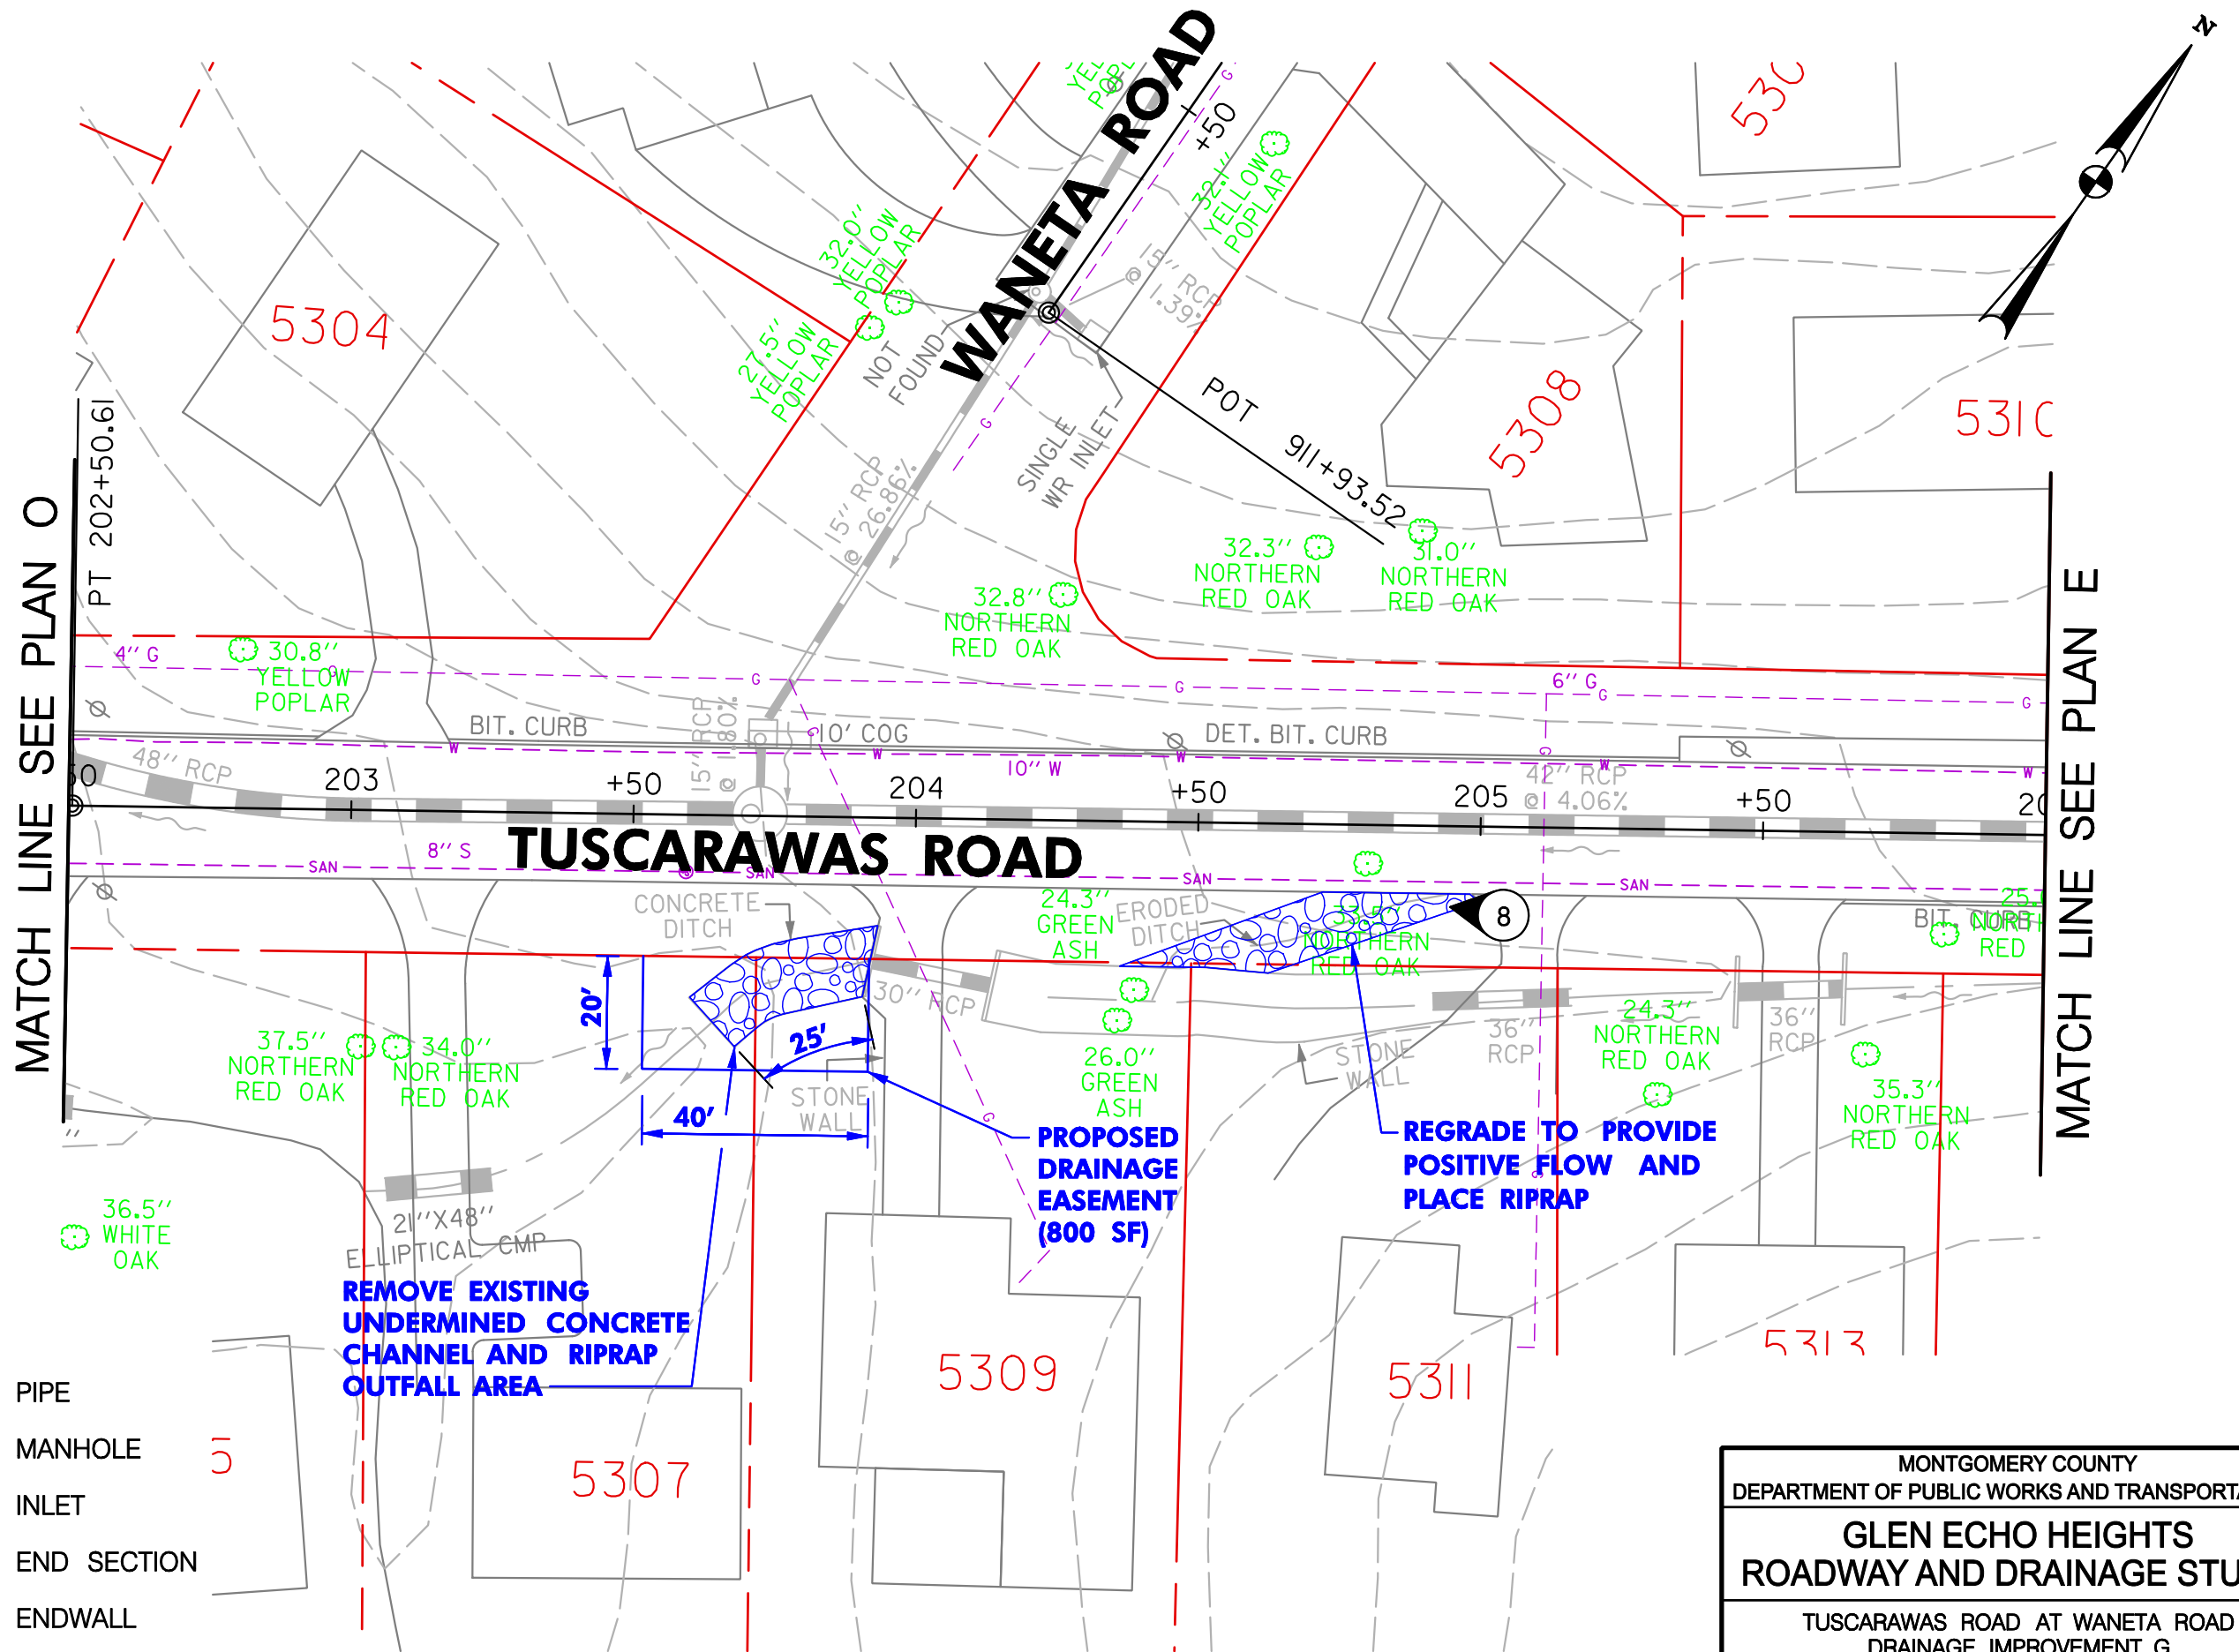
converted into a manhole, more storm runoff was allowed to stay on the surface of the road. Drainage Improvement E proposes to replace this existing manhole with a new inlet to capture a large amount of this runoff (See Drainage Improvement E). It should also be noted that the distance from the last inlet structure on the same side of Tuscarawas Road as this drainage issue is over 500 feet. The second factor is the lack of curbs on Tuscarawas Road. Since there are no curbs keeping the storm drainage along the edge of the road, the runoff has eroded the edge of the road. Another contributing factor is that crown of Tuscarawas Road has been flattened at places due to recent roadwork.

located at the outfall, which shows signs of potential settlement (eg. Cracks in wall, etc.)

1. Tuscarawas Road should be resurfaced in order to redefine the roadway crown, which has been reduced due to roadway patching.
2. The deteriorated and undercut outfall at 5307 Tuscarawas Road should be repaired by removing the remaining portions of the concrete apron and placing riprap to stabilize the outfall. This work should be performed as a first order of work to minimize any additional deterioration of the existing stone retaining wall

Items 1 and 3 should be considered maintenance issues, and can be performed within the existing right of way. Item 2 will require easement or additional Right-of-Way and may have potential Waters of the U.S. impacts. For plan view, refer to Plan G.
