Electric car fire in an underground garage. Courtesy of Fire and Rescue Department of the Capital City of Prague. Computer translated from Czech language Nov 2023

## Electric car fire in an underground garage

Incident Date: 4. 5. 2023 @ 23:56

Location: Praha 2, Bělehradská 299/132. Czech Republic

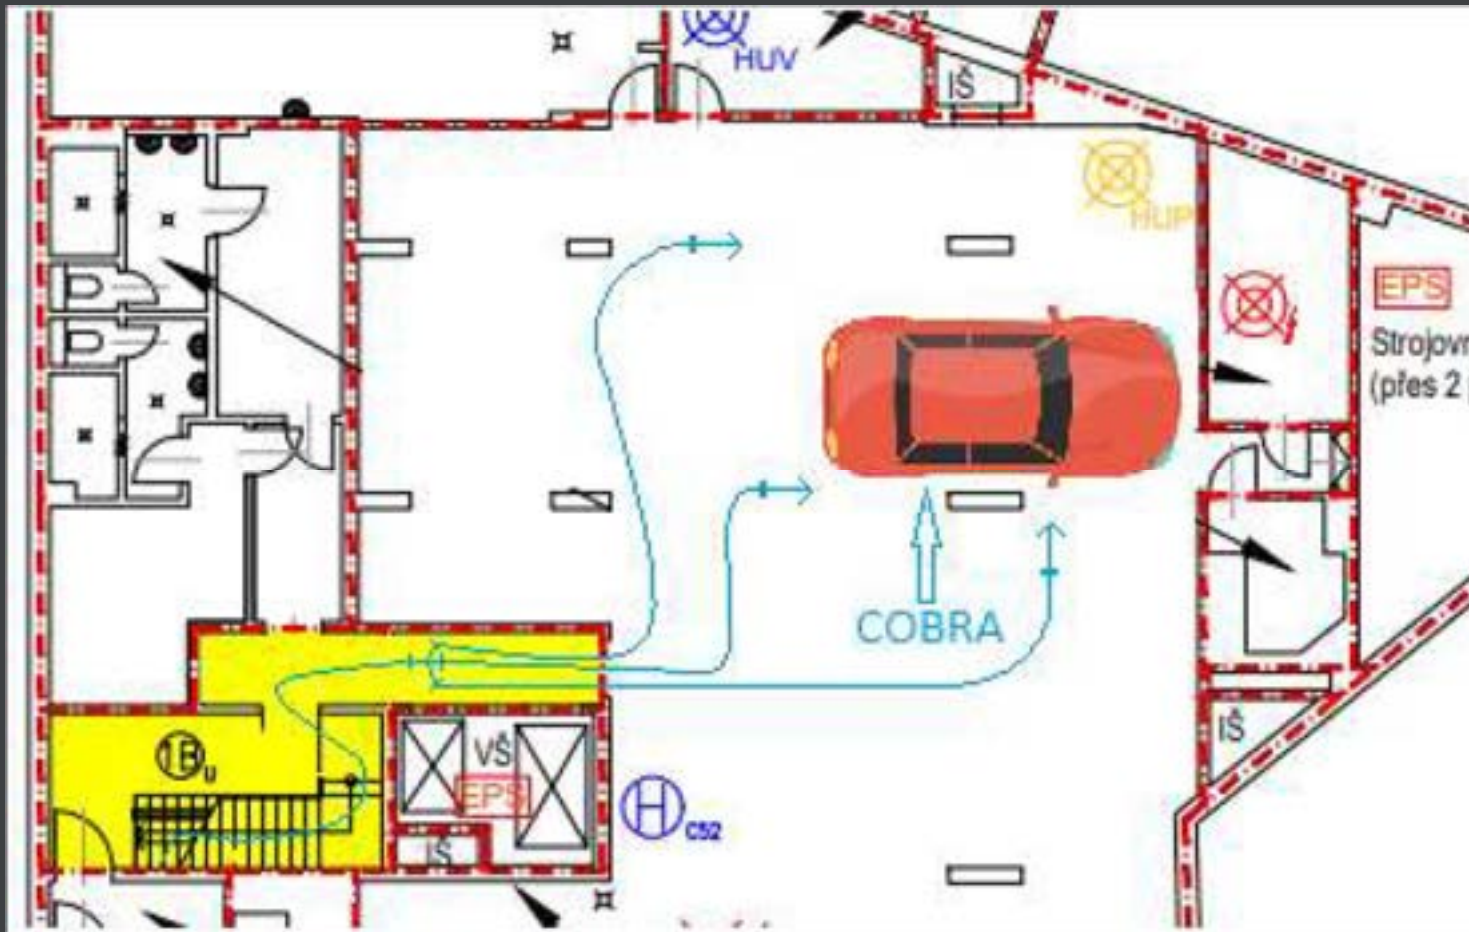
# Situation Drawing

- A survey of these areas revealed white fine smoke coming from an electric car connected to the charging station and visible damage to the traction battery,

- explosion in the chassis part of the EV,
- immediate increase in smoke production,
- flaming burning,
- manual disconnection of the charging rectifier of the car from the electric networks,
- combat development, creation of a transport line 1 x B 75mm with a distributor and deployment of 2 x C42 mm,
- zero visibility,
- orientation possible only with thermal cameras,

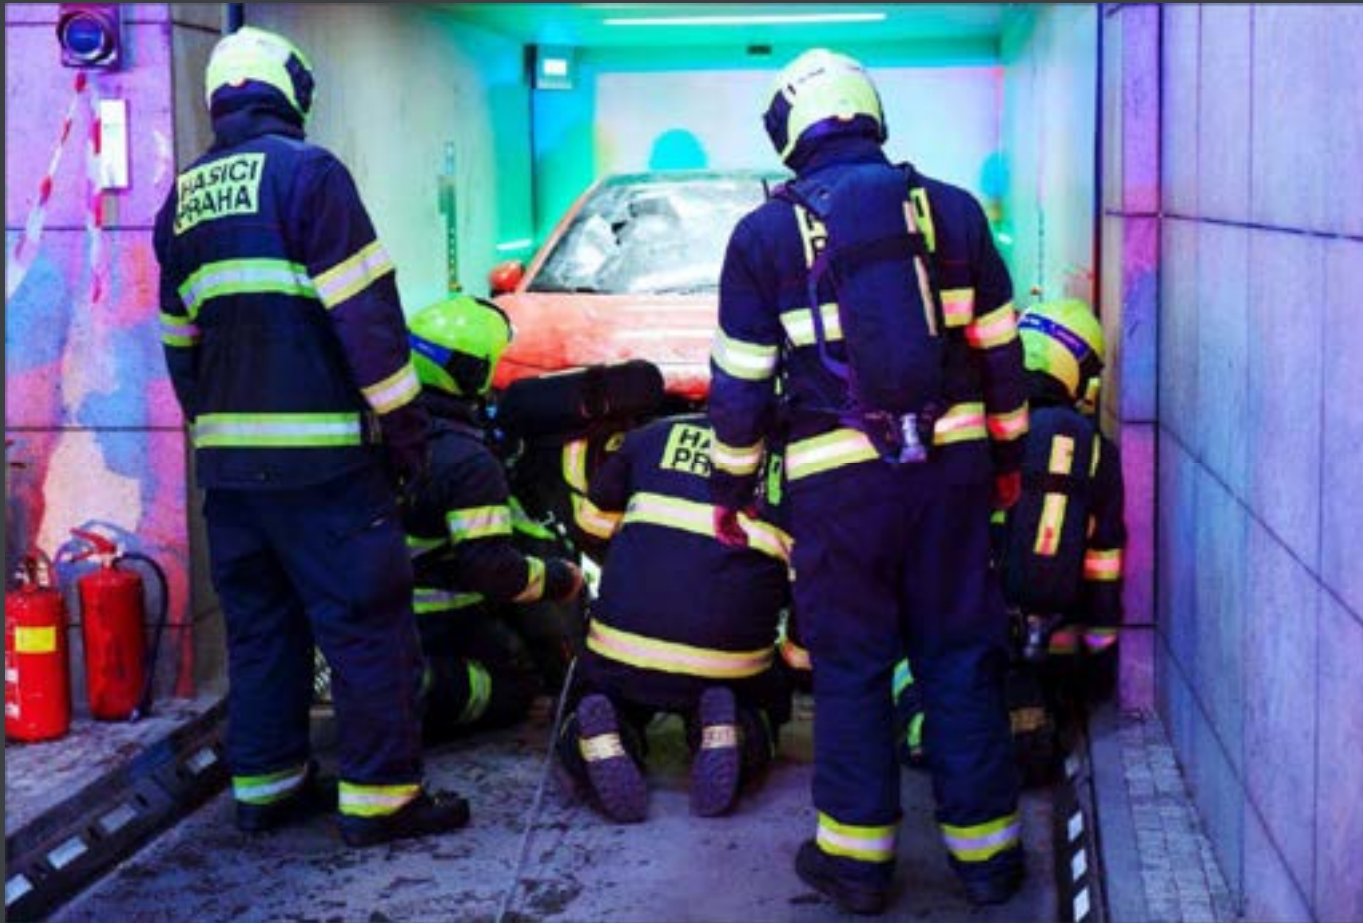
## Intervention Timeline

- lift cabin open on the 1st floor level,
- using the VYA-L1Z electric car pulled out of the lift,
- electrolyte was leaking from the vehicle's battery all the time communication.

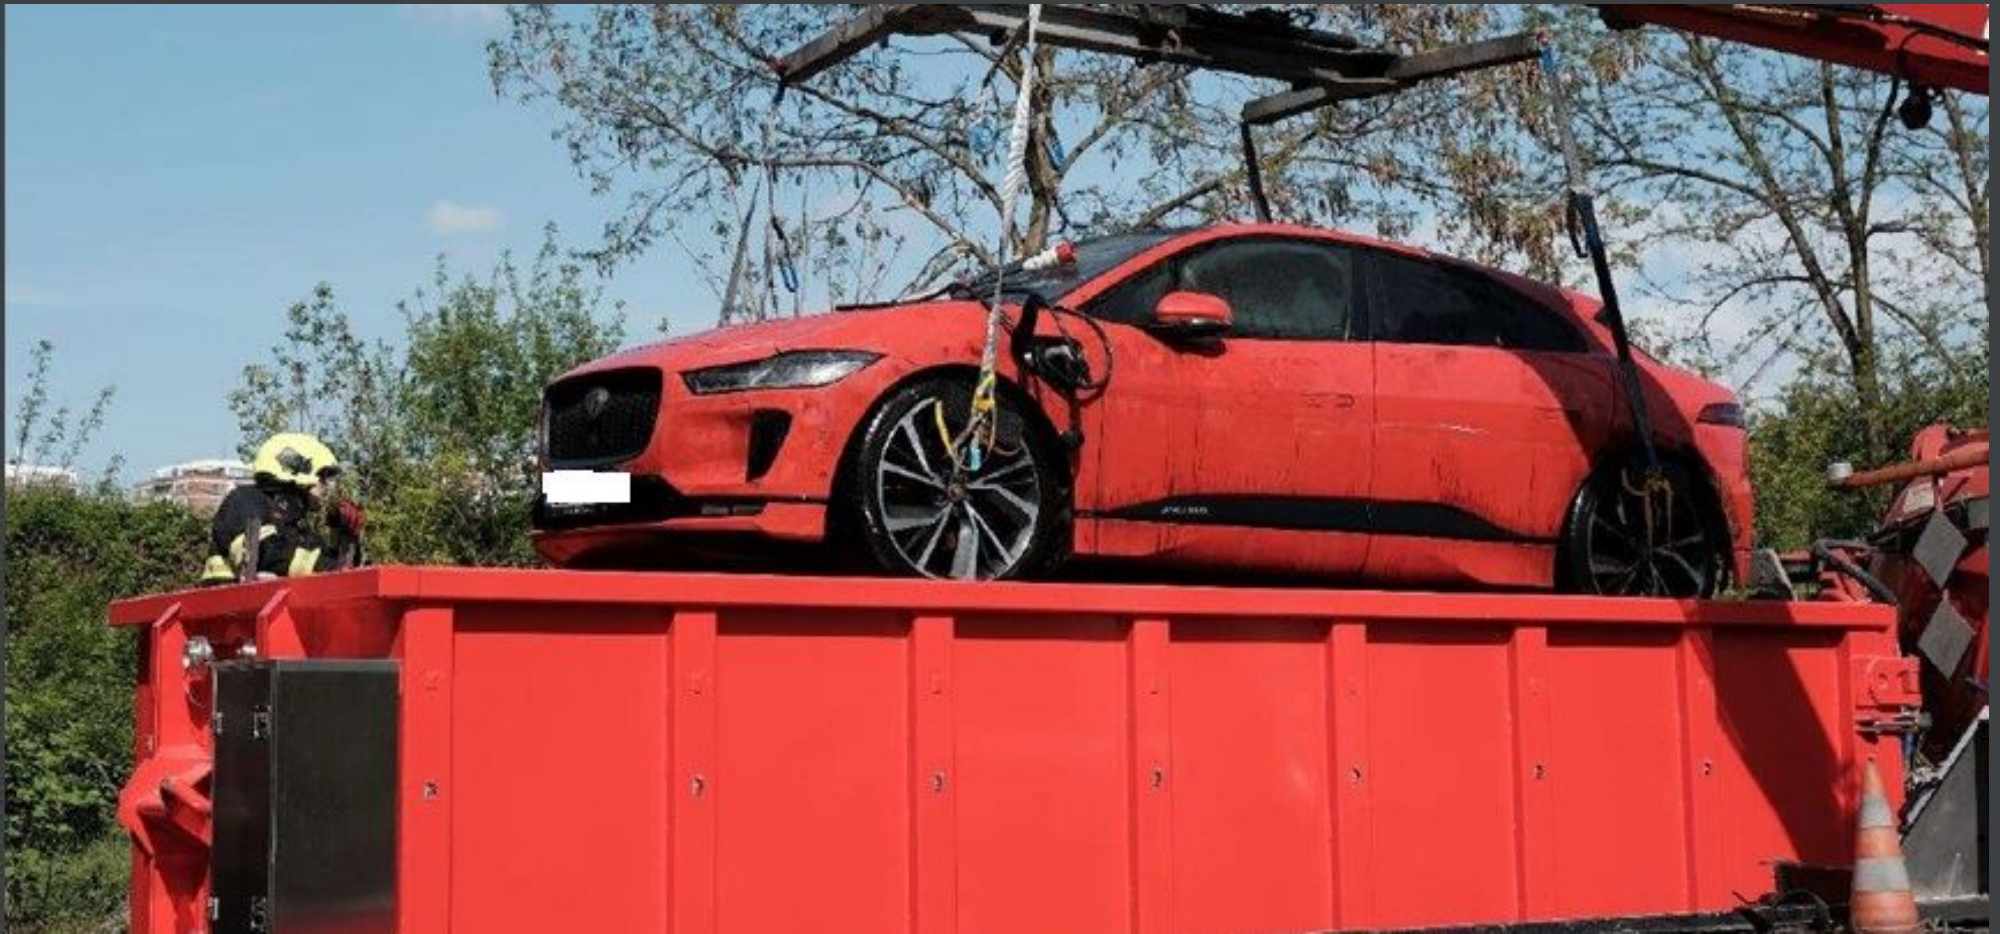
Incident Vehicle with KHE (water container)

- sampling and their analysis,
- checking the condition of the electric car – everything is stable,

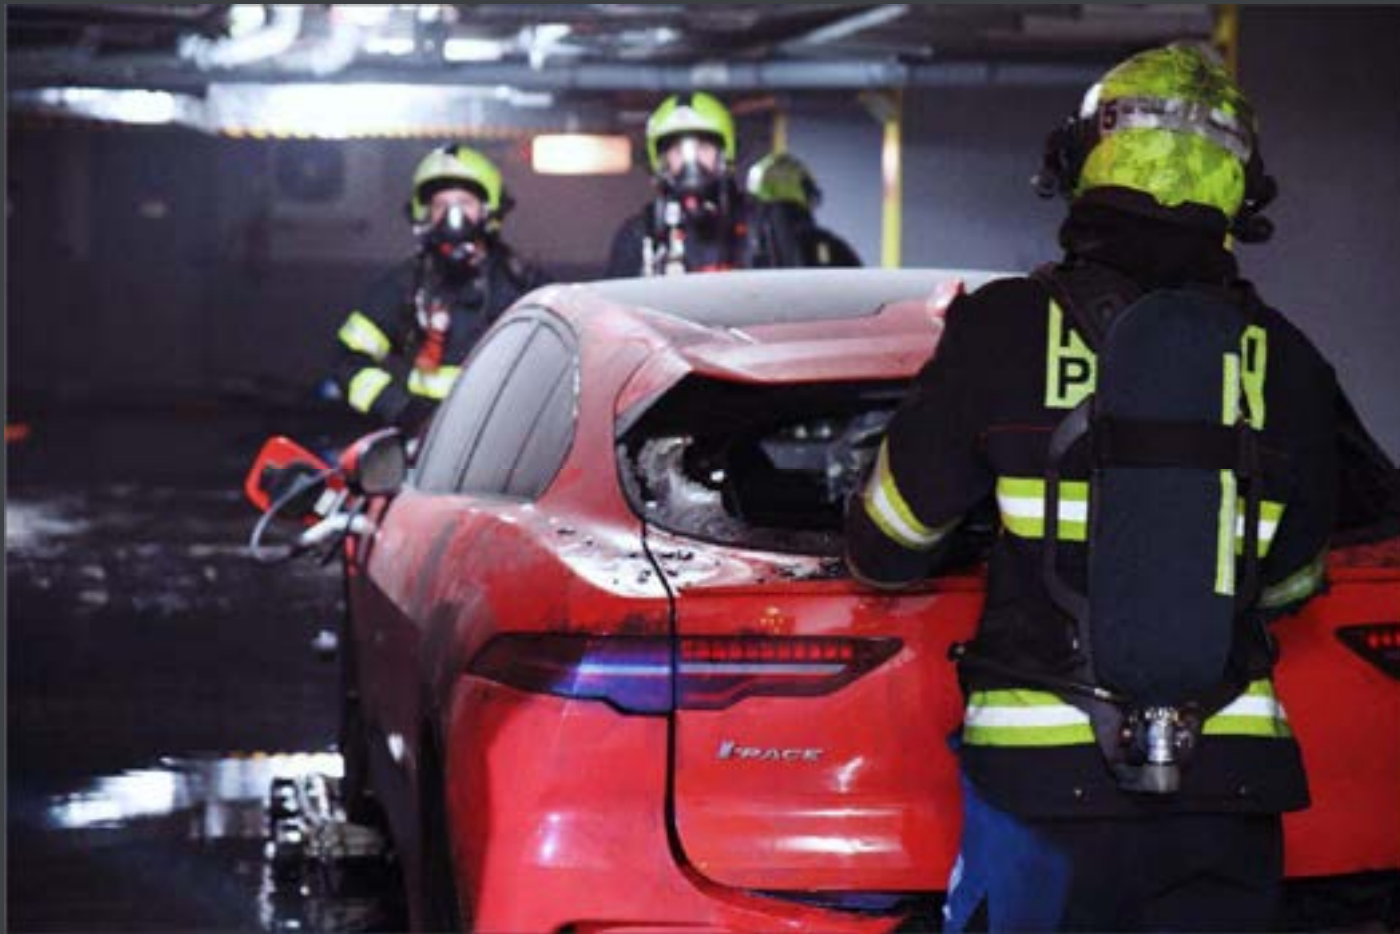
Negative effects of intervention

- the COBRA fire extinguisher does not provide sufficient protection for the operator – it is necessary to have a water jet to cover firefighters from the start of COBRA deployment in the immediate proximity.
- Damaged protective suit of member who used COBRA.

- insufficient width of the lift cabin, unsuitable for transport use trolleys, emergency control of elevators from the cabin, impossibility to stop in the same level with the floor, damage to the transport trolley during attempts to drive up to the elevator, the need to purchase access ramps,
- absence of emergency control of the vehicle lift in the event of a fire – EPS stated elevators to the described mode, it was not possible to operate the elevator further, for example to create a ventilation hole or to transport a vehicle to the surface,
- absence of access ramp equipment for overcoming height differences,
- the elevator system was the only access route for cars to lower floors,

- it is not possible to leave a container anywhere in the city, communication before the building was busy, including tram traffic,
- it is not possible to transport the vehicle in any other way – there is a constant flow of chemicals from the vehicle.
- corrosive substances escape when handling the vehicle,
- elevator shafts and the lower floor were flooded with contamination fire water,
- due to the fire of the traction batteries of the electric car, the premises filled with smoke very quickly.
- there is no device for fire ventilation and local performance. In the building, the installed ventilation is insufficient.

- the Cobra high-pressure cutting device can be placed on the chassis of a pick-up truck with the option driving into underground garages,
  - increase the number of KHE in the territory of Hl. city of Prague, minimum condition 3 pcs.,
  - equip the KHE construction with anchor points in the rear part to ensure transport EV,
  - different design of handling carts under EV wheels, focus on load capacity, width and manoeuvrability, the ideal option is not to exceed the floor plan of the vehicle and possibility of filming all wheels + locking,
  - equipped with approach ramps for overcoming height differences,
  - equipped with crossing plates for overcoming unevenness and holes,
- the wheels of handling carts must be made of durable materials acids and bases,
