Montgomery County Fire and Rescue Service

Post Incident Analysis

Fatal Plane Crash
19733 Drop Forge Lane
Gaithersburg, MD

Incident Date: December 8th, 2014
Incident # 14-0140425
Submitted by Chief Scott Goldstein

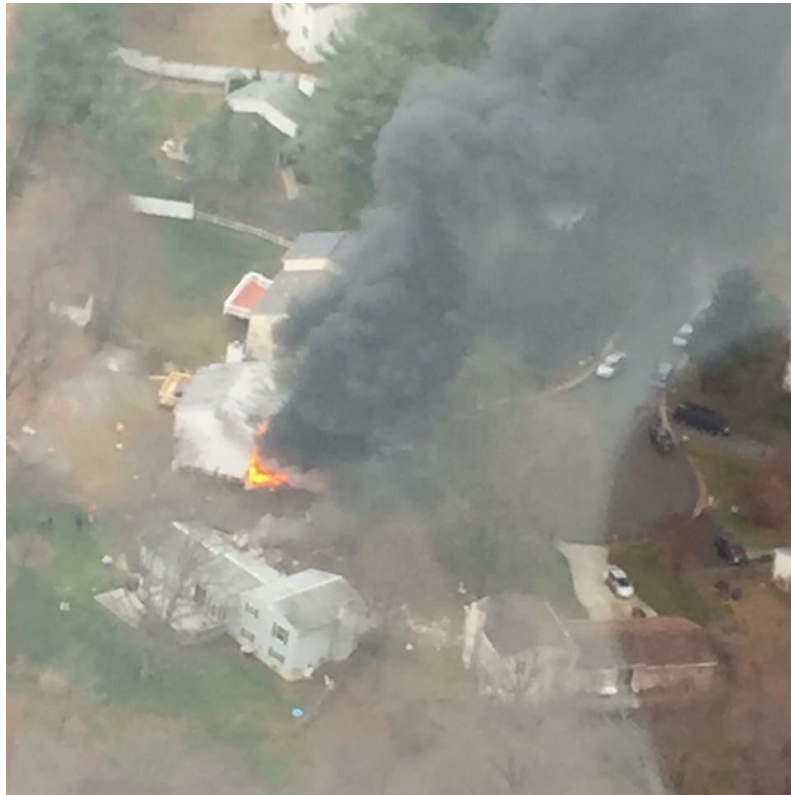
Conditions prior to arrival of Paramedic Engine 728

The initial action plan of Paramedic Engine 728 was to focus on the fire conditions at 19733 Drop Forge Lane as the fuselage in front of 19737 Drop Forge Lane did not appear to contain survivors and the fire there was not a serious threat to that house. The Captain instructed one fire fighter to focus the
