# **SIGNIFICANT INCIDENT INVESTIGATION FINAL REPORT**

**TRUCK 411  
BEACON HILL ROAD  
AUGUST 12, 2014 – 0426 HOURS**

FAIRFAX COUNTY FIRE AND RESCUE DEPARTMENT  
*SIGNIFICANT INCIDENT INVESTIGATION REPORT*

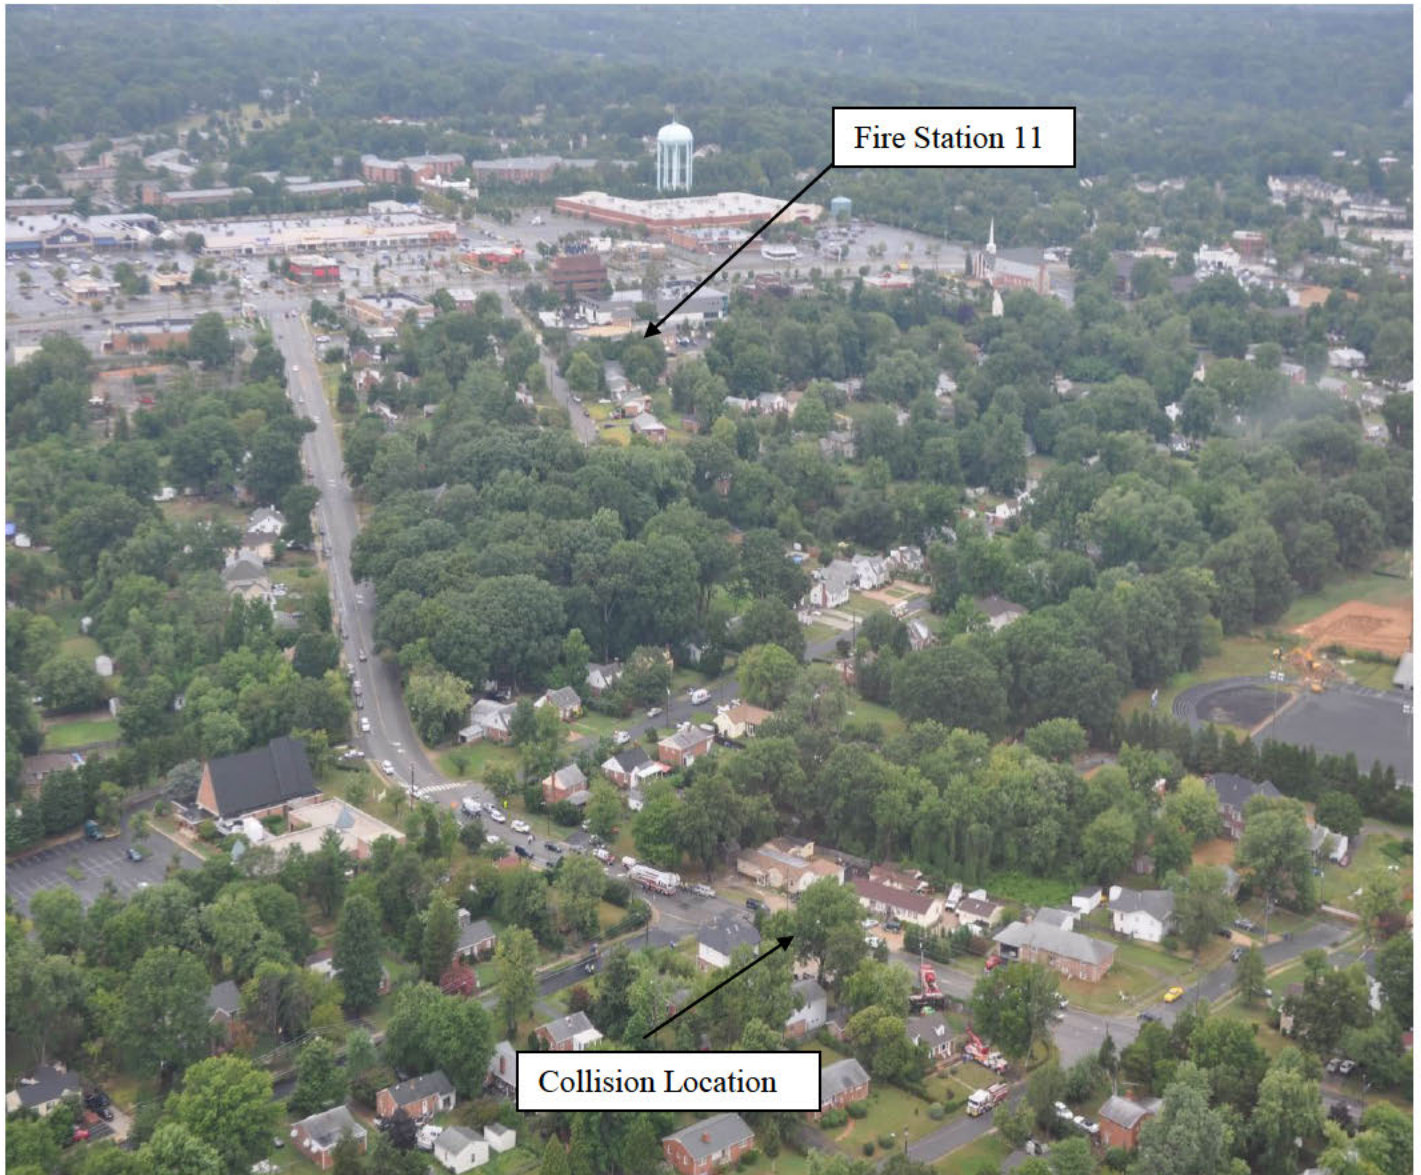
**Scene Photographs**

The utility pole they struck was fractured and severely damaged. Wires were on the ground and in close proximity to the apparatus. The crew members confirmed prior to dismounting that the wires were not in contact with the apparatus. Citizens attempting to assist the crew began to walk towards the apparatus and, unknowingly, the downed power lines. Fearing for the citizens' safety, the crew directed them away from the apparatus.
