Montgomery County Fire & Rescue Service

POST INCIDENT ANALYSIS

8701 Arliss Street Silver Spring, MD 20910

August 10, 2016

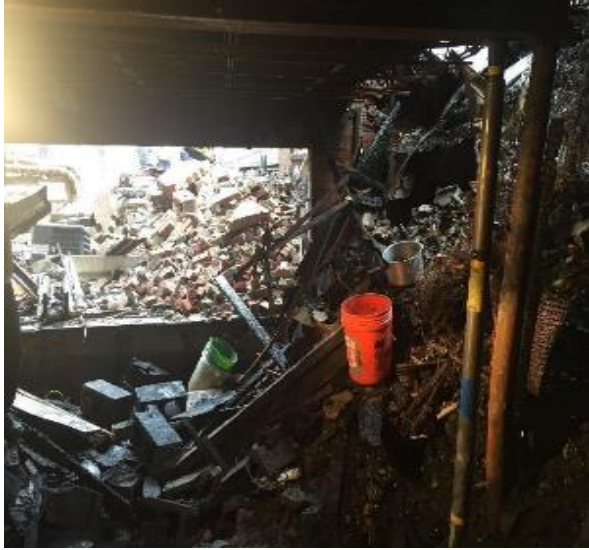
Terrace Level – 8703

1. Shoring on the second floor of 8701 completed
2. Struts placed adjacent to compromised columns in the terrace level of 8703
3. Unstable roof section removed via crane of Side Alpha of 8701
4. During the delayering operations on the terrace level 8703 one victim was located and removed
5. Removed failing brick façade from Side Bravo of 8701 where it joins to 8703
6. Begin delayering operations in the terrace level of 8701
