MONTGOMERY COUNTY FIRE & RESCUE SERVICE
POST INCIDENT ANALYSIS

19350 Churubusco Lane
March 14, 2016

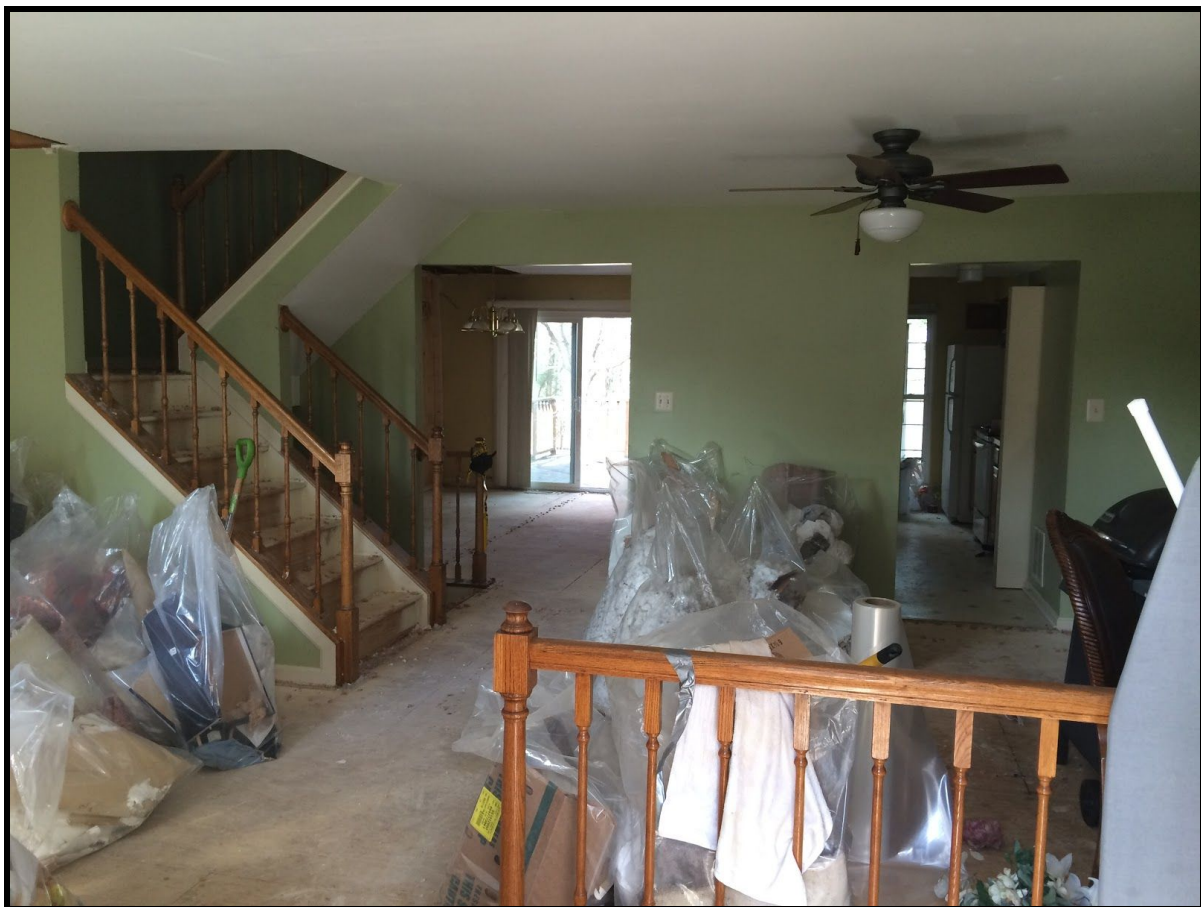
Layout of the first floor as viewed from the front door. Taken from comparable exposure structure.

On the first floor Paramedic Engine 729 found that the floor was sloping from front to back, the neutral plane that was only about 3.5-4 feet off of the floor, and that of all of the water that they flowed into the overhead spaces, none of it rained back down. The crew advanced about 10 feet inside the structure under harsh conditions, this is where the nozzle person was burned.

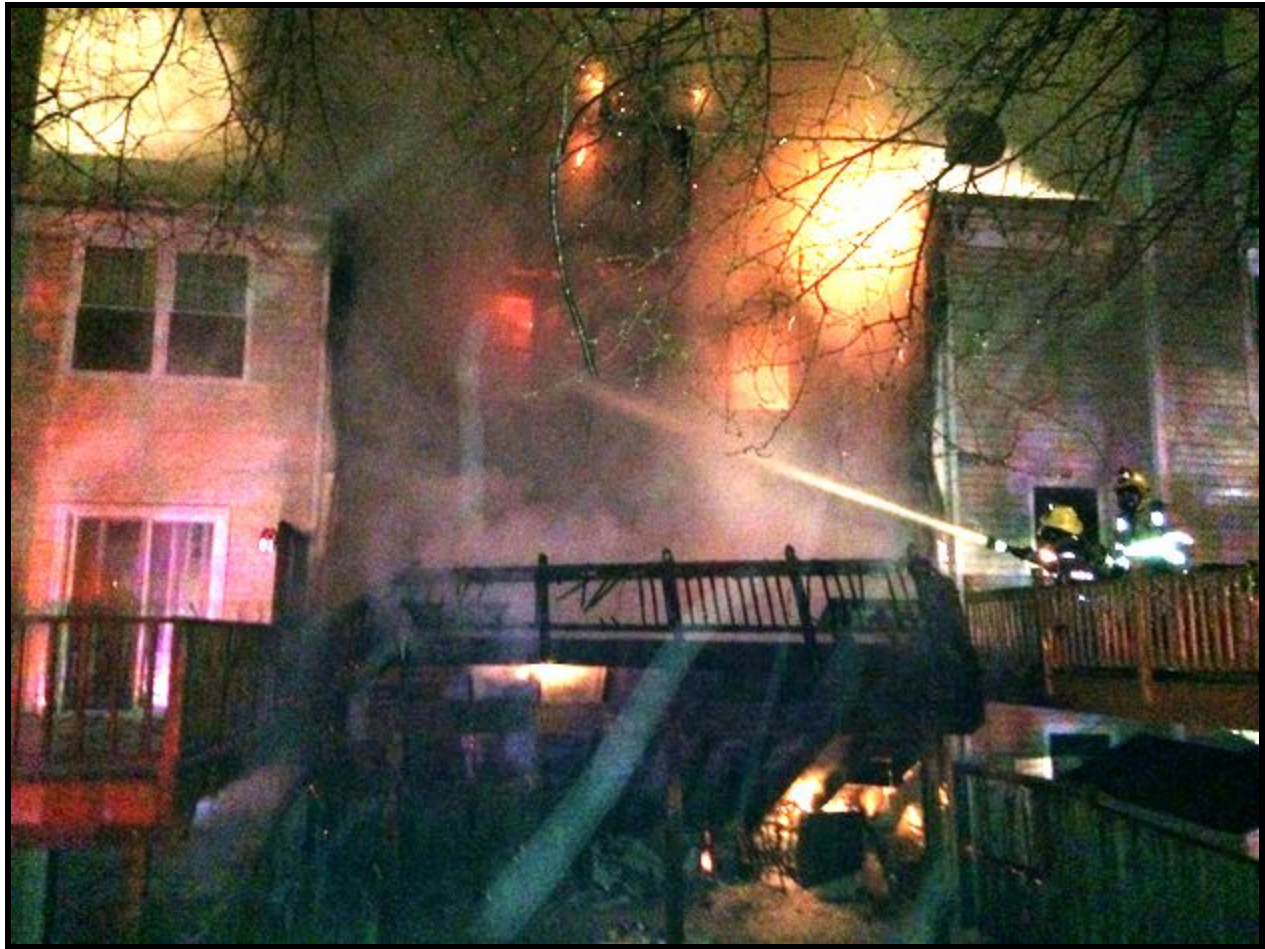
View from Side Charlie of Paramedic Engine 734 attacking the fire.

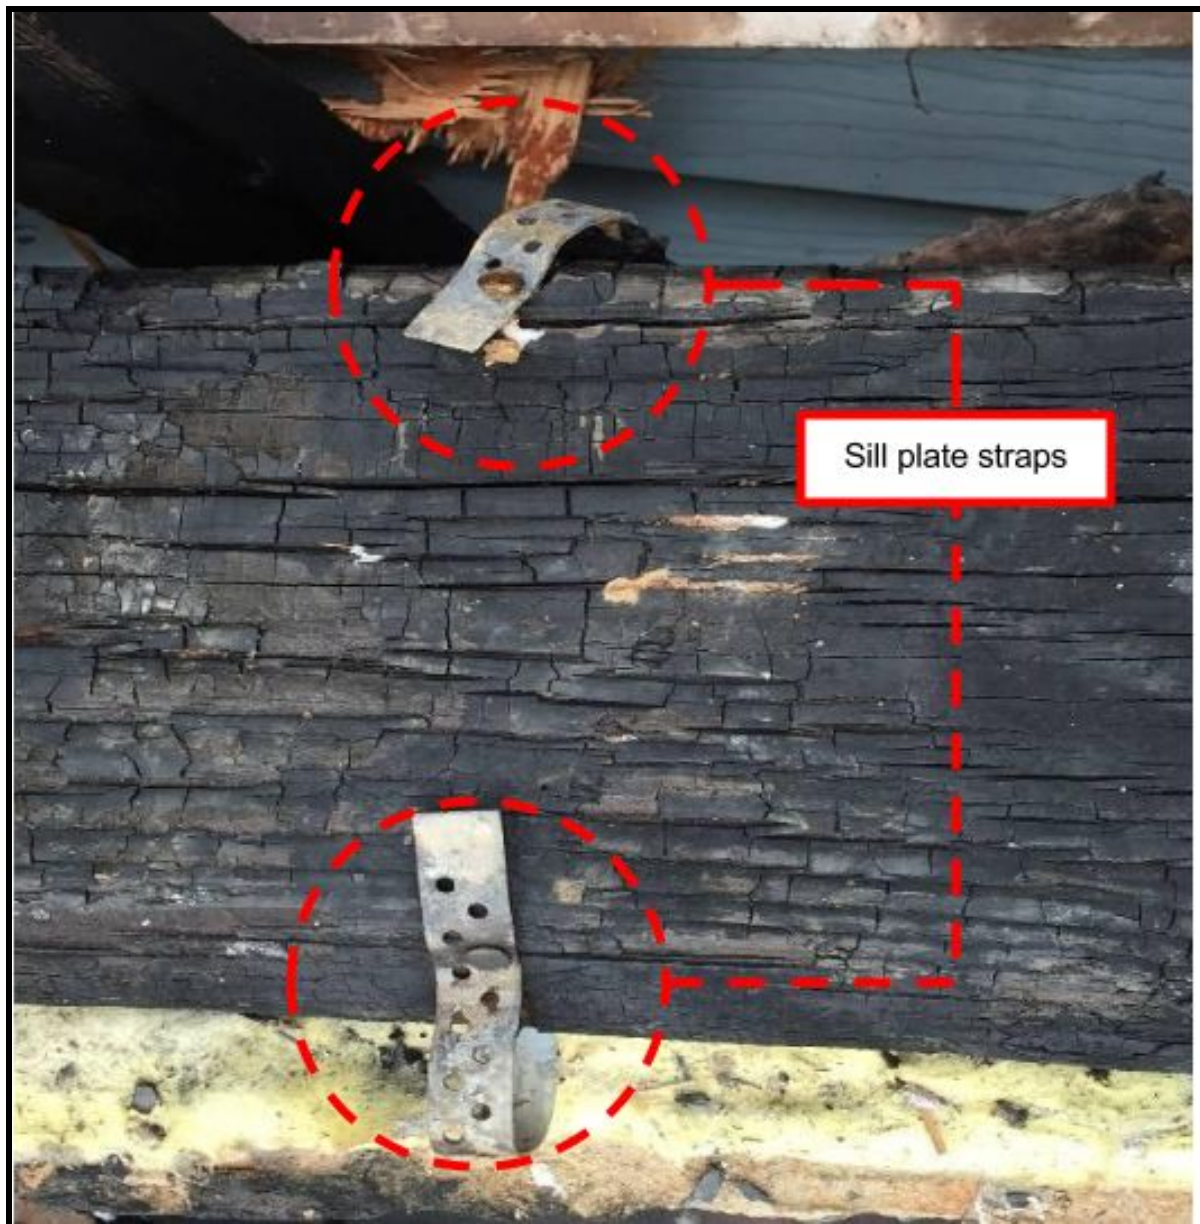
In most cases, the first floor platform would originate off of the foundation walls. An exception to this would be any framing that originates directly from the slab whether it be an at grade slab or from a basement slab. Framing that originates from the foundation walls begins with a sill plate which is typically pressure treated lumber. The sill plate is fixed to the foundation wall via bolting or strapping. In either case, the goal is to permanently fix the sill plate to the foundation wall prior to the installation of any floor joists. You can see the remnants of the strapping system in the photo below.
