## Case Study Review 19211 Watkins Mill Road

### *Gas Leak with Catastrophic Explosion June 15-16, 1993*

Presented by: Lieutenant Bill Bindl &  
Battalion Chief Barry C. Reid

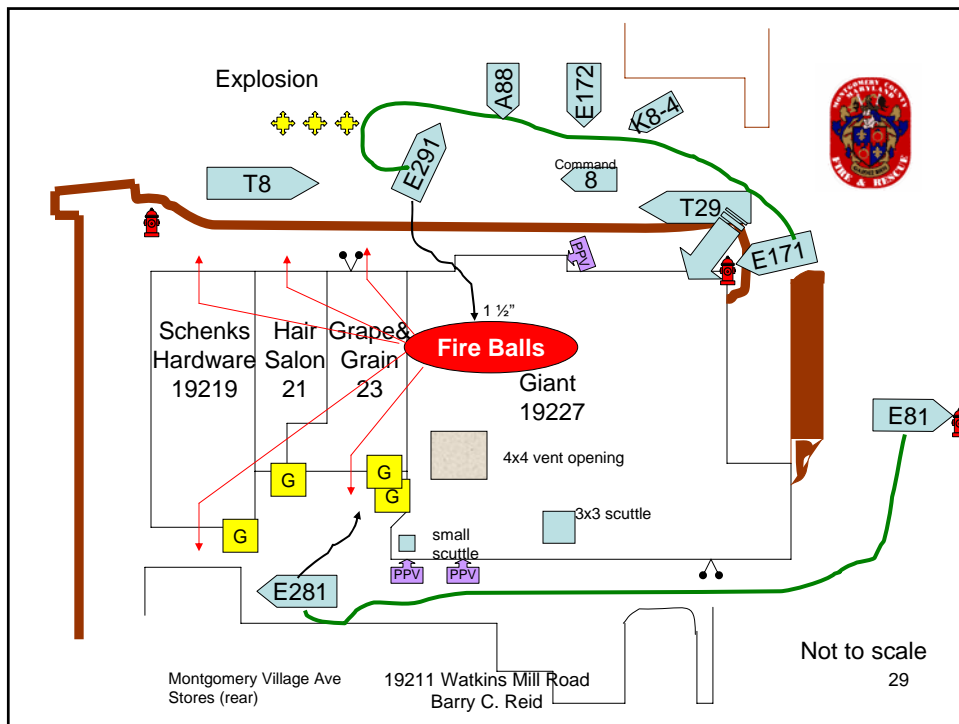
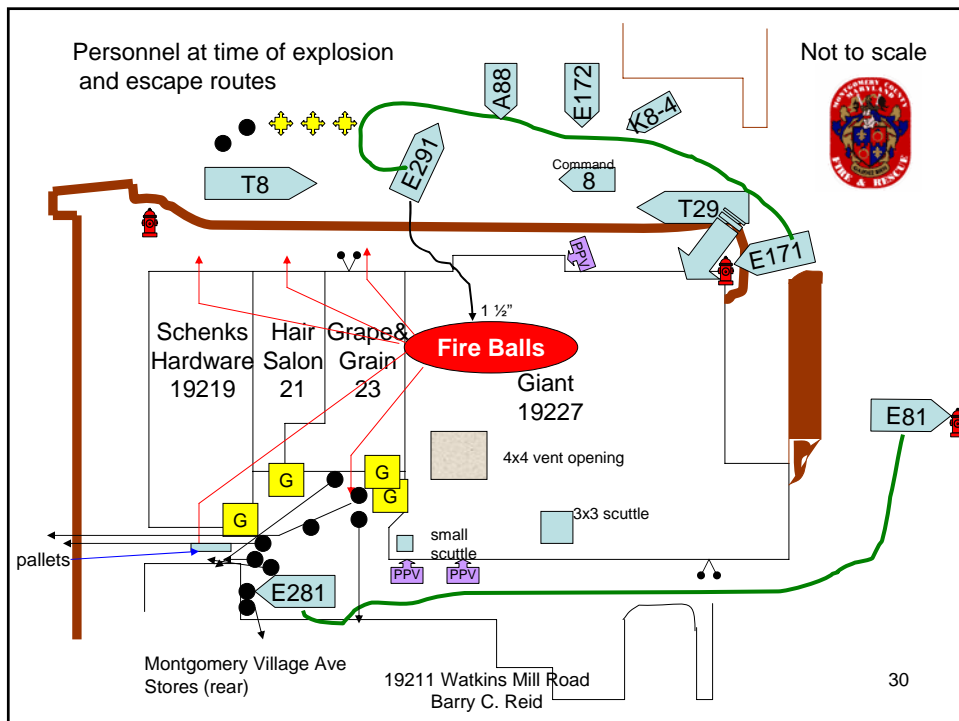
Truck 8 – Parked on Side One in front of the stores where explosion blew glass and debris approx. 200 feet into parking lot when the explosion happened.
