Natural Gas Explosion
Montgomery Village Center
19211 Watkins Mill Road
June 16, 1993
Box 8-4

7 Firefighters and
2 WGL Employees Injured

The pages that follow along with accompanying video and photos are the core of an after action report following a natural gas explosion at Montgomery Village Center on June 15/16, 1993.

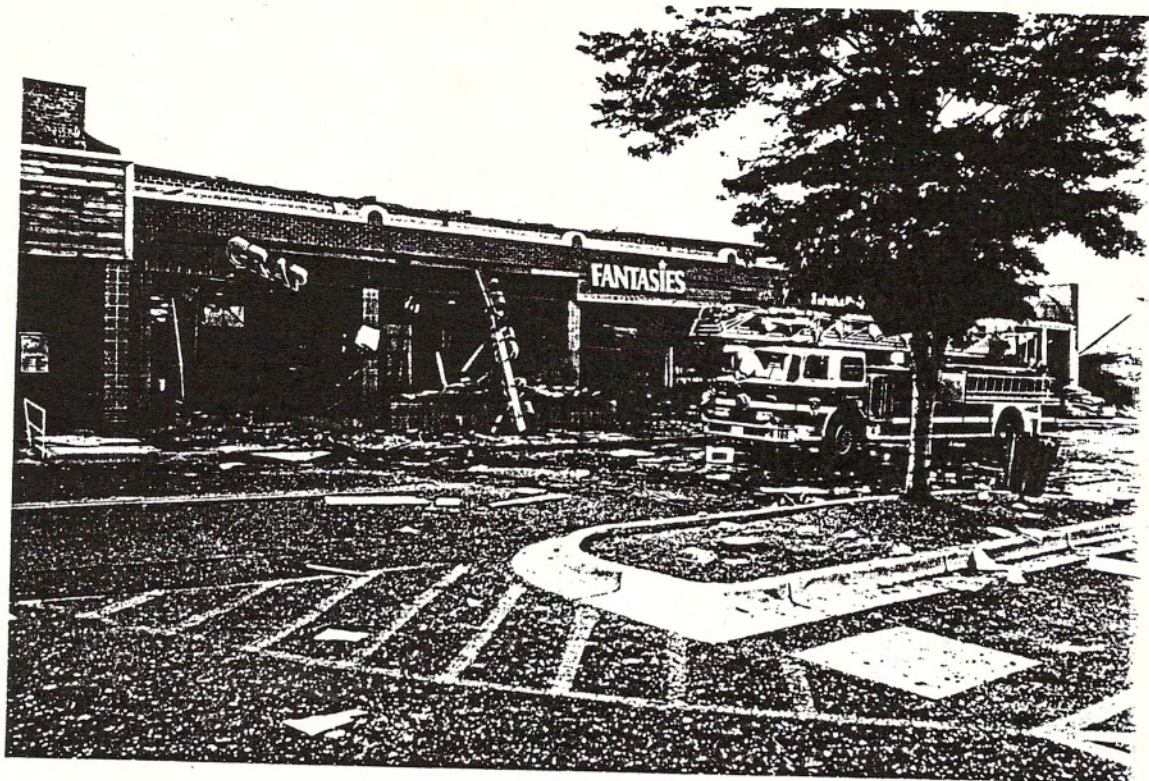
OVERVIEW OF SIDE ONE OF STORES AFFECTED BY EXPLOSION. NOTE AMOUNT OF DEBRIS THAT FORCEFULLY BLEW OUT FRONT OF STORES.
