2nd Alarm Garden Apartment Fire
May 2, 2009
14147 Castle Blvd
FS15's area

Post Incident Analysis for 14147 Castle Blvd

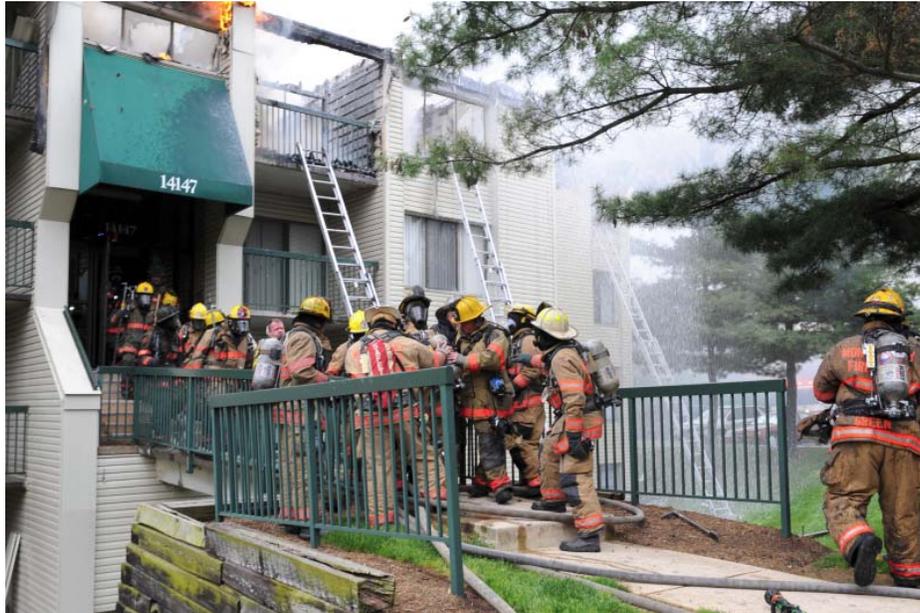
MAYDAY and EB Activations

- There was one actual Mayday for an injured Fire Fighter and five false EB activations on this event.
- Mayday call was first initiated on 7C by E715 Left for the injured Fire Fighter from E724.

- The injured Fire Fighter was working on the 4th floor when the ceiling failed and struck the Fire Fighter on the head. A second Fire Fighter noticed there was issue with the injured Fire Fighter, after the ceiling failed, because the Fire Fighter seemed to be dizzy and stunned. The second Fire Fighter quickly asked for assistance from others around him and started to move the injured Fire Fighter out of the building via the interior stairs.
