Montgomery County Fire and Rescue Service

POST INCIDENT ANALYSIS

**3rd Alarm Retail Clothing Store Fire
6822 New Hampshire Avenue
Takoma Park, MD**

Incident Date: December 5, 2009

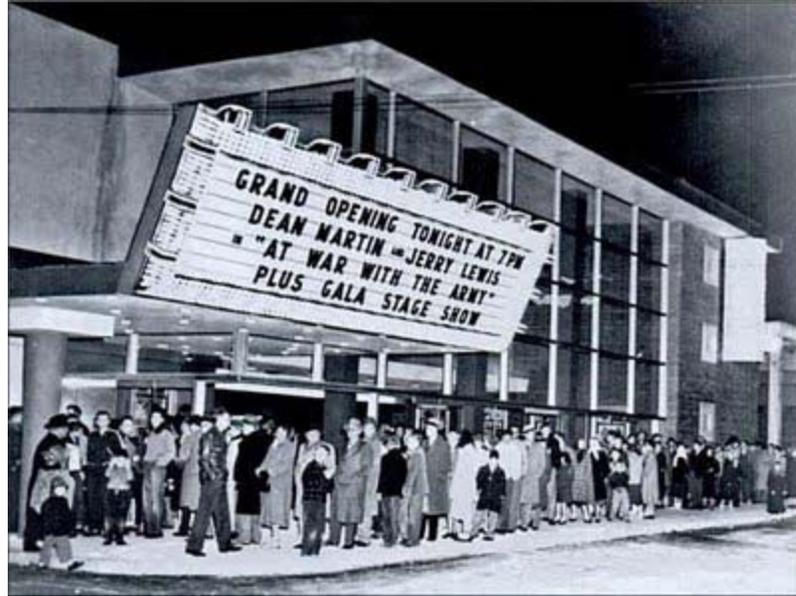
- The structure at 6822 New Hampshire Avenue was built in 1950 as a 946-seat movie theater. It was closed in 1990 and converted into a retail store.

- During the conversion of the structure into a retail store, a level floor was built overtop of the sloping auditorium - thus creating a complex void space that was reportedly used for the storage of sales goods.
- At the time of the fire, the building was operating as Gussini Clothing & Shoes, a discount clothing and shoe merchant.

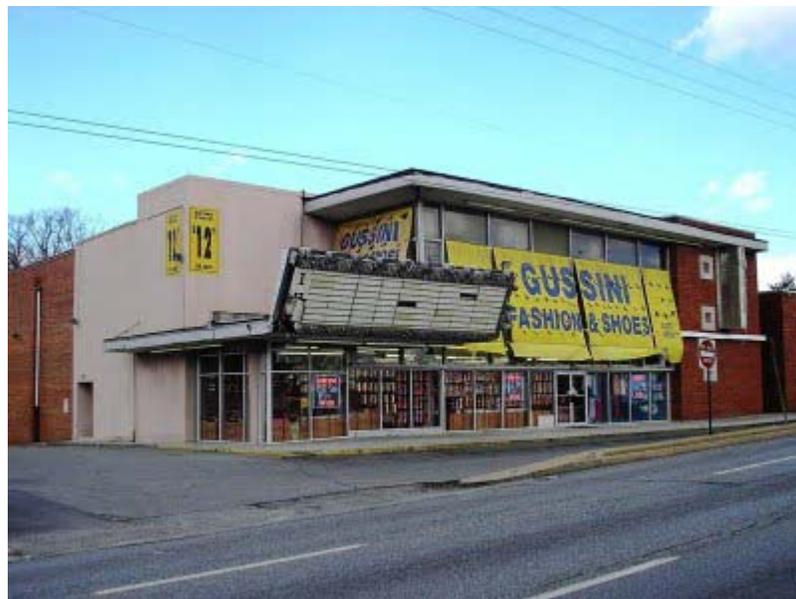
- The building was basically a Type II – Non-Combustible construction building with exterior walls made of brick and concrete block and a skeleton frame constructed of unprotected structural steel.
- The roof assembly was an arched, auditorium style roof with metal I-beam girders and truss assemblies.

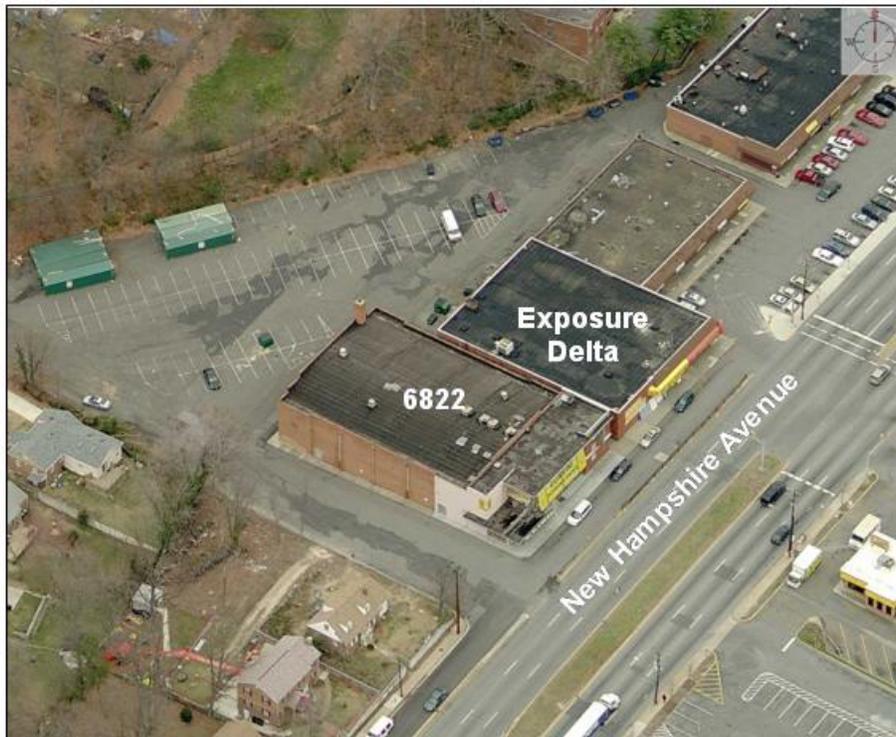
- There were no fixed-fire suppression systems present in the building; they were not required by code when the building was constructed.
- The theatre/store was part of a small shopping complex that also housed a furniture store, a pawn shop, and several other smaller retail occupancies.
- The furniture store (Exposure Delta) was the most severely threatened structure due to its extremely close proximity to the fire building. This exposure was about 20% smaller in size than the fire building and was of similar construction type – with the exception of its flat roof.
