METRO/CSX TRAINS VS. HOT WIRES

Incident #10-0084377

Spring St/Second Ave, Silver Spring, MD

July 29th, 2010

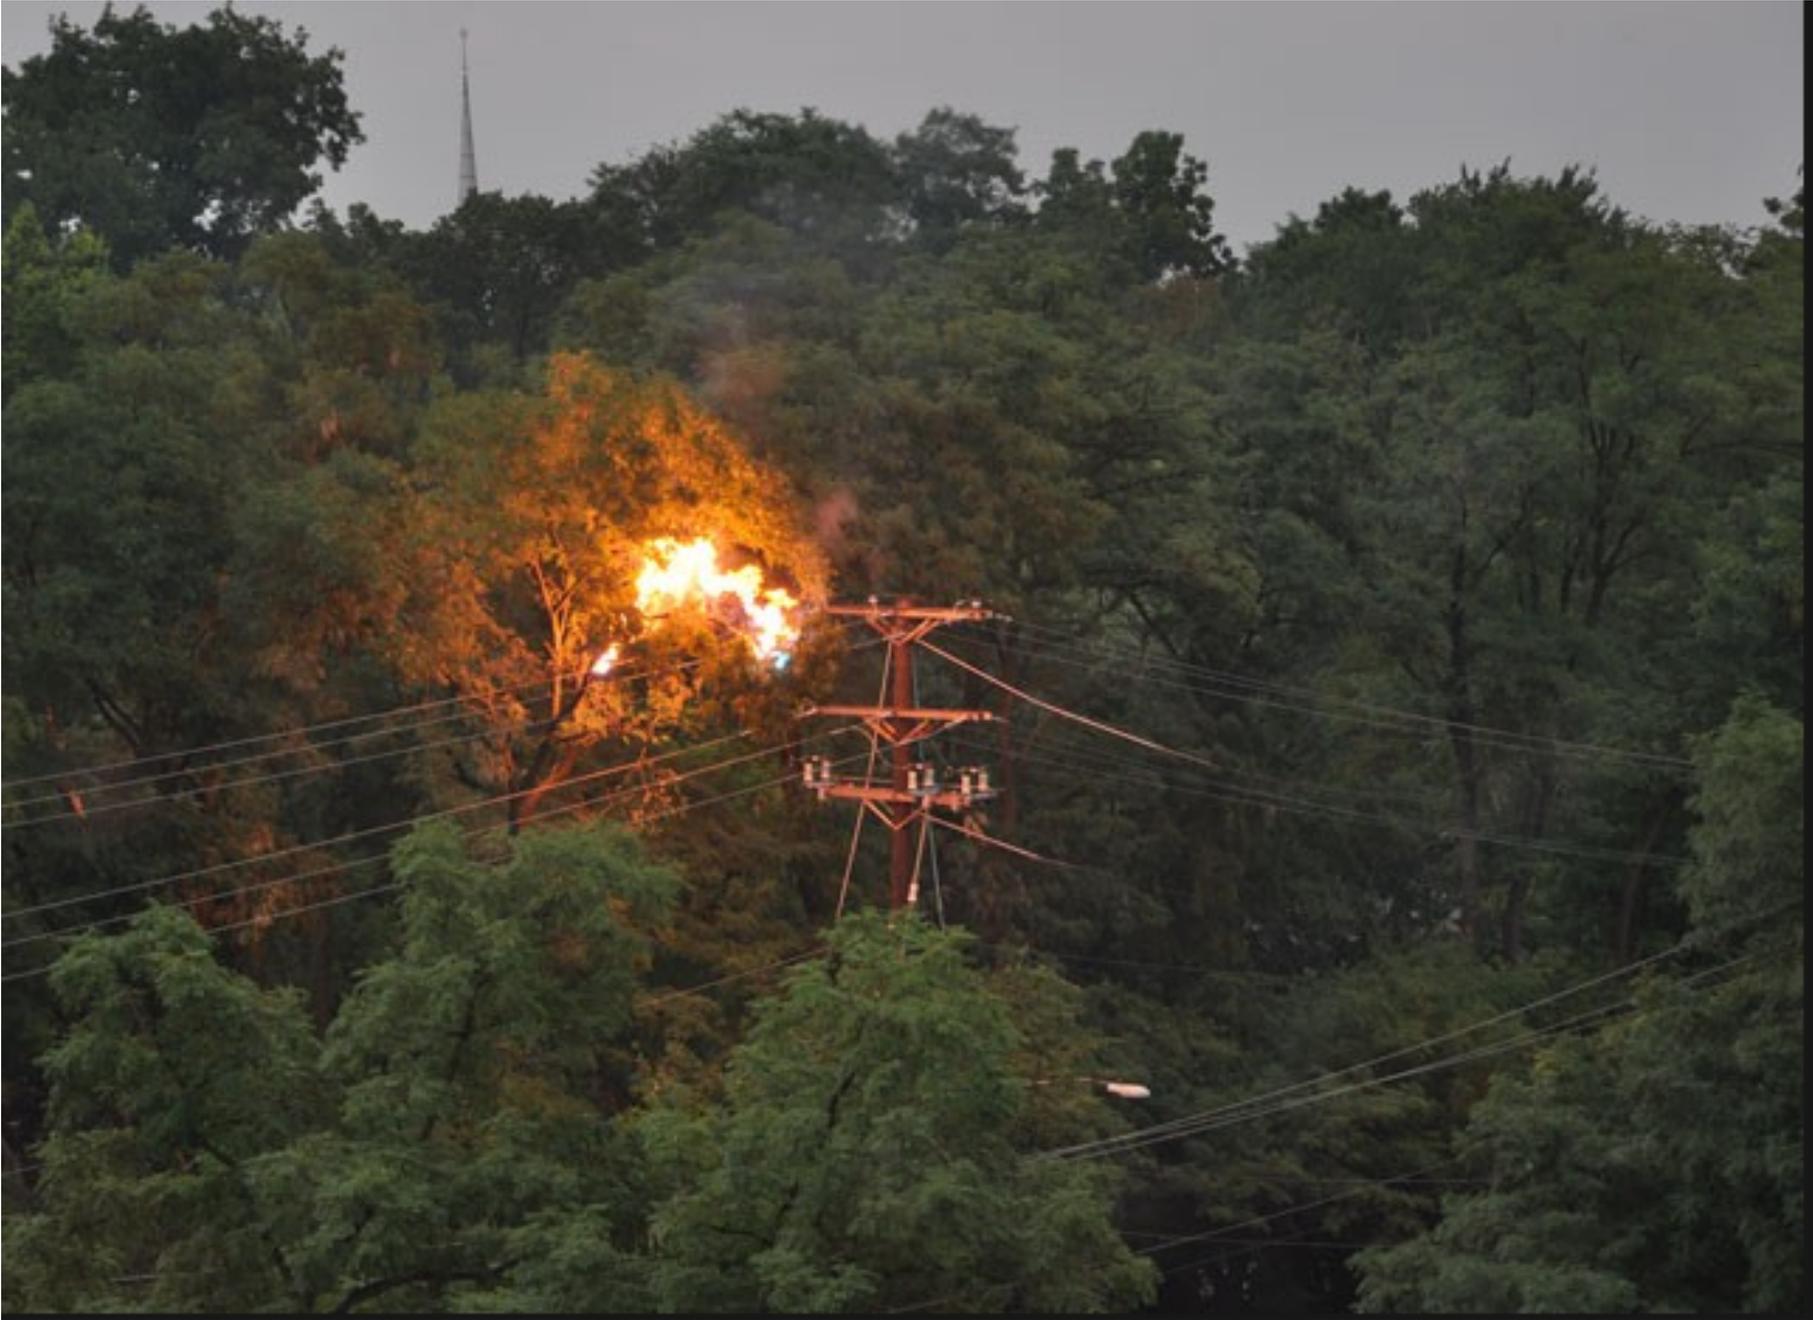
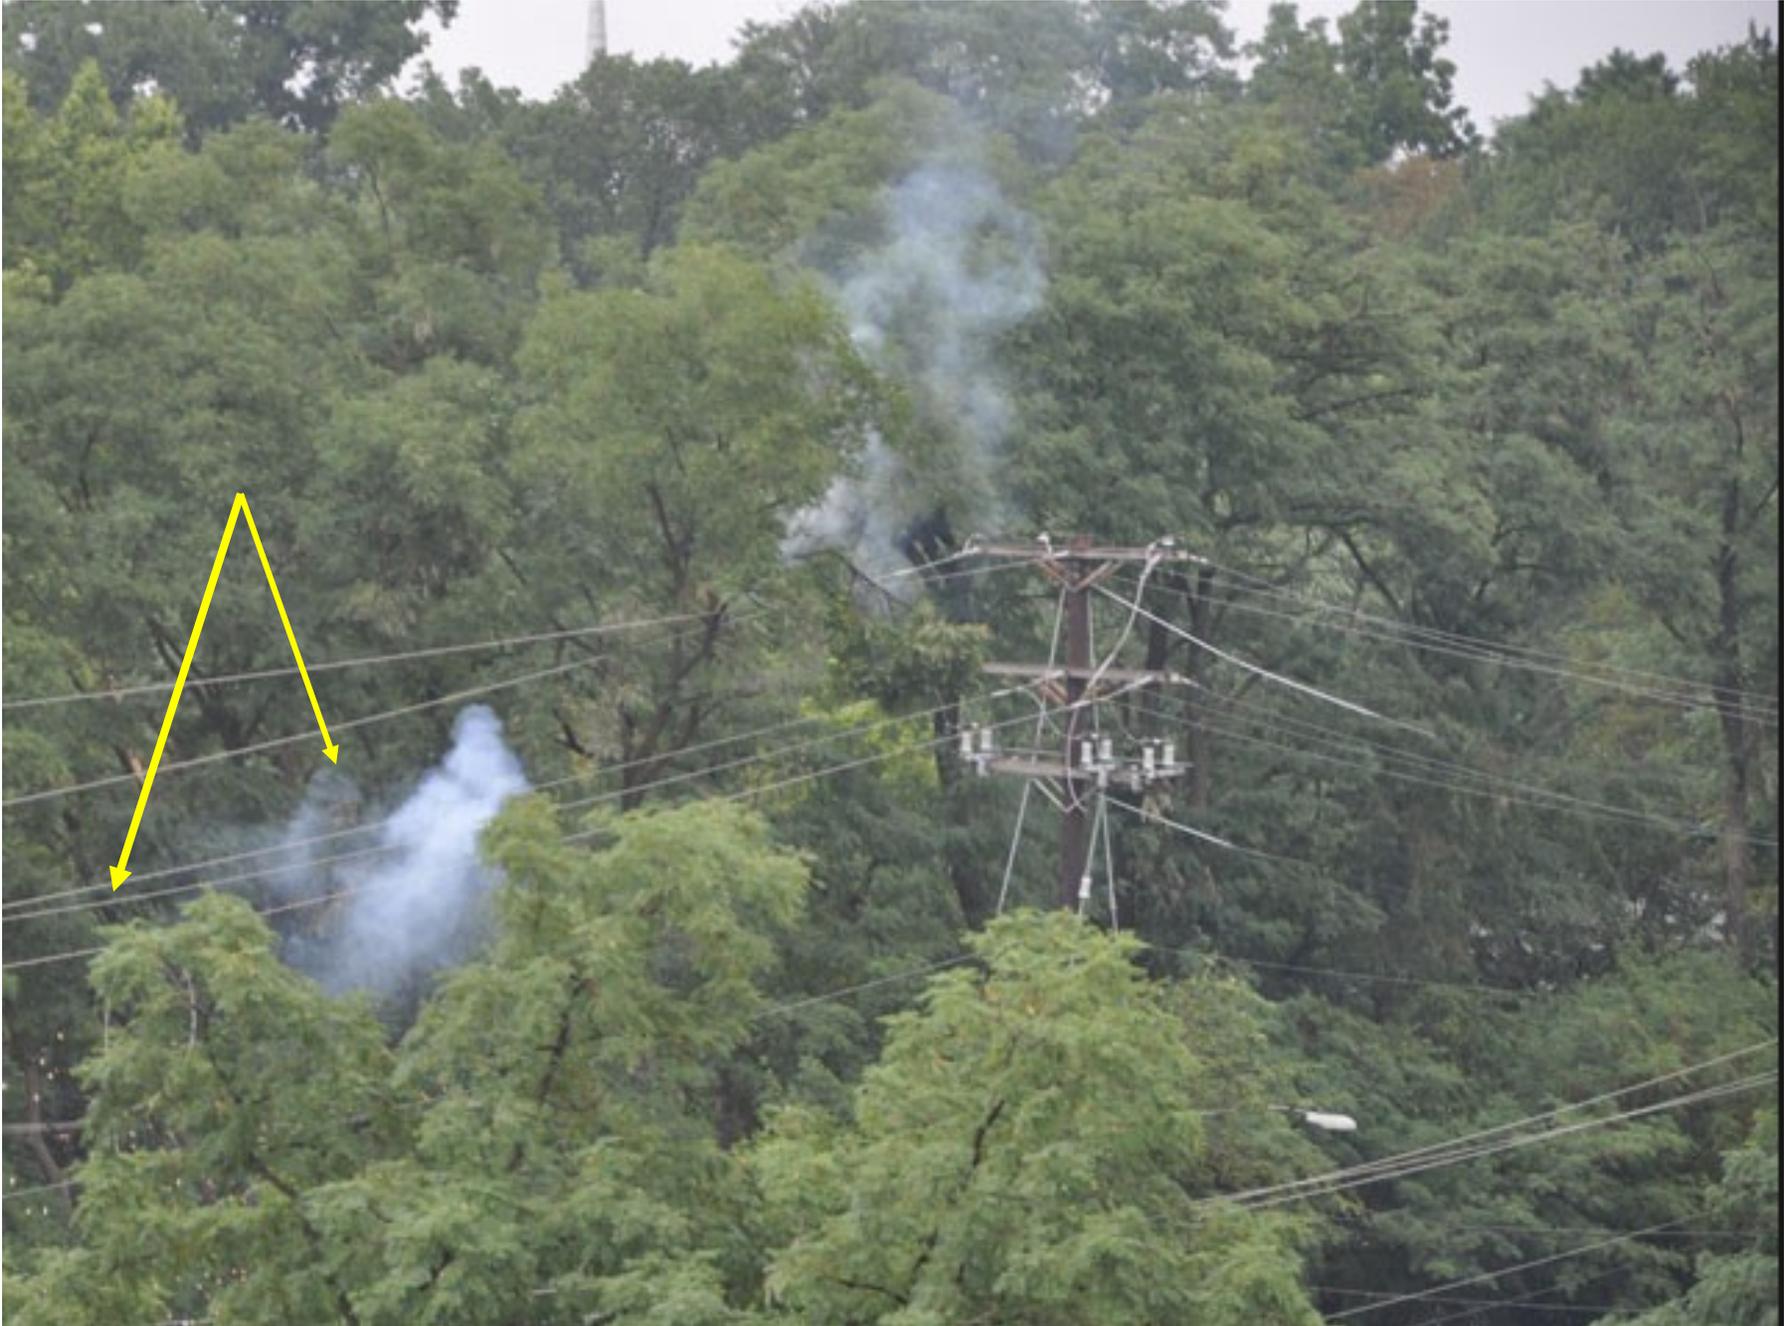
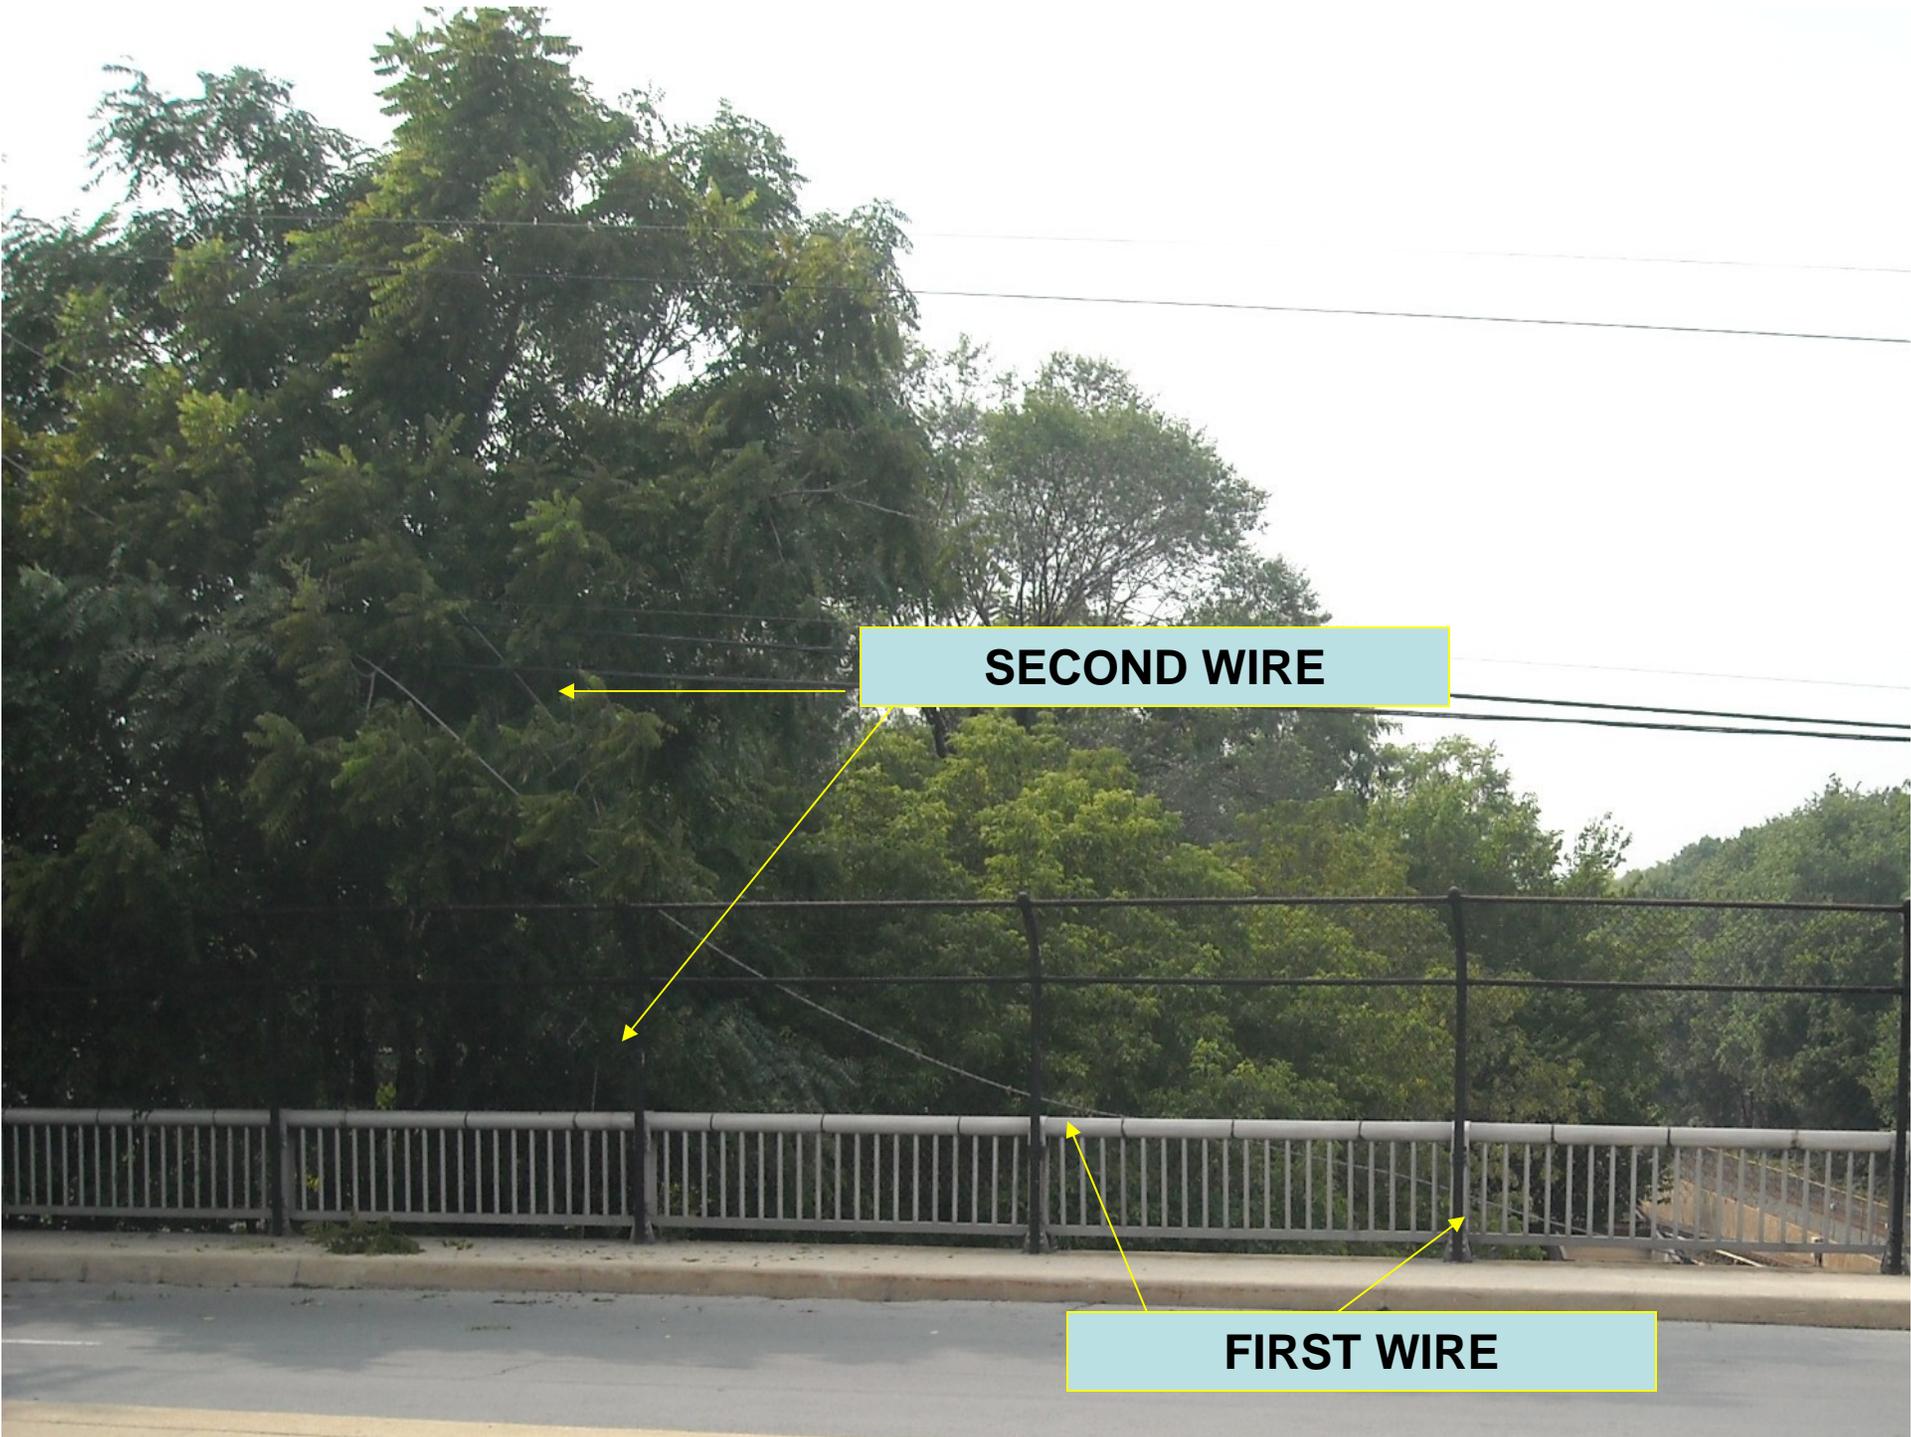
- While controlling traffic second wire begins to arc and burn in tree at eastern side of bridge
- Wire burns through and falls clear of bridge and onto tracks below
- SB (Inbound) METRO train exiting portal strikes falling wire simultaneously

SECOND WIRE

FIRST WIRE

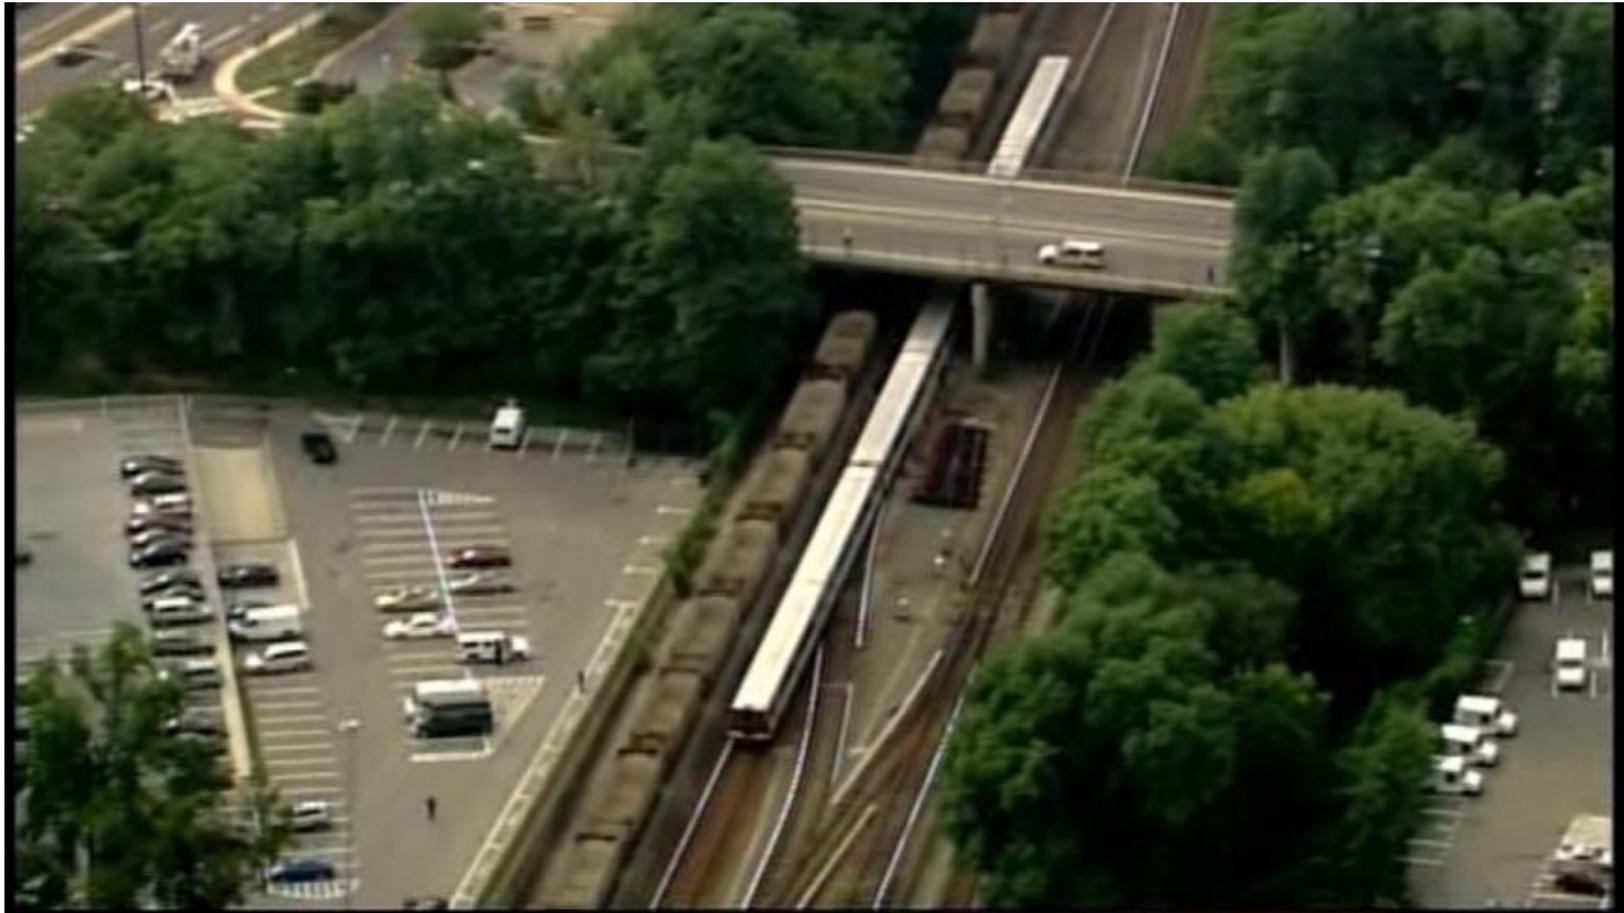
- Violent arcing heard and visually witnessed from undercarriage of front two cars of METRO train
- Train comes to an immediate stop underneath Spring St bridge

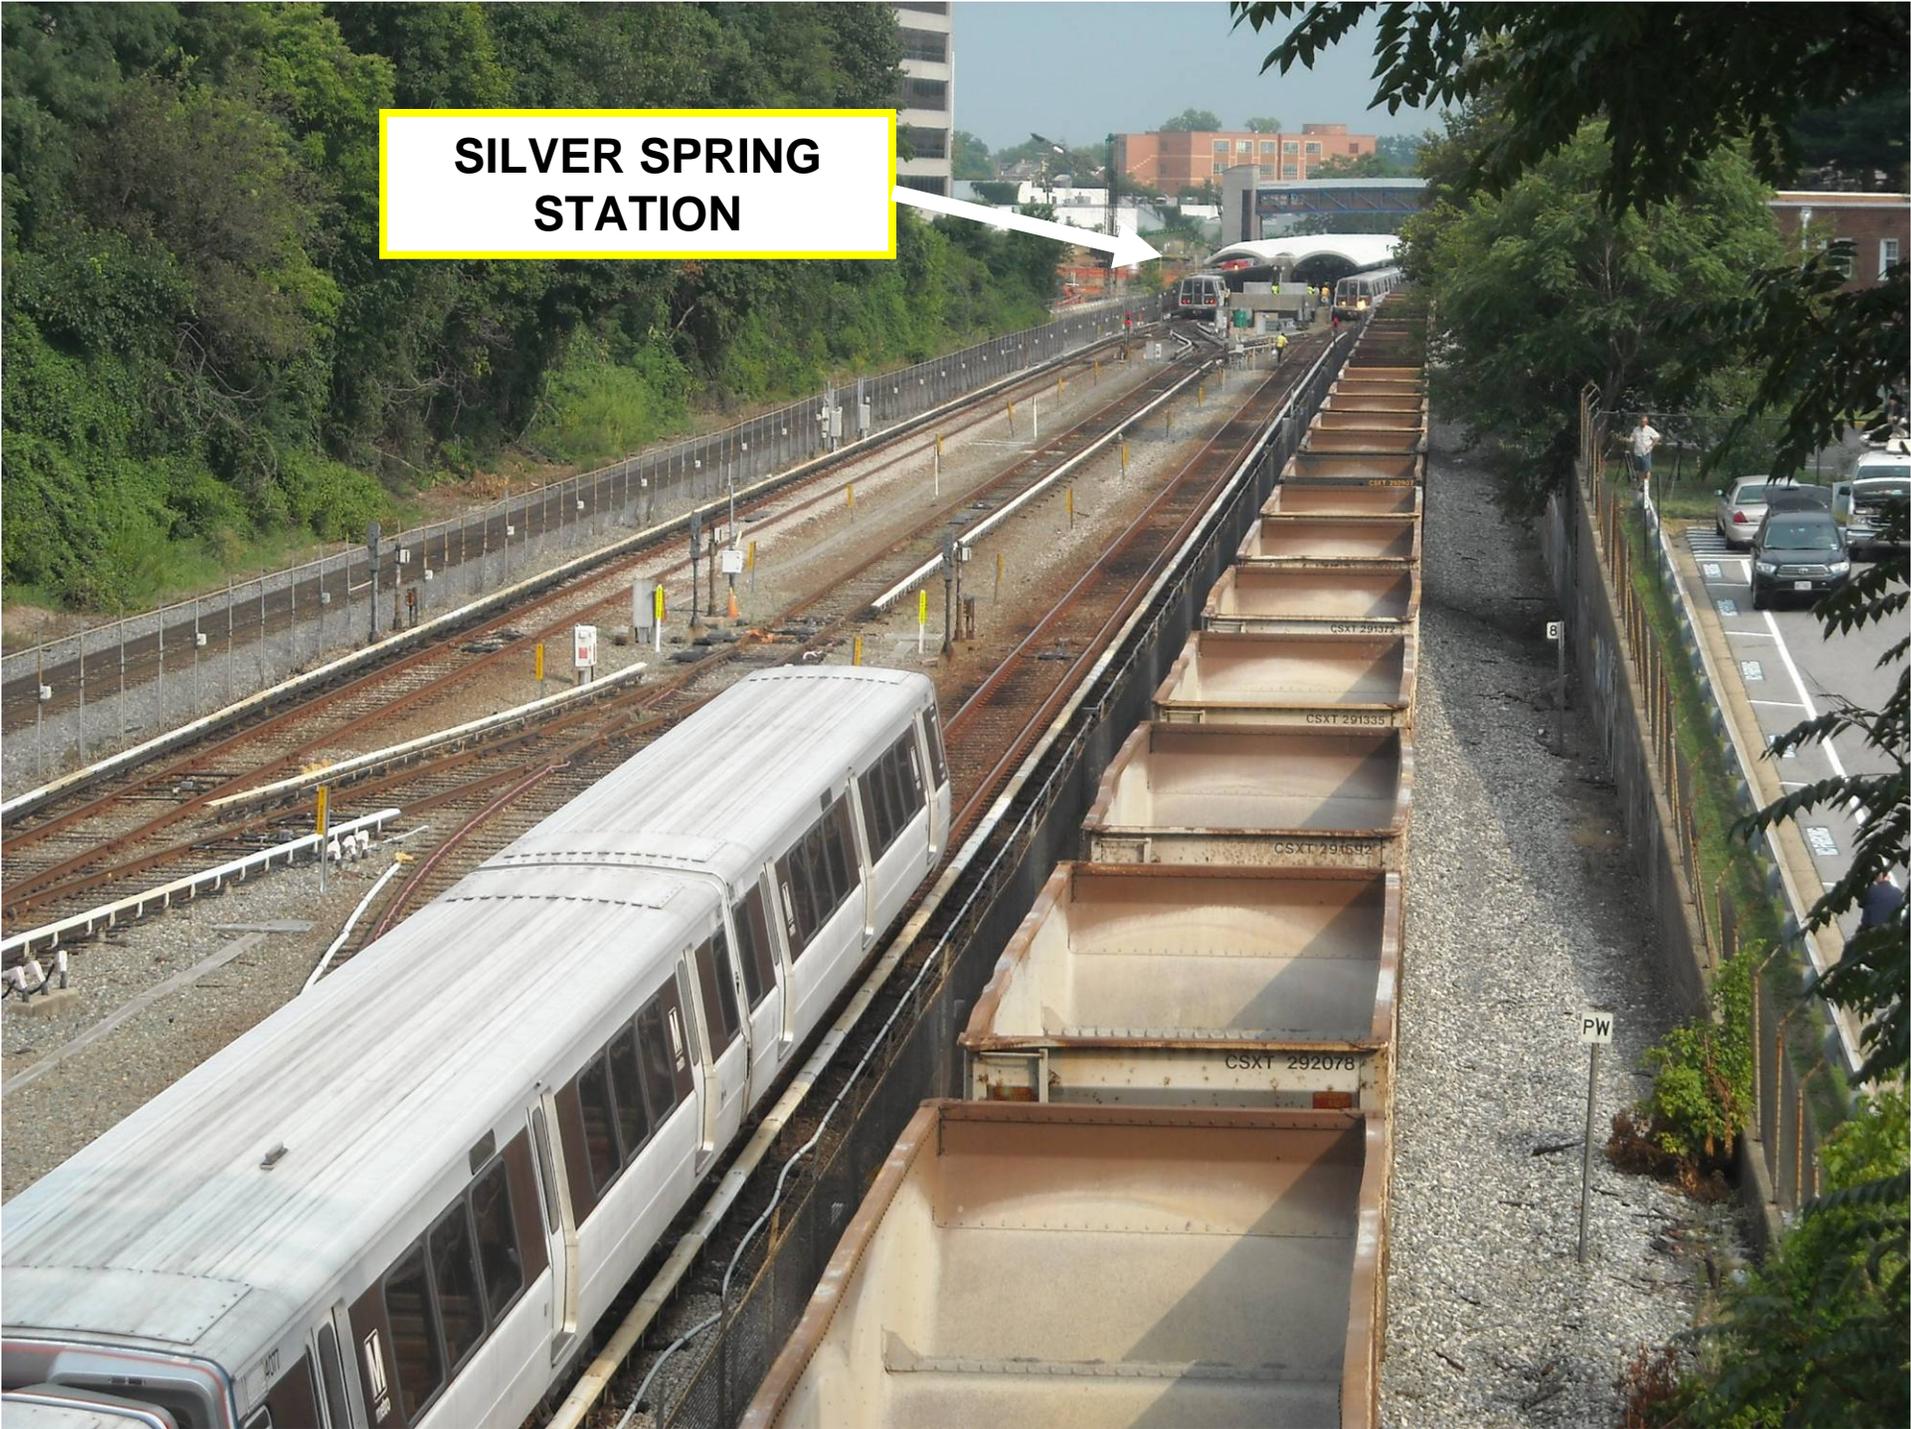
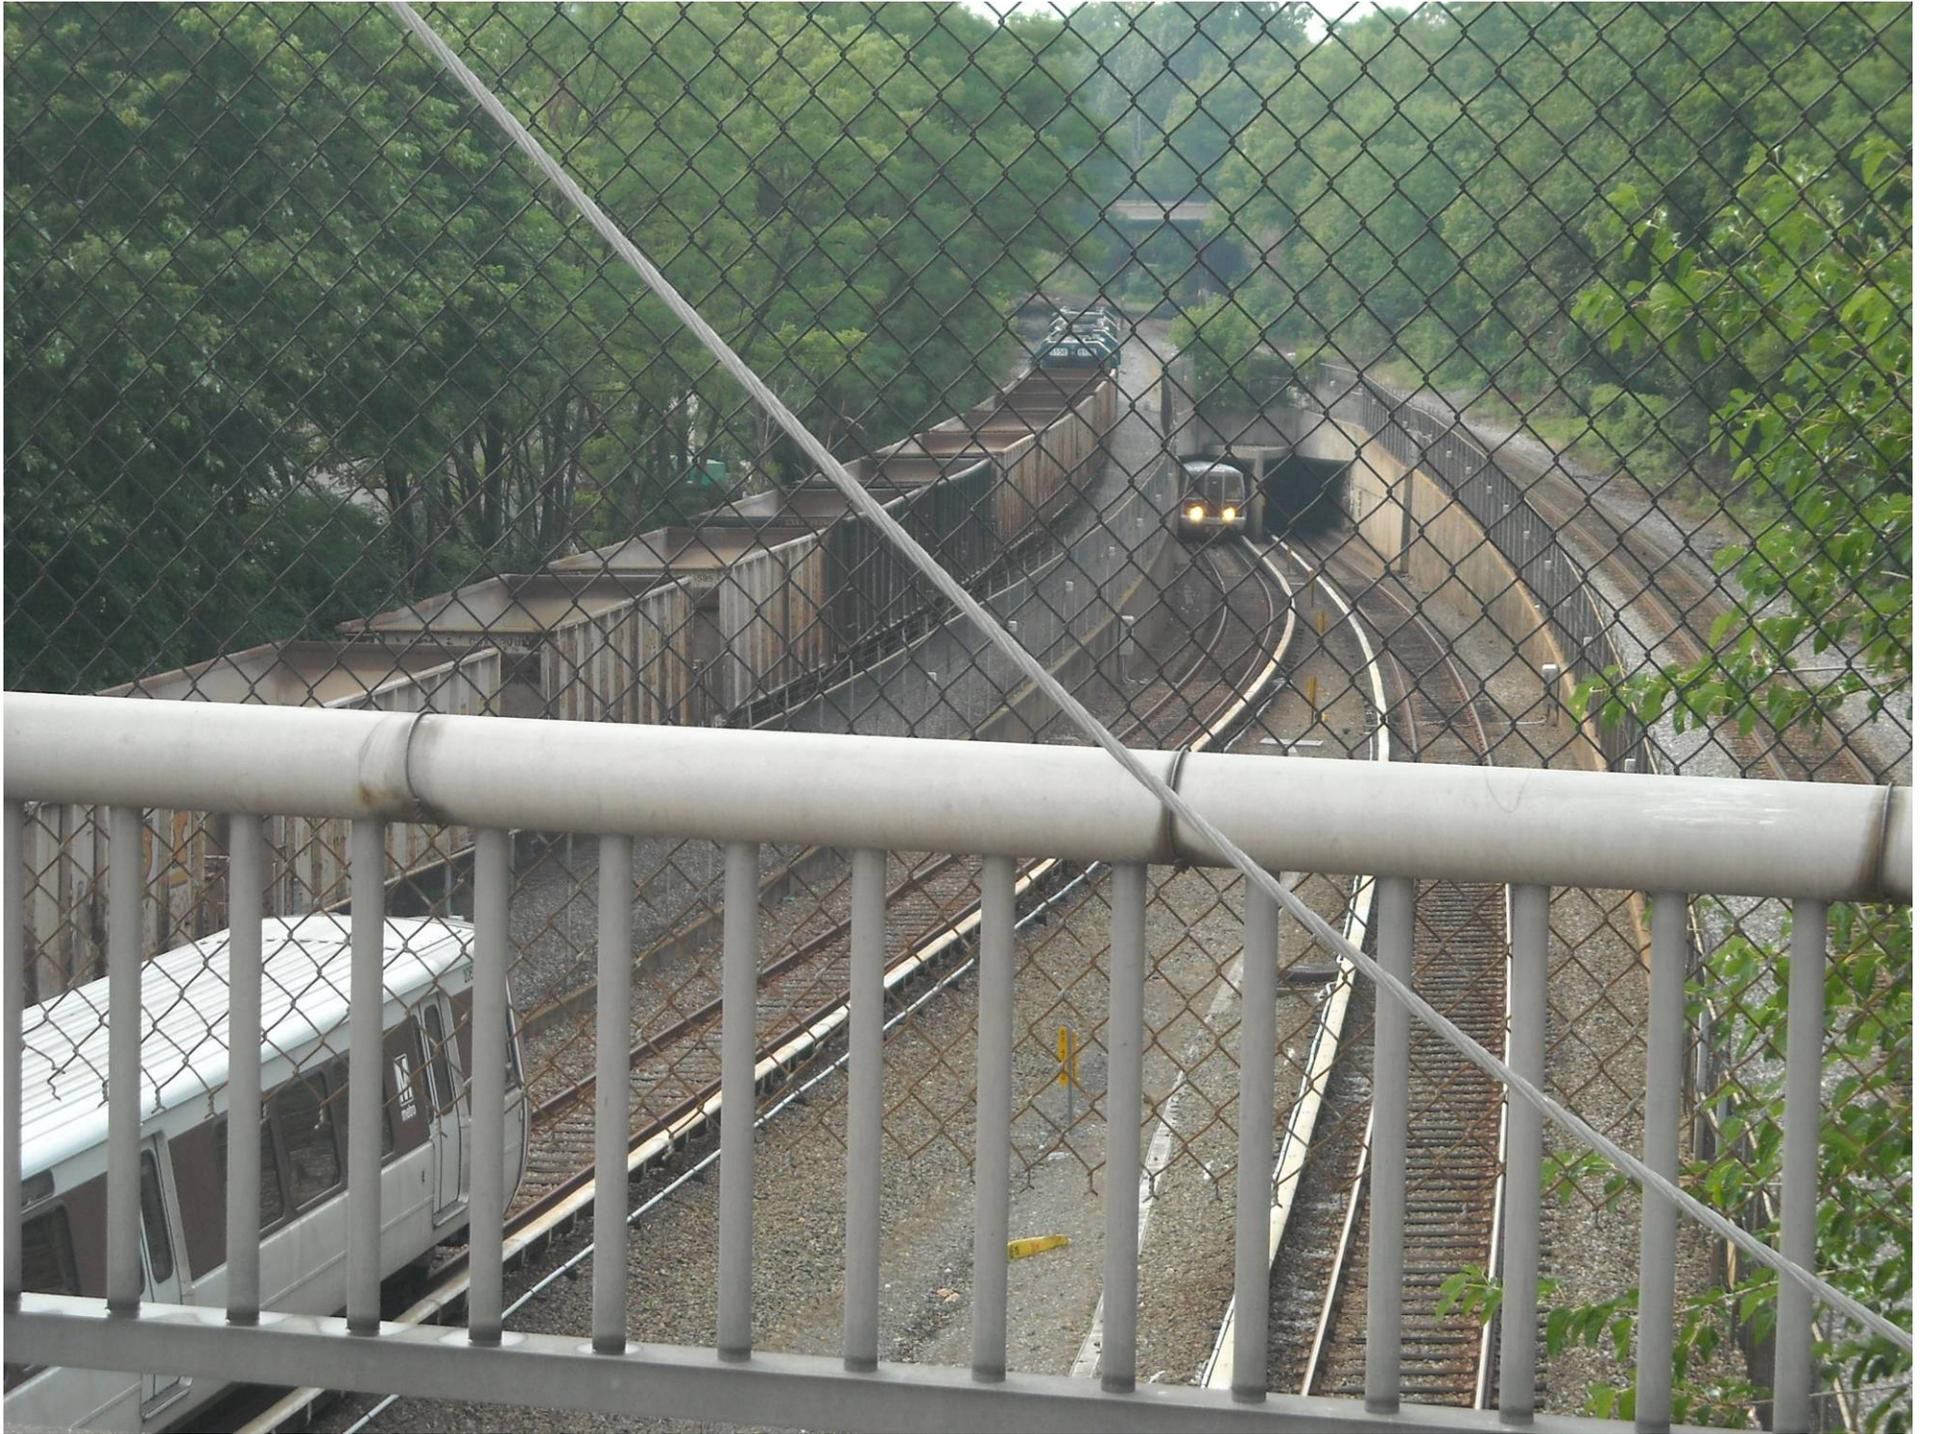
**Downed wire over freight train,
fence, and under METRO train**
