## Post Incident Analysis for 4716 Iris Street

### 4716 Iris Street November 3, 2011

- 1,200 square foot house
- Three injured Fire Fighters
- One injured civilian
- One civilian fatality
- Heavy fire upon arrival with report of people trapped
- Vent, Enter Search (VES) to remove trapped occupant
- Defensive then offensive then defensive fire attack

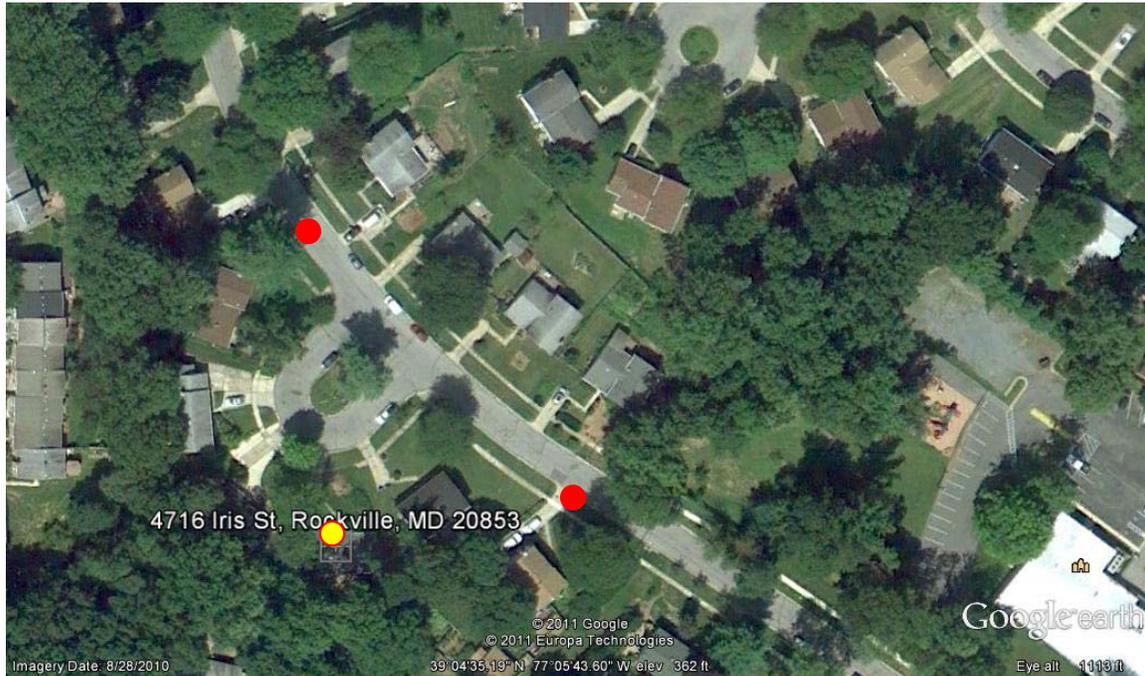
### Site & Structure Layout

- 4716 Iris St is indicated by the yellow dot.
- The two closest fire hydrants are identified by the red dots.
- The structure is approximately 1200 square feet and has two levels (first floor and walk out basement).
- The structure was built on an approximately 9000 square foot lot which sloped down grade from side A towards side C.
- The structure has one stairwell in quadrant delta which allows egress between the first floor and the basement.
- The structure has battery powered smoke detectors on both levels.
- The structure has no sprinkler system or any other fire protection system.

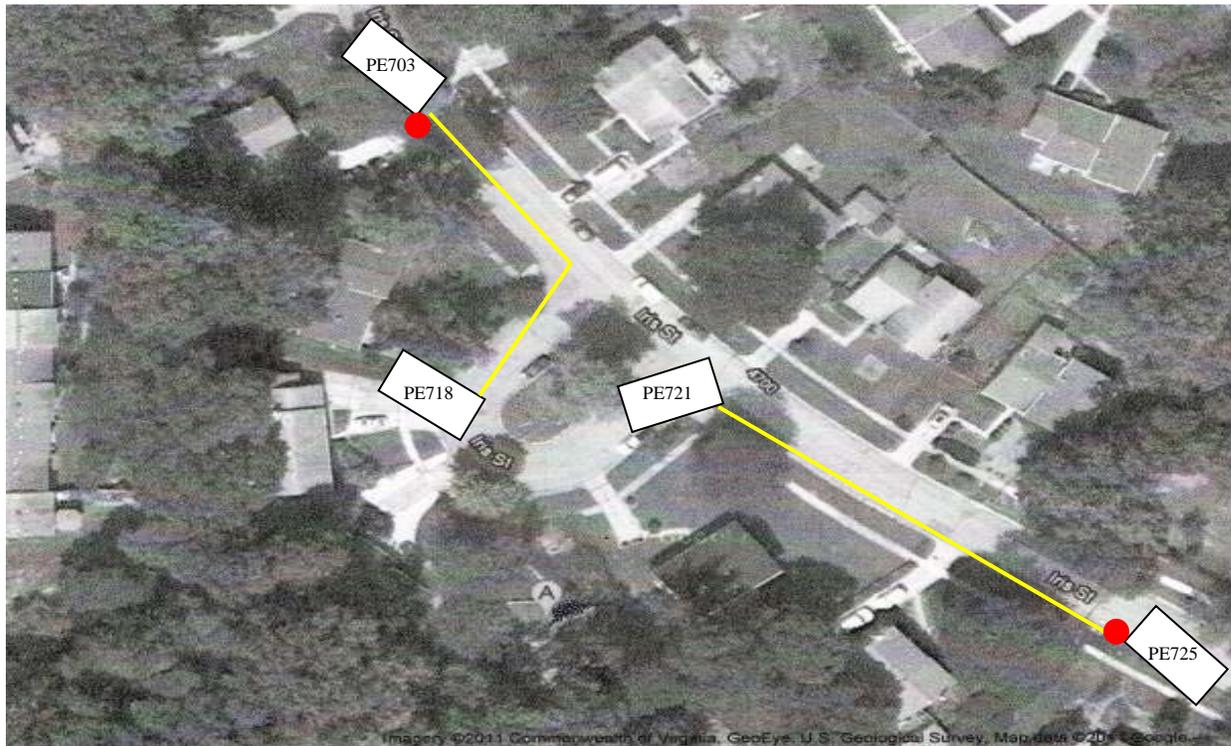
### Water Supply

- PE721 (1<sup>st</sup> Due) laid 400' of 4" supply line from the hydrant in front of 4708 Iris Street which was picked up by PE725 (2<sup>nd</sup> Due).
- PE718 (4<sup>th</sup> Due) laid 300' of 4" supply line from the hydrant in front of 4724 Iris Street which was picked up by PE703 (5<sup>th</sup> Due).

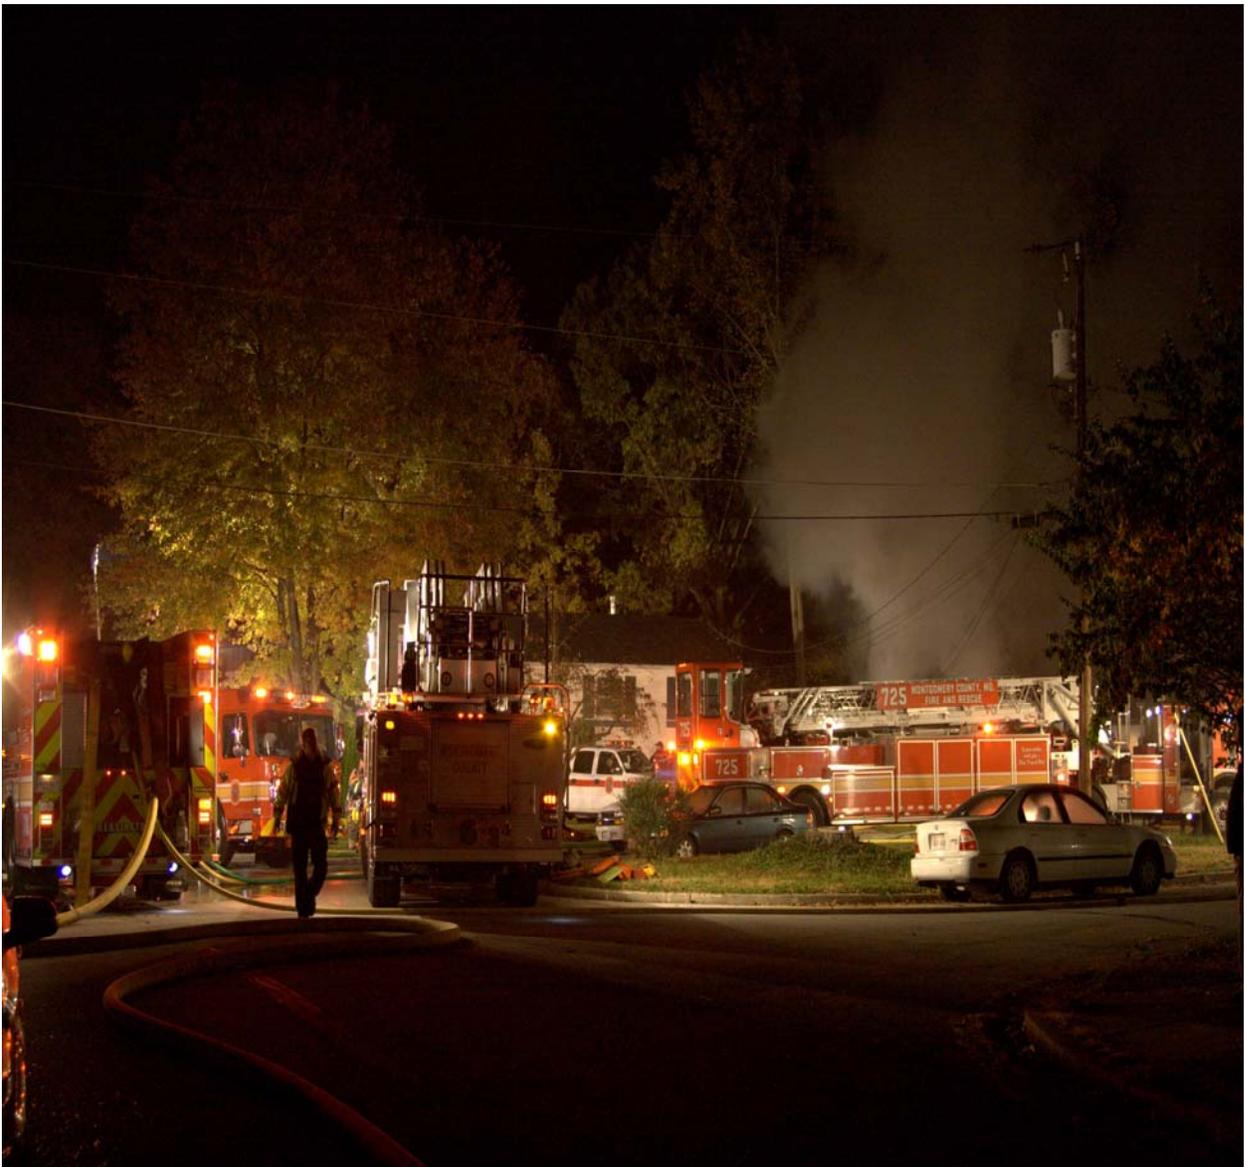
### Tactical Positioning

- All units were positioned appropriately based on the limitations presented by the cul-de-sac.
- There was no apparatus access to side C. However personnel were close enough to stretch attack lines and carry ground ladders to the rear.
- A staging area was never established as all additional units were requested to come directly to the incident scene.
