Montgomery County Fire and Rescue Service

Post Incident Analysis – 2037 Lyttonsville Rd

Incident # 12-0008256

January 22, 2012

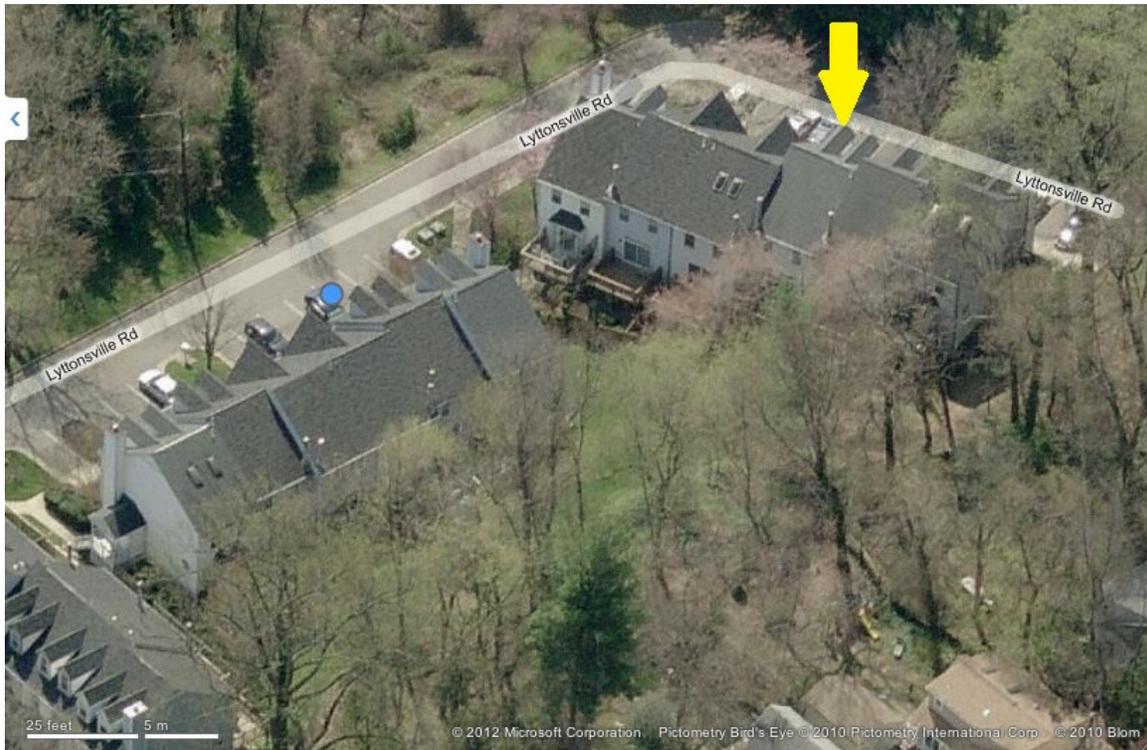
The fire started in the basement in the rear of the structure and quickly spread through the walls and up the outside rear into the attic. The lightweight members likely contributed to the rapid loss of structural integrity.

Access to the front of the structure for both engine and aerial operations was good. The rear of the structure was inaccessible to apparatus but attack lines and ladders were carried to that area. Access issues did not substantially impact the incident.
