Montgomery County Fire and Rescue Service

POST INCIDENT ANALYSIS

**12695 Monnier Court
Mount Airy, Md.**

High Risk Low Frequency- Mutual Aid Mayday

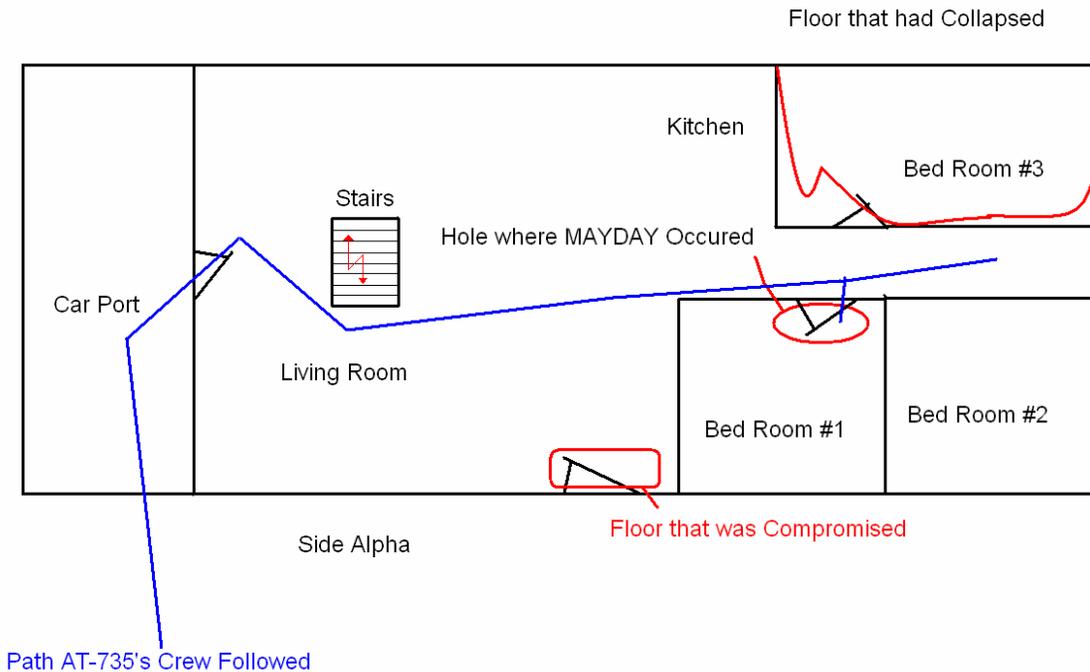
During an interview with the OIC of AT735 he did not know that any of the flooring in the front side of the structure had been compromised before their entry. He thought the floor in the rear of the structure had collapsed. From the exterior of the building, it appeared that most of the damage was in the rear of the structure.

Command knew the fire in the basement was knocked before they sent them in the structure.
