MONTGOMERY COUNTY COUNCIL
OFFICE OF LEGISLATIVE OVERSIGHT
MONTGOMERY COUNTY, MARYLAND

REPORT #78-3

APRIL 10, 1978

An Evaluation of Policies and Procedures Concerning the Premature Failure of Some Schools Roofs and Those of Selected Buildings of Other County and Bi-County Agencies, other Counties and the Private Sector.

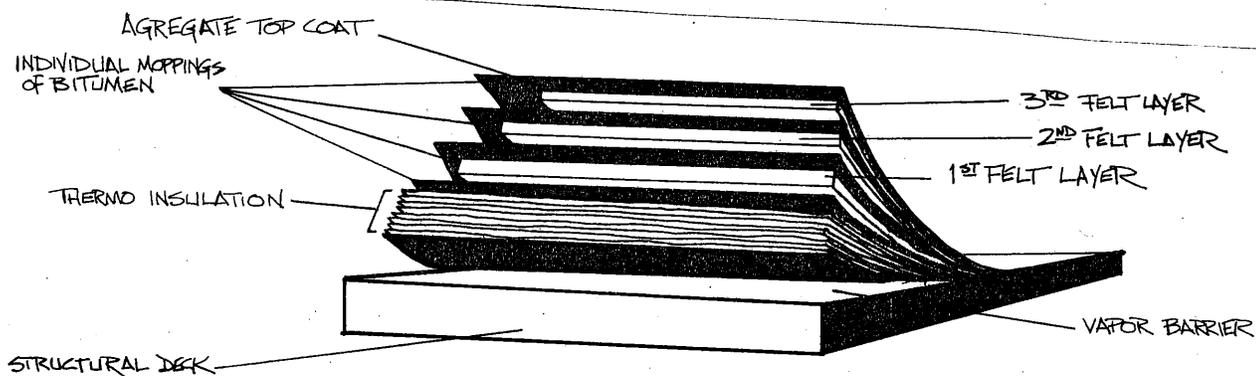
wood, metal, concrete or other material);
 b) vapor barrier (plastic or other impermeable membrane to retard passage of water vapor through the roof);
 c) thermal insulation (to retard flow of heat); and d) the built-up roof membrane. Below is a schematic of a three-ply roofing system.

- PICTORIAL EXPANSION -
THREE-PLY ROOFING SYSTEM
