CHAPTER

9

- Understand the details of ordinary construction, including features found in modern structures of ordinary construction.
- Understand how the structural stability of a masonry wall is compromised.
- Identify specific wall and wall component problems.
- Recognize collapse indicators.
- Identify the problems associated with interior structural elements.
- Identify fire hazards associated with roofs.
- Understand fire spread through void spaces of ordinary construction.
- Explain how masonry walls and fire doors act as fire barriers.

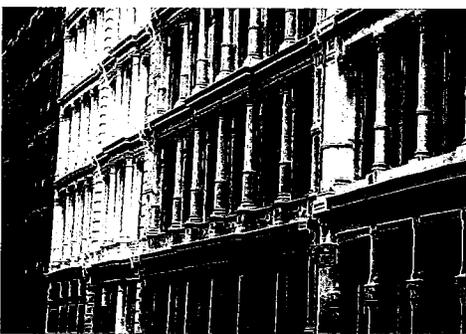
Figure 9-2 Built in the 1850s as commercial buildings, these buildings in lower Manhattan have decorative cast-iron-front walls. Even though these walls are not masonry, they are classified as ordinary construction.

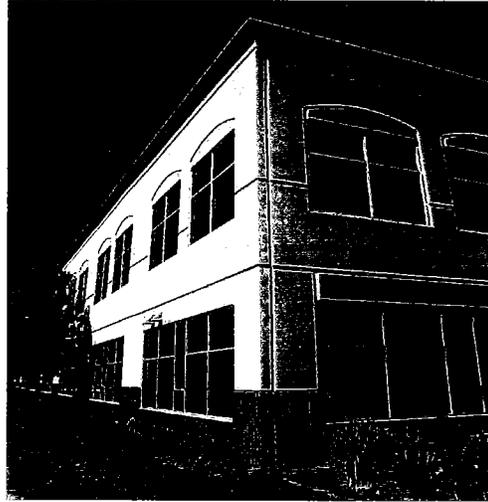
Figure 9-4 It is critical that responding fire fighters know the location of load-bearing walls within a structure, which is impossible to tell from the exterior of this building.

Bearing and nonbearing walls use similar construction materials and are often identical in appearance. In the typical downtown business or commercial building, the side walls are the bearing walls, whereas the front and back walls are nonbearing **Figure 9-4**.

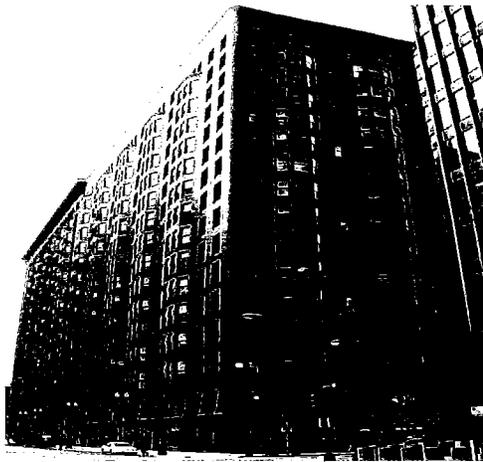
Figure 9-5 Under today's standards, ordinary construction buildings are usually limited to no more than six stories, unlike the Monadnock Building shown here.

There is an inherent limit to the height of masonry buildings due to the necessity for increasing the thickness of the wall as the height of the building increases. The tallest old-style masonry bearing wall building in the United States is the Monadnock Building in Chicago **Figure 9-5**. It is 15 stories high,

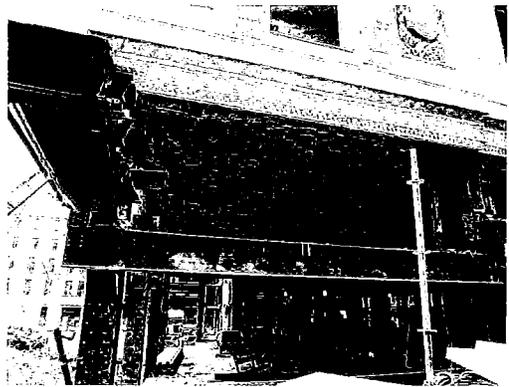
Figure 9-11 The Filene's building in downtown Boston under extensive renovation. Note the clay terra-cotta tiles, which were used to enhance fire resistance over 100 years ago, underneath the exposed second floor.

- **Parging (pargetting):** The process of covering a masonry wall with a thin coat of concrete.
- **Rubble masonry:** Masonry composed of random stones **Figure 9-9**.
- **Rubble masonry wall:** A wall composed of an inner and outer wythe of coursed masonry. The space between is filled with random masonry sometimes mixed with mortar. Such walls are unstable to a lateral thrust.
- **Solid masonry walls:** Masonry units (either solid or hollow) laid contiguously with the joints filled with mortar.
- **Stretcher course:** Bricks laid so that the long side is visible **Figure 9-10**.
- **Terra-cotta tiles:** Made of clay and fine sand, terra-cotta is fired in a kiln. Terra-cotta is both structural and decorative and is used in ornamental facings **Figure 9-11**. Structural terra-cotta has been replaced to a large extent by concrete block.

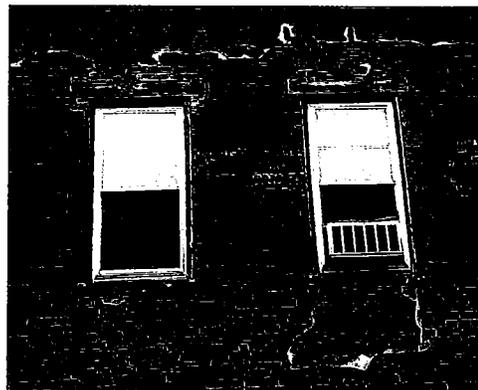
Figure 9-13 Wooden lintels used in masonry walls will have an early failure potential.

Arches and beams are the two ways to carry the wall above an opening. Such a beam is called a lintel. The lintel commonly used today is a steel "L" or channel section. When such sections were first used, the practice was to arrange the bricks above the lintel as a false flat arch. Later, the pretense of an arch was abandoned and the bricks above the window were set vertically. Today, the common practice is to carry the brickwork horizontally across the lintel. Steel lintels are tied tightly into the masonry wall. When heated, they elongate and the masonry can fail. Combustible wood lintels are also sometimes used

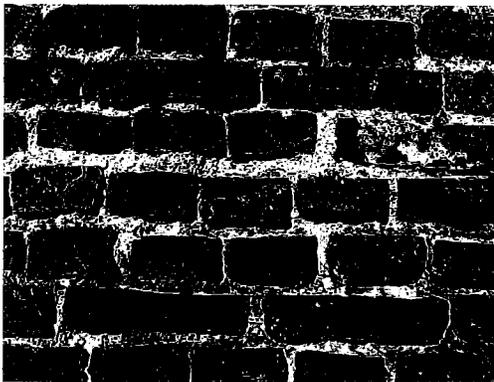
Figure 9-15 Fire fighters directing streams onto a fire situation can wash this mortar out of the walls, causing the wall to fail and collapse.

As has been noted, the use of sand-lime mortar creates a potential failure hazard because it is water soluble (Figure 9-15). Suspect any building built in the last century or early in this century of containing this type of mortar. To get rehabilitation tax credits, sand-lime mortar must be used to repair old sand-lime mortar buildings. Consequently, even currently restored buildings should be suspect. If a wall is torn down, look at the bricks. If they are clean with little mortar clinging, sand-lime mortar was used.

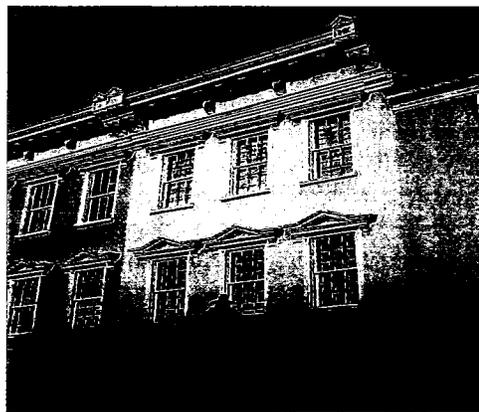
Figure 9-24 Decorative cornices at the roof level of two buildings.

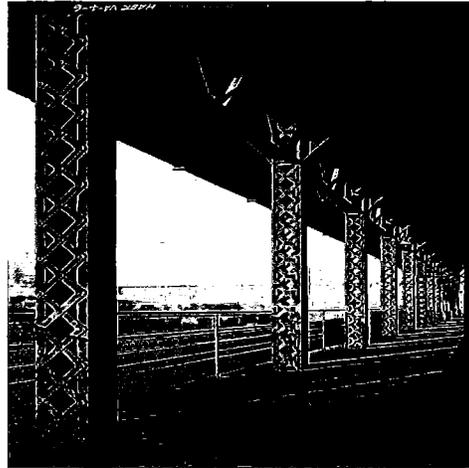
Figure 10-4 A lattice column.

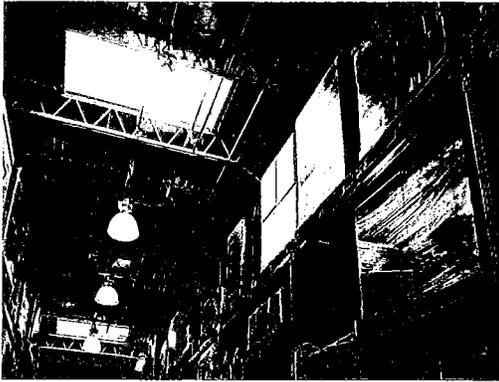
Figure 10-6 Roof bar joists.

Steel framing is used for many commercial and industrial buildings, usually of one-story construction. To achieve a peaked roof, the framing may consist of columns and beams with triangular trusses. The columns may support deep parallel-chord trusses spanning wide areas, with smaller trusses, often called **bar joists**, spanning the main trusses to support a flat roof. Space frames (three-dimensional trusses) provide huge clear spans in some modern buildings.

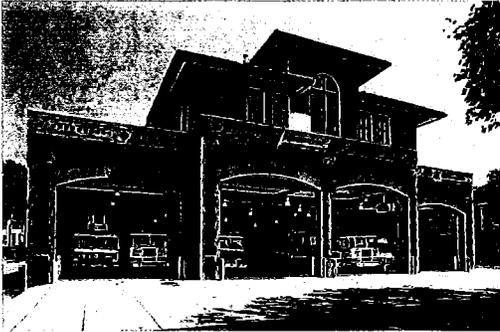
Figure 10-8 This Washington, D.C., Fire Department reserve apparatus building is a Butler building, incorporating an exterior insulation finishing system (EIFS) and masonry into the exterior walls.

Many steel-framed buildings are prefabricated. The Butler Company is a prominent manufacturer of steel “prefabs.” Such buildings are often referred to as “Butler buildings,” regardless of the manufacturer. Originally, the lightweight steel-framed building was exclusively for industrial use, but in recent years, schools, churches, and many other types of buildings have been built with similar designs **Figure 10-8**.

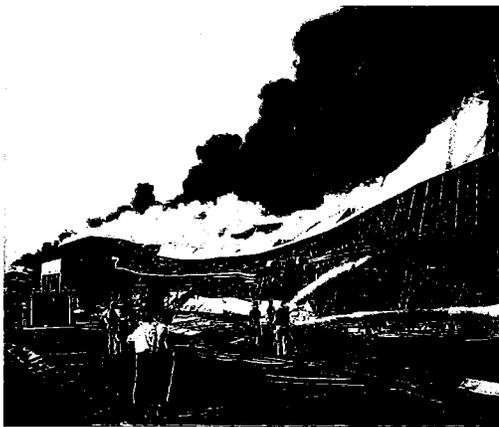
Figure 10-16 The Livonia, Michigan, General Motors fire in 1953.

In August 1953, the General Motors transmission plant at Livonia, Michigan, burned **Figure 10-16**. Its loss of \$32 million was the largest industrial fire loss to that date. The metal deck roof was the principal contributing factor to the destruction of the plant.
