MONTGOMERY COUNTY FIRE/RESCUE  
SERVICE  
POST INCIDENT ANALYSIS

**2-Alarm Garden Style Apartment Fire  
Box Area 25-08  
14128 Whispering Pines Court  
September 12, 2014  
Incident #14-0104672**

**Written By: Battalion Chief Frank Doyle**

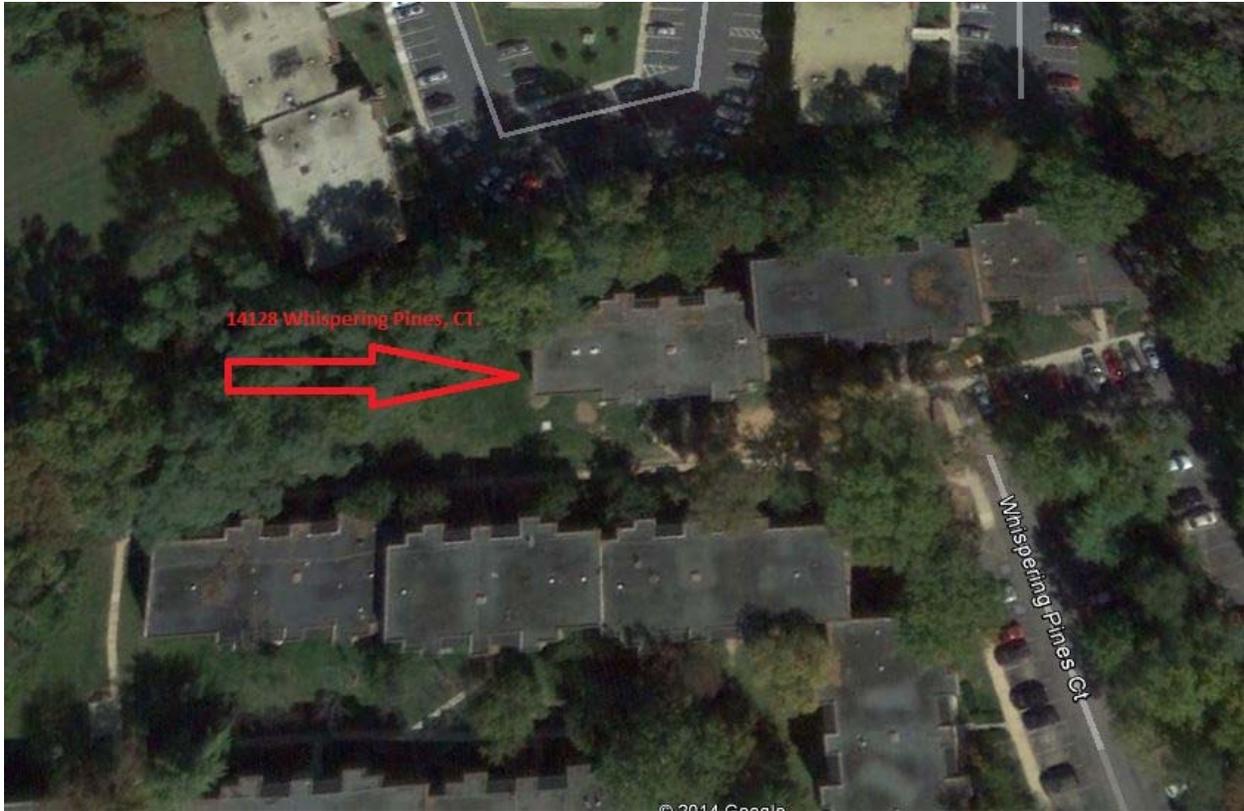
14128 Whispering Pines Court is a three story garden apartment building containing twelve individual apartments. Four apartments were located on each floor of the building with all entrances coming from the main center open stairwell accessed only from the Alpha side. Charlie side access to the structure was only through sliding porch doors on the Charlie side terrace level apartments. The exterior dimensions of the Type III Ordinary Constructed building are 40 x 100 feet with an overall square footage approximating 12,000 square feet. The individual apartments range in square footage from 744 to 1311 square feet.

14128 Whispering Pines Court was connected to a single exposure 14120 Whispering Pines Court, of similar size and construction, by a 26 foot portion of the Side Delta Masonry wall. The building was protected by a local unmonitored alarm system. There was no sprinkler or standpipe present in the structure. Battery operated smoke detectors were present in the individual apartments. The smoke was detected by the occupant before the fire alarm activated.

Apparatus access to the scene was limited by the position of the building at the end of a Court. There was no direct access on the Alpha side for aerial apparatus. The possibility to place an aerial on the Alpha side on the soft ground was prevented by the placement of decorative landscaping boulders. The closest apparatus access to Side Charlie was from the Strathmore House Apartment complex accessed from Bel Pre Road. Units had to cut down a wood fence and traverse a short downhill distance of sixty feet to access the fire building. There was aerial access on the Charlie side in the event a master stream was required but the reach of the closest aerial tower was approximately ten feet short of the roof edge. The first due engine on the Alpha Side with optimal position, was still one hundred and fifty feet from the Alpha Side entrance.

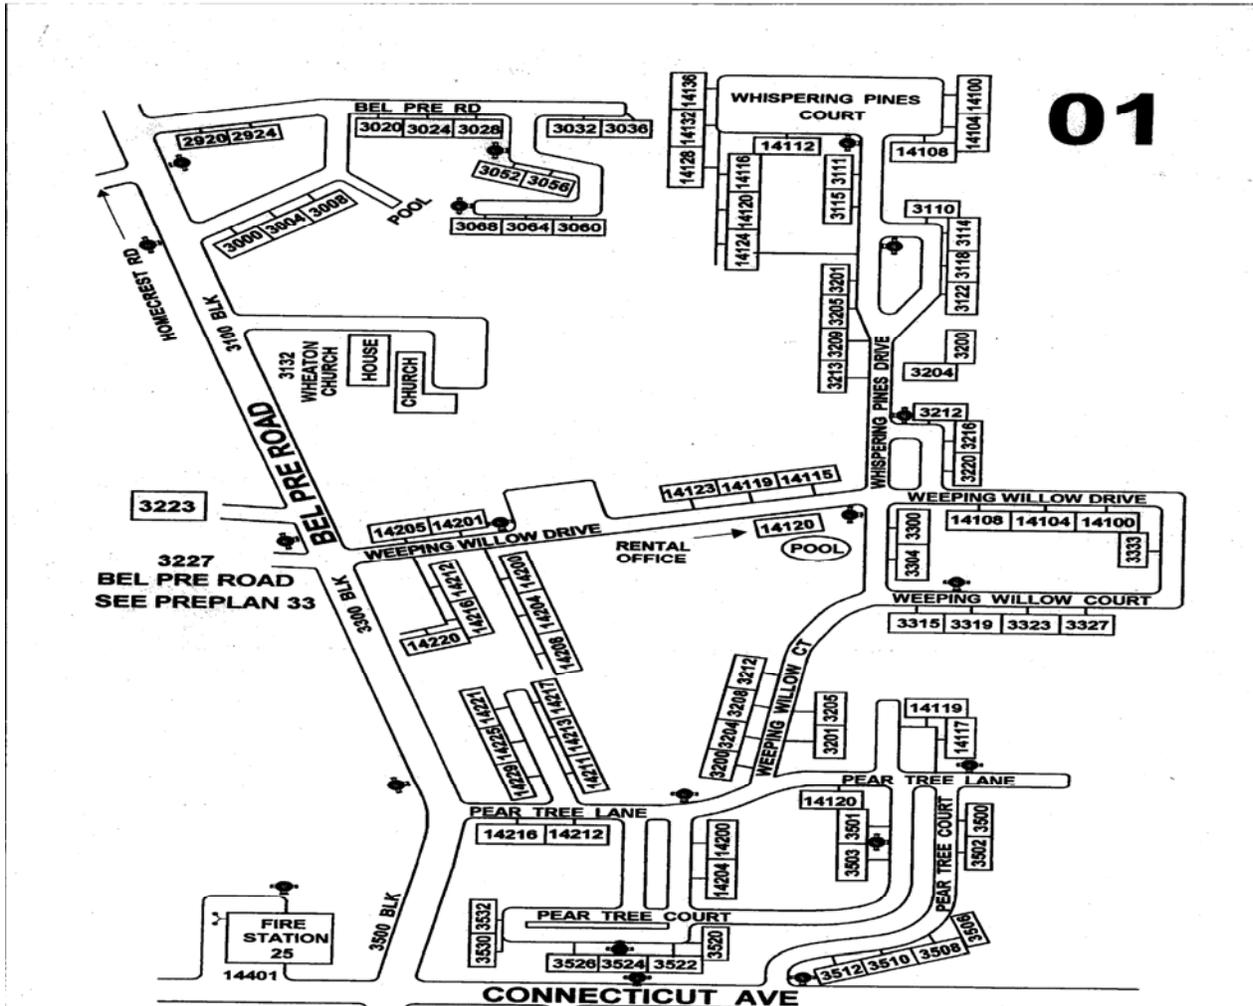
There is no pre-fire plan for the structure other than the current "box map" prepared by Fire Station 25's personnel. The map was available in all responding fire apparatus and units with operating Mobile Data Computers. The map was not accessed or required for use by Incident Commander.
