MONTGOMERY COUNTY FIRE AND RESCUE SERVICE POST-INCIDENT ANALYSIS

Townhouse Fire with 1 Fatality
Box Area 08-02
996 West Side Drive
April 2, 2017
Incident # 17-00500214

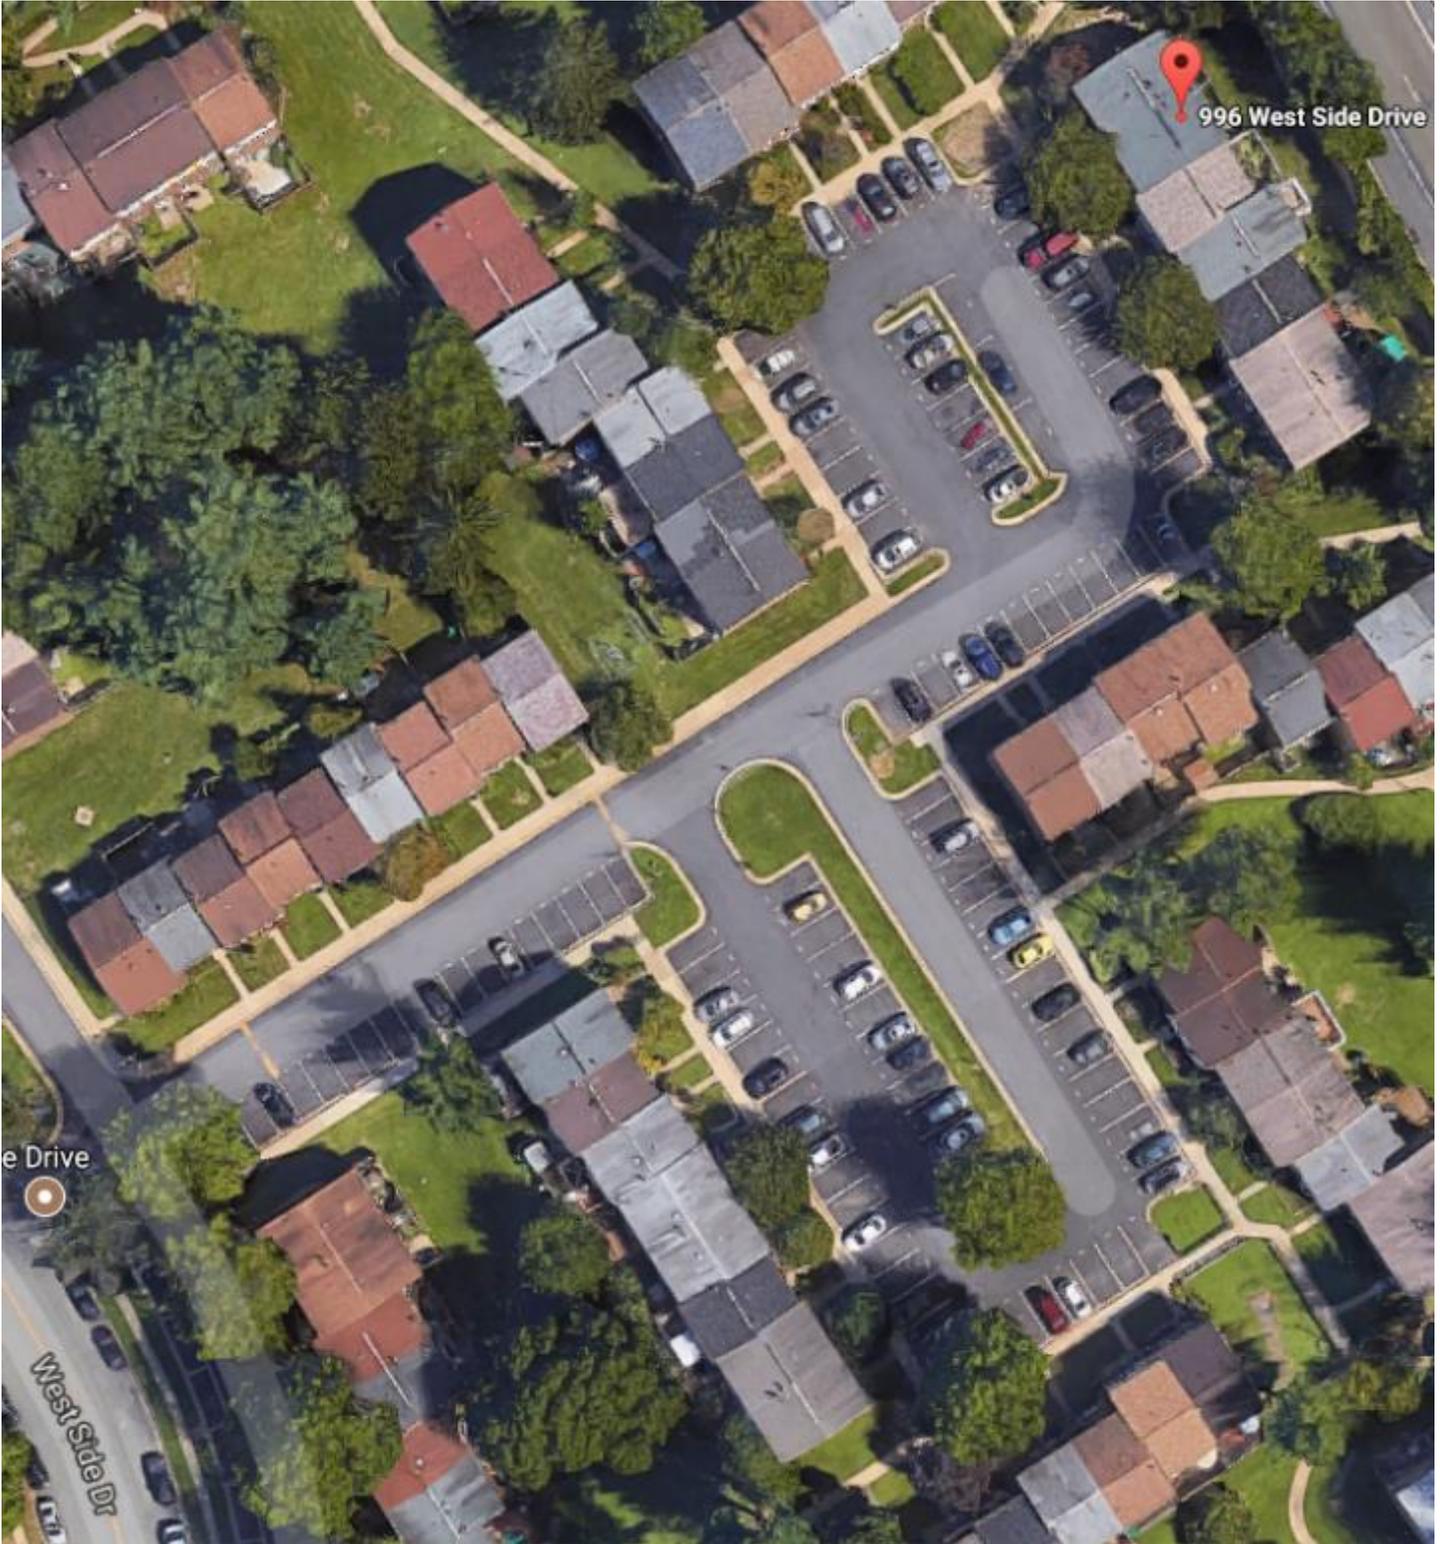
The structure at 996 West Side Drive is part of a residential neighborhood comprised of other similar style and constructed homes. There are no fixed fire suppression systems. The townhouse is a two-story middle of the row dwelling with a basement built in 1994. Side Charlie is two stories without a basement exterior entrance.

The construction is Type Five with brick veneer. The roof covering is asphalt shingles. The home is 1,806 square feet. There is no garage and only street parking on Side Alpha. Both the Bravo and Delta attached exposures were occupied at the time of the incident. There is a concrete patio on Side Charlie with a privacy fence on both the Bravo and Charlie sides.

The closest hydrant was two hundred and forty feet away in the complex. This hydrant was laid out from but not used until late in the incident. Instead the hydrant in the cul-de-sac of West Side Drive was used by the first and fourth due as the main water source. This hydrant is four hundred feet away.
